# GLEN ROAD PEDESTRIAN BRIDGE ENVIRONMENTAL ASSESSMENT STUDY PUBLIC INFORMATION CENTRE #2 OCTOBER 24, 2017

# Welcome to the second Public Information Centre (PIC) for the Glen Road Pedestrian Bridge Class Environmental Assessment

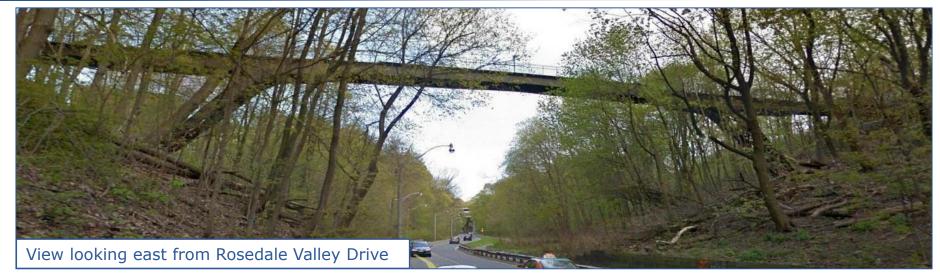
- Existing structure was built in 1973; steel inclined leg rigid frame bridge with a timber deck
- Three (3) spans structure; totaling 107 m
- Deck width ~ 3.7 m; Height ~ 20 m
- The 2014 routine inspection revealed substantial deterioration at a greater rate than expected
- Emergency repairs in 2015 were not intended to be a long-term solution, as corrosion will continue. The bridge remains safe but requires replacement

View of corrosion on inclined leg

View looking south

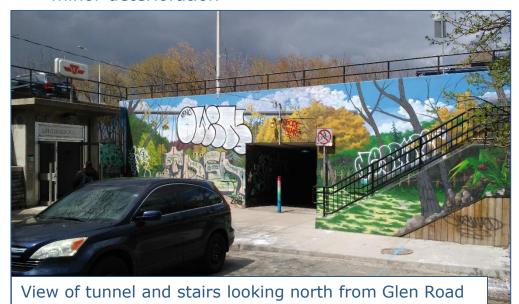
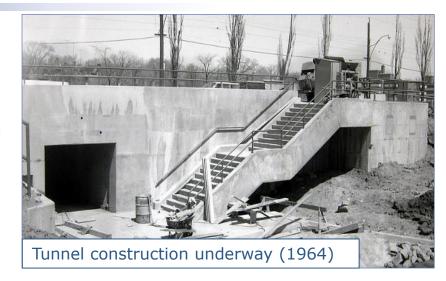
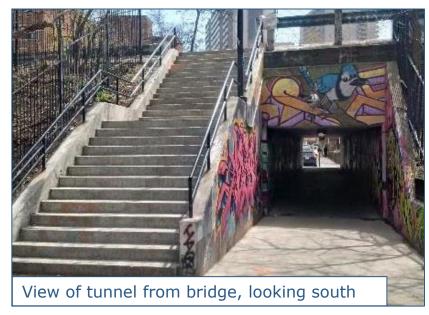
- Tunnel construction initiated in 1962
- Rigid frame reinforced concrete box structure
- 26.2m long; 2.4m wide; 2.9m high
- Bloor Street East access from staircases at north and south end of tunnel
- Utilities are located below, parallel and above the tunnel
- Tunnel inspection for this study identified the structure is generally in good condition with local minor deterioration

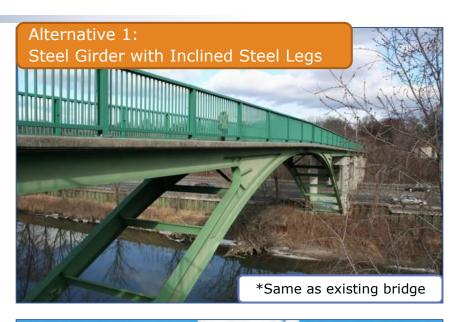
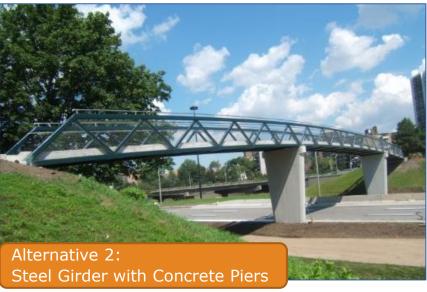
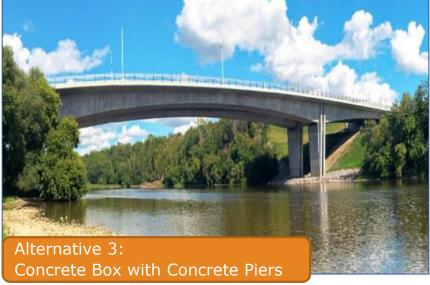
Three bridge types were chosen for evaluation, as shown here.

These bridge types were considered based on the study area topography, and ability to be sympathetic to the cultural heritage value of the existing bridge.

#### Alternative 1 Steel Girders with Inclined Steel Legs

#### Alternative 2 **Steel Girders with Concrete Piers**

#### Alternative 3 **Concrete Box with Concrete Piers**

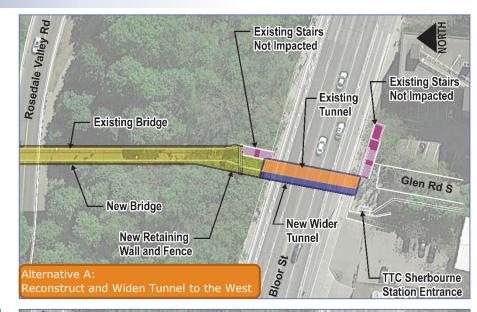
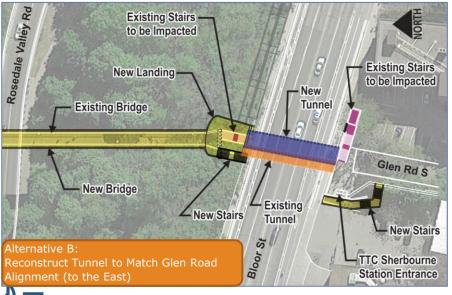
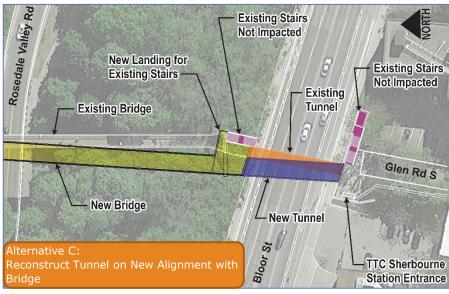
Three tunnel widening alternatives were generated for evaluation, as shown here.

Existing Tunnel

Tunnel Alternative

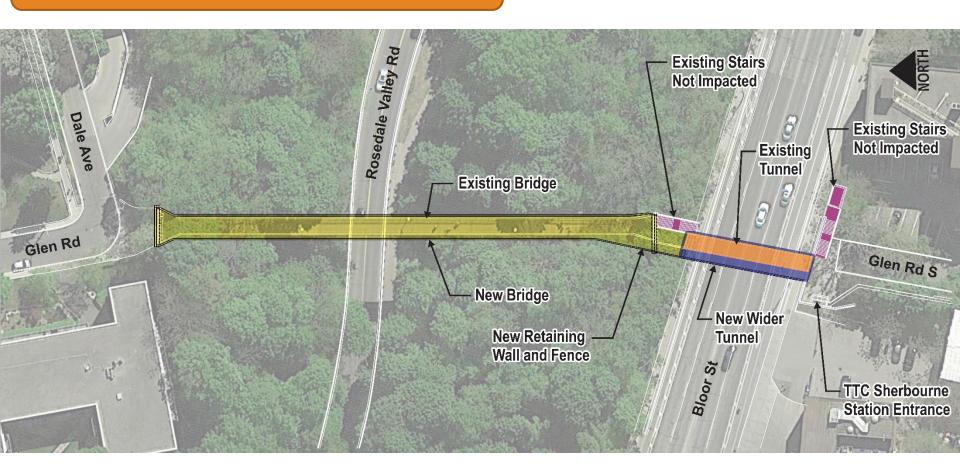
Alternative A:

Reconstruct and Widen Tunnel to the West

- Replace the bridge in the same location with a steel girder incline leg bridge type, and
- Replace and the widen the tunnel to the west.

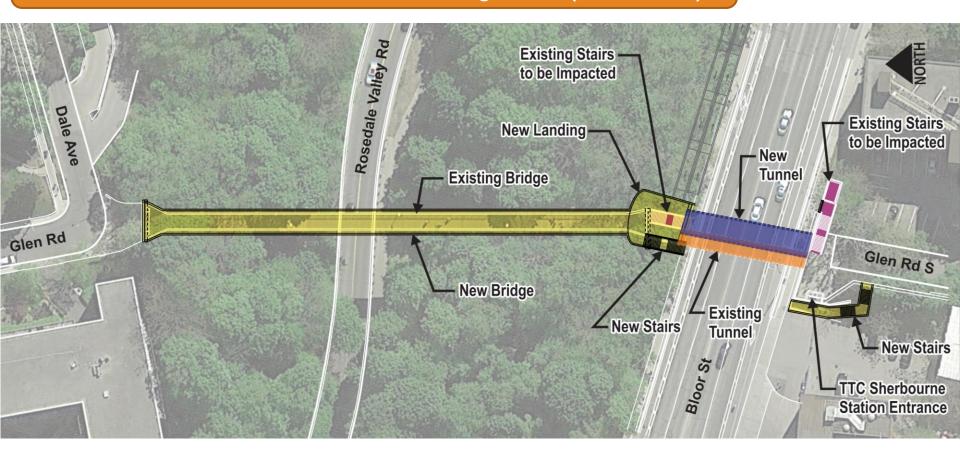
Alternative B:

Reconstruct Tunnel to Match Glen Road Alignment (to the East)

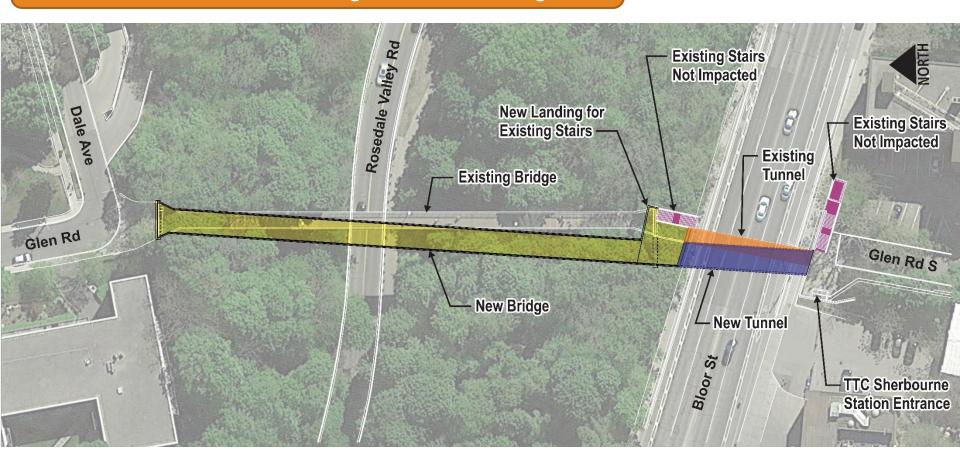
Alternative C:

Reconstruct Tunnel on New Alignment with Bridge

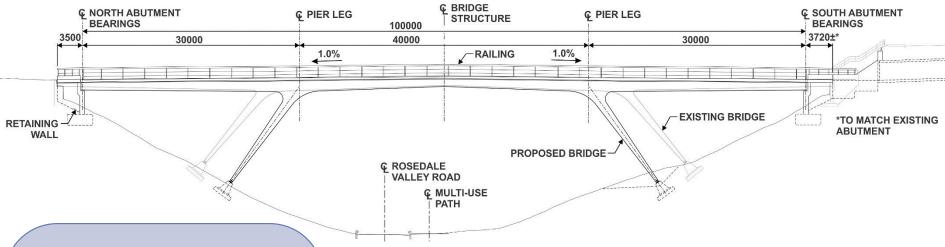
- The cross-section was developed based on the Toronto Multi-Use Trail Design Guidelines.
- A 4.8m cross-section is proposed as the bridge and tunnel are considered a High-Capacity Trail based on the various types of users, volume, and adjacent destinations including the TTC entrance.
- Designated for pedestrian use only.
- Maintaining existing requirement for cyclists to dismount on bridge and through tunnel.
