Phase 1 Environmental Site Assessment

**PHASE I ENVIRONMENTAL SITE ASSESSMENT
SCARBOROUGH CENTRE
TRANSPORTATION MASTER PLAN
CITY OF TORONTO, ONTARIO**

LEA Consulting Ltd.

Date: December 15, 2016
File: 12114

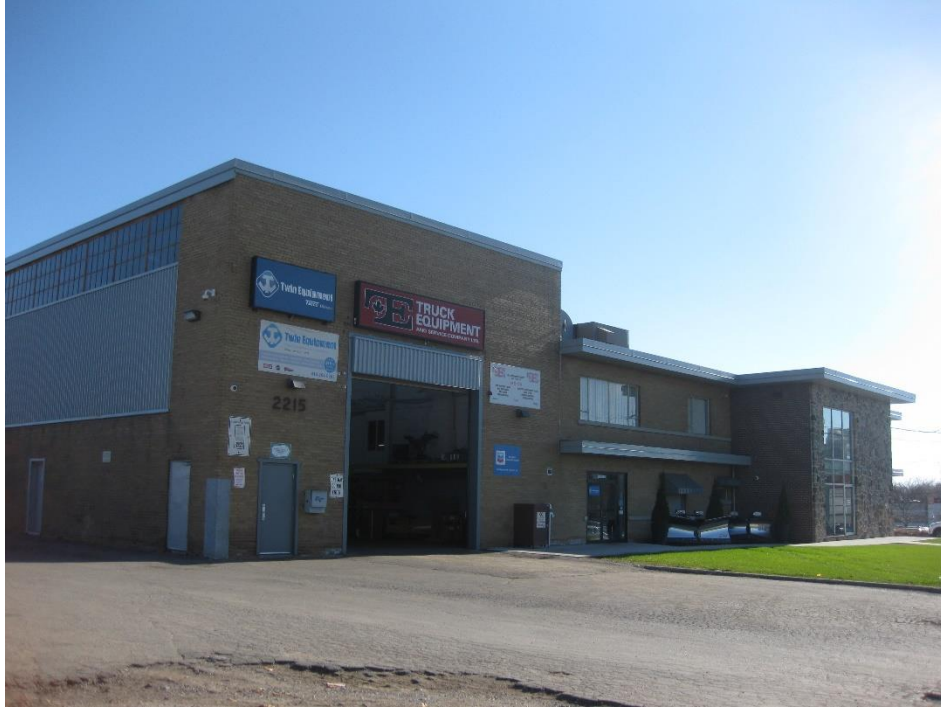
- The land usage along Midland Avenue between Highway 401 and Progress Avenue mainly consisted of industrial and commercial properties including shops and warehouses. Automobile parts shops were observed at 2250 and 2285 Midland Avenue, and a truck equipment manufacturing facility was observed at 2215 Midland Avenue (Photo 1).

Photo 1: Truck Equipment manufacturer at 2215 Midland Avenue

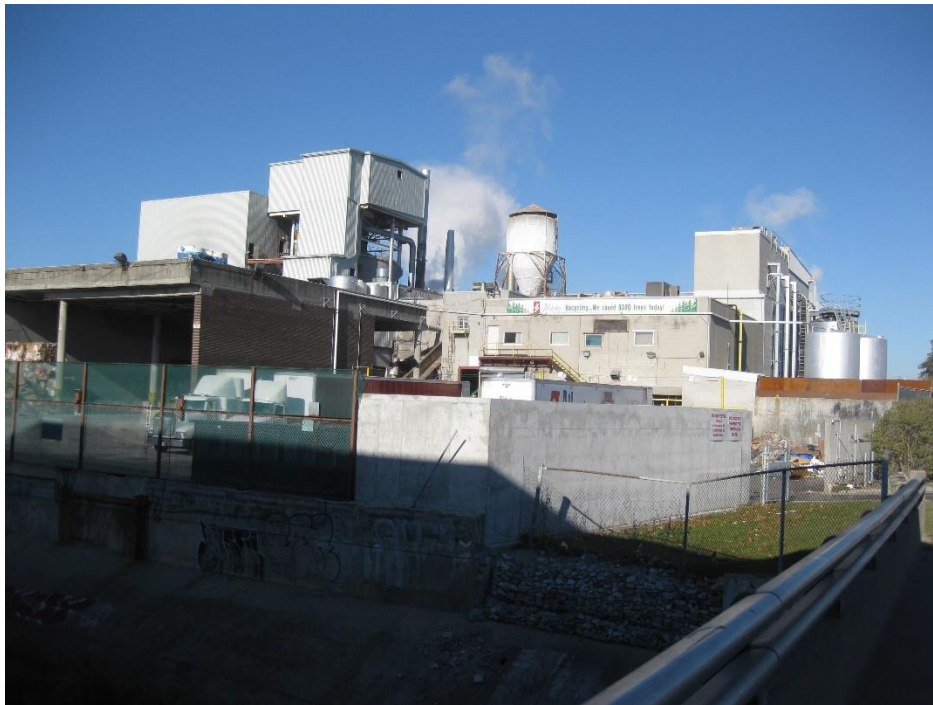
- An Atlantic Packaging Products factory was observed along the west side of Midland Avenue between the TTC Scarborough RT corridor and Progress Avenue (111 Progress Avenue) (Photos 2 and 3). Commercial shops and warehouses were observed on the east side of Midland Avenue across from the factory. The Scarborough RT track and Midland Station cross Midland Avenue at approximately 275 m south of Progress Avenue.

Photo 2: Atlantic Packaging Products factory, facing north

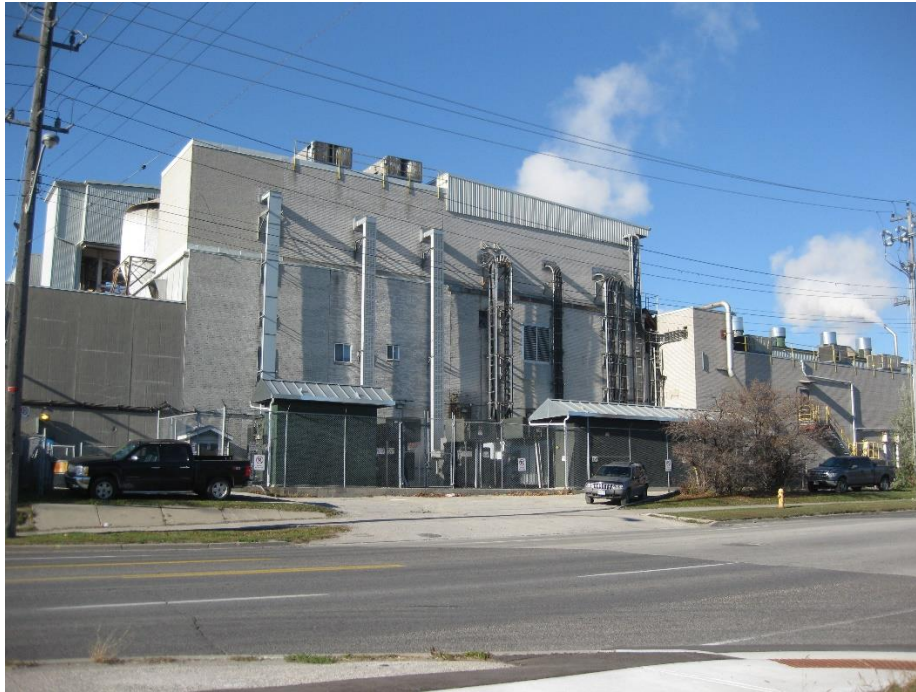
Photo 3: Atlantic Packaging Products factory, facing west

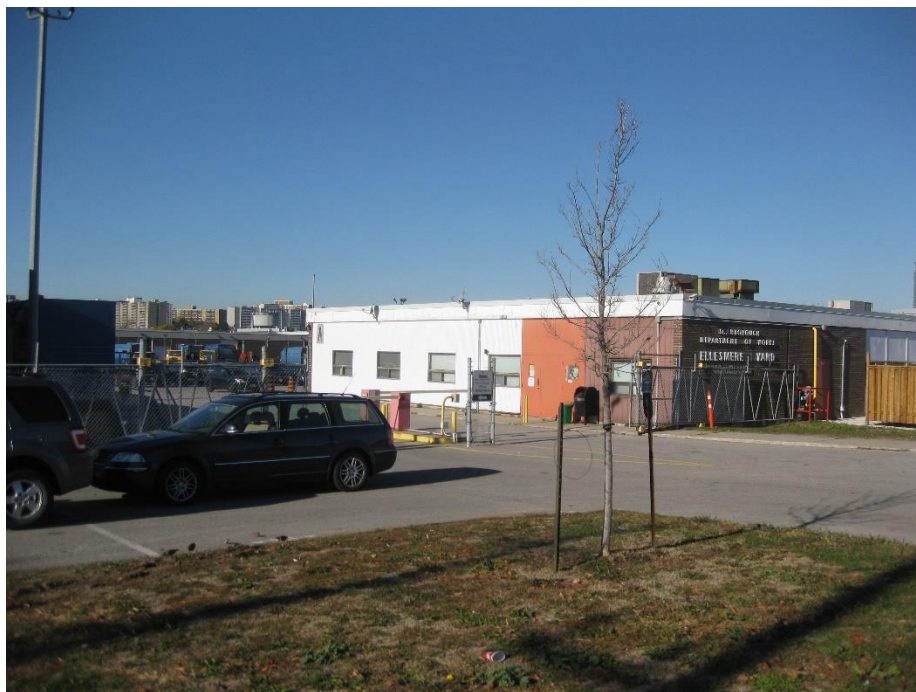
- The Scarborough Department of Works Ellesmere Yard was observed on the west side of Midland Avenue south of the RT tracks at 2000 Midland Avenue (Photo 4). Several garbage trucks were observed on the property (Photo 5). Commercial shops, warehouses and offices were observed on the east side of Midland Avenue between the RT tracks and Ellesmere Road. Commercial plazas were observed on the south side of Ellesmere Road at Midland Avenue.

Photo 4: Ellesmere works yard, facing northwest

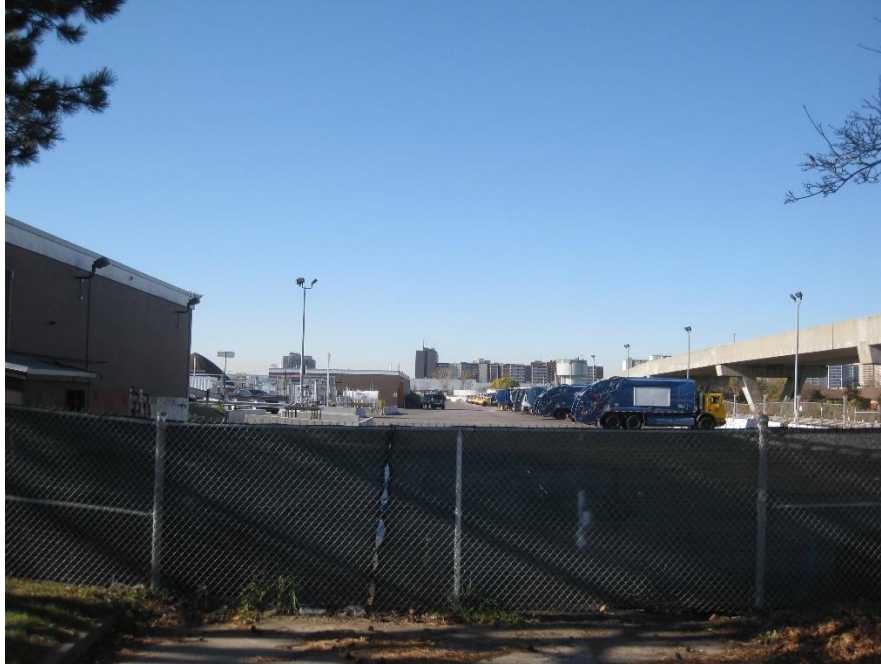
Photo 5: Garbage trucks at Ellesmere works yard, facing west

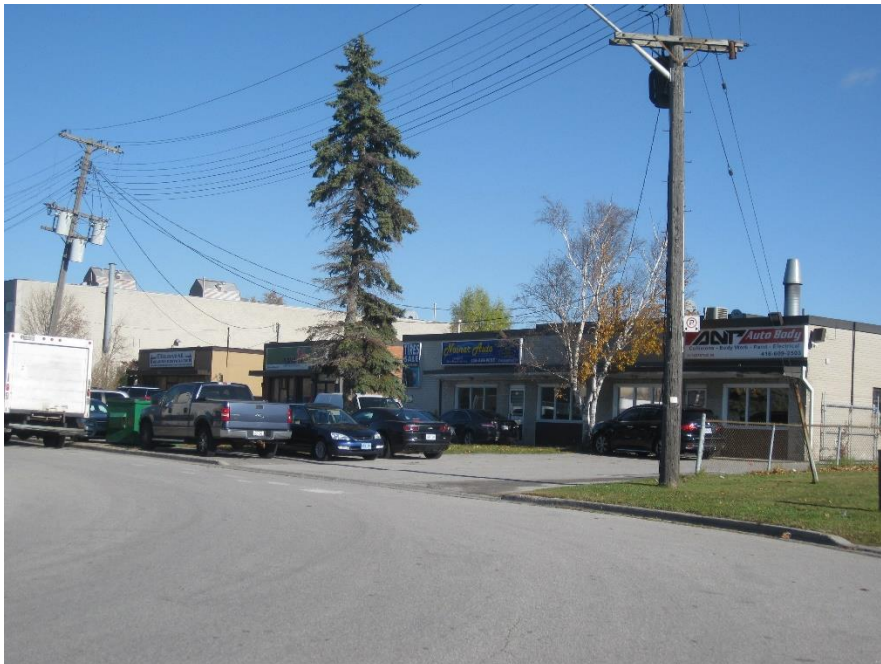
- Several automotive repair shops and other commercial warehouse buildings were observed along Cosentino Drive, east of Midland Avenue (Photo 6). A plastic bottle manufacturing facility with several above ground storage tanks (Silgan Plastics) was located at 1200 Ellesmere Road, east of Midland Avenue.

Photo 6: Automotive repair shops on Consentino Drive, facing northeast

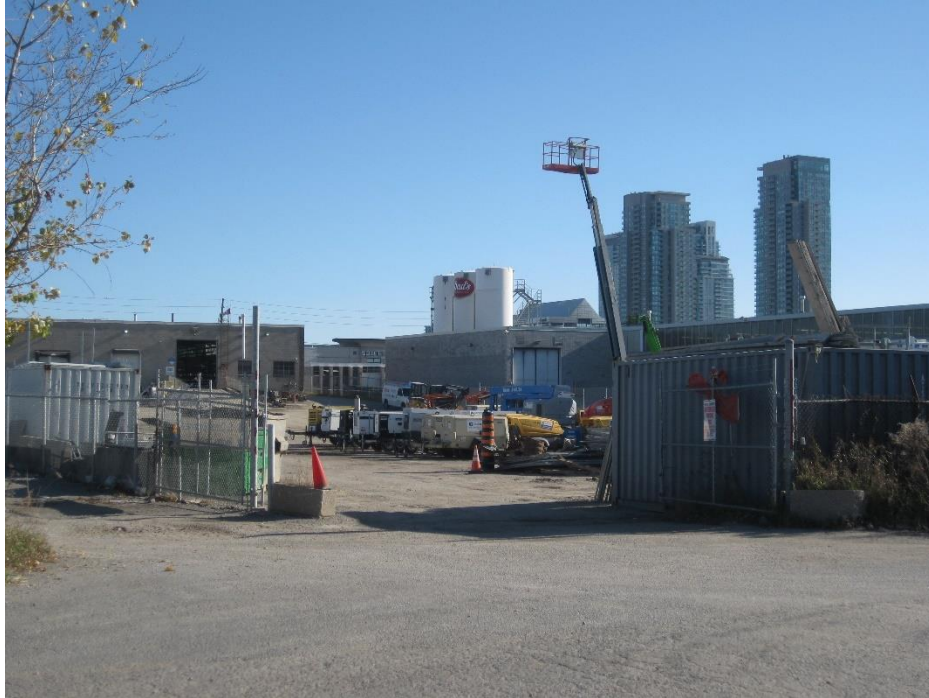
- An Atlantic Packaging Products factory was observed at 333 Progress Avenue, west of Brimley Road. Cooper Rental Equipment was observed near the northwest corner of Brimley Road and Progress Avenue (1750 Brimley Road), which contained storage of industrial equipment including generators and hydraulic boom lifts to the west of the building (Photo 7).

Photo 7: Cooper Equipment Rental storage yard, facing east

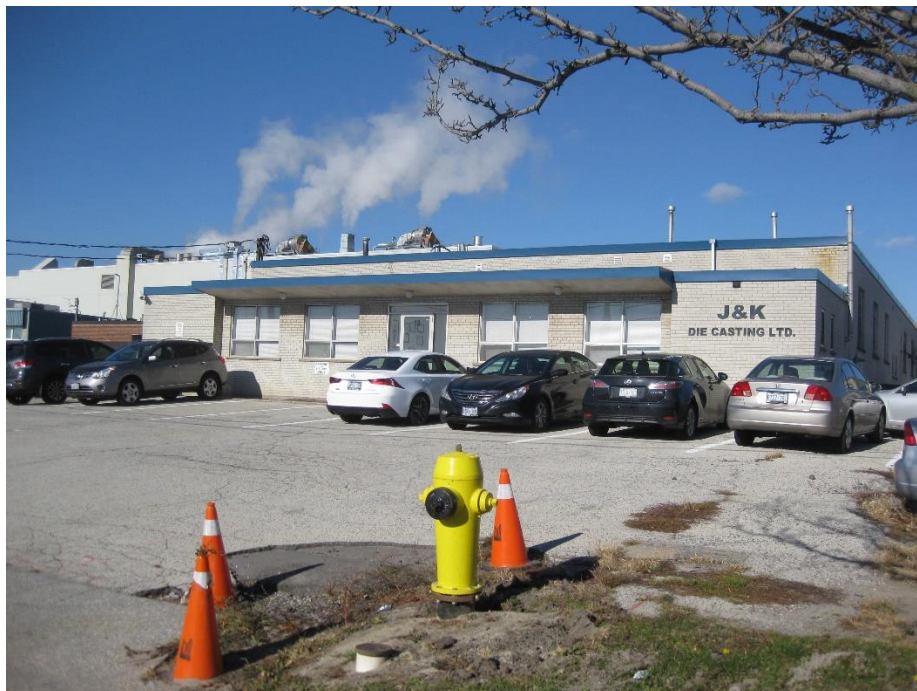
Photo 8: Industrial property (die casting) on Golden Gate Court, facing north

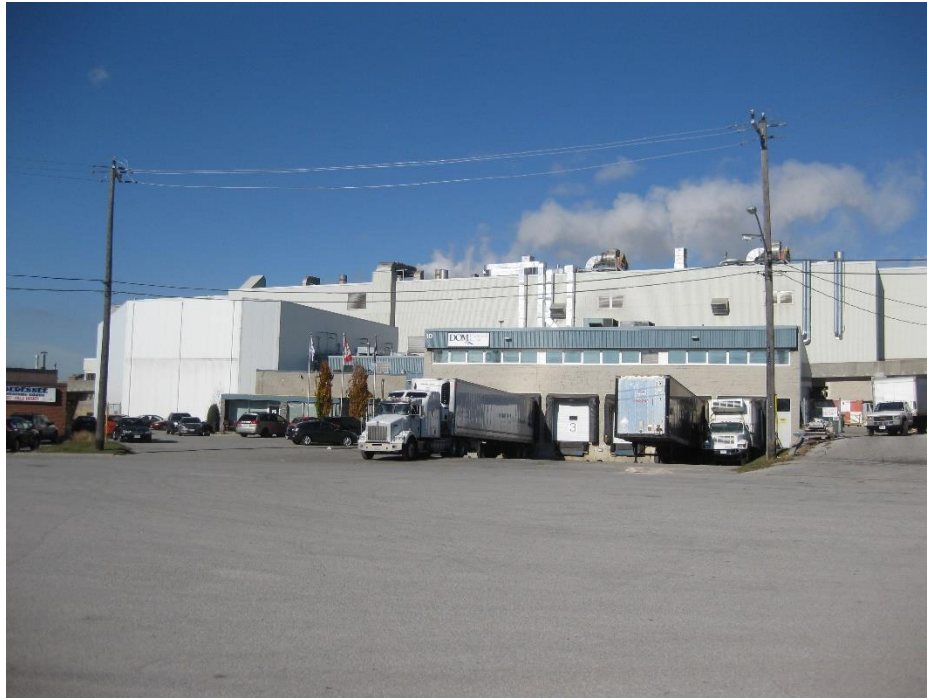
Photo 9: Distribution warehouse on Golden Gate Court, facing north

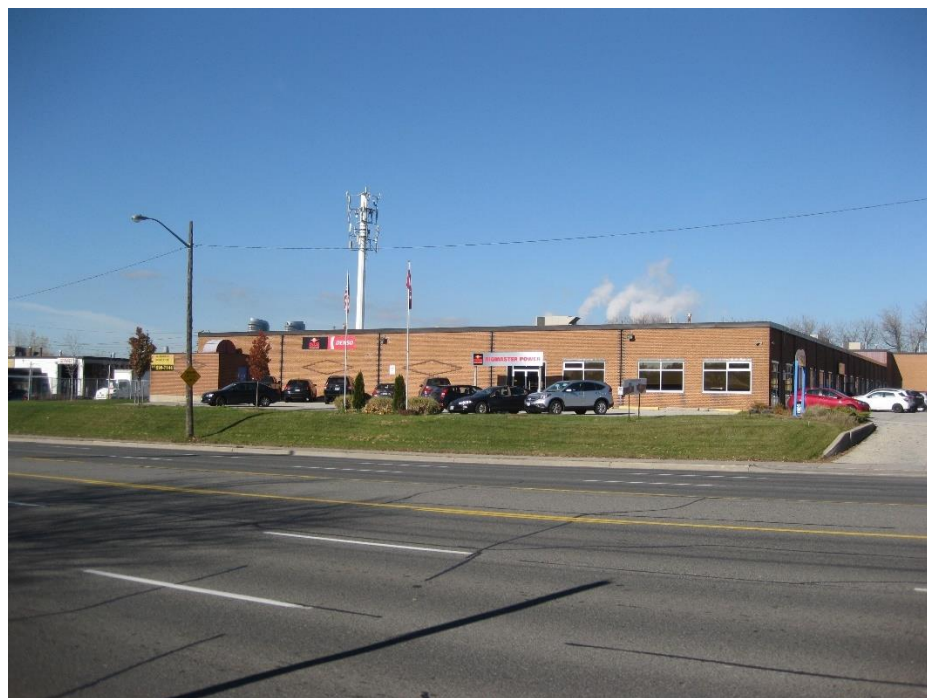
- Several industrial and commercial properties were observed along the north side of Ellesmere Road, west of Brimley Road including truck parts manufacturing, an

Photo 10: Truck part manufacturing at 1320 Ellesmere Road, facing north

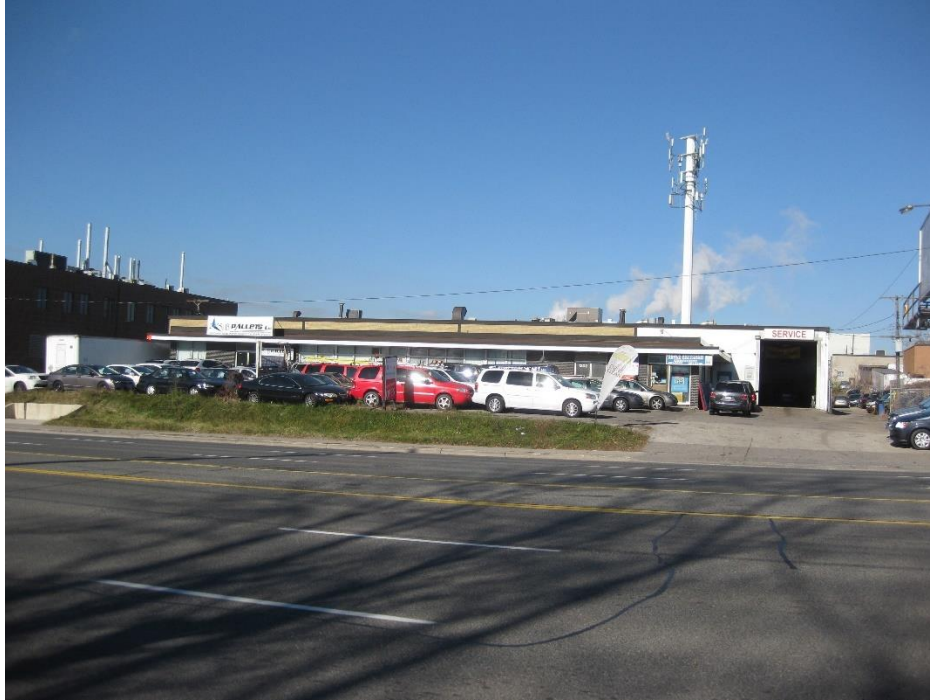
automotive repair shop, an analytical laboratory and window and door manufacturing (Photos 10 to 12). A Petro-Canada gas station was observed at the southwest corner of Ellesmere Road and Brimley Road (1270 Brimley Road) (Photo 13).

Photo 11: Automotive repair shop at 1300 Ellesmere Road, facing north

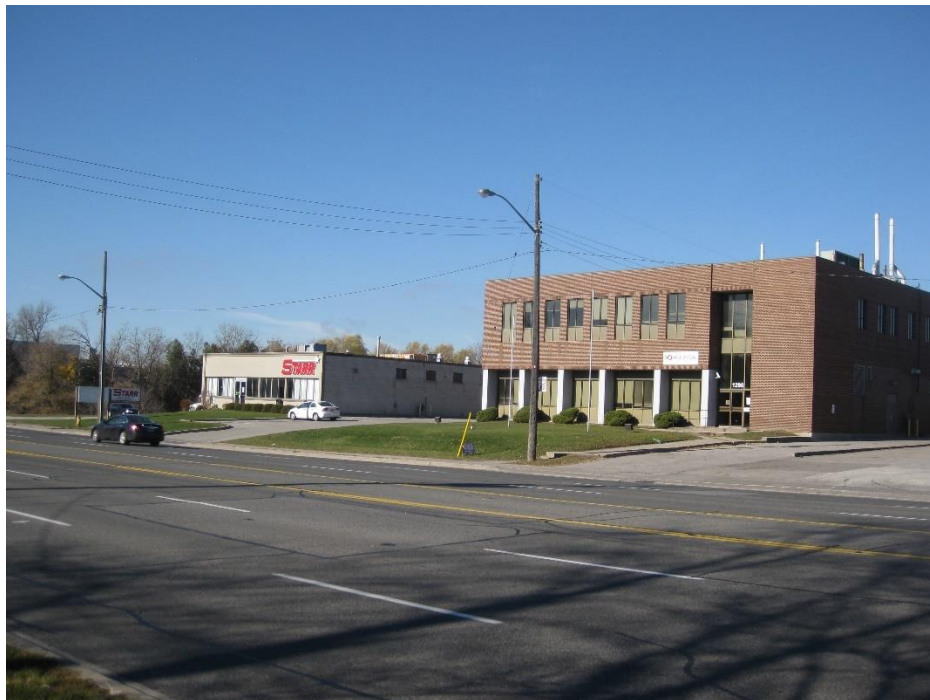
Photo 12: Window manufacturing at analytical laboratory (1276 & 1290 Ellesmere Road), facing north

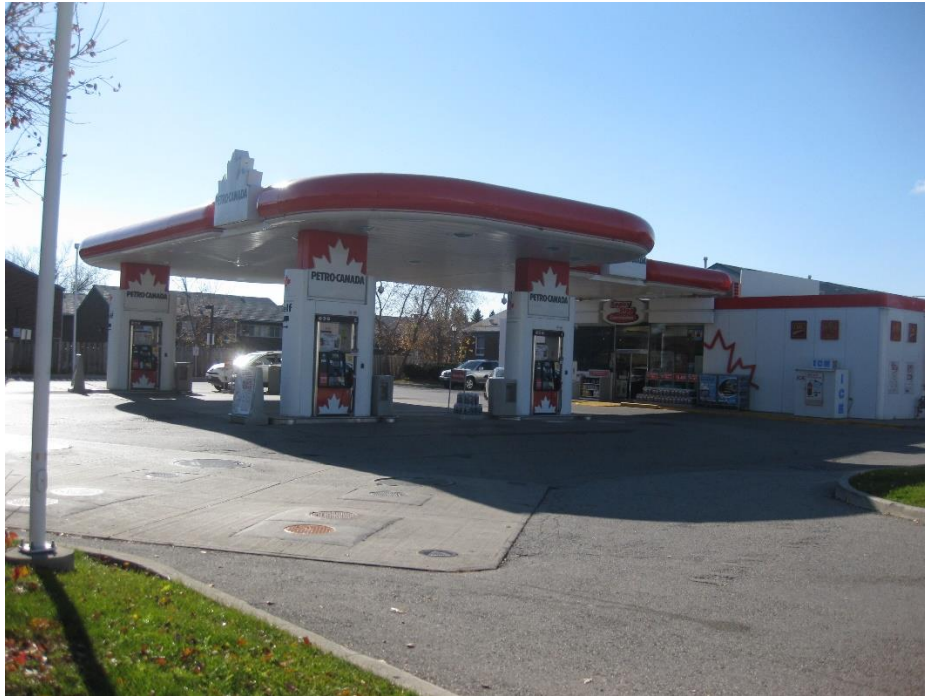
Photo 13: Gas station at 1270 Brimley Road, facing southwest

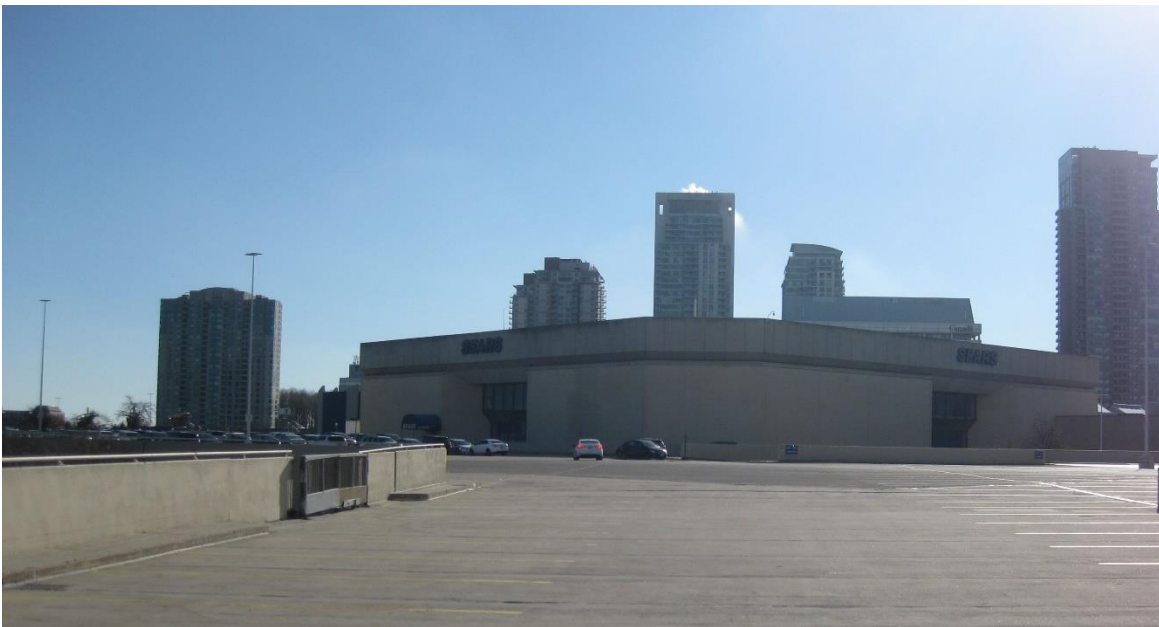
Photo 14: Facing south toward Scarborough Town Centre and residential apartments

- The majority of the land usage between Brimley Road and McCowan Road consisted of commercial, residential and city properties. The Scarborough Town Centre shopping mall and other commercial stores were observed to the north of the RT tracks, and the Scarborough Civic Centre and residential buildings were observed to the south of the RT tracks (Photo 14). The Scarborough Station for the Scarborough RT was located immediately south of the shopping mall. A small works yard was observed near 510 Progress Avenue, north of the shopping mall (Photo 15). A CTV broadcasting facility was observed on the west side of McCowan Road, north of Highway 401 at 9 Channel Nine Court. At the southwest and southeast corners of Ellesmere Road and McCowan Road, ESSO and Petro-Canada gas stations were observed (1615 and 1651 Ellesmere Road, respectively) (Photos 16 and 17).

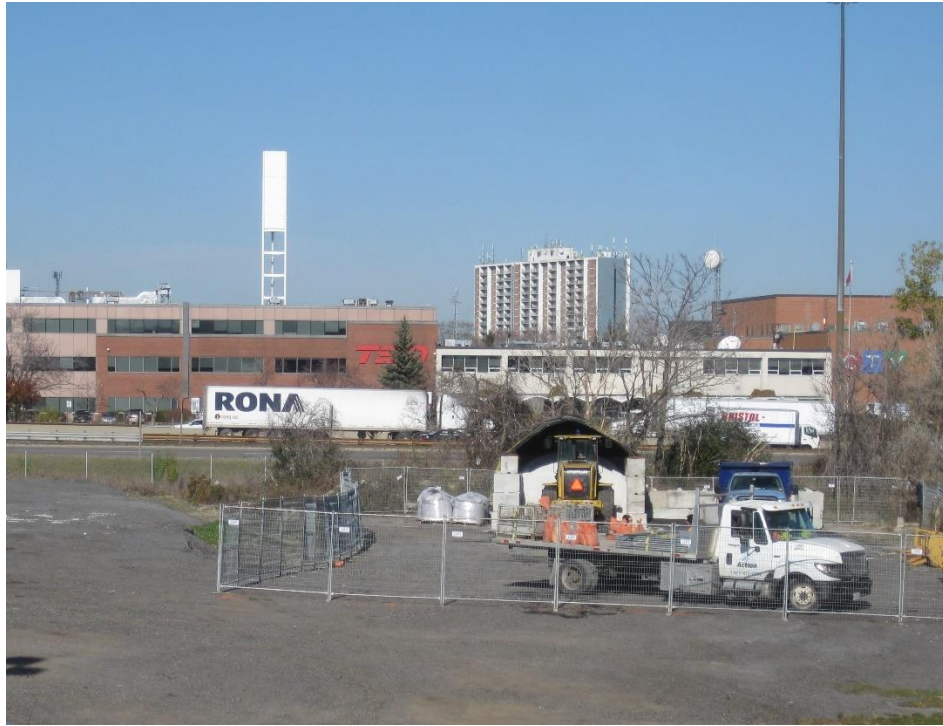
Photo 15: Works yard north of Scarborough Town Centre, facing north

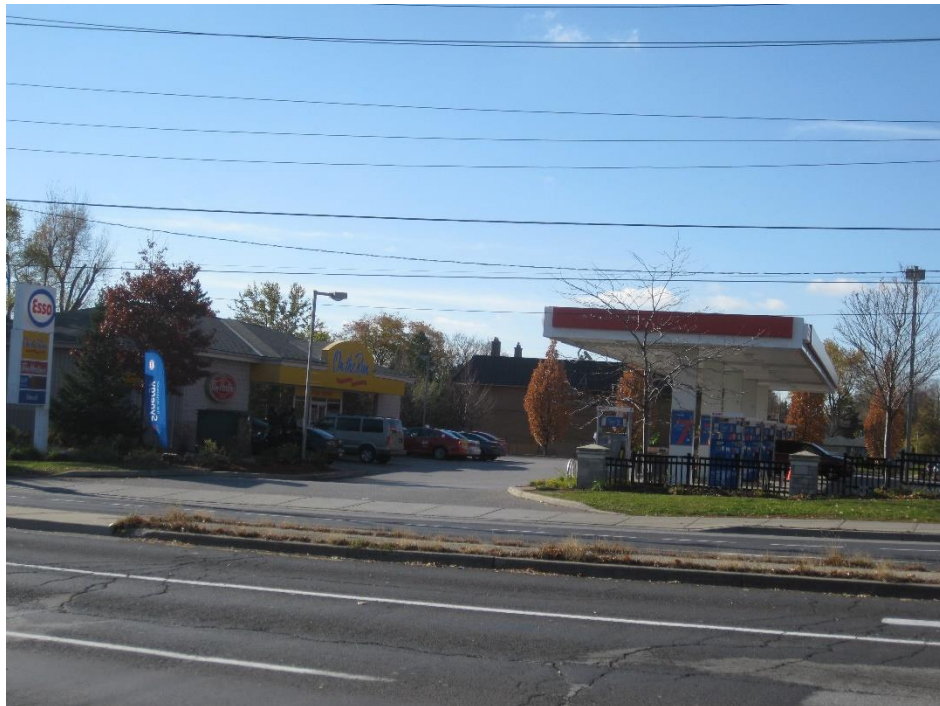
Photo 16: Gas station at 1615 Ellesmere Road, facing west

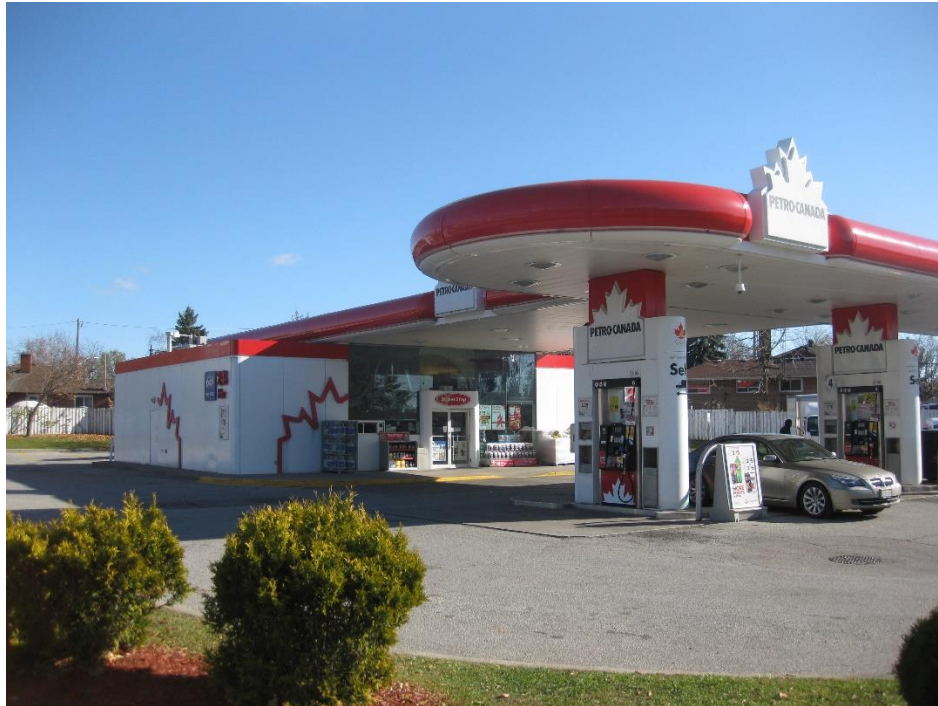
Photo 17: Gas station at 1651 Ellesmere Road, facing southeast.

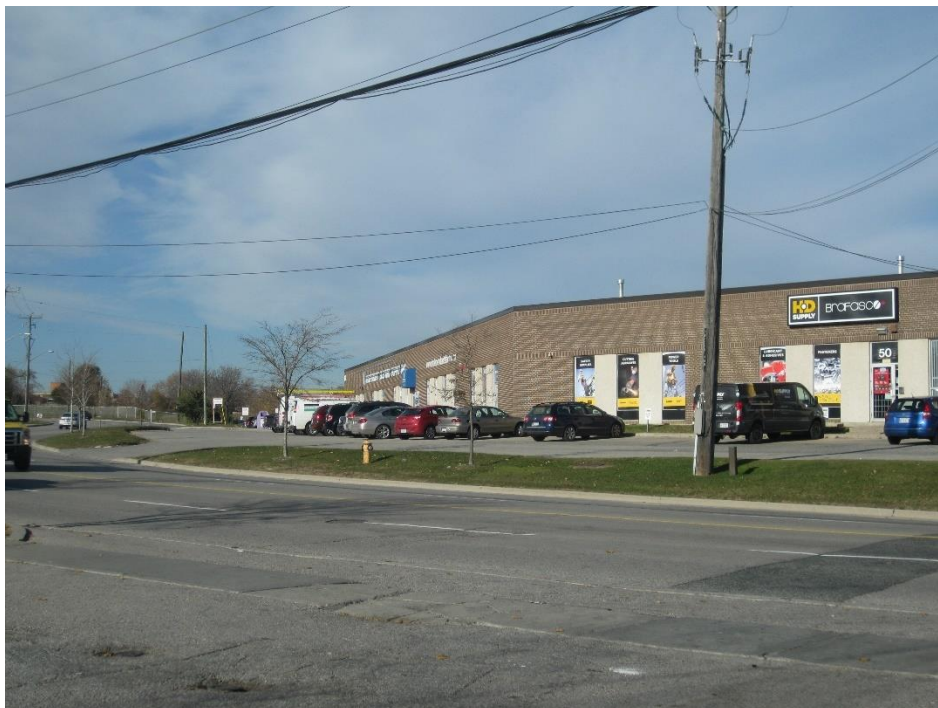
- North of Highway 401, several industrial and commercial warehouses and plants were observed along Milner Avenue between McCowan Road and Markham Road (Photos 18 to 20).

Photo 18: Commercial buildings at 48 Milner Avenue, facing north

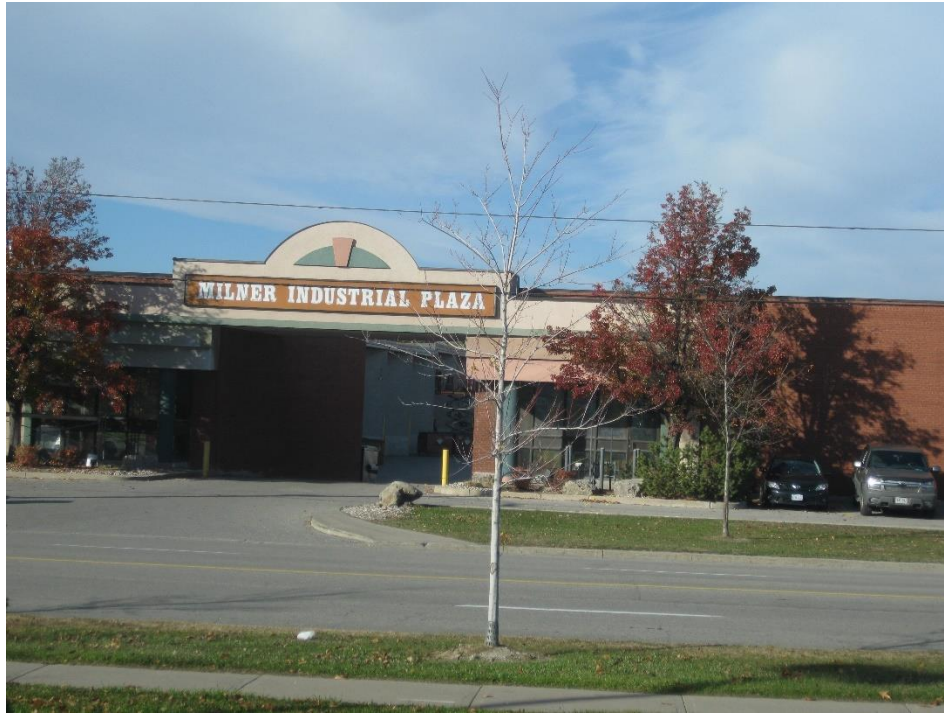
Photo 19: Industrial buildings at 140-150 Milner Avenue, facing north

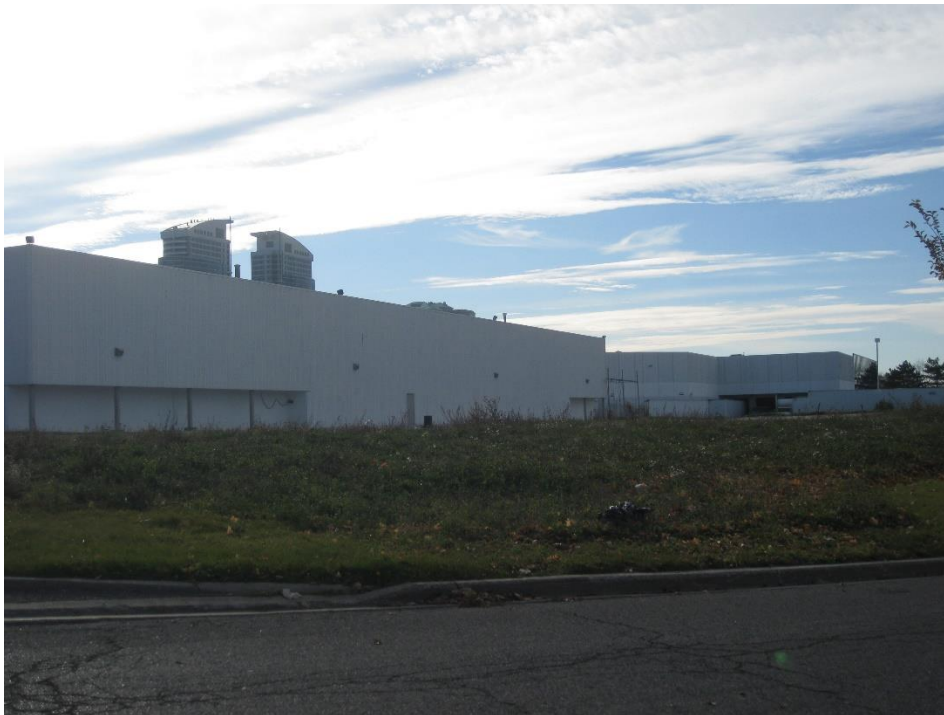
Photo 20: Warehouse at 165 Milner Avenue, facing southwest

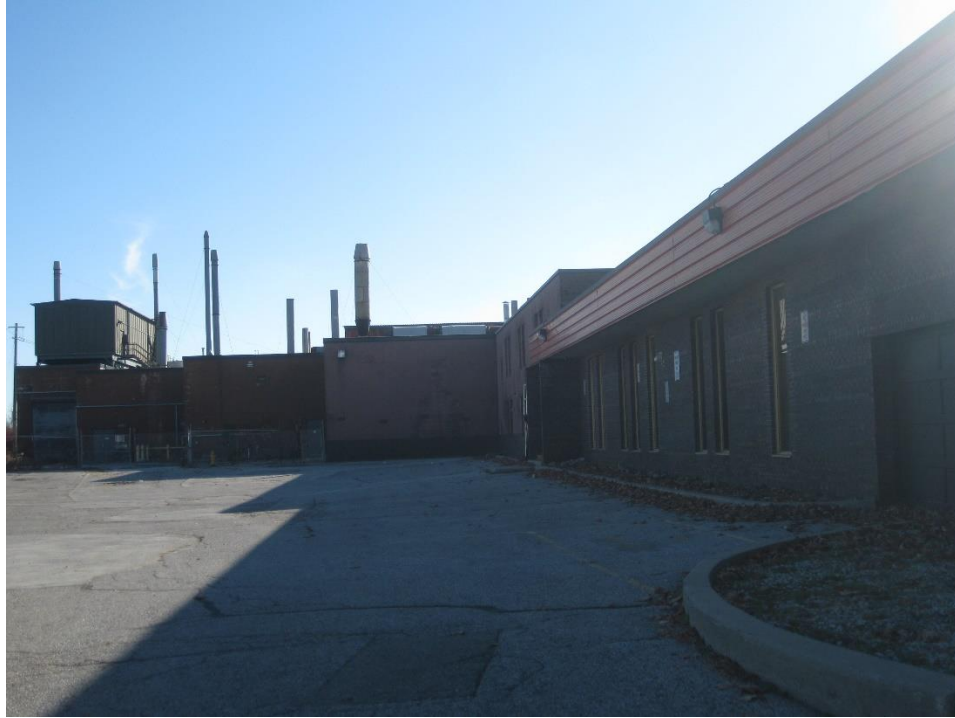
- Several industrial and commercial warehouses were observed along Progress Avenue between Grangeway Avenue and Bellamy Road N, including a large factory that appeared to be vacant at 675 Progress Avenue (Photo 21). A Scarborough RT railway yard (TTC McCowan Yard) was observed at 1720 Ellesmere Road, south of the vacant factory. A dry-cleaning shop (Parkers Dry Cleaners) was observed at 1744 Ellesmere Avenue, south of the railway yard.

Photo 21: Possibly vacant factory at 675 Progress Avenue, facing south

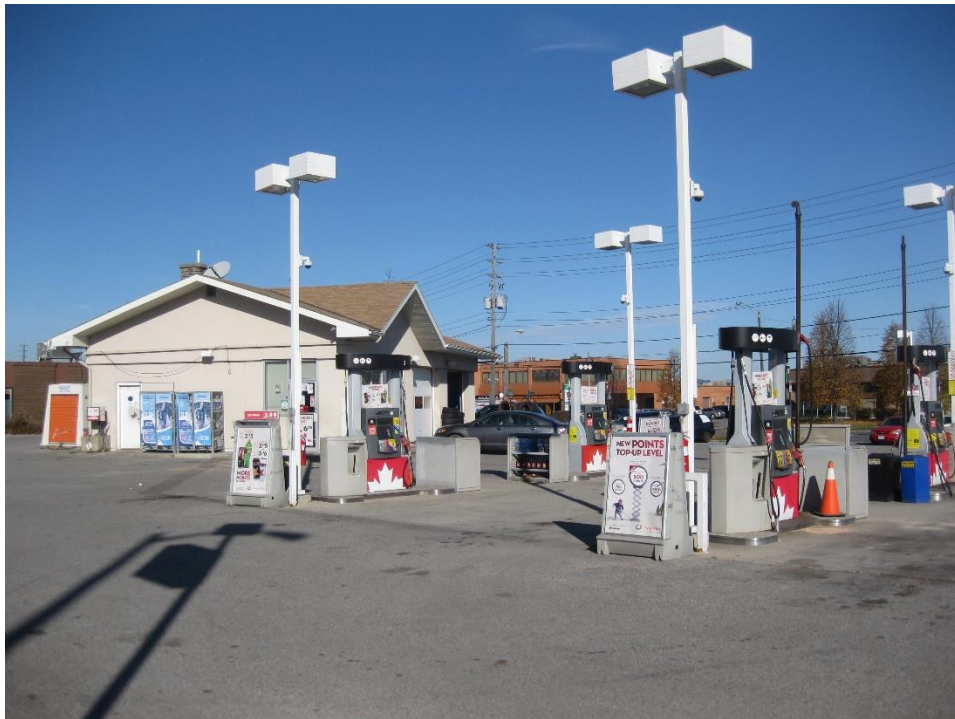
- Several commercial buildings were observed along Bellamy Road N and on the north side of Ellesmere Road, west of Bellamy Road N. A Petro-Canada gas station and automotive repair shop were observed at the northwest corner of Bellamy Road N and Ellesmere Road (1860 Ellesmere Road) (Photo 22).

Photo 22: Gas station at 1860 Ellesmere Road, facing northeast

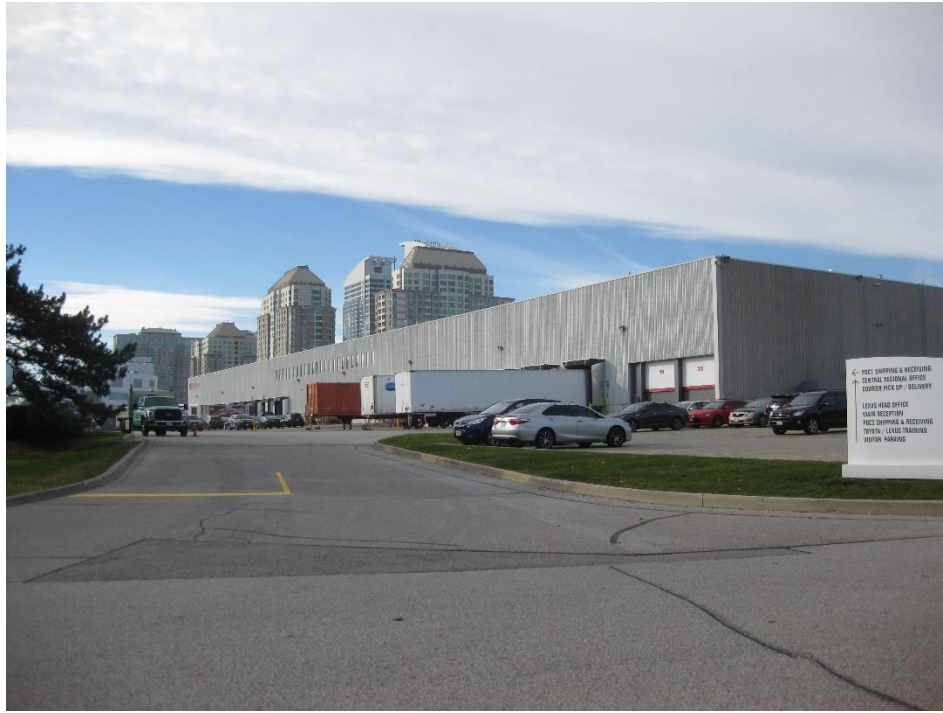
- East of Bellamy Road, a large Toyota office building / warehouse was observed on the north side of Progress Avenue (1 Toyota Place) (Photo 23). South of Progress Avenue, several industrial and commercial buildings were observed between Bellamy Road N and Production Drive, including a Bell Canada facility with a vehicle storage yard.

Photo 23: Toyota facility at 1 Toyota Place, facing northwest

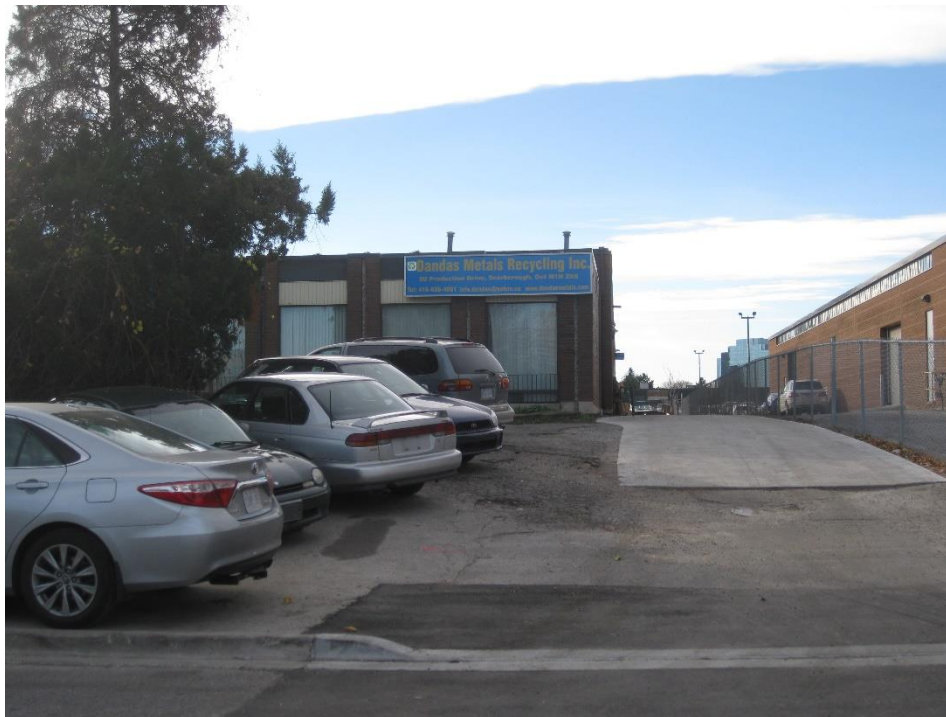
- On Production Drive, south of Progress Avenue, several industrial buildings were observed, including a printing facility, elevator manufacturing, Penske truck rentals, and metal recycling (Photo 24).

Photo 24: Metal recycling facility at 52 Production Drive, facing west

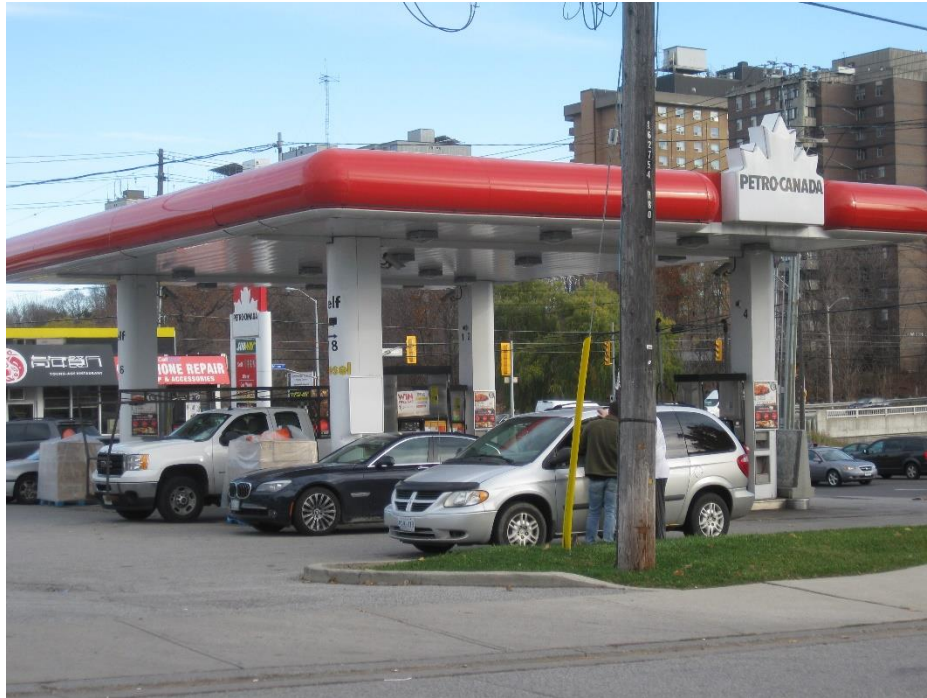
- Various industrial and commercial properties were observed along Estate Drive, west of Markham Road. A Petro-Canada gas station was observed between Estate Drive and Markham Road at 900 Progress Avenue (Photo 25).

Photo 25: Gas station at 900 Progress Avenue, facing east

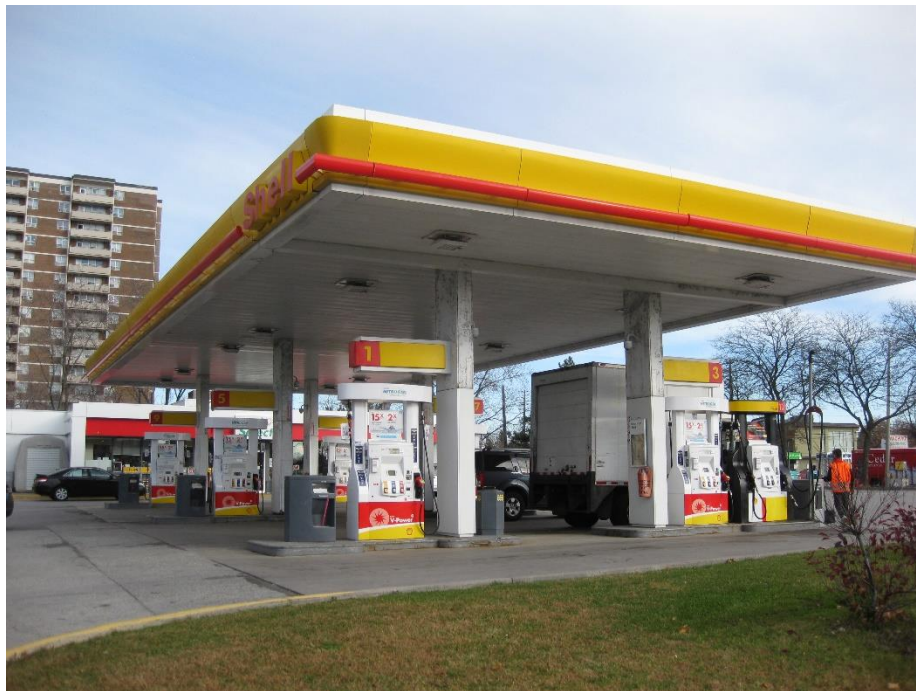
- Several multi-tenant industrial and commercial buildings were observed along the north side of Ellesmere Road between Bellamy Road N and Markham Road, including multiple automotive repair shops and various manufacturing companies. A Shell gas station and an ESSO gas station were observed at the northeast and southwest corners of Markham Road and Ellesmere Road respectively (1201 and 1150 Markham Road) (Photos 26 and 27).

Photo 26: Gas station at 1201 Markham Road, facing east

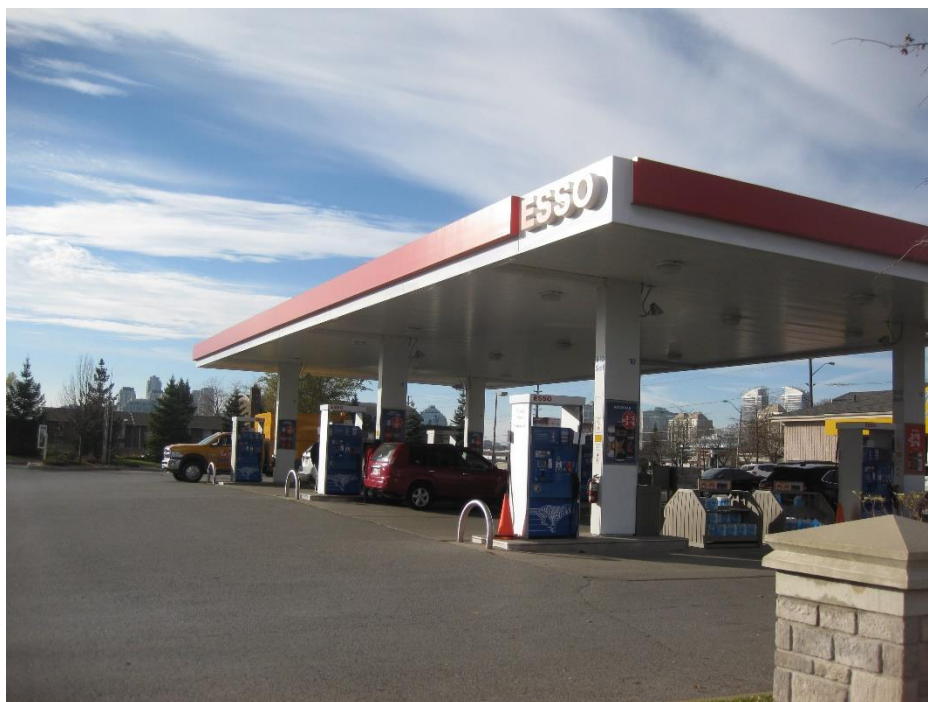
Photo 27: Gas station at 1150 Markham Road, facing west
