HUMBER TREATMENT PLANT

2018 Annual Report

March 28, 2019

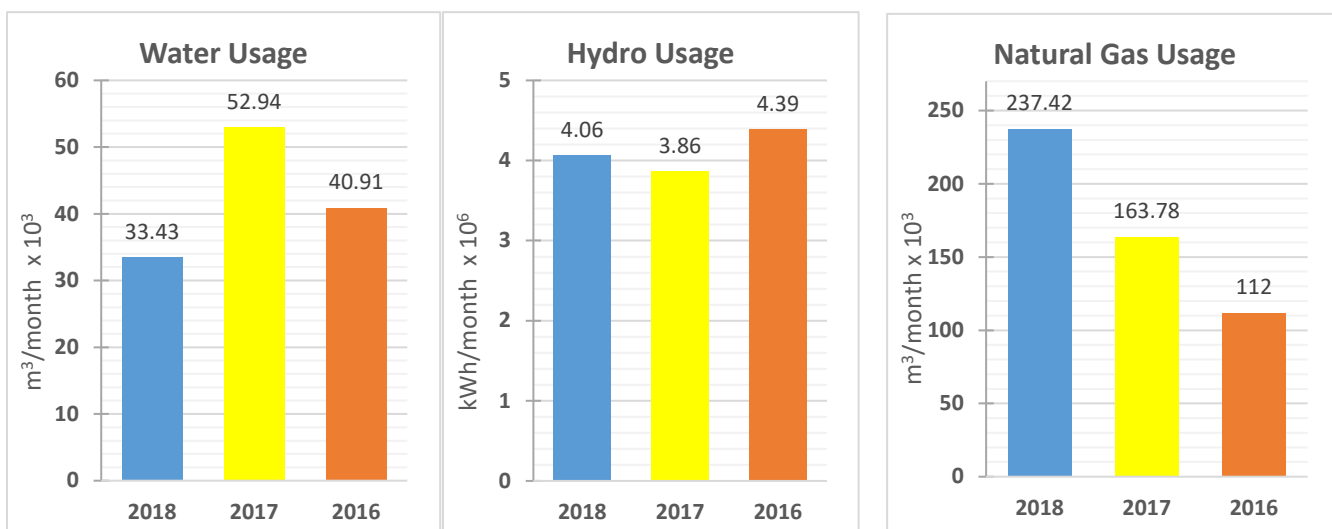
Figure 1: Annual Utility Consumption (Water, Hydro, Gas)

A summary of monthly utility consumption for the previous three years at Humber Treatment Plant is provided in Figure 1. Table 8 below summarizes the total cost and average unit cost for water, hydro, and natural gas. Total annual consumption of potable water, hydro, and natural gas was 401,173 m³, 48.7M kWh, and 2.8M m³, respectively.

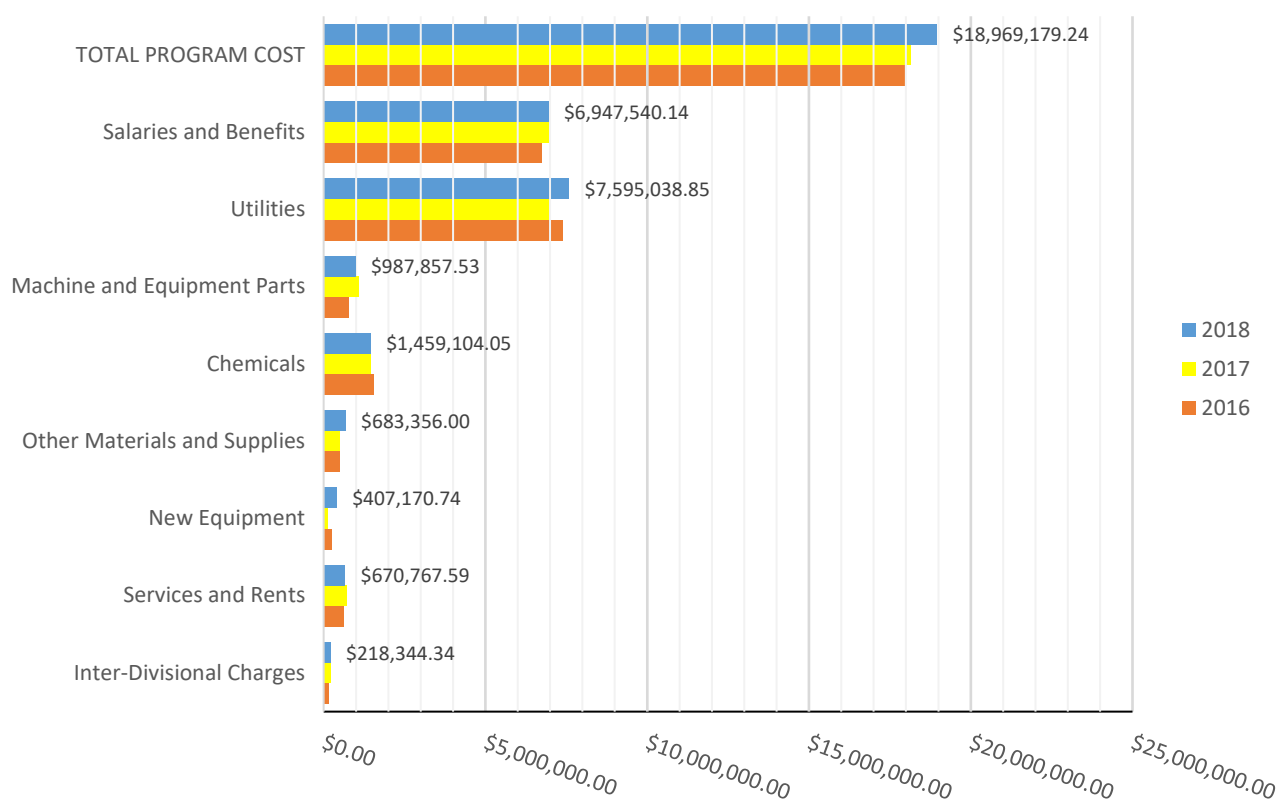
Figure 2: Operations and Maintenance Cost Breakdown

The 2018 plant direct operational costs are broken down into five categories: Salaries and Benefits, Materials and Supplies, New Equipment, Services and Rents, and Inter-Divisional Charges. Materials and Supplies is further segregated into Utilities, Machine & Equipment Parts, Chemicals and Other Materials and Supplies. A breakdown of annual operations and maintenance costs for the past three years is illustrated in Figure 2. Overall, operational costs increased by 5.5% from 2017.

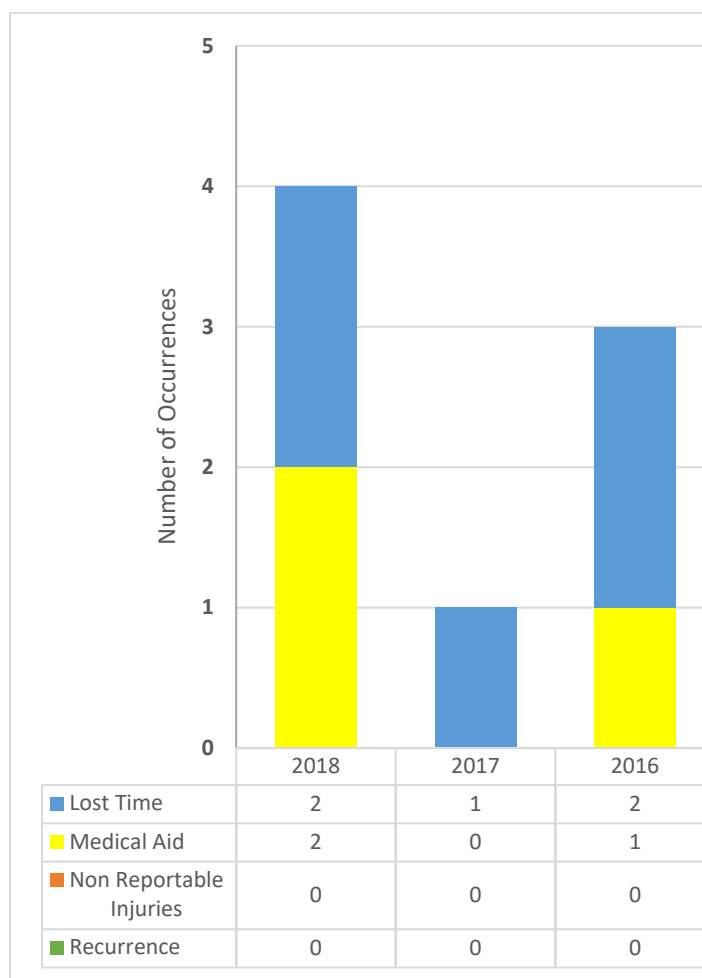
Figure 3: Humber Treatment Plant Health & Safety Injury Summary³

Continuous efforts are made to ensure a safe working environment at the Humber Treatment Plant. The Joint Health and Safety Committee (JHSC) assists management in resolving issues through regular meetings and monthly workplace inspections. Plant Health and Safety statistics for the Humber Treatment Plant are included in Figure 3.

As of December 31, 2018, there were four health and safety incidents and a total of 5 lost time days in 2018 due to work related injuries.

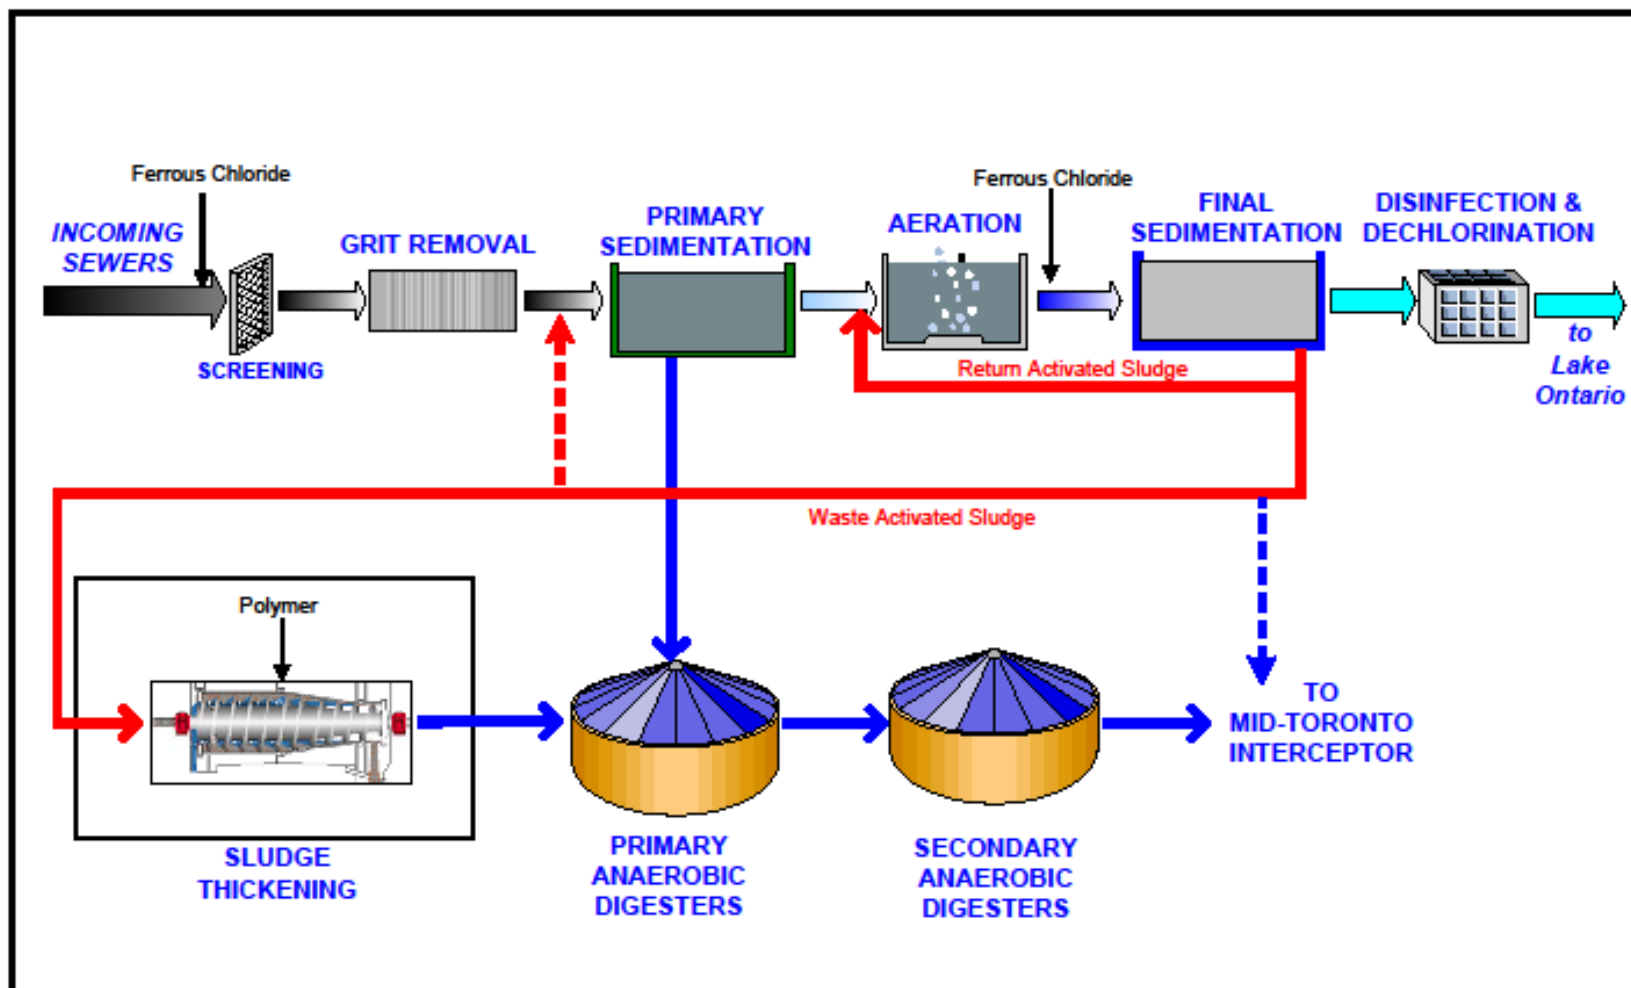
Process Flow Diagram for Humber Wastewater Treatment Plant

A description of the plant process is included below. A Plant process flow diagram is available in Appendix A. Additional information on the plant's process can be found on the City of Toronto website¹.

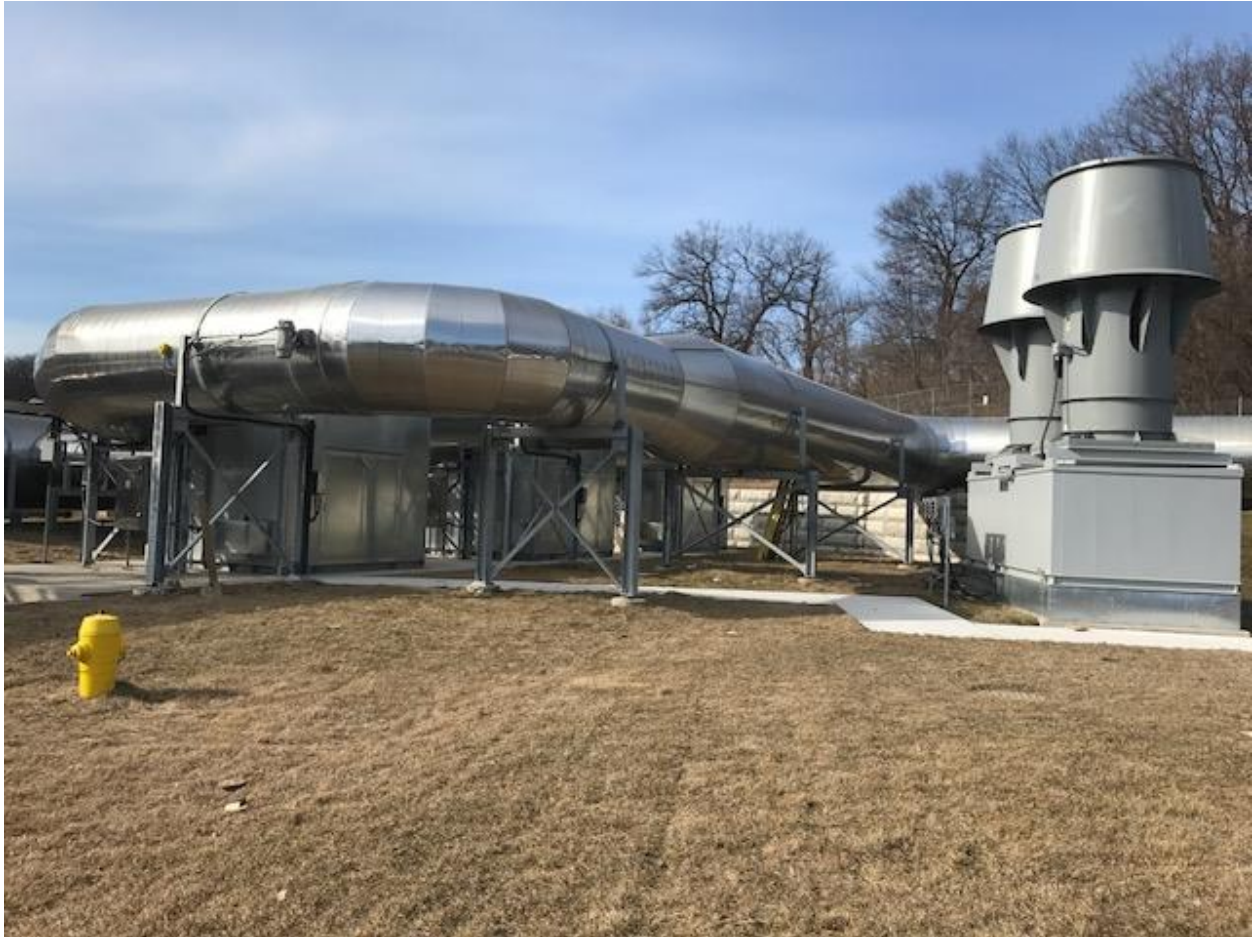
Figure 1: The Central Biofilter fans

In 2018, work on the Odour Control Project continued, and significant progress was made. The central biofilter has essentially been completed and is running under the control of the contractor. The biofilter and all associated systems and ductwork have been completed, including the balancing and commissioning of the system. The central

biofilter fans and ductwork can be seen in Figure 1. Note, the biofilter is located underground.

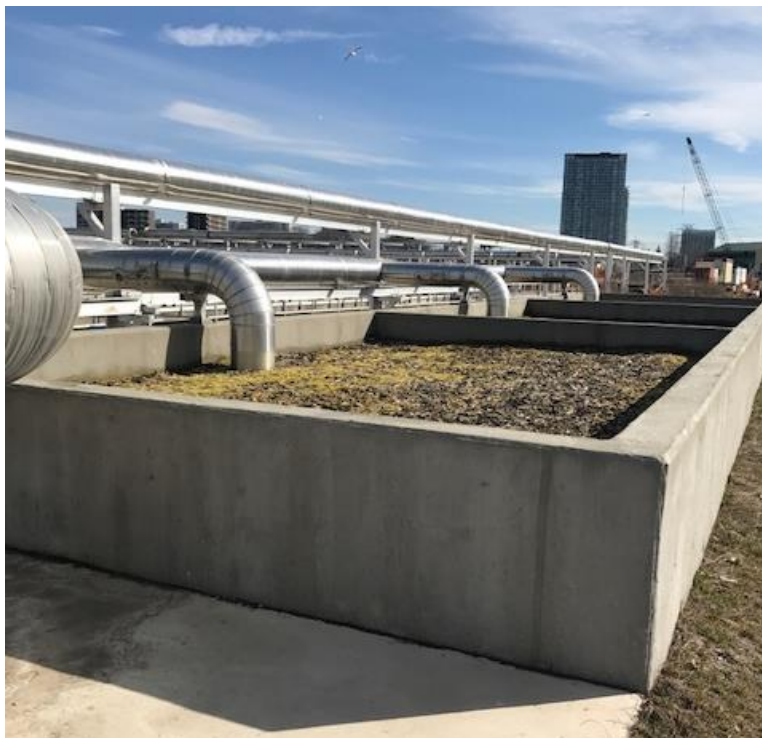
Figure 3: The South Biofilter

The construction of the south biofilter has been completed has been commissioned (Figure 3). A biomass has been established in the filter, which should result in a 20% reduction in odours at the property line. Odour reductions will be confirmed by source testing upon completion of the project.

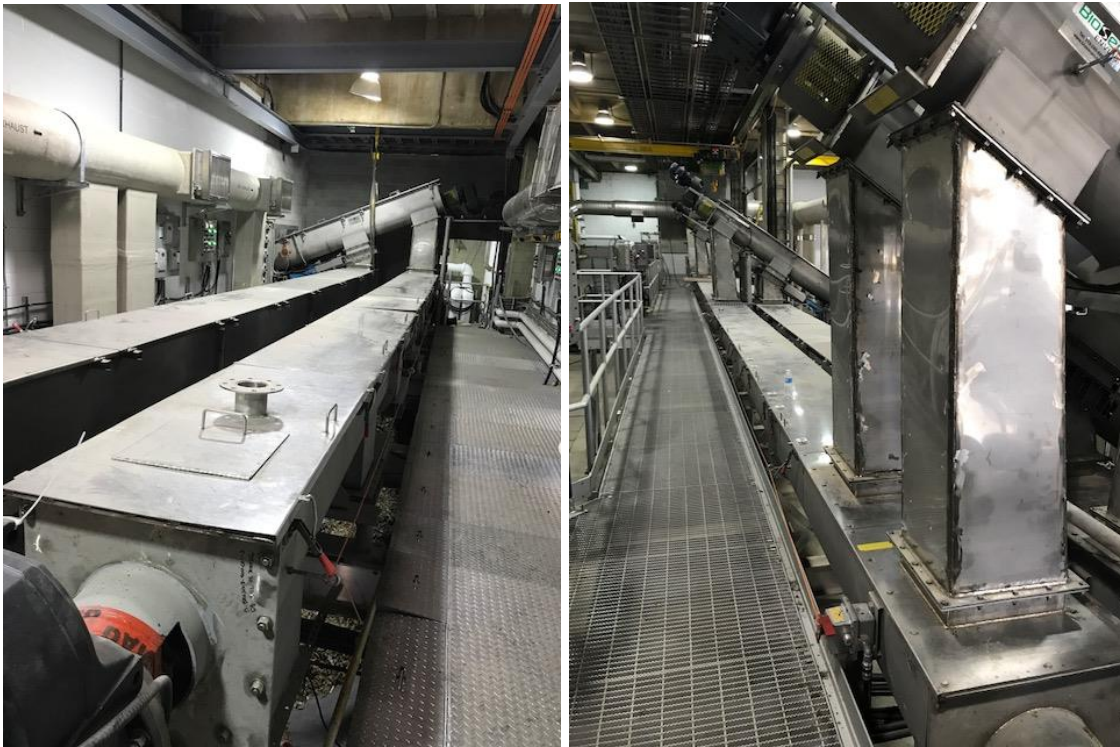
- Two new bar screens and associated conveyor systems
- A new loading bay (Figure 4)
- Three north grit tanks
- The north grit loading bay, including classifiers and conveyors, (Figure 5)
- Six south grit vortexes
- Air handling equipment, including and testing and balancing of the system

Figure 4 The new headhouse loading bay (left) and screenings conveyor systems (right)

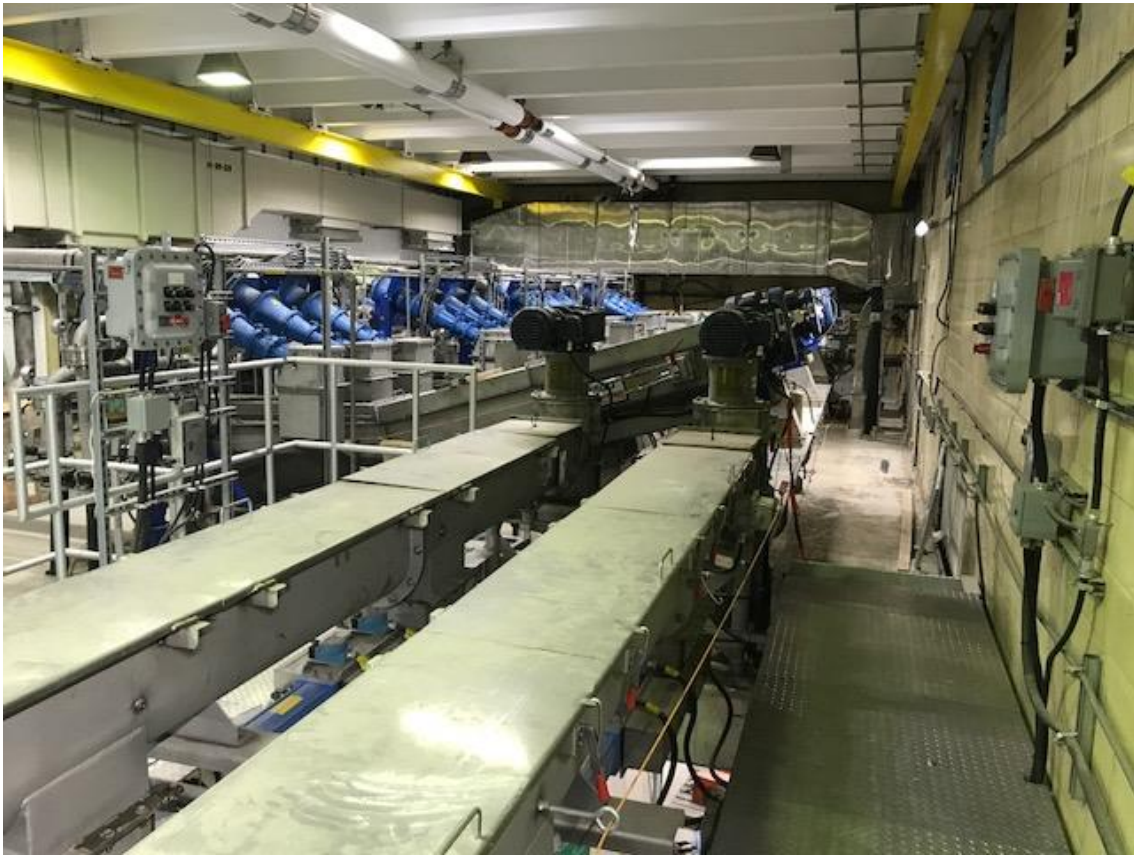
Figure 5: The North Grit Building loading bay has been commissioned
