# City Wide Study of Existing City of Toronto Dogs Off-Leash Areas (OLA)

### MERRILL BRIDGE ROAD PARK

### Inventory and Analysis

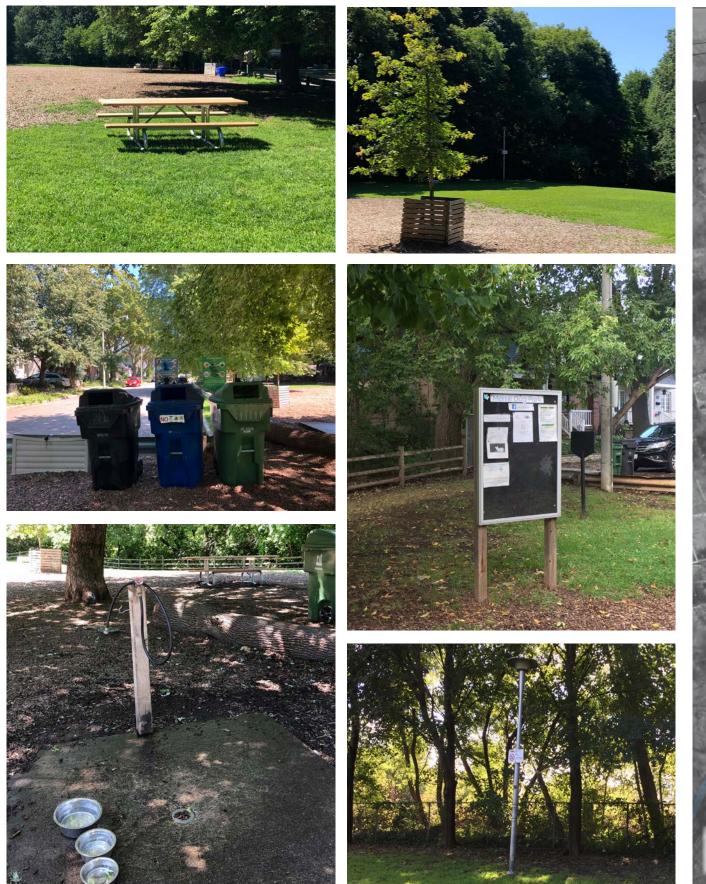
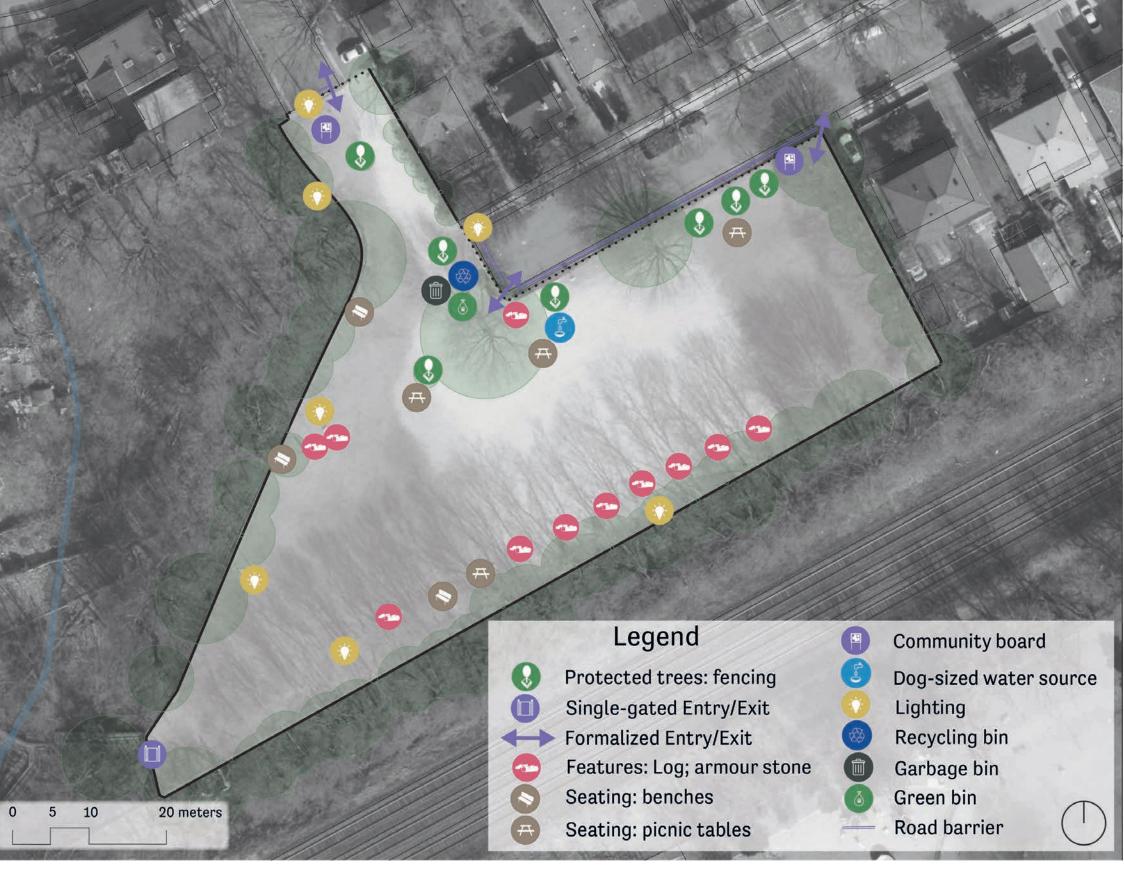
2-11% slope **Topography**

paved sidewalks for main entry; Access Area wooden boardwalk steps for back

grass/natural surface & wood chips/ Surfacing EWF; some holes and digging damage;

> some erosion and compaction; material migration.

wire mesh and post and paddle; Fencing style chainlink; unfenced on several sides

1.2m post and paddle; 1.8m chainlink Fencing height

Fence condition good condition

Gates 1 single gate at ravine entrance

5: 1 gated; 3 semi-formal; 1 informal Exits/Entrances

7 young trees fenced/protected; 1-2 mature trees with urine ring damage, some root exposure; perimeter has

healthy trees

Other vegetation none beyond groundcover

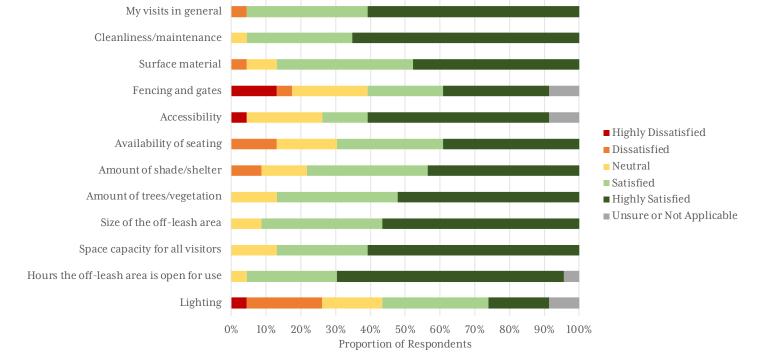
A public survey on all City of Toronto Off-Leash Areas (OLA) has been completed, and individual case study site data for Merrill Bridge satisfaction rating is included in the chart below.
