## Mid Humber Gap (Phase 2) Feasibility Study

RO# 10007881

July 30, 2019

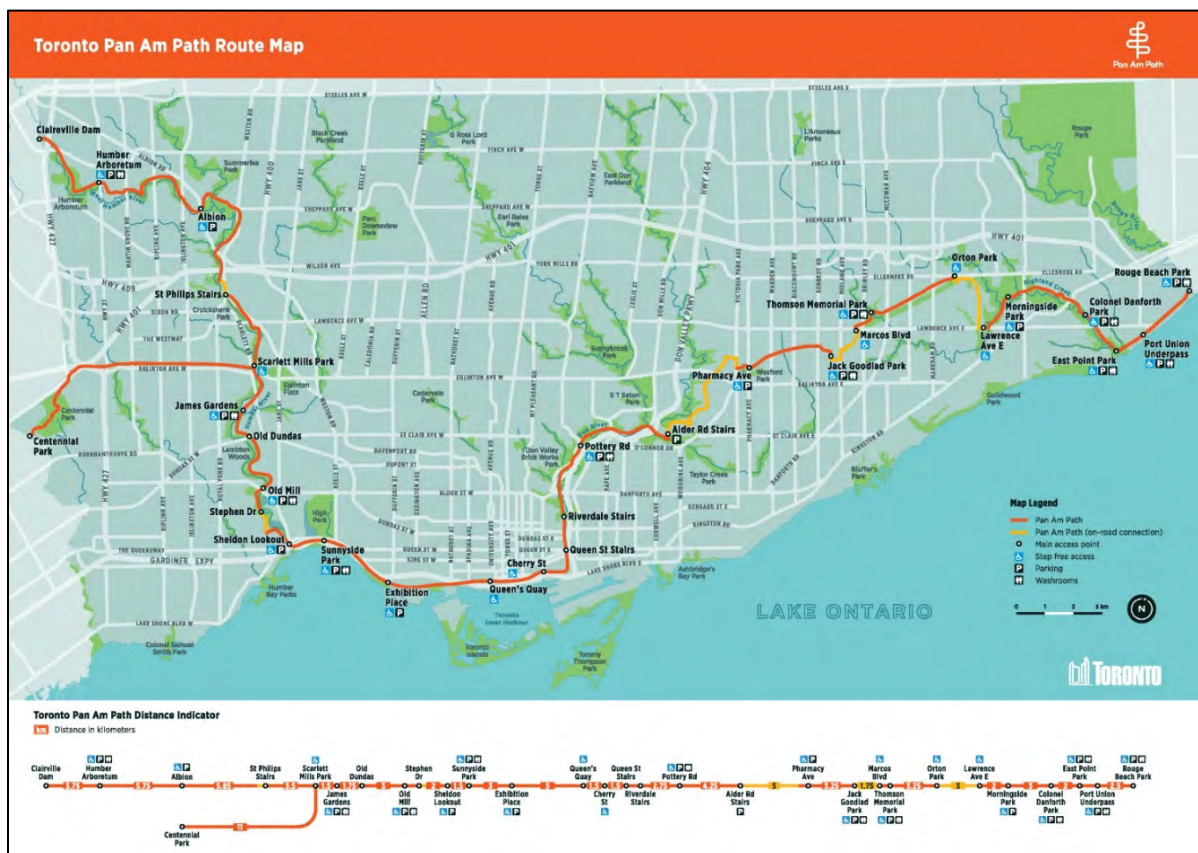
**Figure 1** Pan Am Path Route Map, City of Toronto

The Mid Humber Gap is a barrier in the Humber River trail system, which extends 29-kilometres from the Claireville Dam to Lake Ontario. This gap is also a discontinuity in the 80-kilometre Pan Am Path which connects Brampton to Pickering (**Figure 1**).

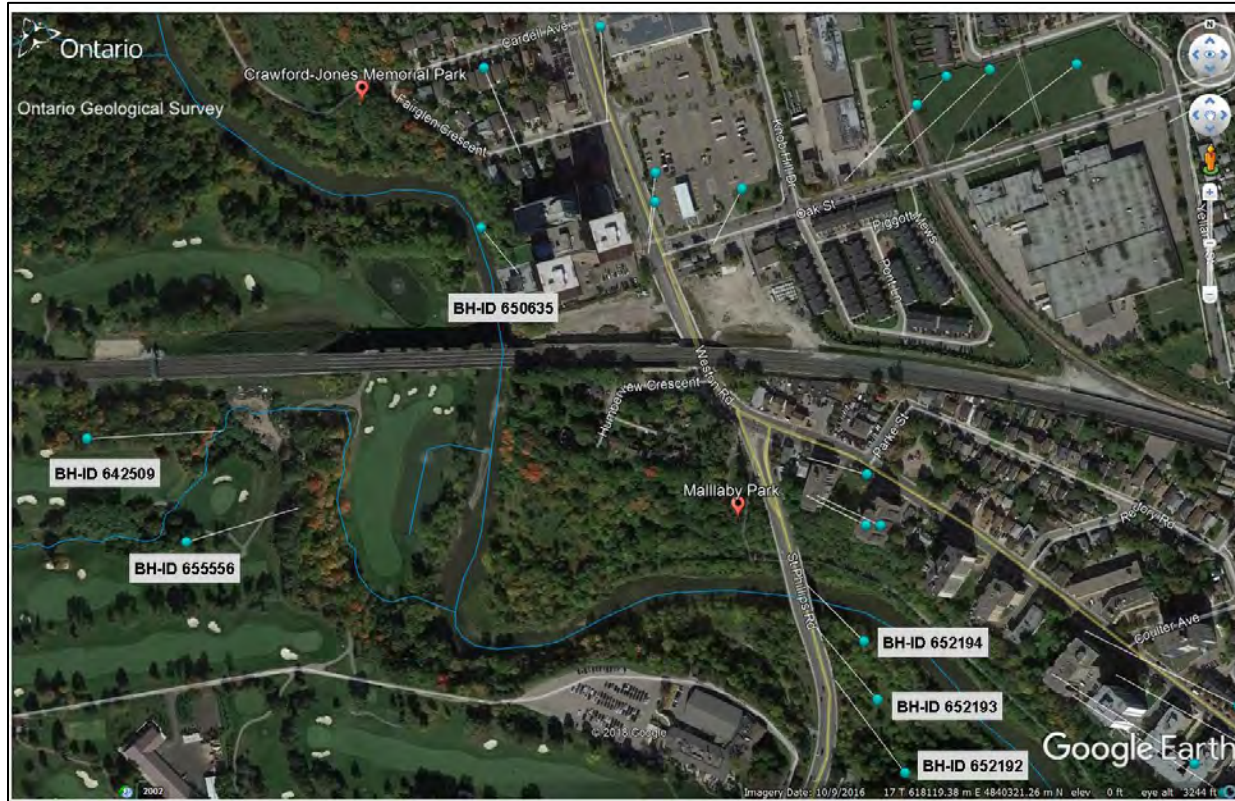
**Figure 14** Location of Ontario Geotechnical Borehole Data in the Study Area Source: Google Earth, 2018

Data are available for 6 Ontario Geotechnical Boreholes in the vicinity of the study area, the borehole locations can be seen in **Figure 14**. Available information from these boreholes is summarized below in **Table 4**.

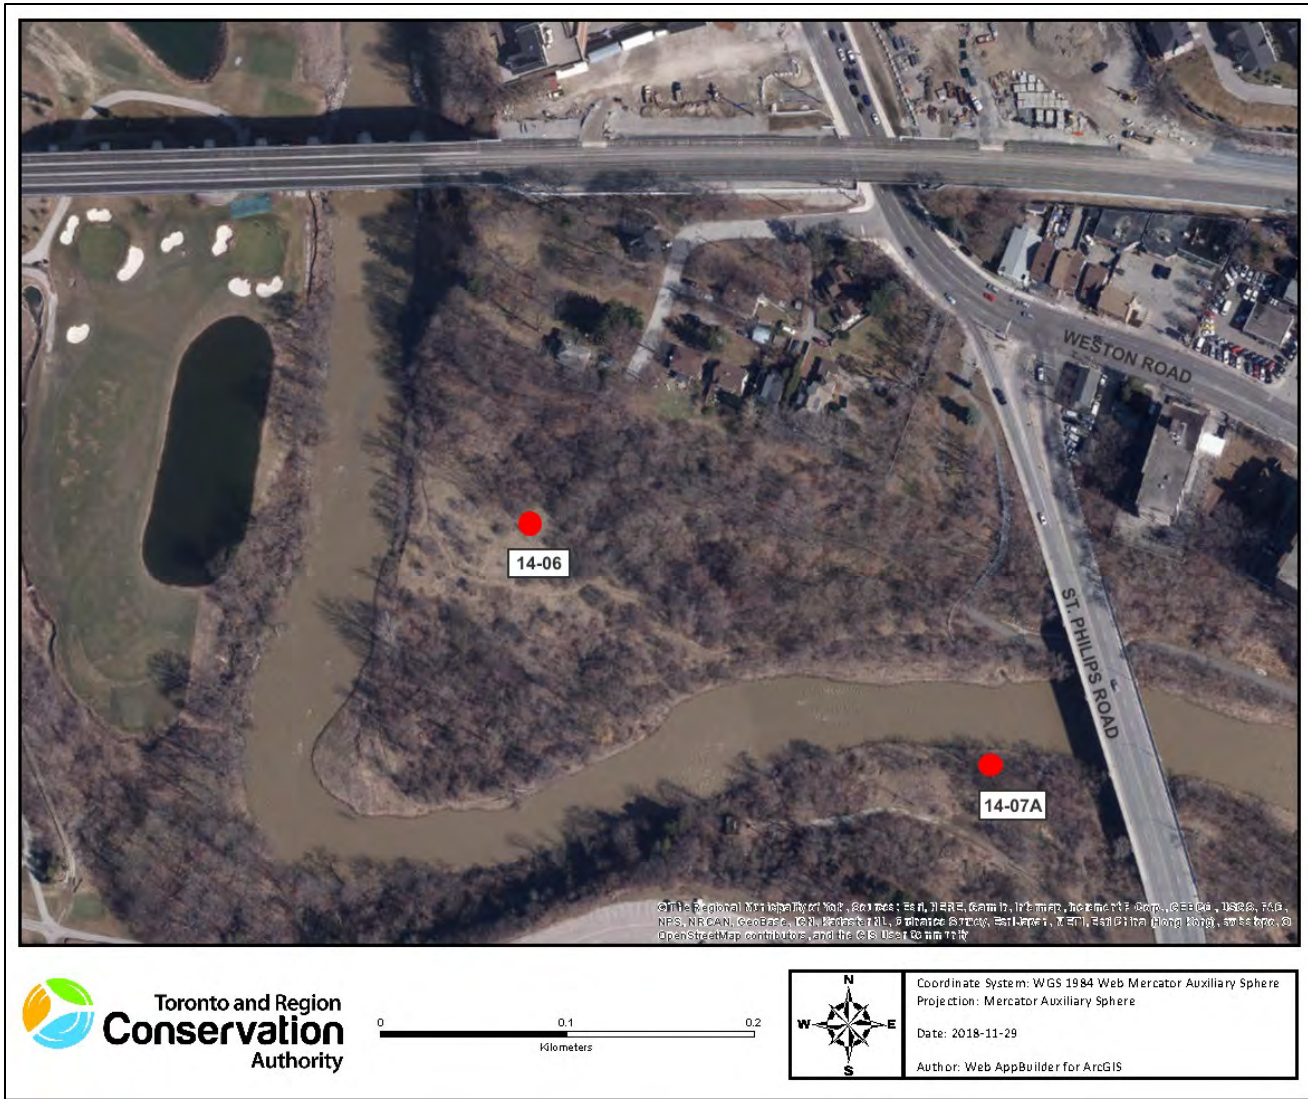
**Figure 15** Location of Albion STS MCEA Boreholes in the Study Area Source: TRCA, 2018

The location of boreholes drilled for the Albion STS are shown below in **Figure 15**. For a view of borehole logs and bedrock core photographs, please refer to Figures 27 and 28 in Appendix B.

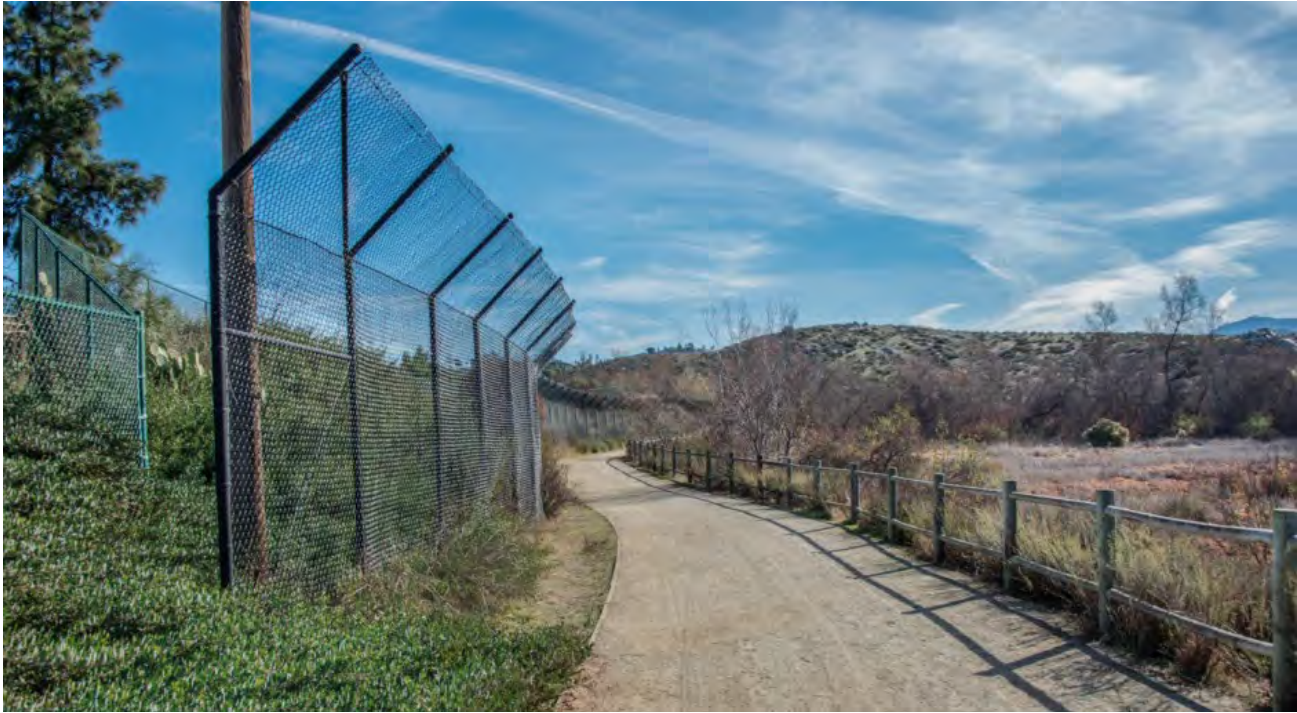
**Figure 17** Example of trail fencing with arched top from Mule Hill Trail Source: Hiking San Diego County, 2018

To construct the trail alignment concepts in their current configuration, a barrier or cage is required to protect the public from stray golf balls, and to ensure that trespassers are not able to enter the WGCC property. Traditional sports netting would likely pose a barrier for birds, a shorter fence with an arched top is likely sufficient to protect trail users. An example is shown below in **Figure 17**.

This barrier should be explored in more detail during the detailed design phase.
