Taylor Creek Park Management Plan

Final Report

SCHOLLEN & Company Inc
North-South Environmental Inc
Lura Consulting Ltd

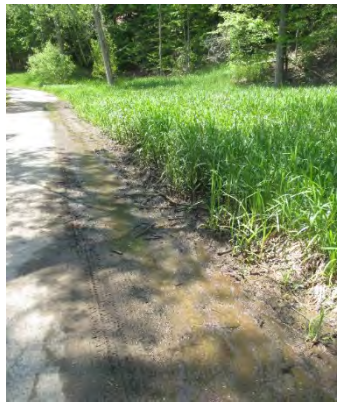
Address seepage/drainage issues over pathway. Remove manna grass.

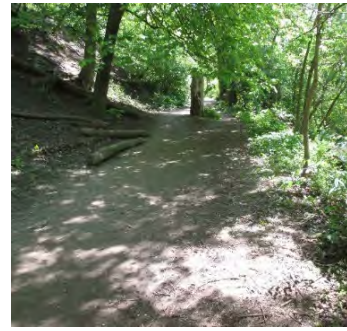
Deter access to steep slopes. Bike-use resulting in denuded slopes.

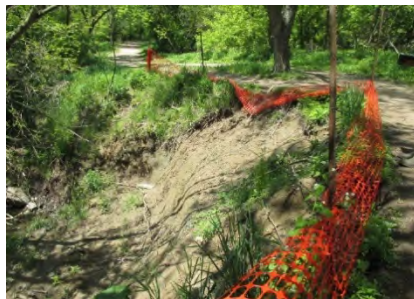
Outer creek bank failure; stabilize bank and relocate trail.

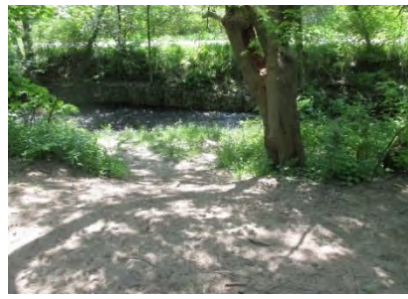
Erosion due to dog/ human access to water.

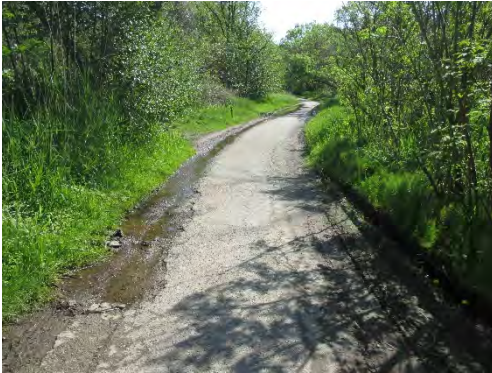
Flood-prone pathway requires replacement.

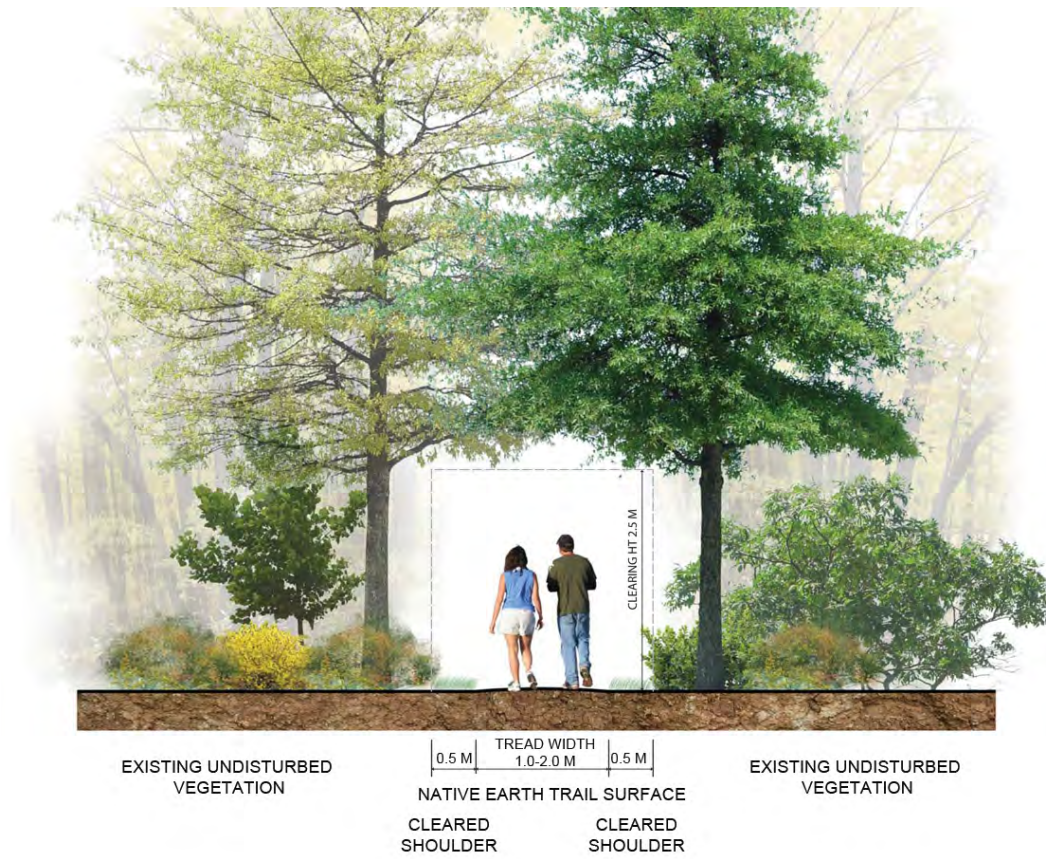
Figure 42: Natural Surface Trail Cross-Section

Trails that are proposed to be located between the 5-100-year flood lines will not be impacted by flooding as often and therefore can be constructed using more traditional on-grade design options with minimal enhancement to the substructure. However, soft soils may be encountered more often within Taylor Creek Park than would be expected in areas above the 100-year flood elevation, and drainage/water movement must be addressed to reduce erosion. Natural surface trails are proposed to comprise an earth surface with limited drainage enhancements (required only in areas where existing drainage patterns direct runoff towards the trail). Trails of this type can be pursued where appropriate conditions exist, where user numbers are not excessively high, and there is a benefit to user experience that would be satisfied by a more natural type of trail.

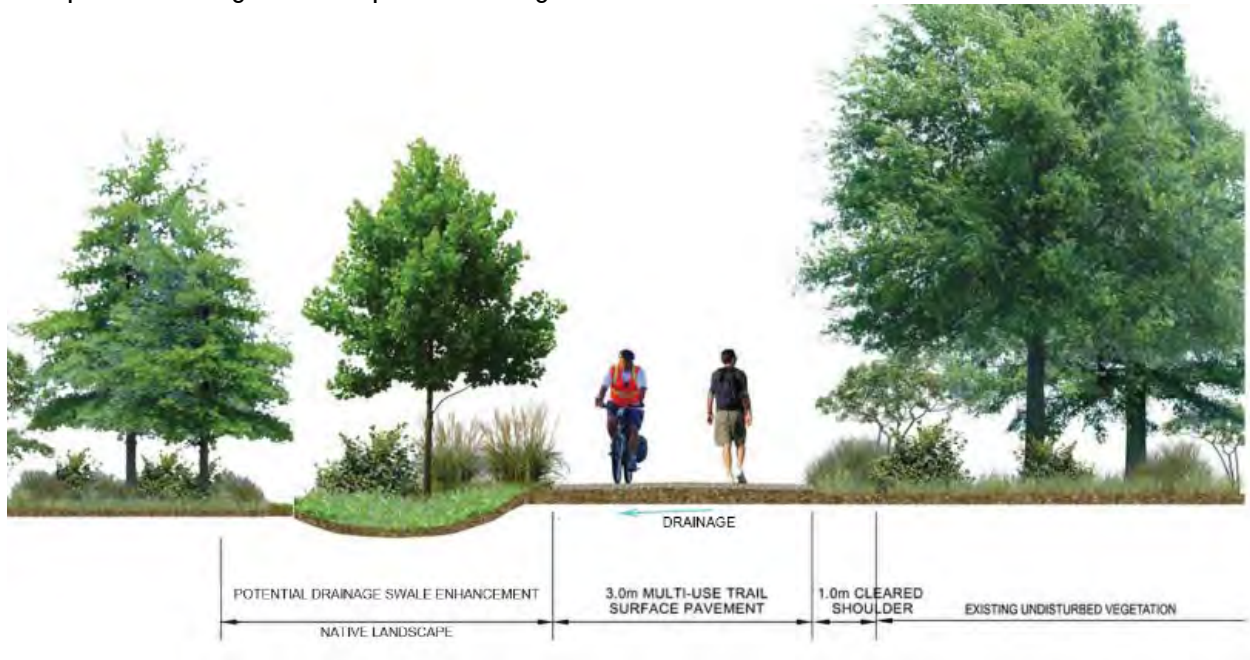
Figure 43: Typical Asphalt Multi-Use Trail Cross-Section

The existing official trails will remain as asphalt multi-use trails that conform to the City's Trail Design Guidelines. Proposed asphalt trails should be constructed on competent subsoils with the required depth and composition of granular base. Drainage infrastructure should be installed to convey runoff beneath proposed asphalt trails. In some cases, existing unofficial trails within the Study Area that are chosen to become formalized will remain as earthen or granular trails, but these trails may require short sections of asphalt surfacing where slopes of 8% or greater are unavoidable.

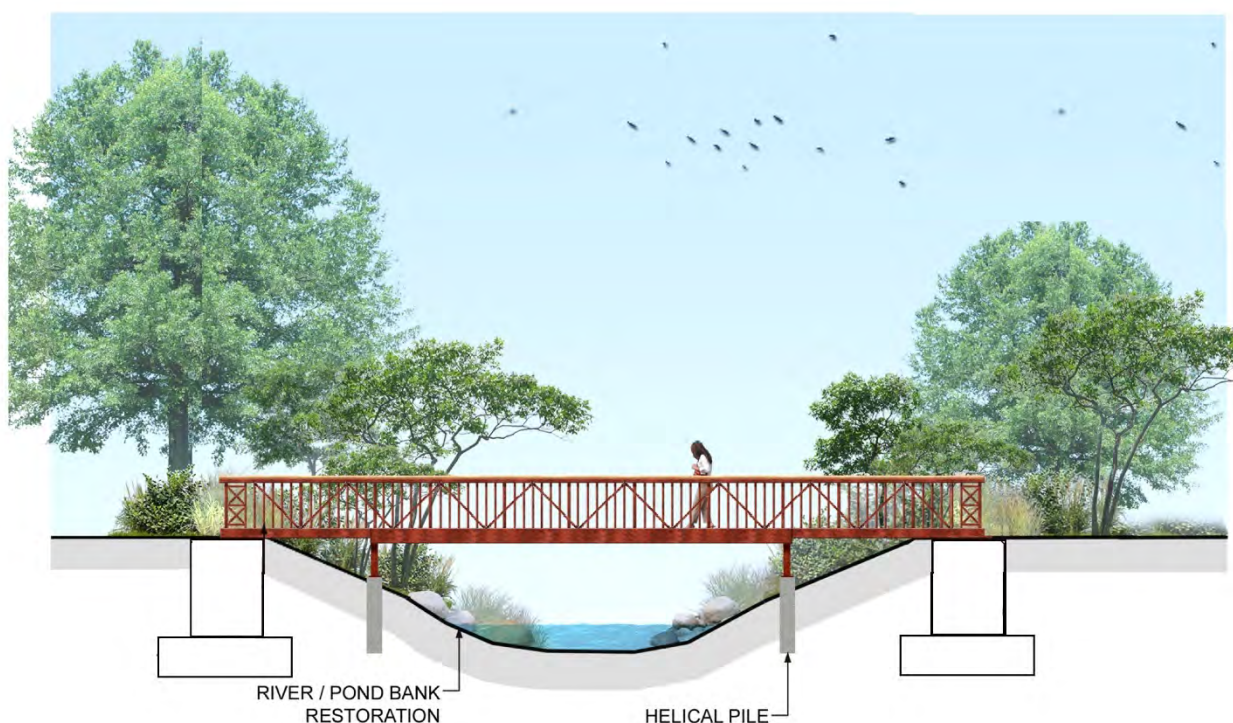
Figure 44: Typical Pedestrian Bridge Cross-Section

New bridges are to be clear span structures that are constructed using primarily a metal frame, wood or concrete deck and concrete abutments. Bridge positioning and spans are required to be determined through the completion of a geomorphological assessment, and/or appropriate structural and geotechnical engineering reviews. For general guidance, span lengths are to be determined based upon the width of the channel plus an erosion setback to achieve the 25-year stable slope line. Additional constraints specific to each location must also be accounted for when determining the optimal span and placement for a proposed bridge. Channel scour potential as well as navigability beneath the bridge are also considerations. Cast-in-place concrete abutments anchored by helical piles is often the construction technique that results in the most compact footprint of disturbance.
