## ARBORIST REPORT

### RE-IMAGINING YONGE STREET - SHEPPARD TO FINCH AVENUE – ENVIRONMENTAL STUDY REPORT

City of Toronto

September 16, 2016

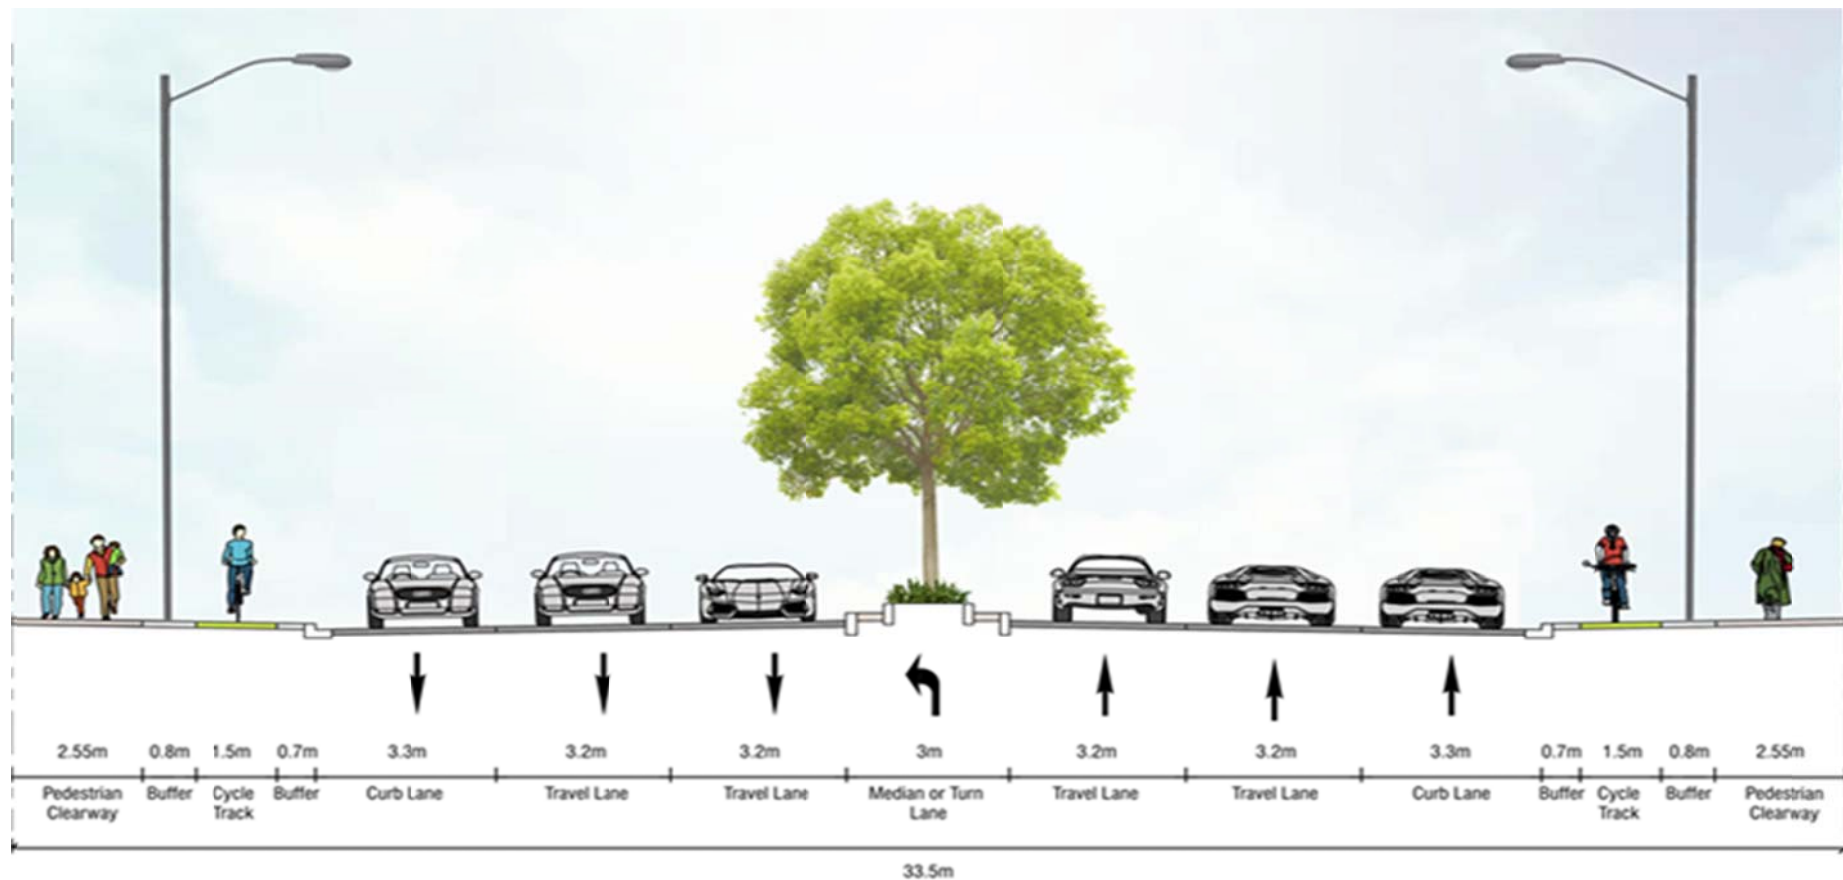
## DESIGN OPTION 4A: 6 LANES

- Table 1: Tree Inventory and Preservation Chart (Table 1)
- Cross sections:
  - Design Option 4A: 6 lanes from Sheppard south to Avondale, showing a median, bike lanes and pedestrian walkway
  - Design Option 4B: 4 lanes from Sheppard to Finch, showing a median, bike lanes, tree & furnishing zones and pedestrian walkways

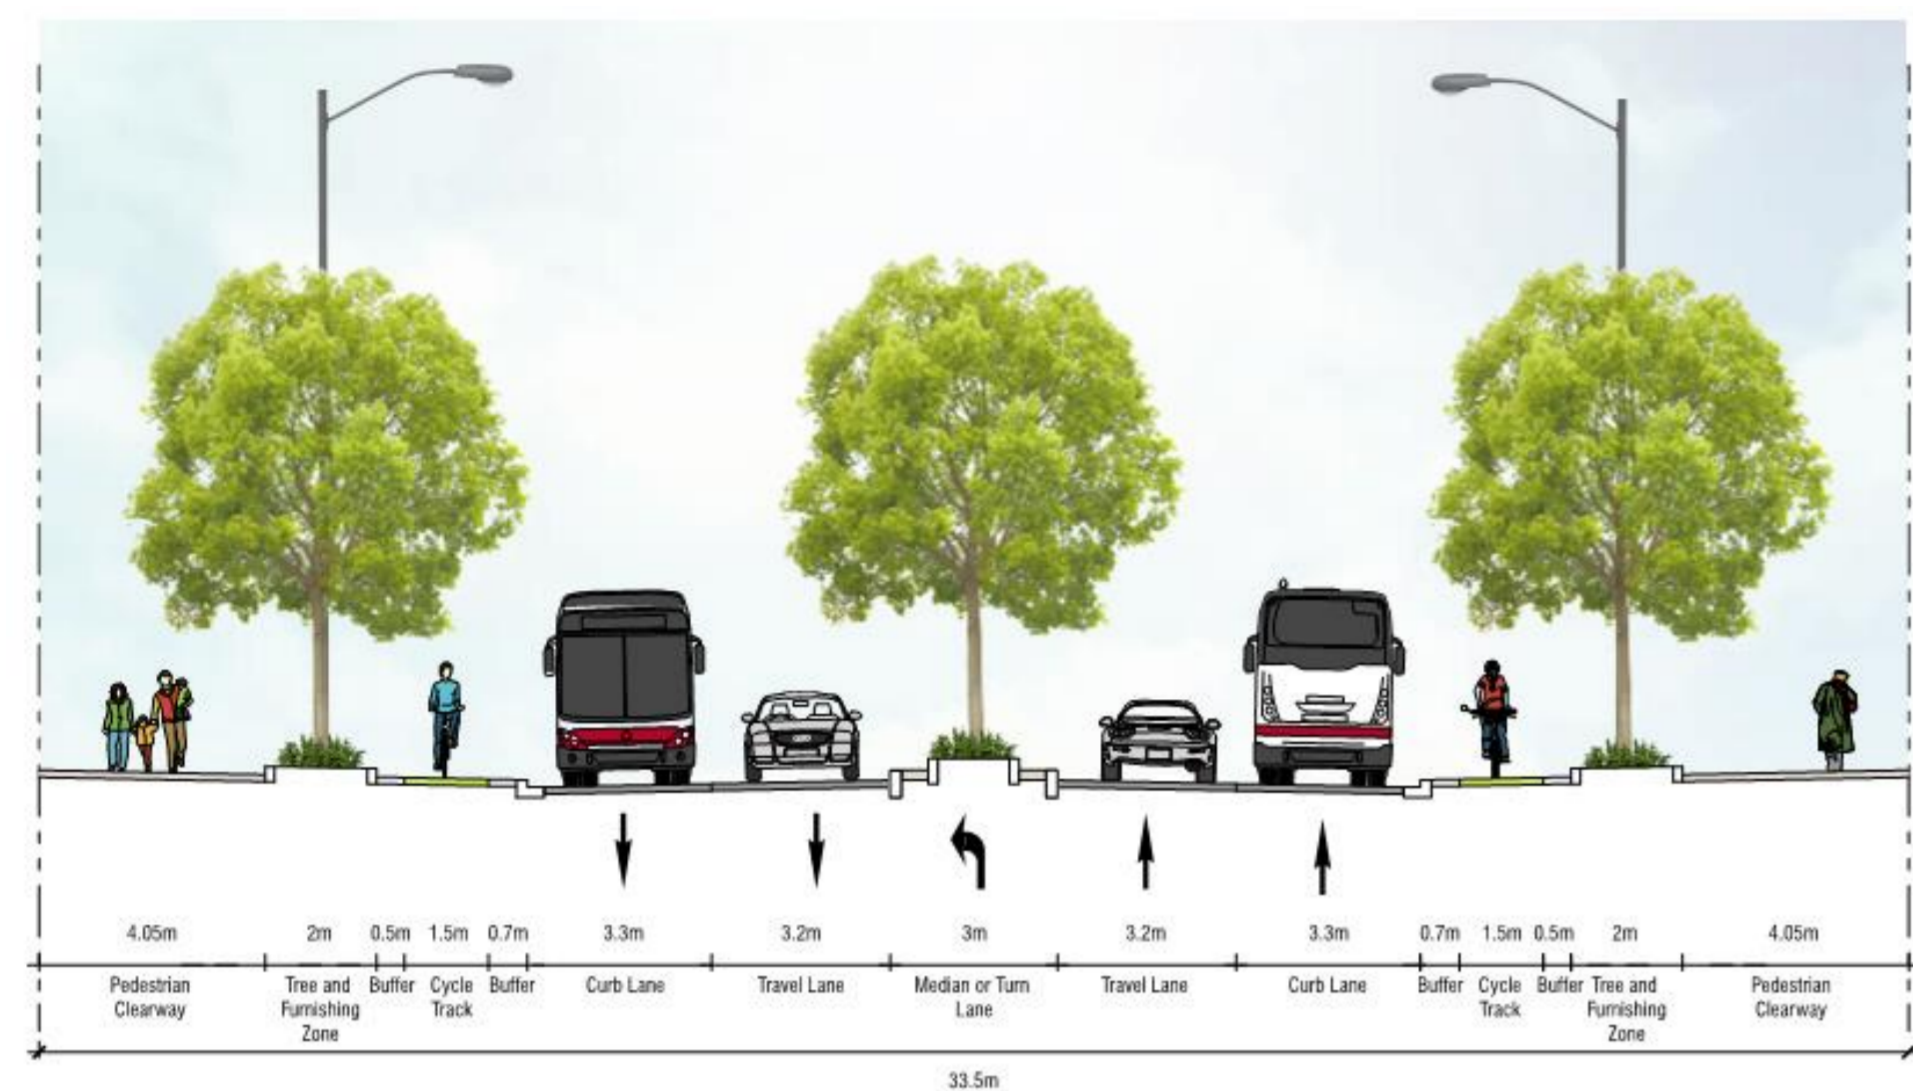
Typical Cross Section

# DESIGN OPTION 4B: 4 LANES
