12. Field Investigations

12.2 Geotechnical Assessment

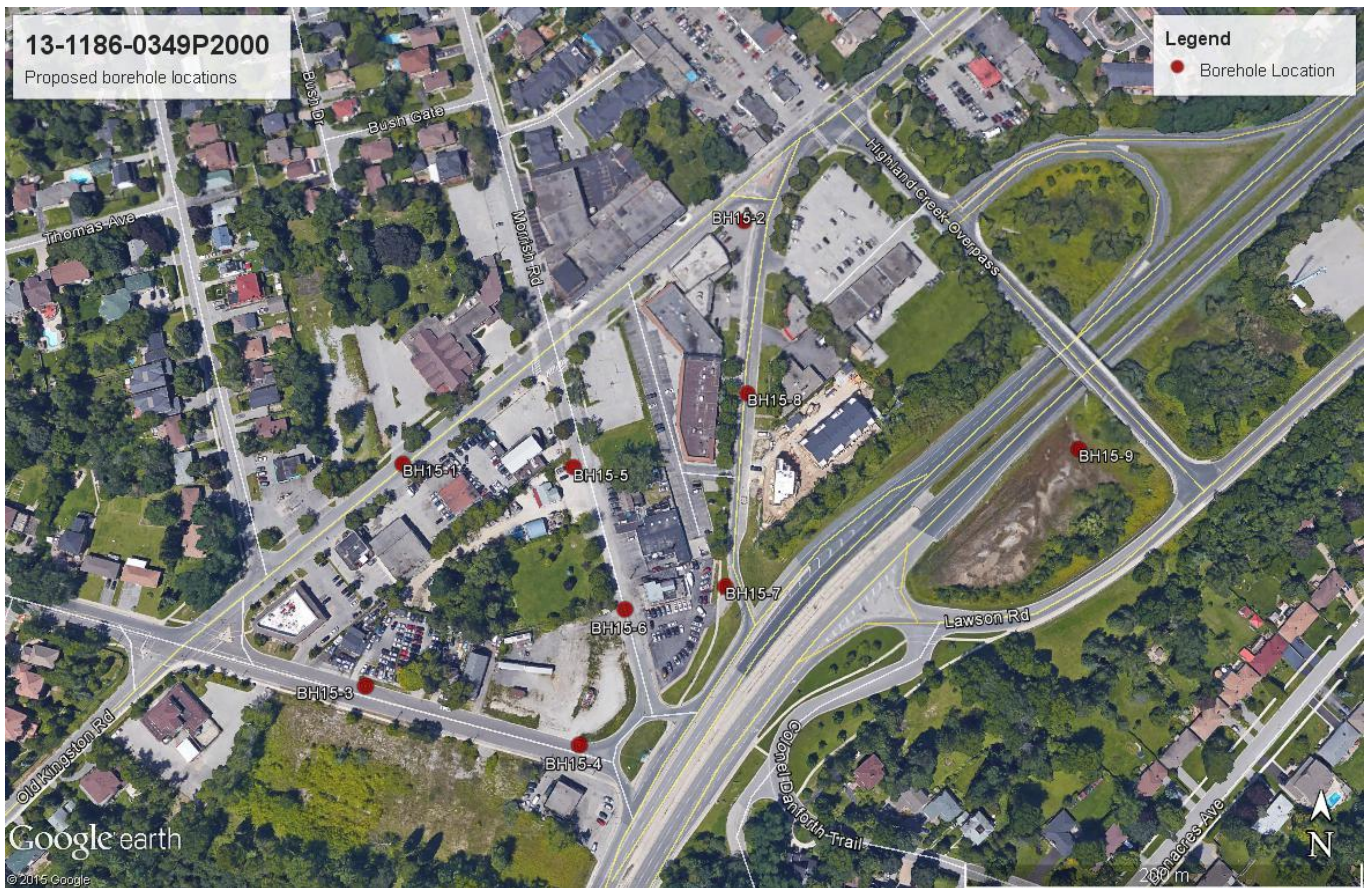
Exhibit 12-1: Borehole Locations

As previously summarized in **Section 4.6**, Golder Associates conducted a desktop review of existing borehole information in the HCV study area and determined that the available information was not adequate for preliminary design purposes. Consequently, targeted borehole investigation was recommended to be undertaken as part of this study. The geotechnical investigation includes nine boreholes advanced at the locations shown in **Exhibit 12-1**.

- **BH15-1:** Support of the rehabilitation of Old Kingston Road
- **BH 15-2:** Support of new construction of re-aligned Old Kingston Road – Kingston Road connection

- **BH 15-3:** Support of the new construction of laneway parallel to Old Kingston Road
- **BH 15-4 and BH 15-9:** Permeability and groundwater information
- **BH 15-5:** Support of the rehabilitation of Morrish Road
- **BH 15-8:** Support of the rehabilitation of Kingston Road
- **BH 15-6 and BH 15-7:** Support of new construction of “loop” road connection between Kingston Road and Morrish Road.
