# German Mills Creek Geomorphic Systems Master Plan Environmental Assessment

Public Consultation: August 2023

# German Mills Creek Geomorphic Systems Master Plan

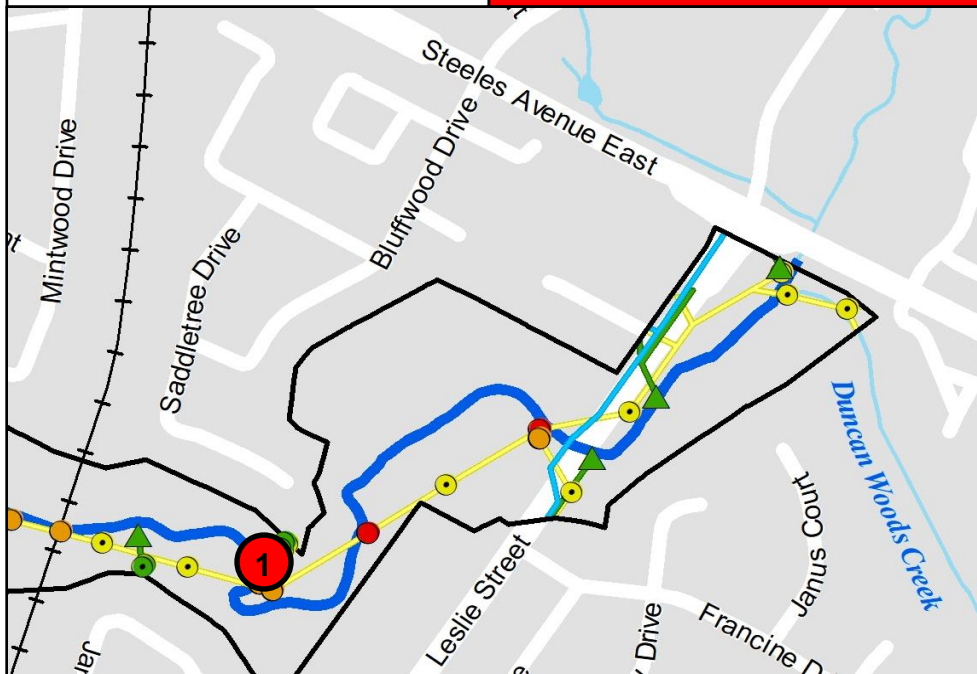
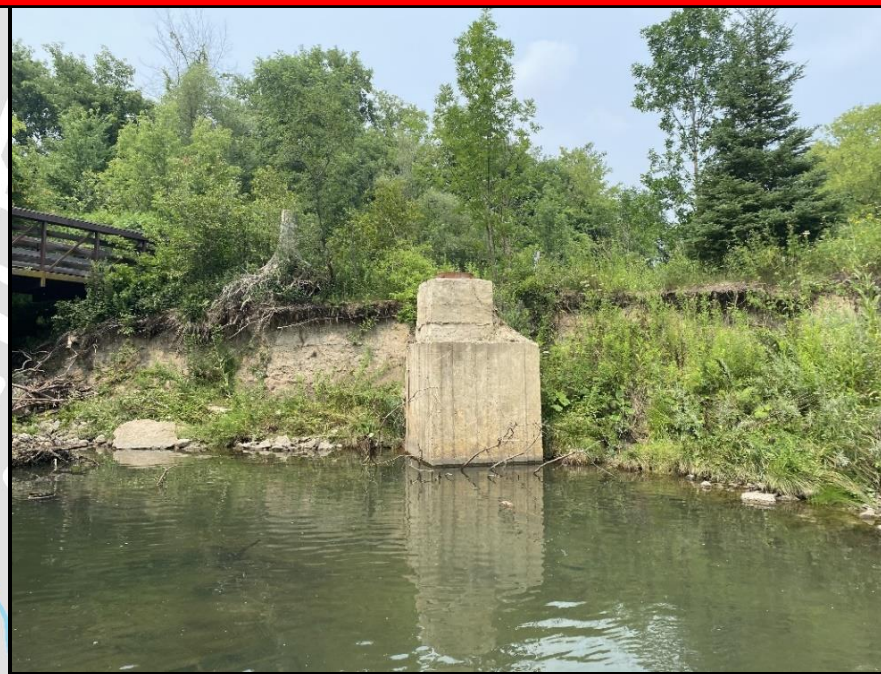
# Risk Assessment: Priority Site 1

## Sanitary sewer maintenance hole and lateral sewer connection

- Exposed maintenance hole and pipe
- Other 2 pipes 1.2 m and 0.16 m depth of cover remaining
- At an actively eroding large meander

**Imminent**

Project No.	Recommended Solution	Evaluation Detail
1	Local work and floodplain connection  Possible realignment of the pedestrian bridge located 500 metres west of Leslie Street to allow the stream a natural course	<p>Recommended solution:</p> <ul style="list-style-type: none"> <li>Addresses erosion risk within existing footprint without major corridor realignment and grading</li> <li>Floodplain connection not as essential in these areas as it is generally well connected</li> <li>Erosion issues are less severe in these locations</li> </ul> <p>Future implementation of the recommended natural channel design projects requires tree removal, to be followed by restoration and replanting with native trees and shrubs.</p>
2	Local work and floodplain connection	Same as Project No. 1 above
3	Local work and floodplain connection	Same as Project No. 1 above

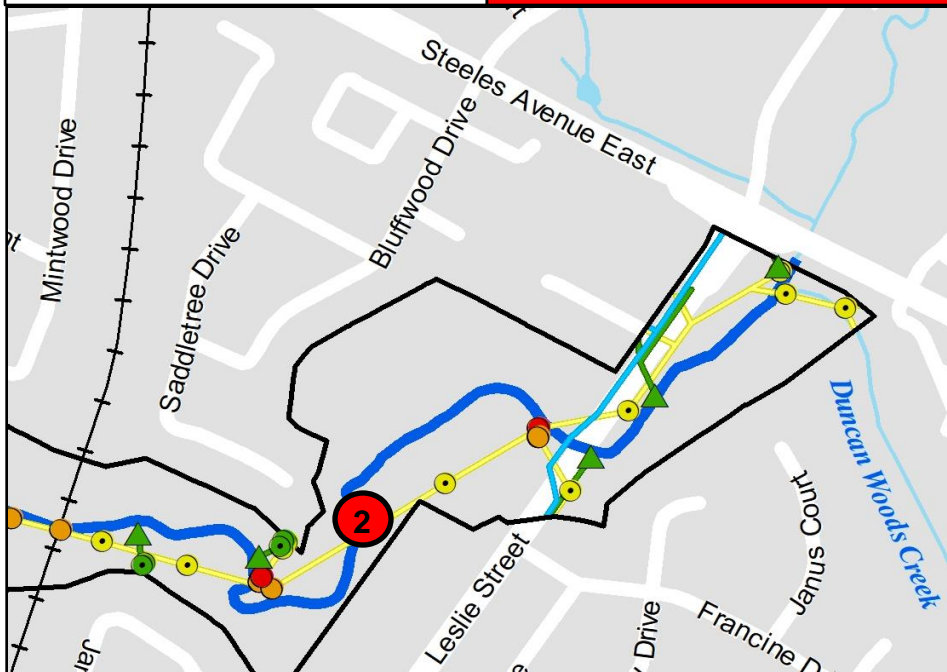
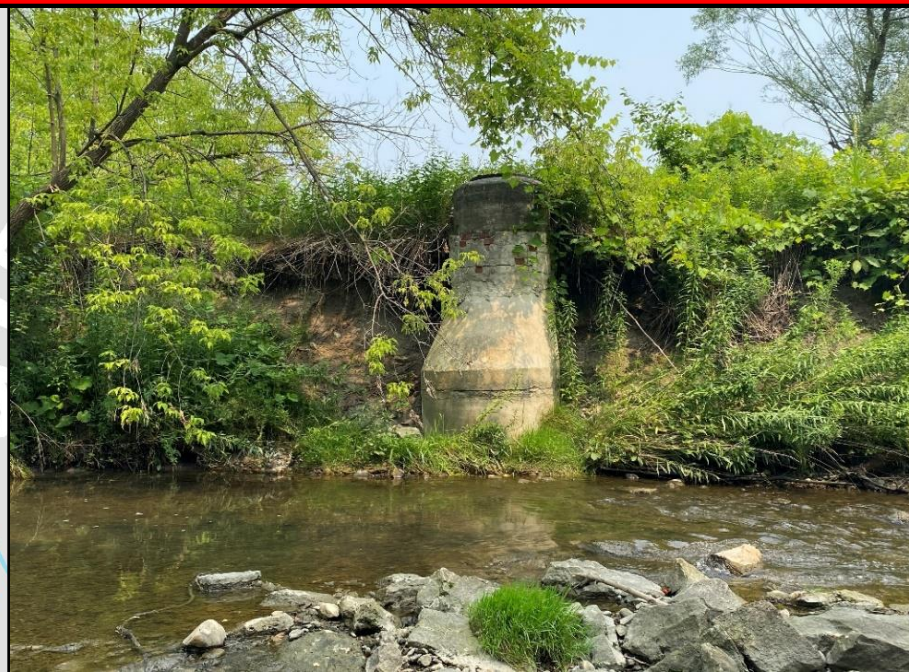
# Risk Assessment: Priority Site 2

## Sanitary sewer maintenance hole

- 1 maintenance hole fully exposed
- 1.3 m depth of cover remaining at sewer crossing
- Severe and ongoing bank erosion occurring

**Imminent**

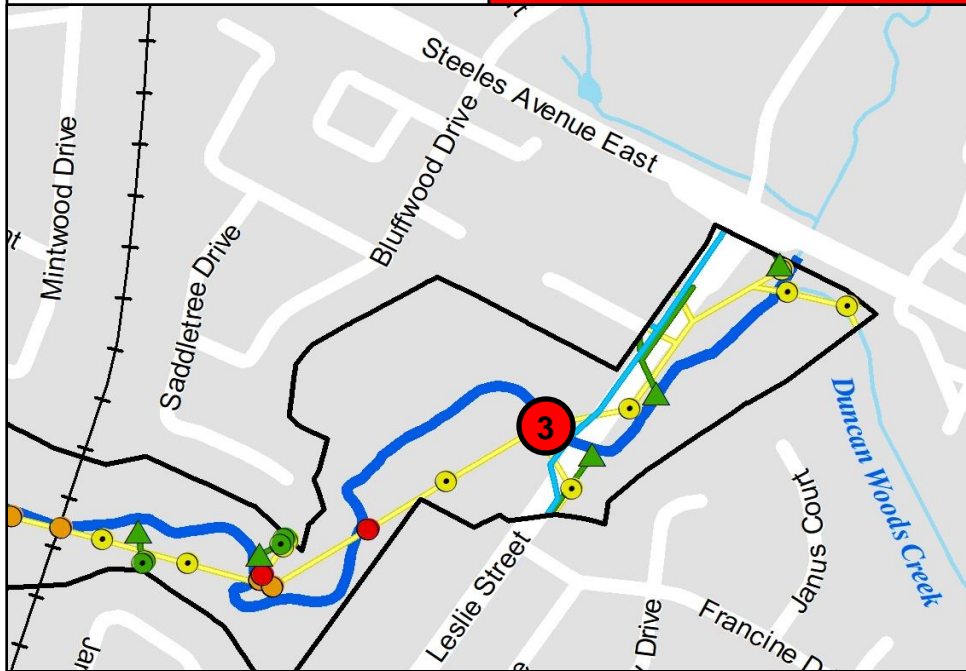
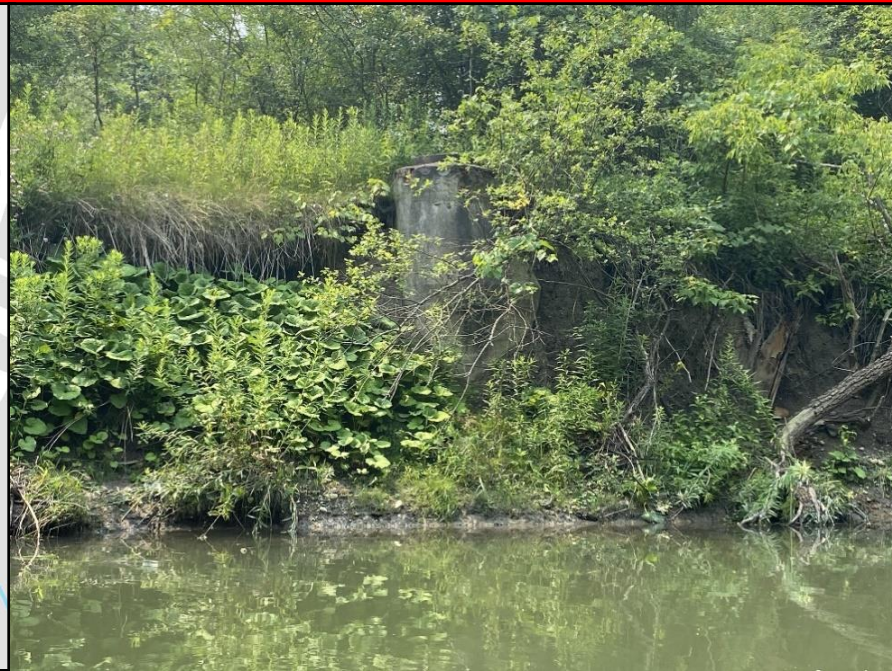
# Risk Assessment: Priority Site 3

## Sanitary sewer maintenance hole

- 0.92 m and 1.54 m depth over nearby pipe crossings
- 1 maintenance hole is fully exposed
- Severe and ongoing bank erosion

**Imminent**

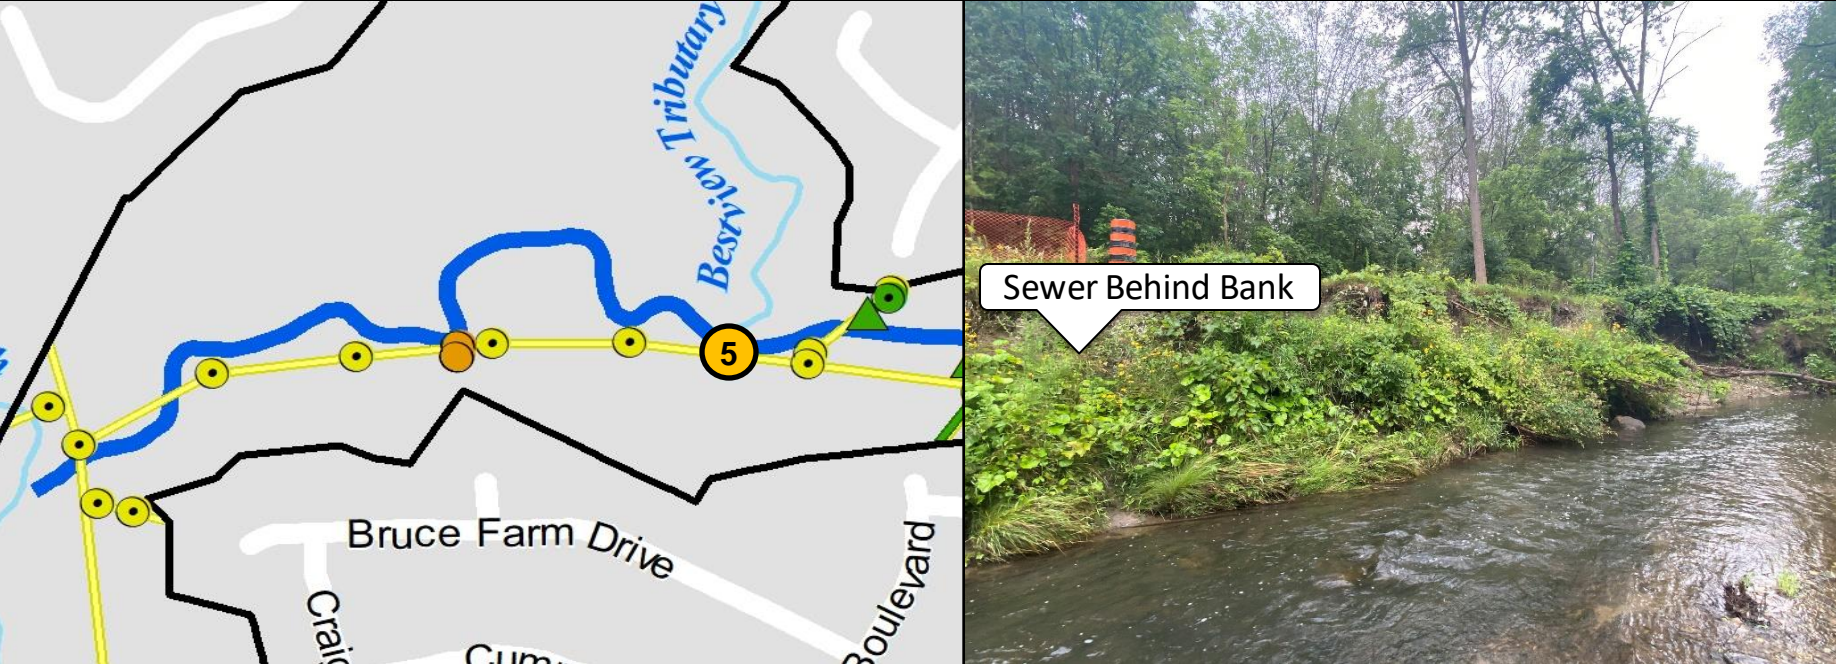
# Risk Assessment: Priority Site 5

Sanitary sewer adjacent to pathway	
Descriptions of conditions	<ul style="list-style-type: none"><li>• Sewer within 1 m from edge of creek</li><li>• Sewer runs parallel to pathway and creek</li><li>• Bank is actively eroding and near confluence with Bestview Tributary</li></ul>
Risk level	High

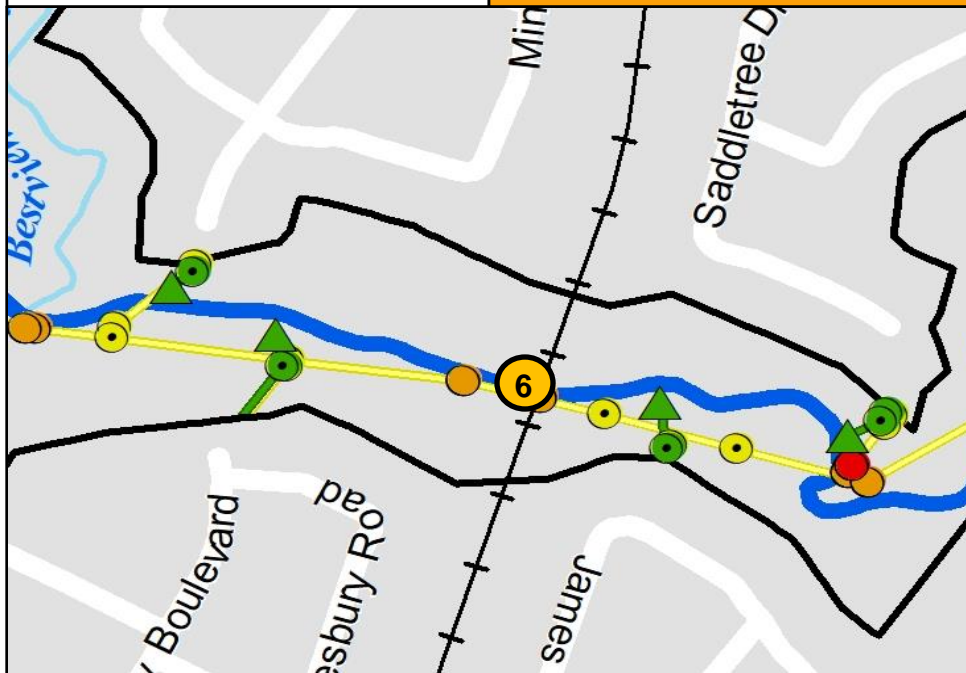
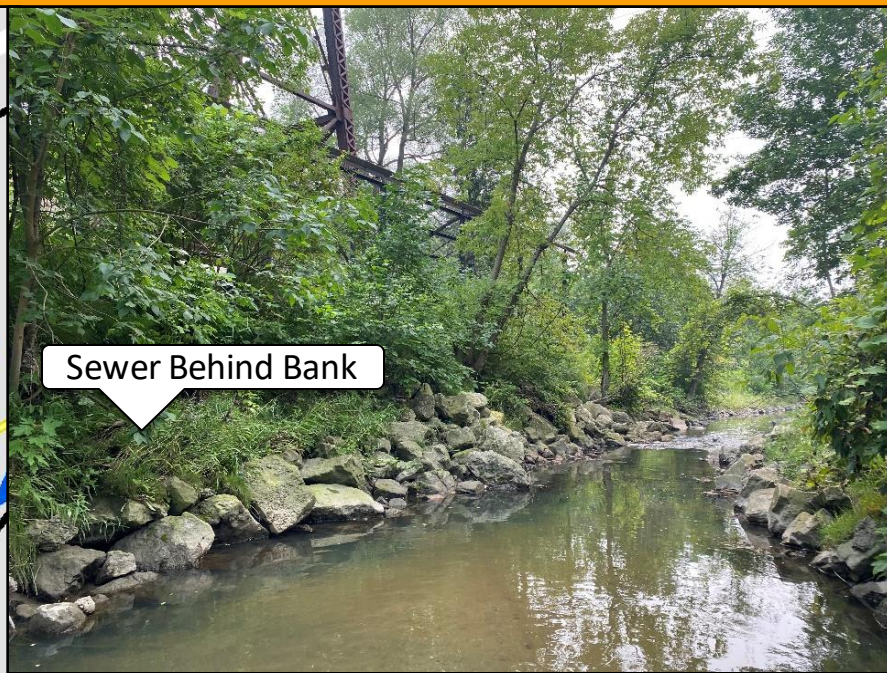
# Risk Assessment: Priority Site 6

## Sanitary sewer adjacent to pathway and railway

- Sewer within 1 m from edge of creek
- Existing erosion protection moderately stable

**High**

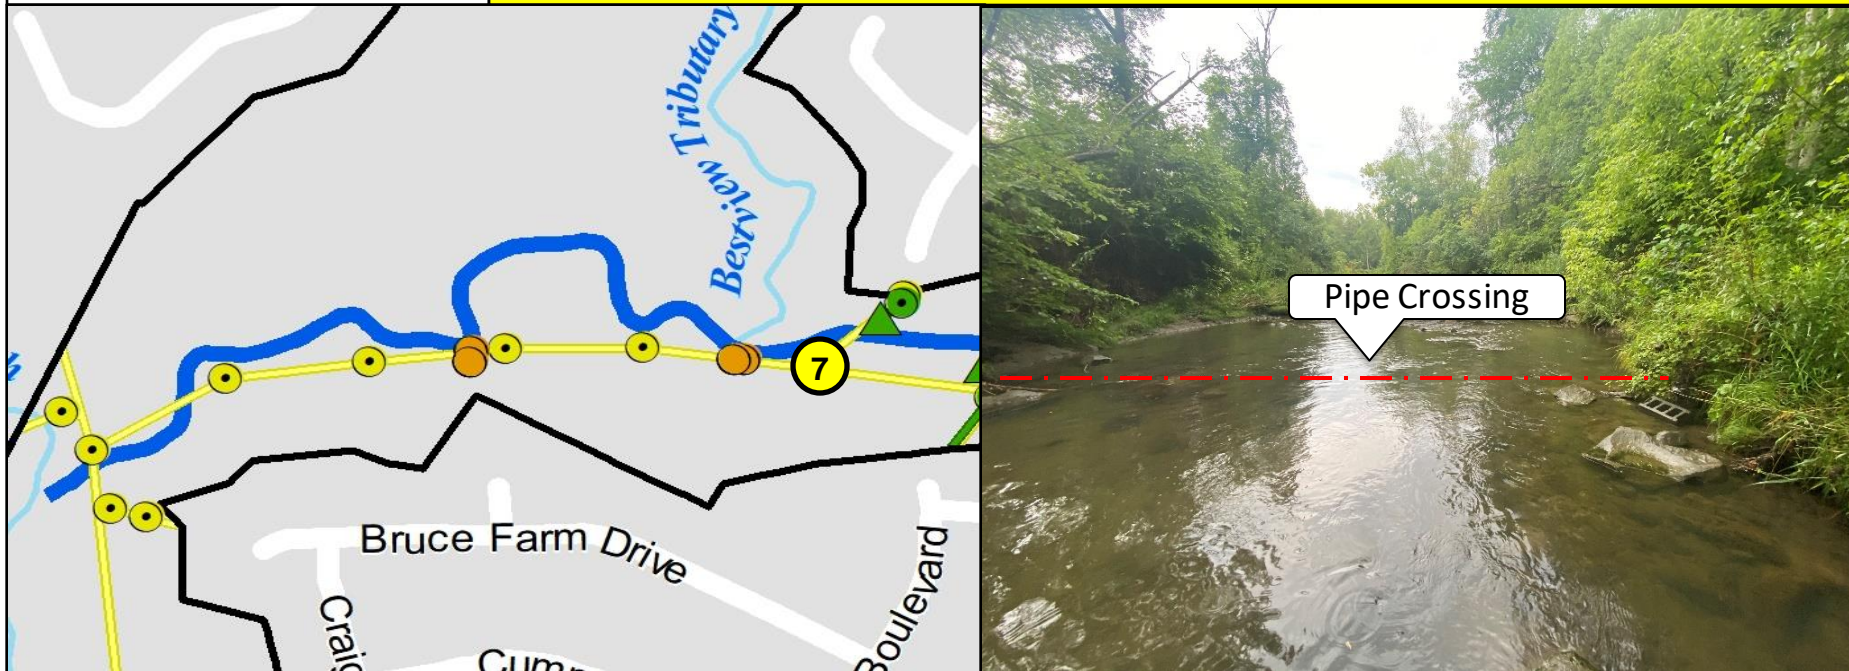
# Risk Assessment: Priority Site 7

<b>Sanitary sewer pipe crossing</b>	
<b>Descriptions of conditions</b>	<ul style="list-style-type: none"><li>• 0.37 m depth of cover over existing pipe</li><li>• Channel substrate is mainly sand so more susceptible to erosion</li></ul>
<b>Risk level</b>	<b>Medium</b>

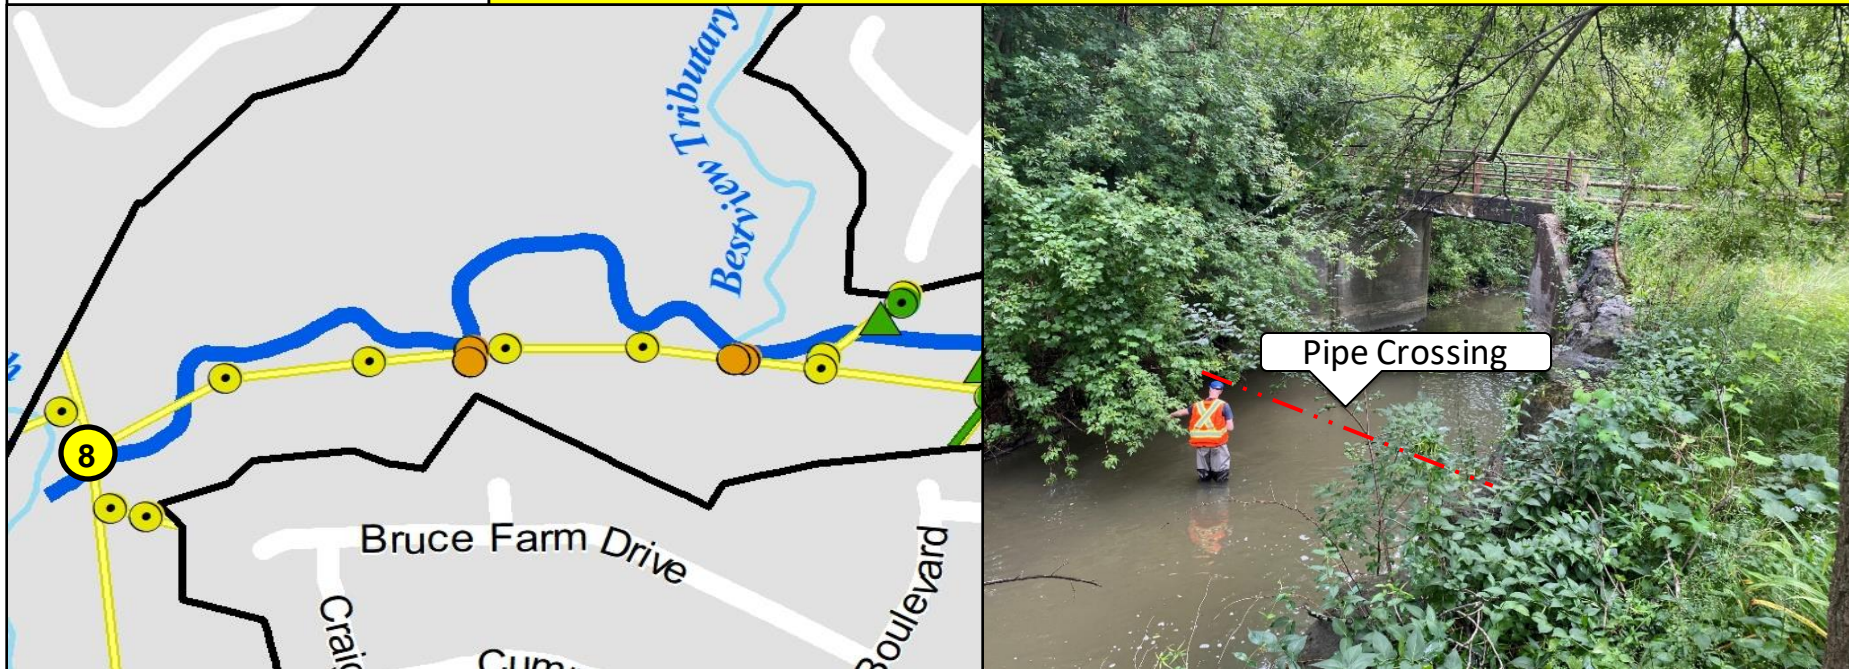
# Risk Assessment: Priority Site 8

<b>Sanitary sewer pipe crossing</b>	
<b>Descriptions of conditions</b>	<ul style="list-style-type: none"><li>• 0.48 m depth of cover over existing pipe</li><li>• Channel substrate is cobble and gravel so less susceptible to erosion</li></ul>
<b>Risk level</b>	<b>Medium</b>

Project No.	Recommended Solution	Evaluation Detail
8	Local works less than 200 metres and floodplain connections	<ul style="list-style-type: none"> <li>Projects in close proximity to each other – addresses multiple erosion risks to infrastructure at once within one construction period as well as provides efficiencies in design costs</li> <li>Balances in-stream erosion reduction and tree removals</li> </ul> <p>Future implementation of the recommended natural channel design projects requires tree removal, to be followed by restoration and replanting with native trees and shrubs</p>
9	Local works less than 200 metres and floodplain connections	Same as Project No. 8 above

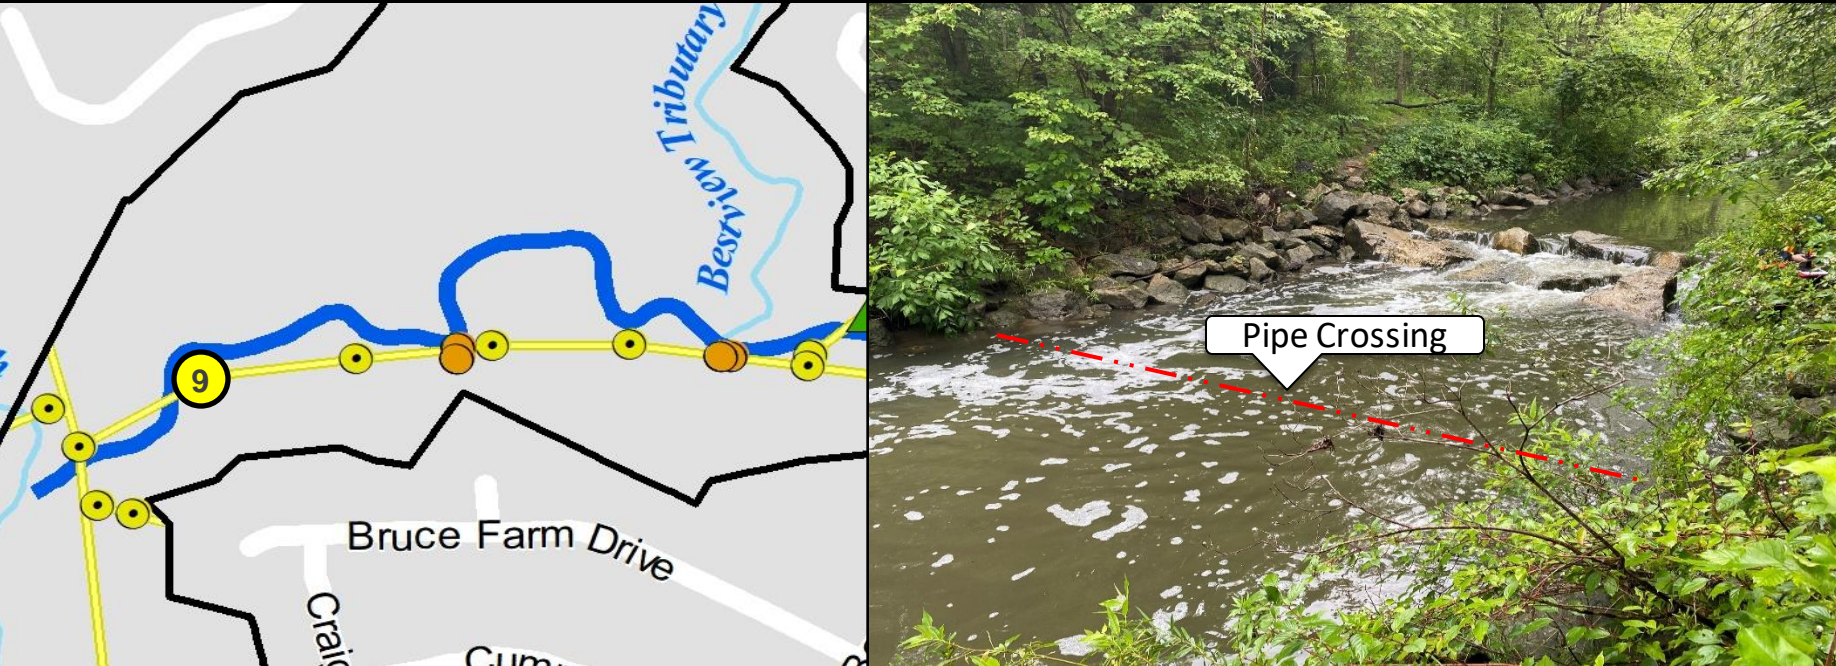
# Risk Assessment: Priority Site 9

Sanitary sewer pipe crossing	
Descriptions of conditions	<ul style="list-style-type: none"><li>• 1.2 m depth of cover over existing pipe</li><li>• Grade control structures (rocky ribs) to reduce channel velocities</li></ul>
Risk level	<b>Medium</b>

The bottom section of the table contains two images. On the left is a map showing a blue line representing a waterway, labeled 'Beaumont Tributary'. A yellow line representing a sanitary sewer pipe crosses the tributary. A yellow circle with the number '9' is placed on the pipe. Other labels on the map include 'Bruce Farm Drive' and 'Craig'. On the right is a photograph of the tributary, showing a rocky channel with water flowing over several small cascades. A red dashed line indicates the location of the pipe crossing, and a white callout box with the text 'Pipe Crossing' points to this location.

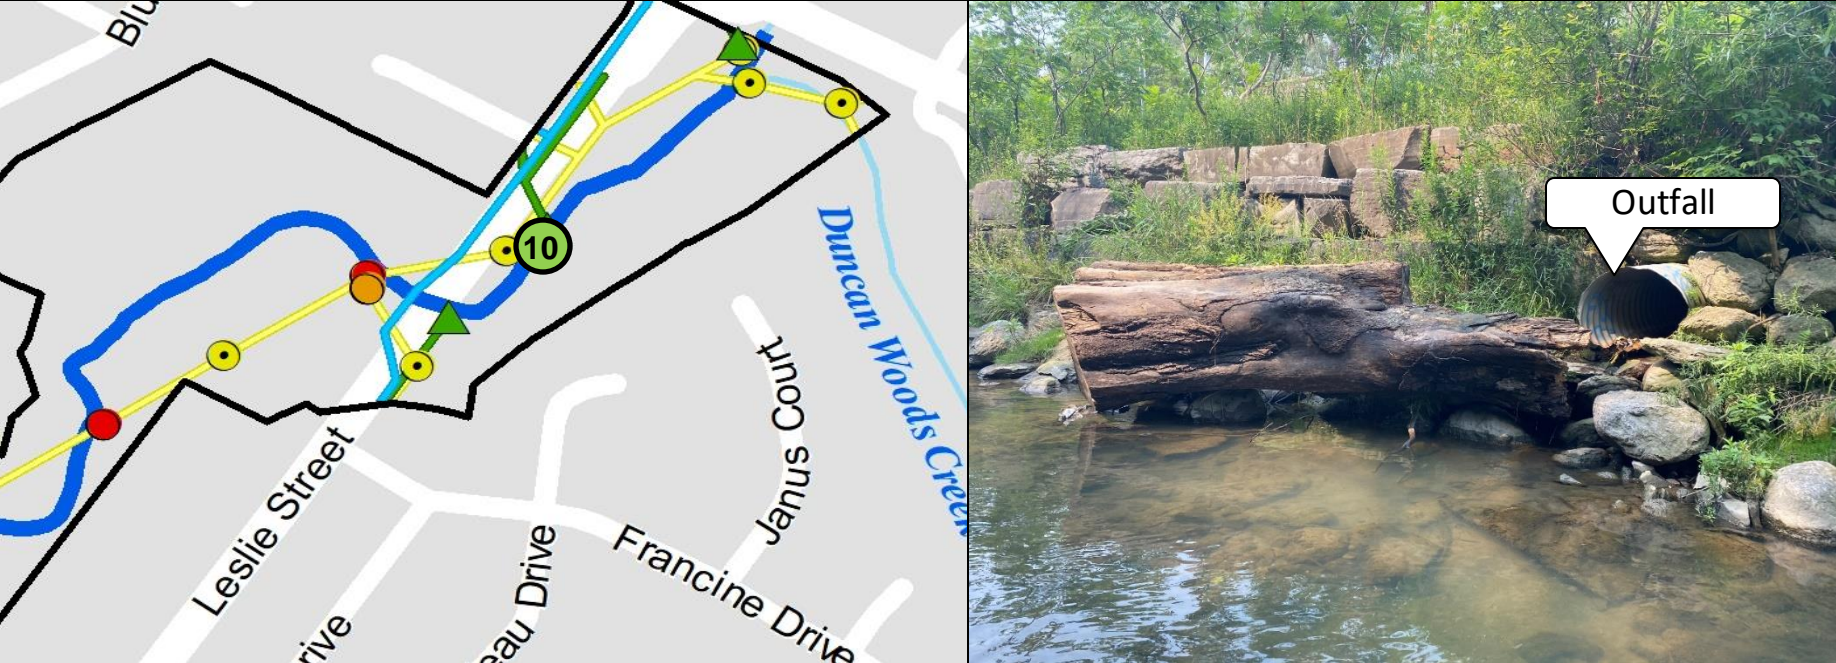
# Risk Assessment: Priority Site 10

<b>Sanitary sewer outfall</b>	
<b>Descriptions of conditions</b>	<ul style="list-style-type: none"><li>• Outfall protected by armourstone and large boulders</li></ul>
<b>Risk level</b>	<b>Low</b>

The table's bottom row contains two images. On the left is a map showing a network of streets including Leslie Street, Beau Drive, Francine Drive, and Janus Court, with Duncan Woods Creek flowing through the area. A green circle with the number '10' is placed on the creek. On the right is a photograph of the creek's edge, showing a large log and several large boulders. A white callout box with the word 'Outfall' points to a pipe opening in the rocks.

Project No.	Recommended Solution	Evaluation Detail
10	Local works less than 200 metres	<ul style="list-style-type: none"> <li>Low erosion risk, therefore local works minimize cost and impacts to surrounding infrastructure</li> </ul> <p>Future implementation of the recommended natural channel design projects requires tree removal, to be followed by restoration and replanting with native trees and shrubs</p>
11	Local works less than 200 metres	Same as Project No. 10 above

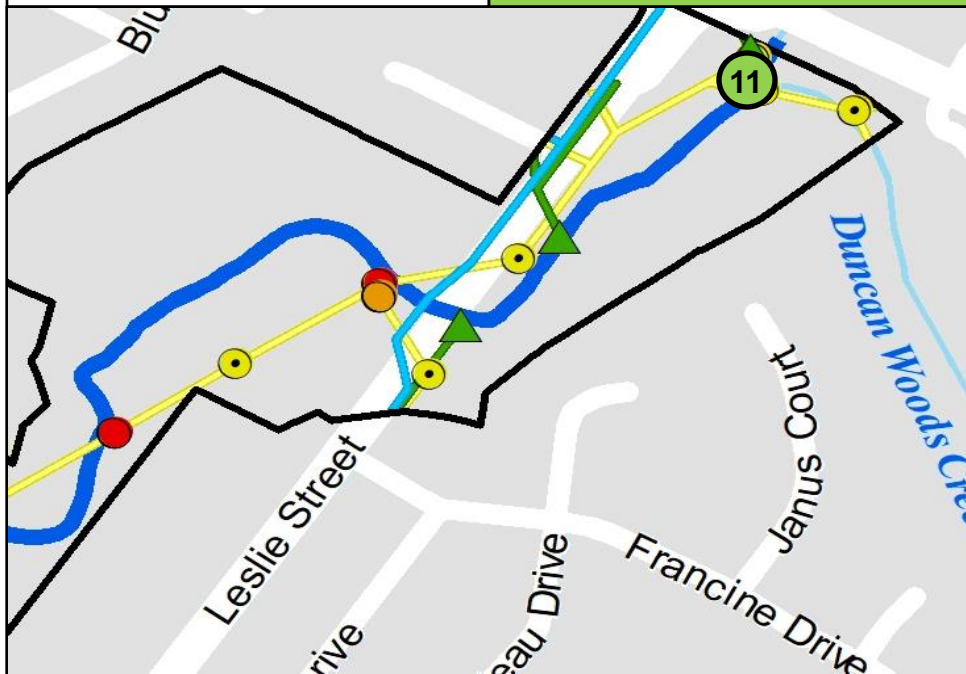
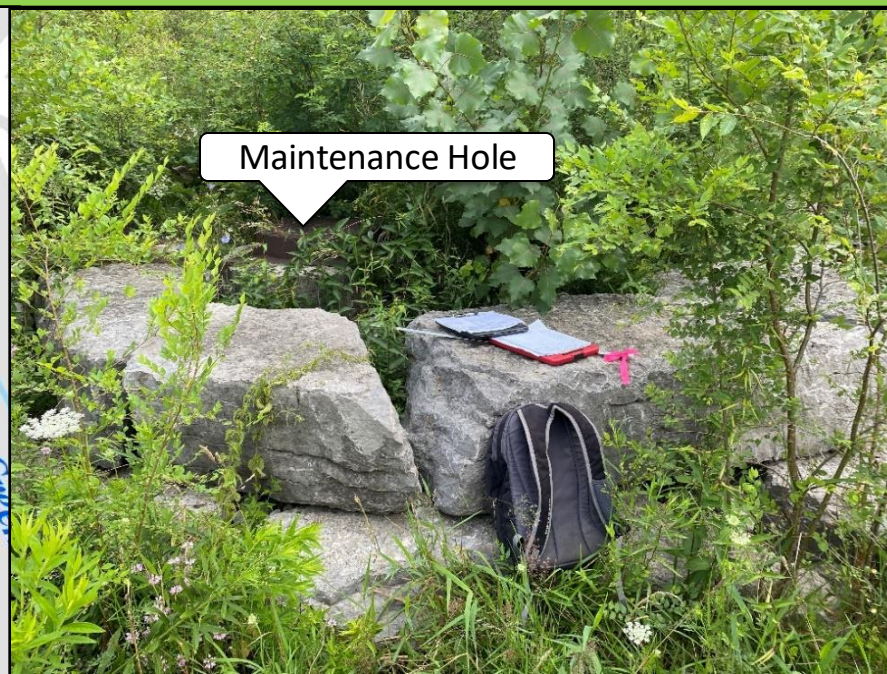
# Risk Assessment: Priority Site 11

## Sanitary sewer maintenance hole

- Maintenance hole well protected behind armourstone blocks
- No sign of active erosion but maintenance hole is within 4 m of creek

Low

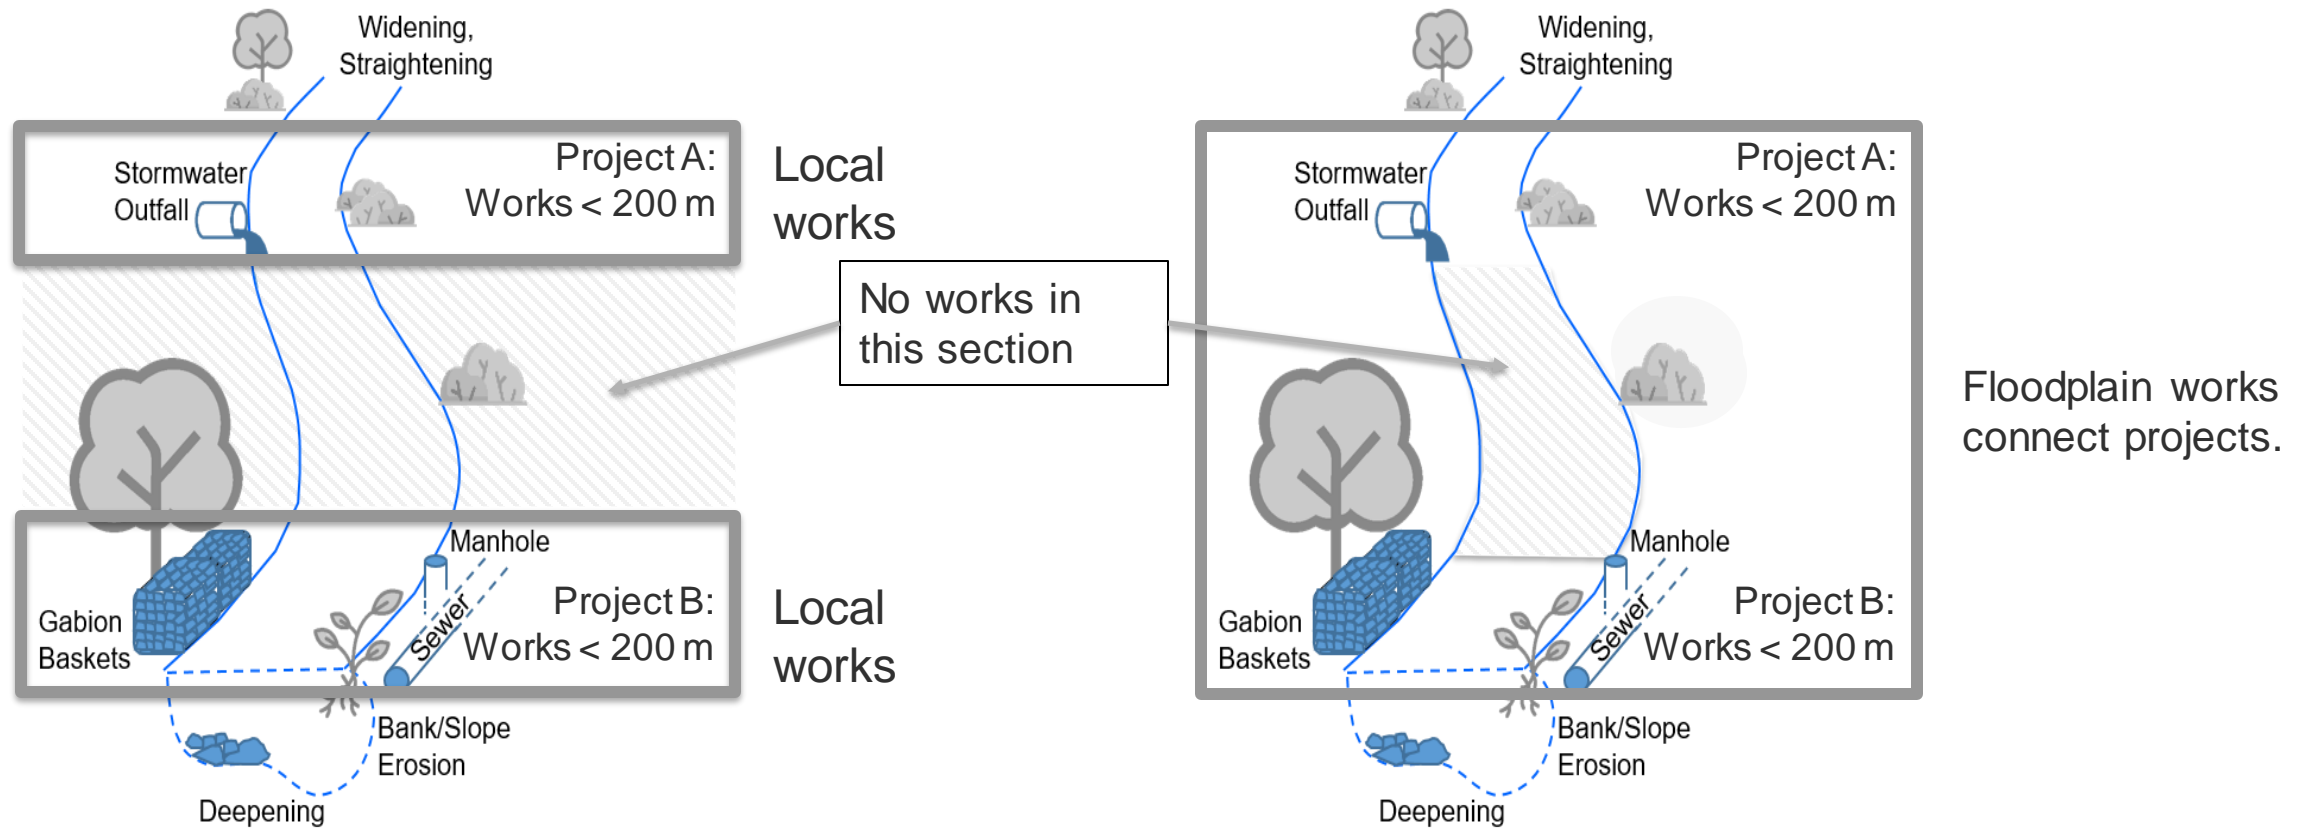
**Alternative 2** – Project A and B separated

**Alternative 3** – Project A and B connected through works in the floodplain

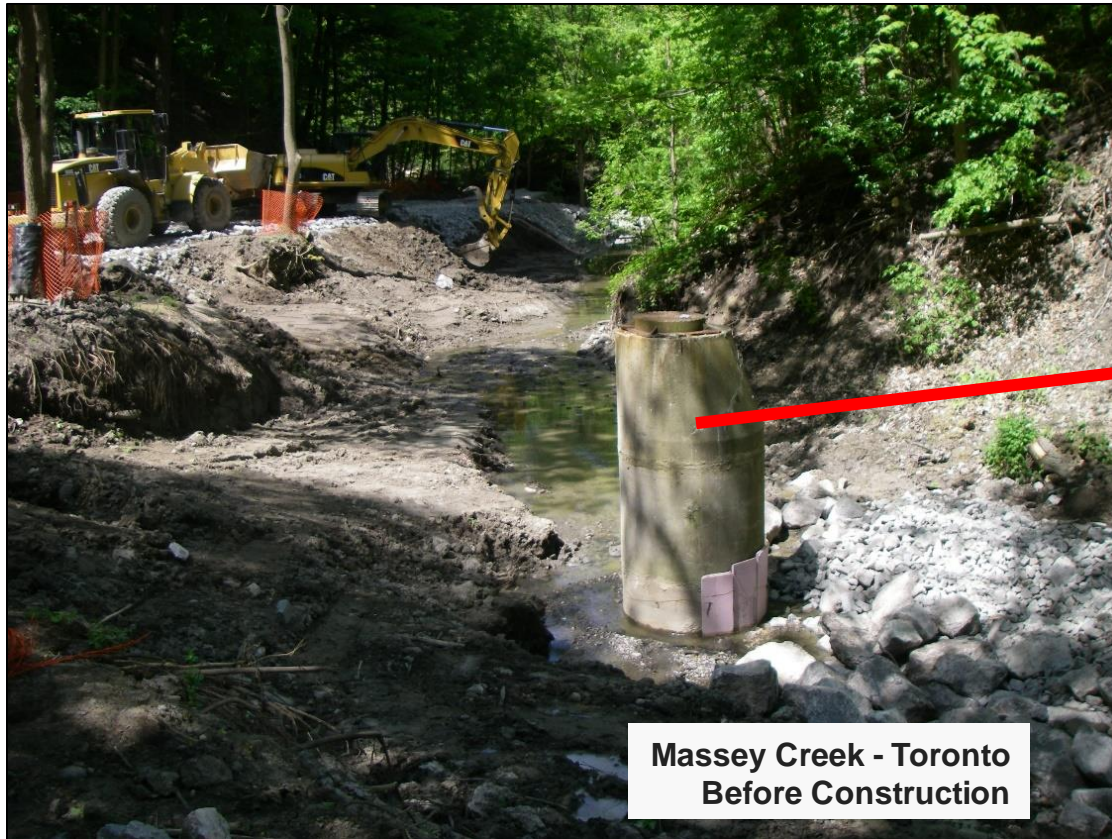
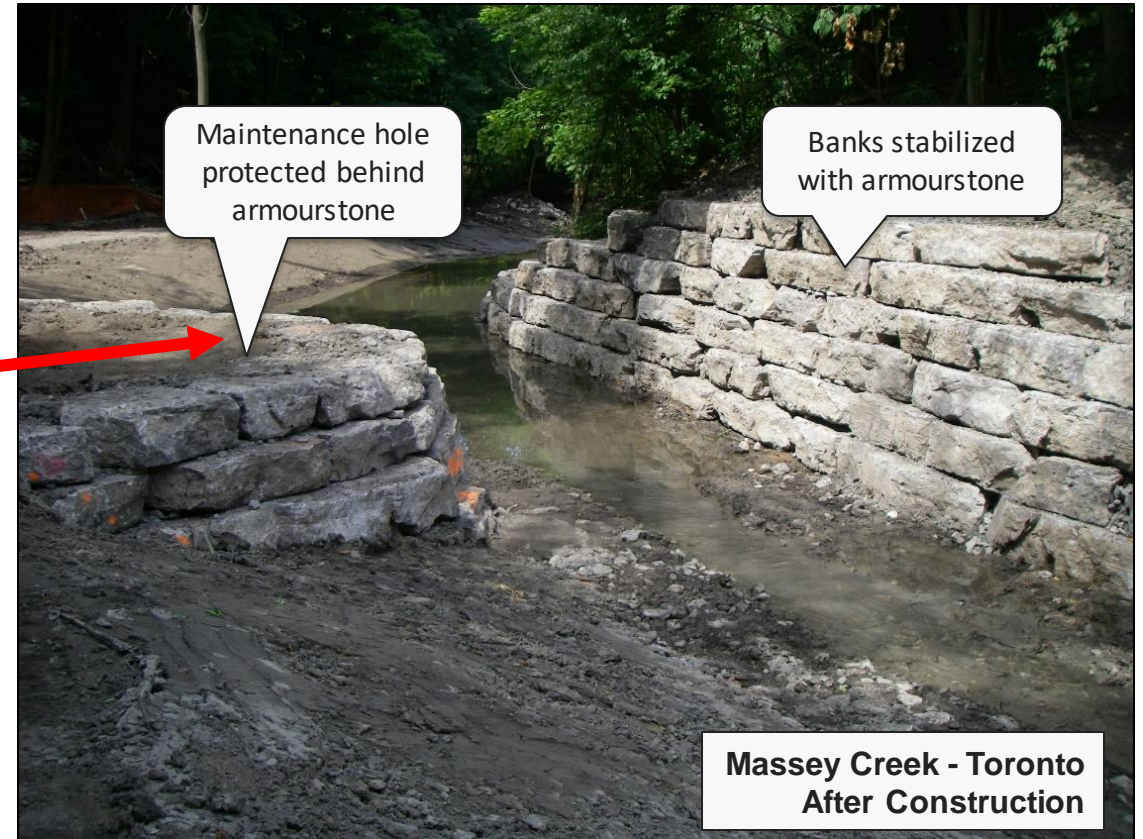
# Example of Alternative 2

Improvements through local works less than 200 metres

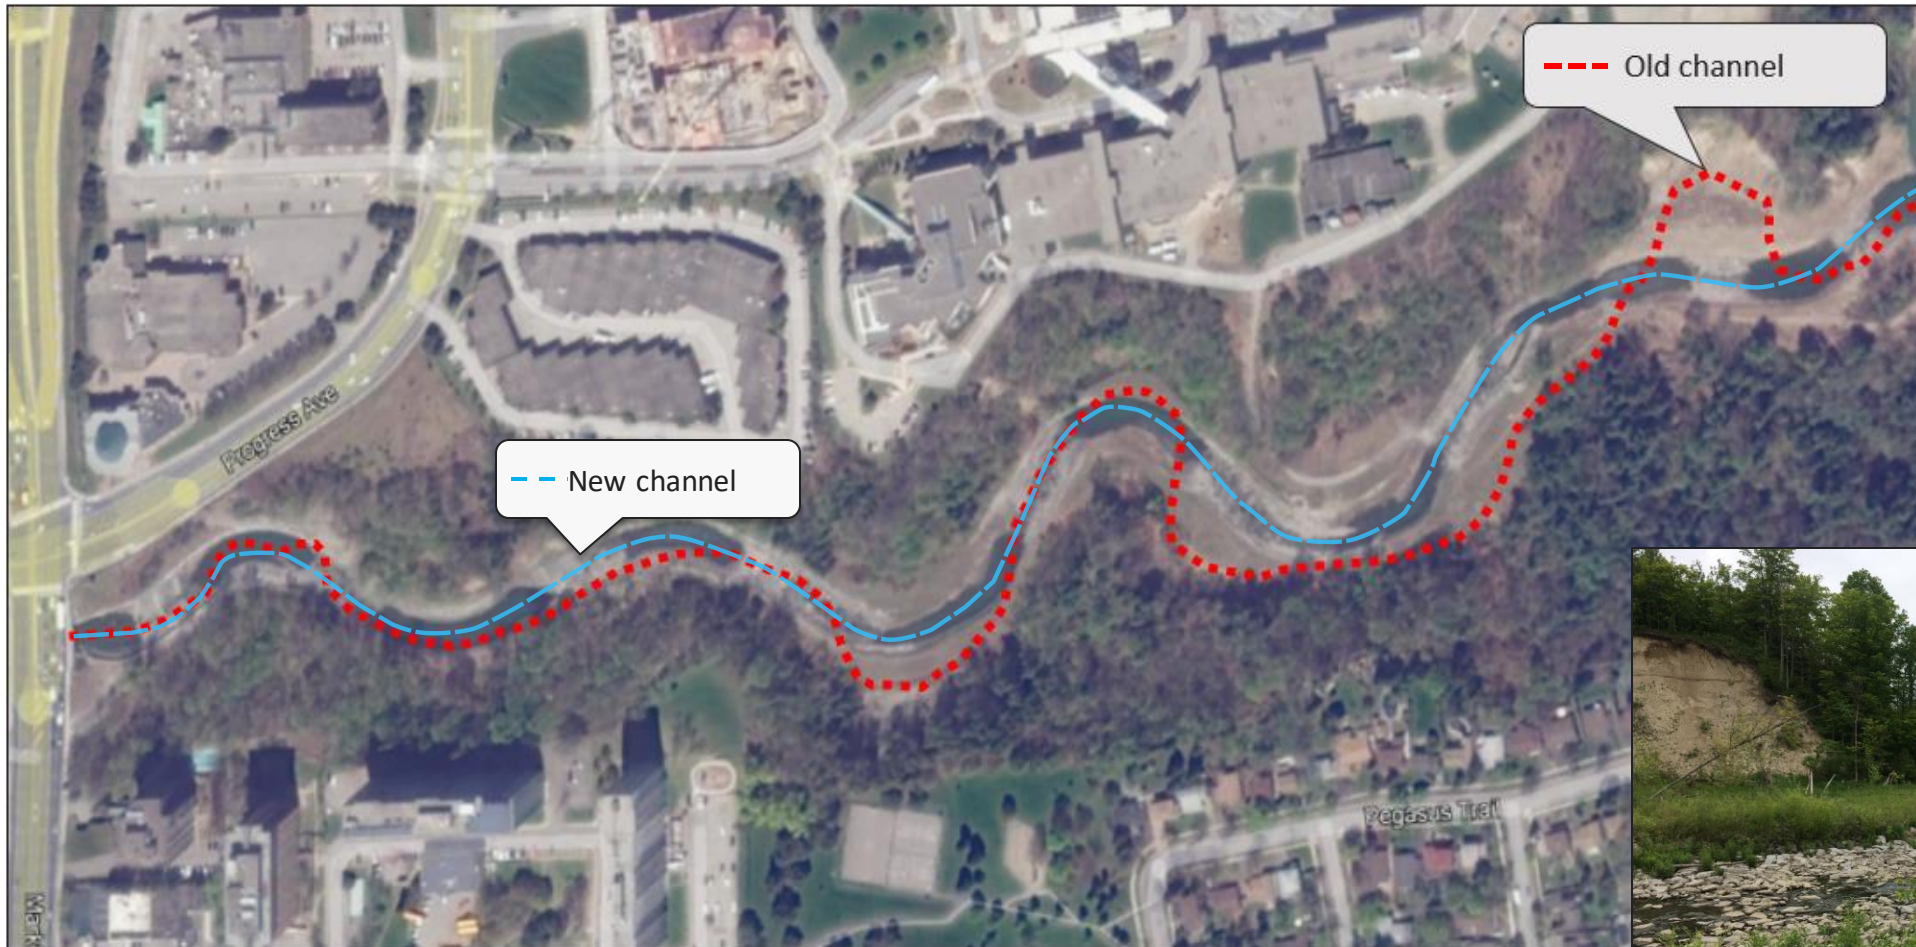
# Example Alternative 4, Greater than 200 m

Improvements through local greater than 200 metres

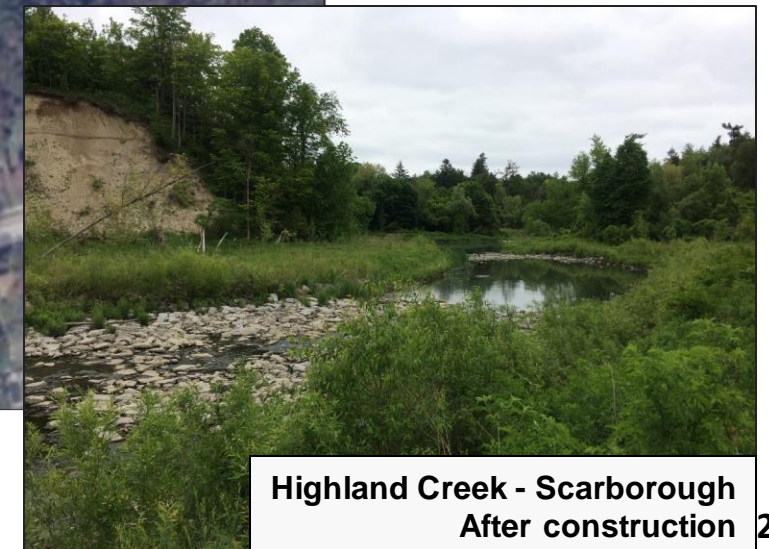
Section of creek realigned
