3. Existing Conditions

3.1 Technical Environment

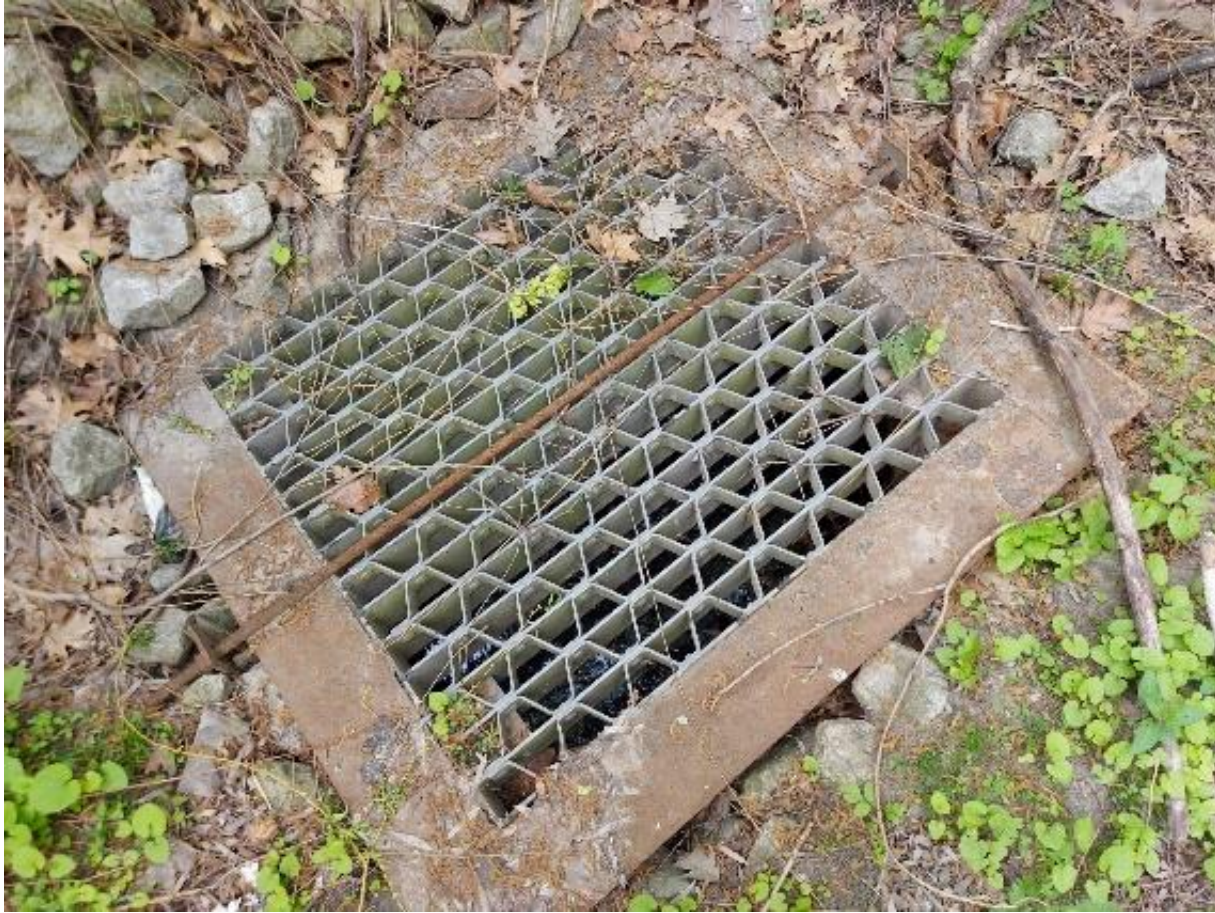
Figure 3-3: Existing Mimico Creek Outfall

The existing Mimico Creek outfall (OF3101406209) is located within Humber Bay Park. The outfall is a 600 mm polyvinyl chloride (PVC) pipe. The existing outfall does not provide sufficient capacity under the 100-year event. During the 100-year event, the outlet's insufficient capacity would cause the water level in the storm sewers along Legion Road, Fleeceline Road and Lake Shore Boulevard West to surcharge above the ground level, increasing surface flooding and basement flooding risks for the adjacent properties. Refer to **Figure 3-1** for a photo of the existing outfall.

The existing storm sewer outlet was located in the wooded area north of the Mimico Mouth Wetland near the intersection of Lake Shore Boulevard West and Humber Bay Park Road West. The outlet consisted of an overflow grate that drains to the Mimico Mouth Wetland ephemerally with limited channel definition or evidence of substrate sorting, which poses an impediment to fish passage to the outlet. Approximately 70% of the wetland was covered in emergent vegetation and organic and woody debris.

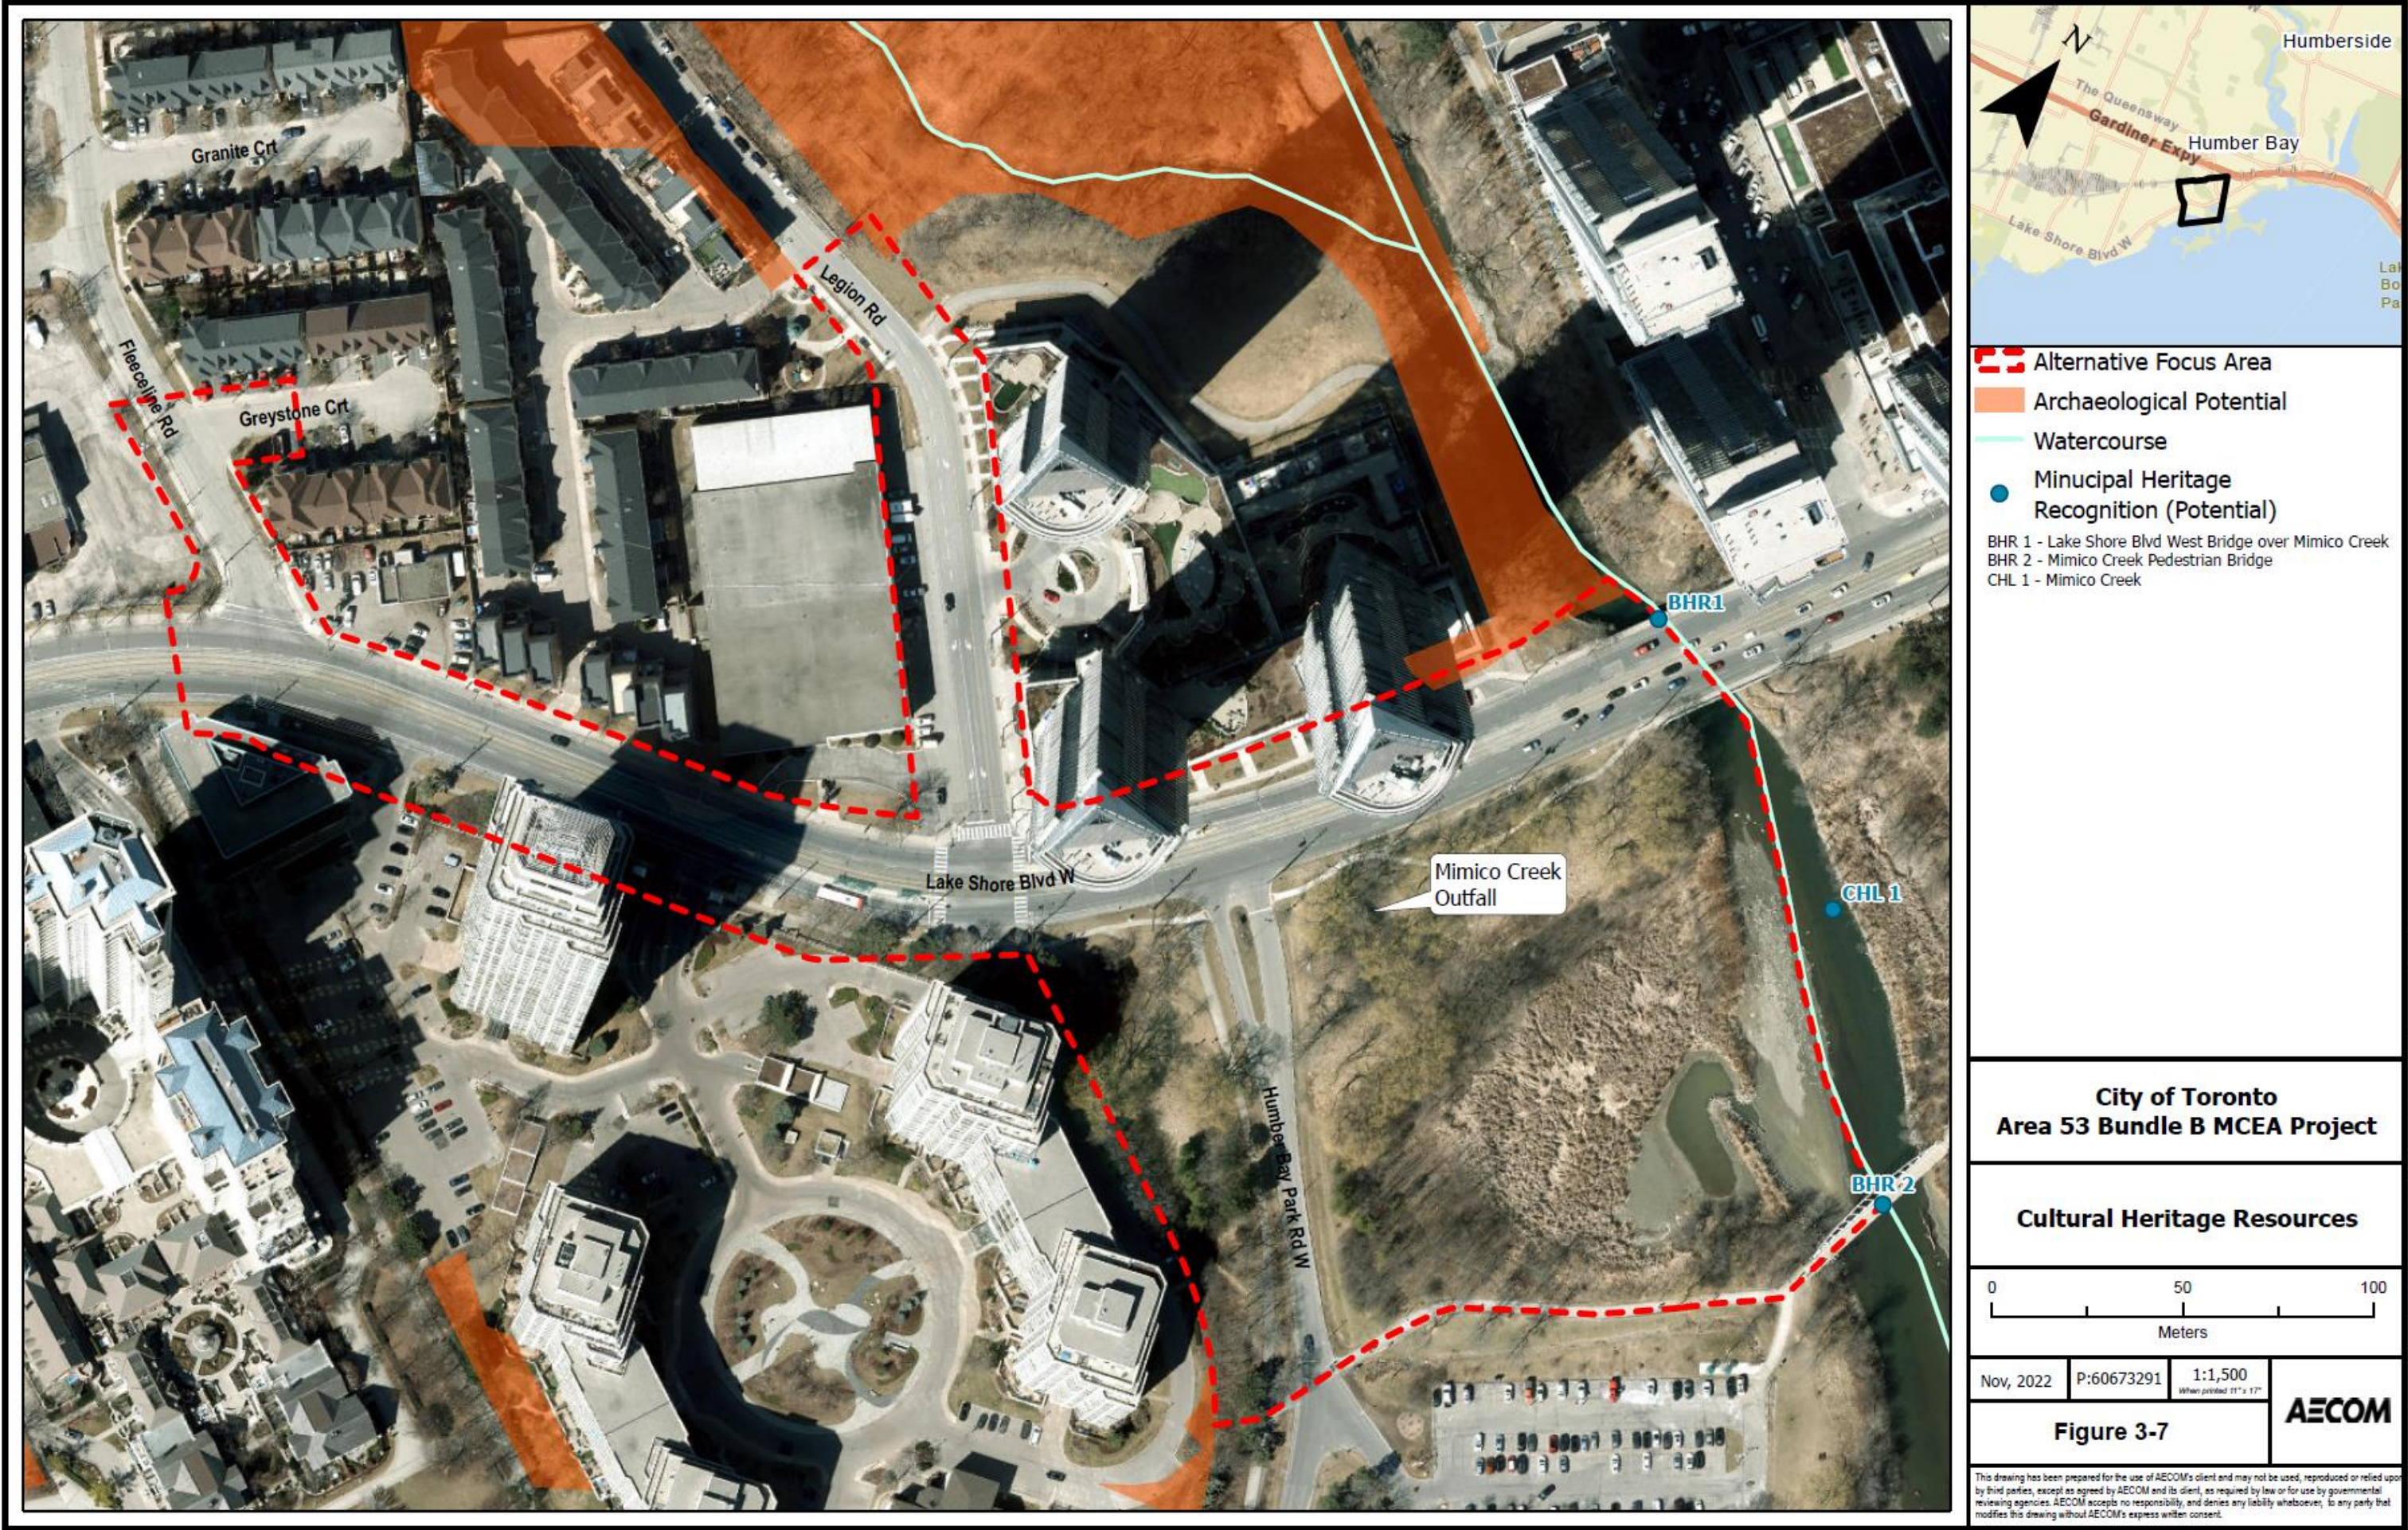
Figure 3-7: Cultural Heritage Existing Conditions

Based on the preliminary impact assessment undertaken, BHR 1, BHR 2 and CHL 1 will not be directly adversely impacted or indirectly impacted by the Project. Therefore, no further work is required.
