Newtonbrook Creek Restoration and Water Infrastructure Protection Study Geomorphic Systems Master Plan

Public Consultation: October 2023

Newtonbrook Creek Geomorphic Systems Master Plan

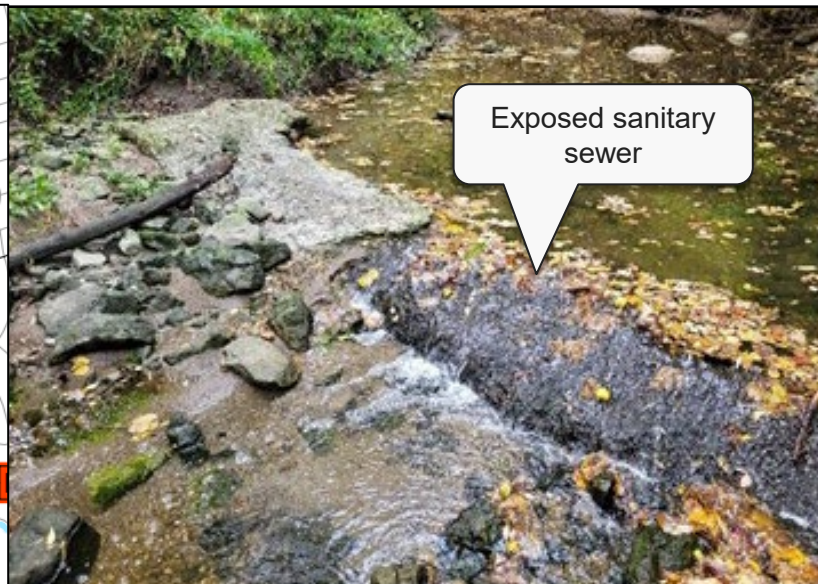
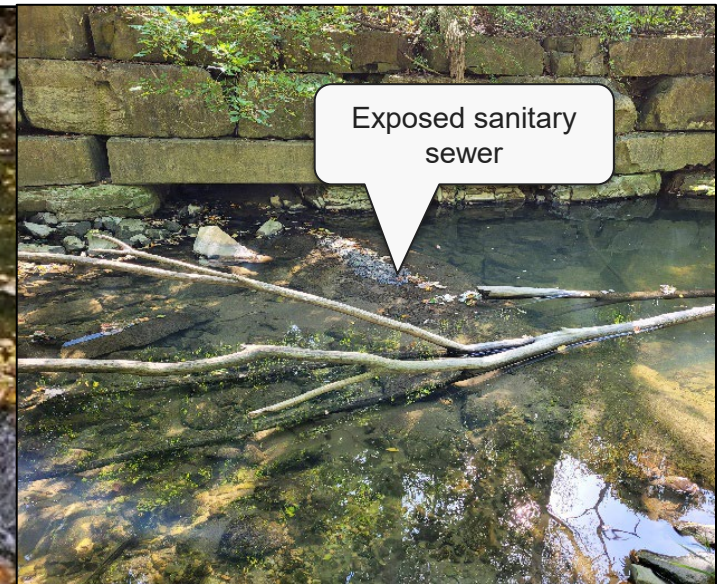
Risk Assessment - Project #1

Multiple sanitary sewer infrastructure risks downstream of Bayview and Finch

- x4 Exposed sanitary sewer crossings
- x1 Exposed sanitary sewer maintenance hole
- x4 Sanitary sewer laterals (where the bank is eroding towards the sewer)
- x2 Degraded storm sewer outfalls

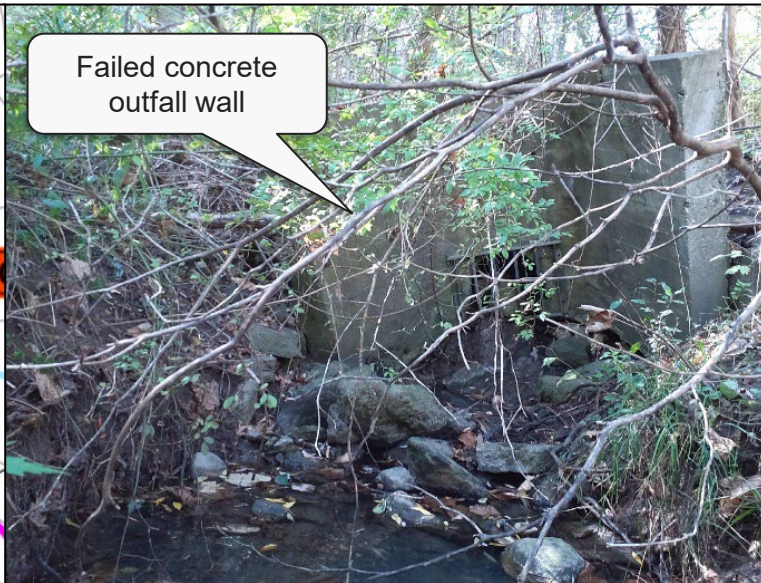
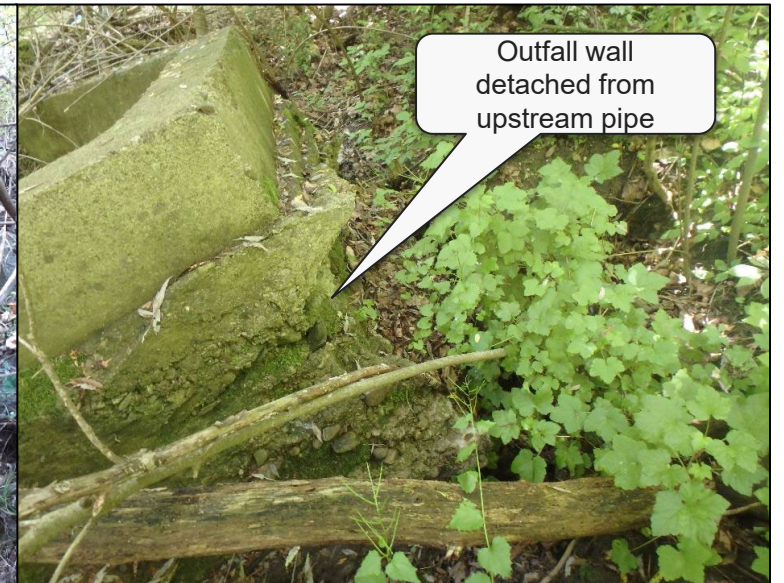
Risk Assessment - Project #2

Failed storm sewer outfall by Canary Crescent

- x1 Failed storm sewer outfall
- Slope erosion/failure observed along the upstream pipe alignment
- Ongoing bank erosion

Project No.	Evaluation Details
2	<ul style="list-style-type: none"> Addresses identified erosion risks while minimizing the area of environmental disturbance. Lower capital costs and more economically efficient than the sub-reach scale alternative given the isolated nature of the project site. <p>Future implementation of the recommended natural channel design projects requires tree removal, to be followed by restoration and replanting with native trees and shrubs.</p>
5	<ul style="list-style-type: none"> Same as Project No. 2 above
8	<ul style="list-style-type: none"> Same as Project No. 2 above
9	<ul style="list-style-type: none"> Same as Project No. 2 above

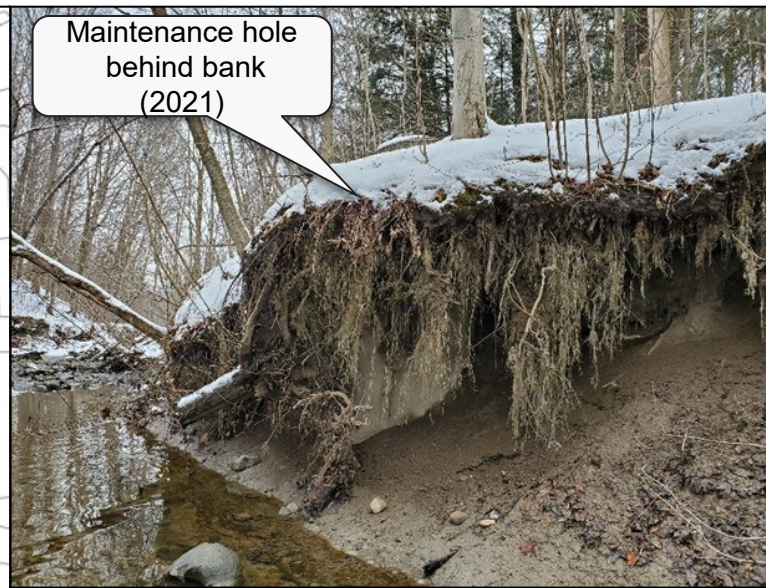
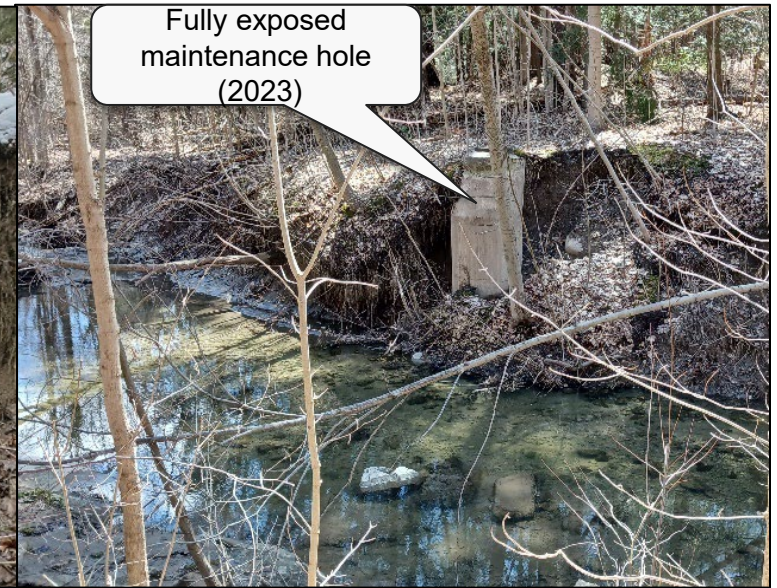
Risk Assessment - Project #3

Exposed sanitary sewer maintenance hole near Don River confluence

- x1 Exposed sanitary sewer maintenance hole
- x1 Exposed sewer crossing
- x1 Additional crossing with less than 1.0 m cover
- x2 Sanitary sewer laterals (where the bank is eroding towards the sewer)

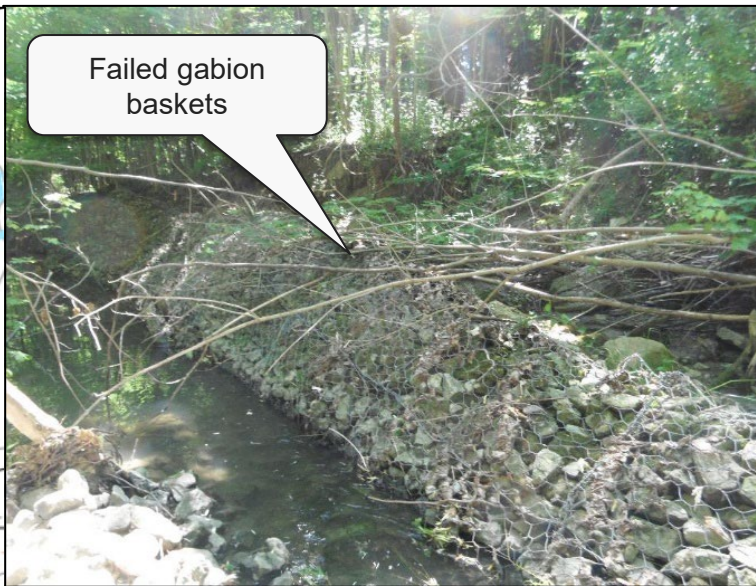
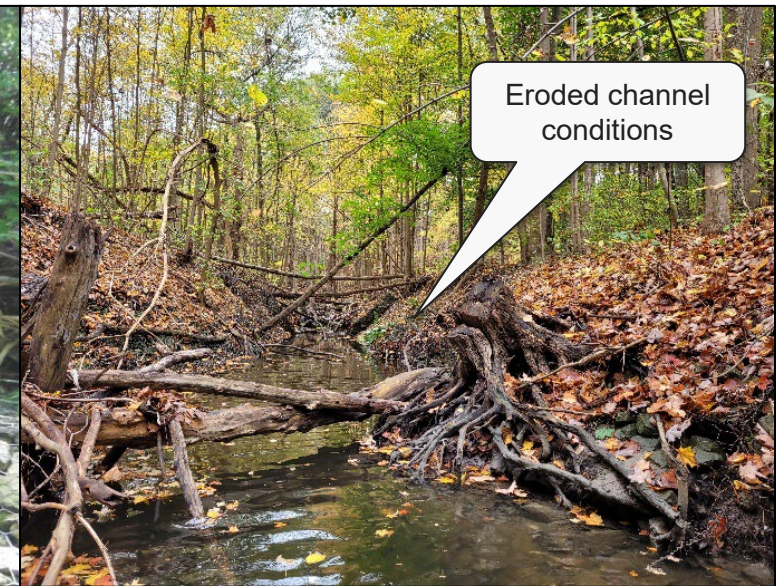
Risk Assessment - Project #4

Exposed sanitary sewer crossing downstream of Forest Grove Drive

- x1 Exposed sanitary sewer crossing
- x1 Additional crossing with less than 1.0 m cover
- x2 Sanitary sewer lateral risks (where the bank is eroding towards the sewer)

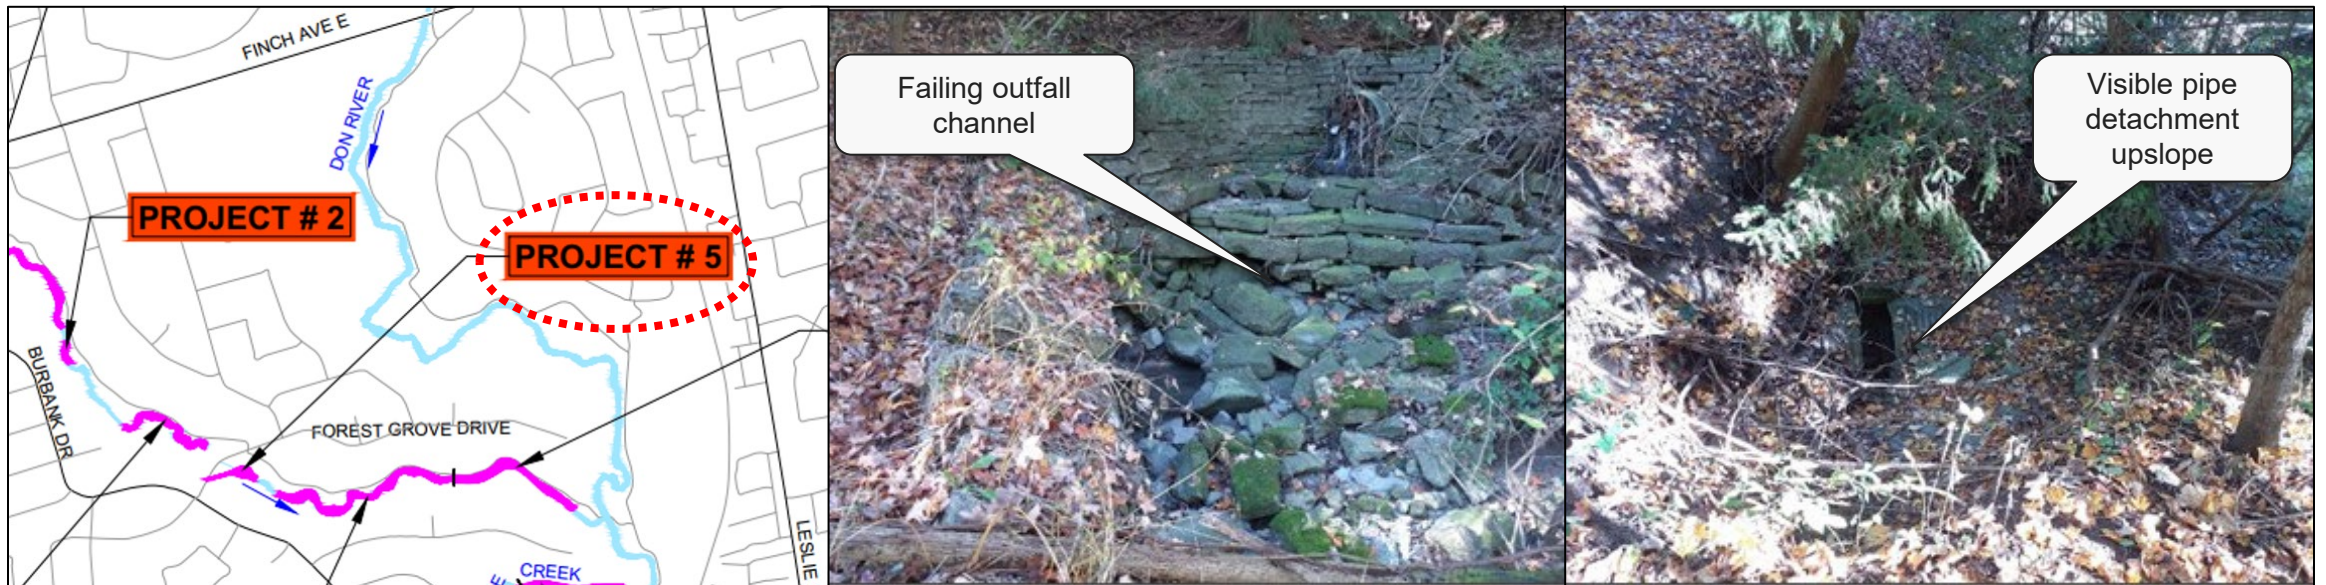
Risk Assessment - Project #5

Failed storm sewer outfall downstream of Forest Grove Drive

- x1 Failed storm sewer outfall
- x1 Sanitary sewer lateral risk (where the bank is eroding towards the sewer)
- Slope erosion/failure observed along the upstream pipe alignment

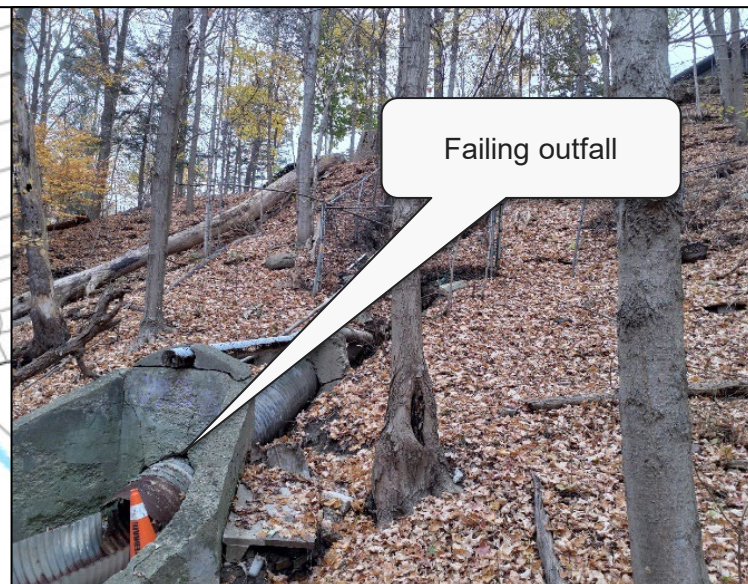
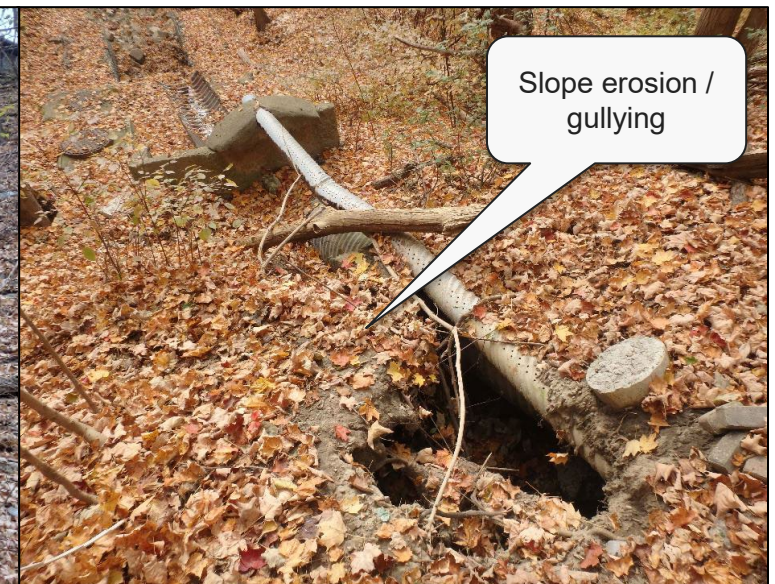
Risk Assessment - Project #6

Failed storm sewer outfall by Hi-Mount Drive

- x1 Failed storm sewer outfall
- x2 Sanitary sewer lateral risks (where the bank is eroding towards the sewer)
- Slope erosion/failure observed along the upstream pipe alignment

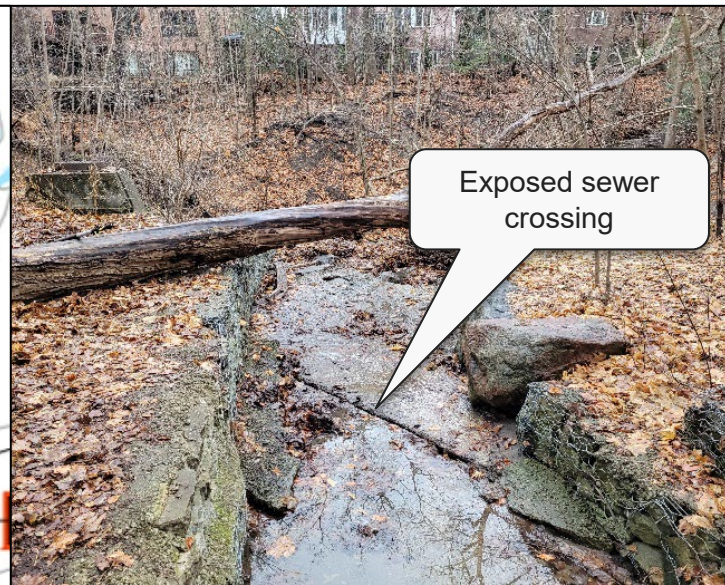
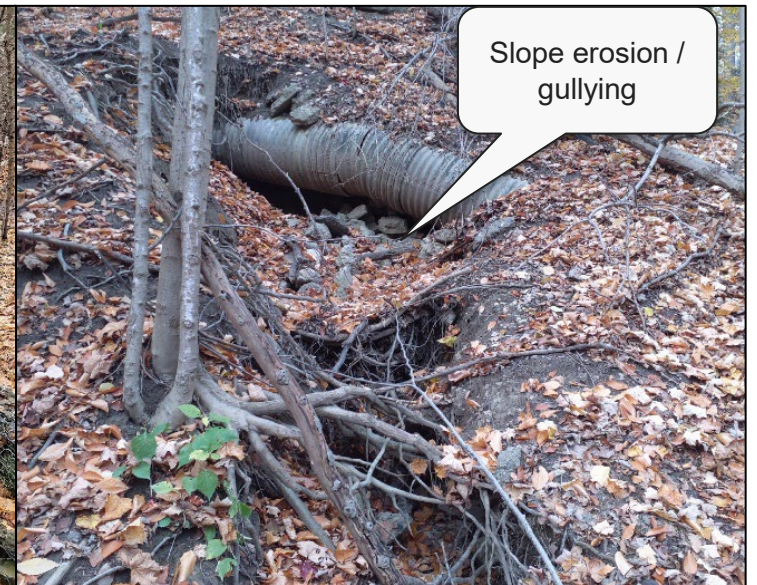
Risk Assessment - Project #7

Exposed sanitary sewer crossing and failed storm sewer outfall by Sifton Court

- x1 Exposed sanitary sewer crossing
- x1 Failed storm sewer outfall
- Slope erosion/failure observed along the upstream pipe alignment
- x4 Sanitary sewer laterals (where the bank is eroding towards the sewer)

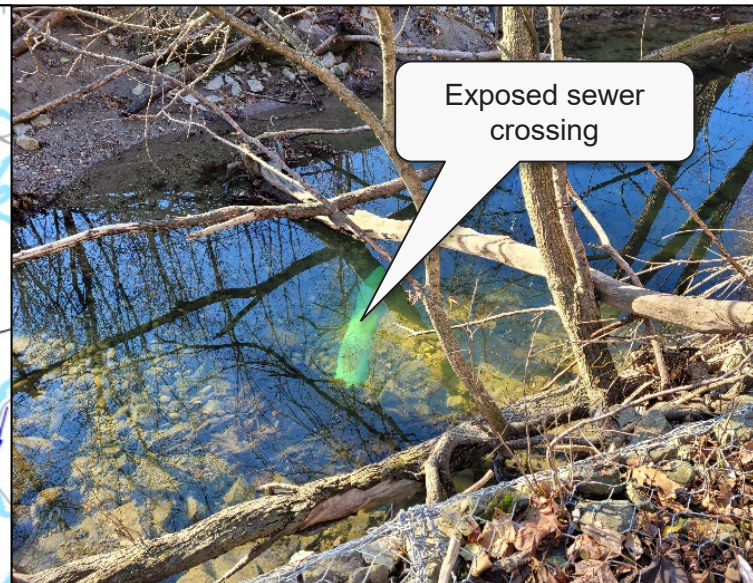
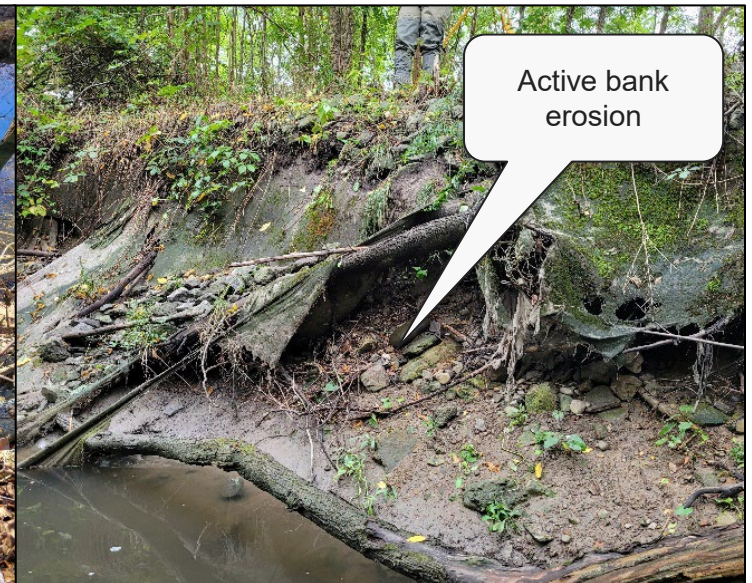
Risk Assessment - Project #8

Exposed sanitary sewer crossing downstream of Maxome Avenue

- x1 Exposed sanitary sewer crossing
- x1 Additional crossing with less than 2.0 m cover
- x1 Degraded storm sewer outfall
- x3 At risk oil pipeline crossings

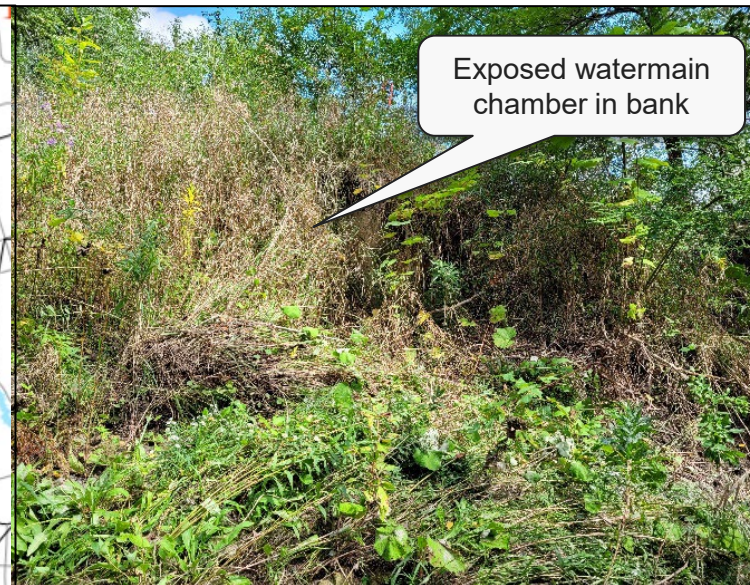
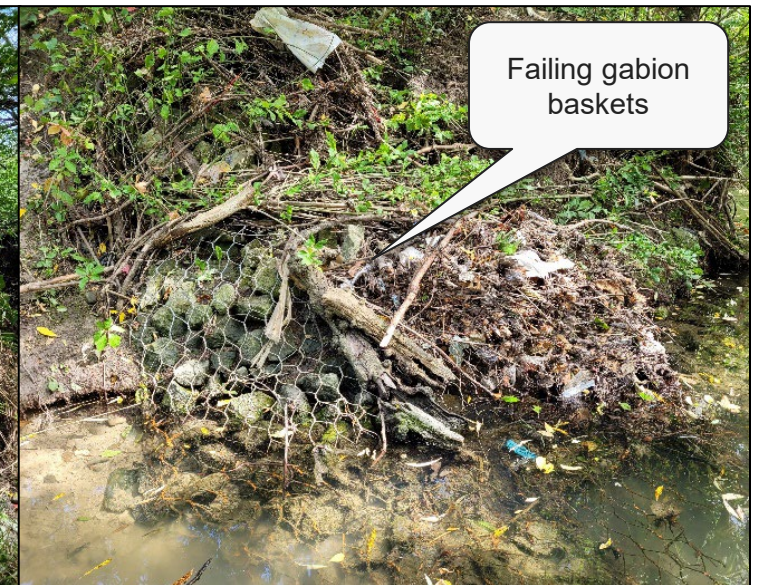
Risk Assessment - Project #9

Exposed watermain chamber upstream of Finch and Bayview

- x1 Exposed watermain chamber
- x1 Watermain crossing with less than 1.0 m of cover
- x1 Sanitary sewer crossing with less than 2.0 m of cover
- x1 Degraded storm sewer outfall

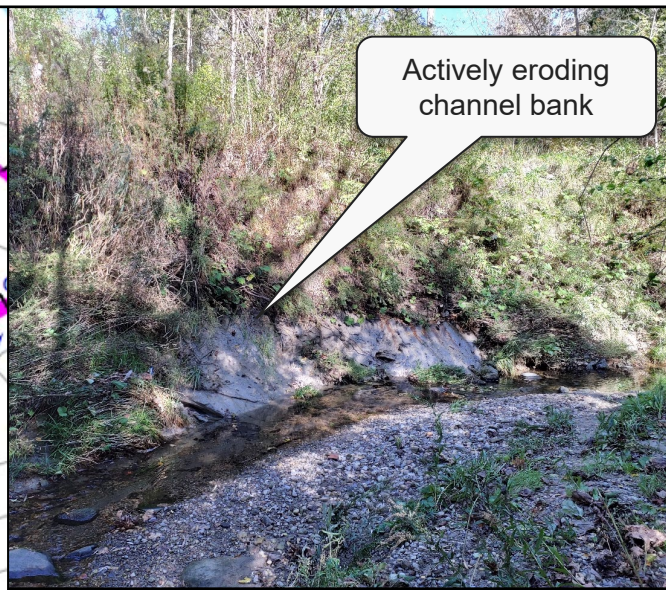
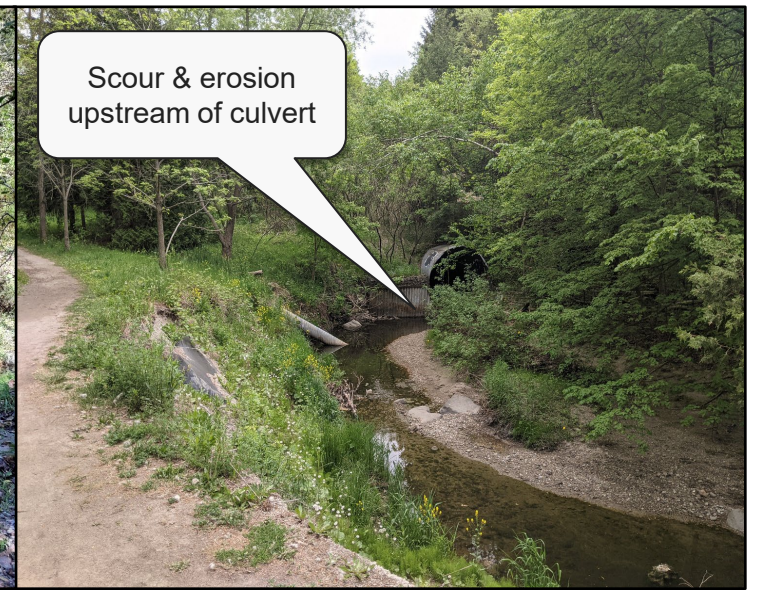
Risk Assessment - Project #10

Lateral erosion risks to sanitary sewer infrastructure upstream of Forest Grove Drive

- x2 Sanitary sewer lateral risks (where the bank is eroding towards the sewer)
- Actively eroding channel banks
- Scour and erosion upstream of the Forest Grove Drive culvert

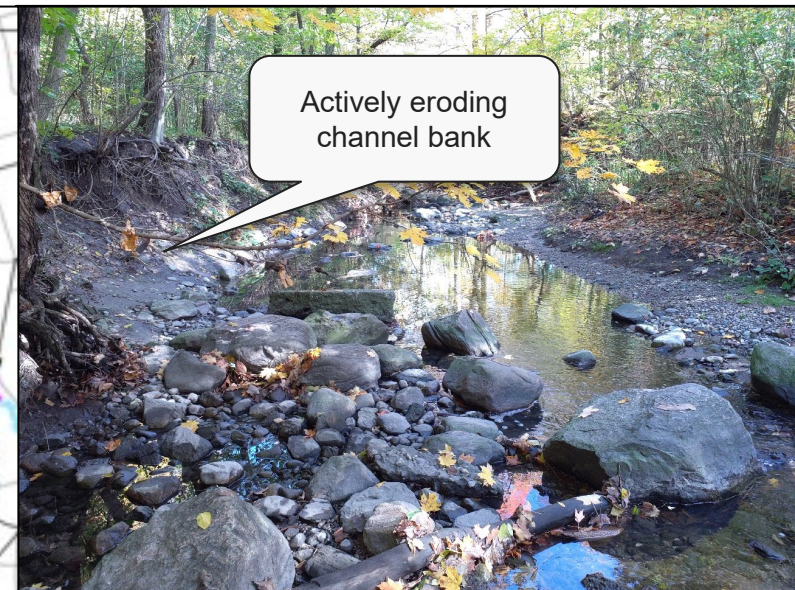
Risk Assessment - Project #11

Lateral erosion risks to sanitary sewer infrastructure upstream of Maxome Avenue

- x2 Sanitary sewer lateral risks (where the bank is eroding towards the sewer)
- x2 Sanitary sewer crossings with less than 1.0 m cover
- Actively eroding channel banks

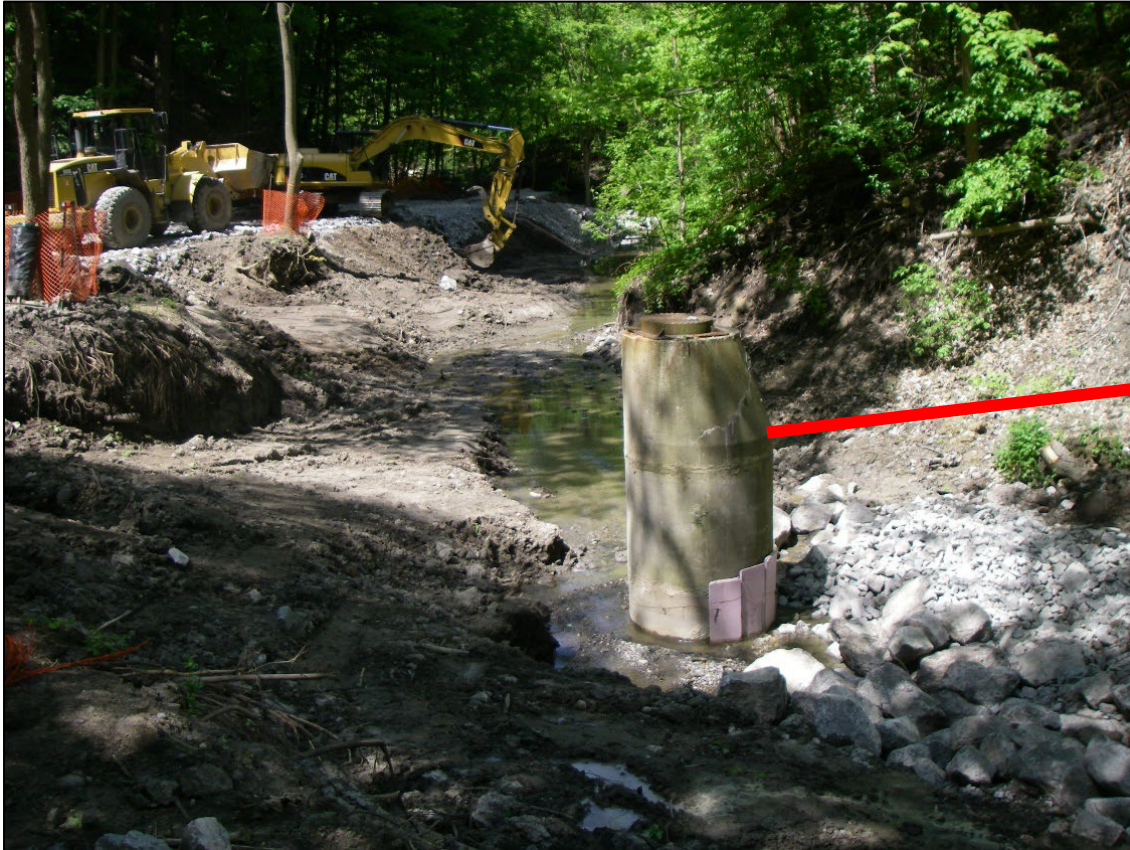
Massey Creek - Sanitary sewer maintenance hole within the creek channel (during-construction)

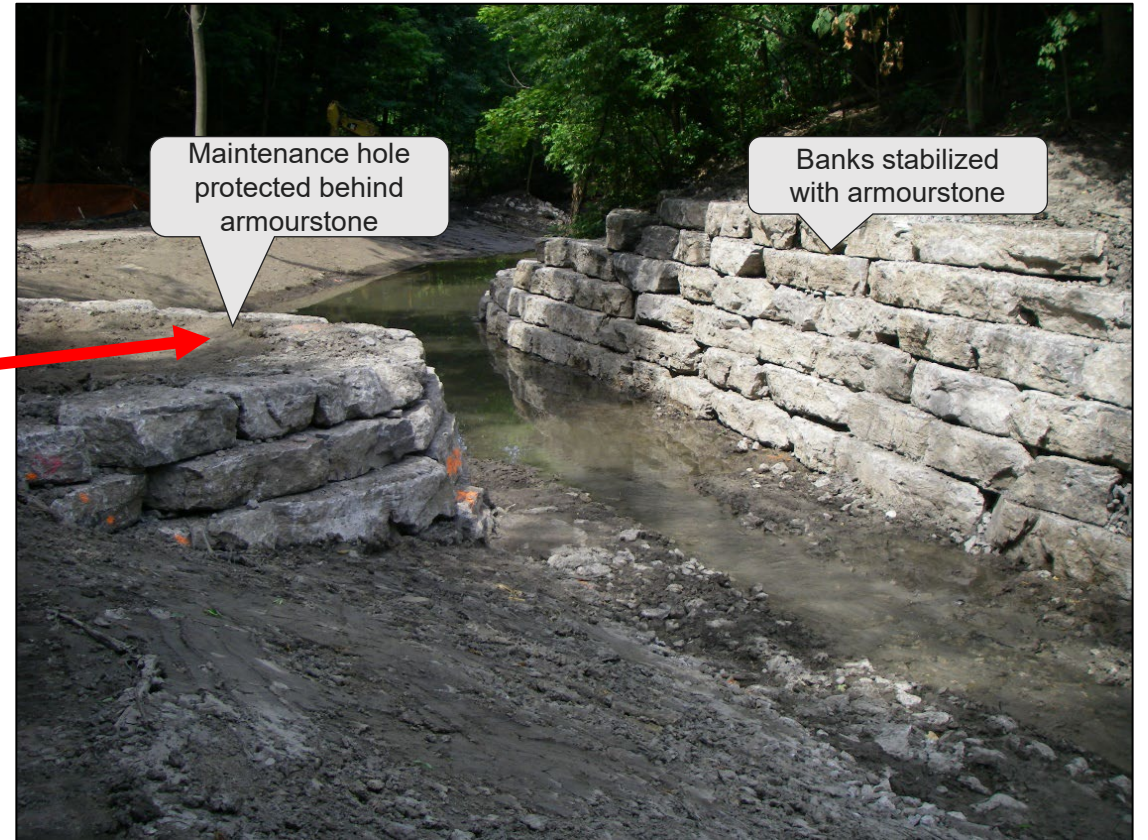
Massey Creek – Creek has been realigned away from maintenance hole with Armourstone walls built as bank protection (post-construction but pre-restoration)

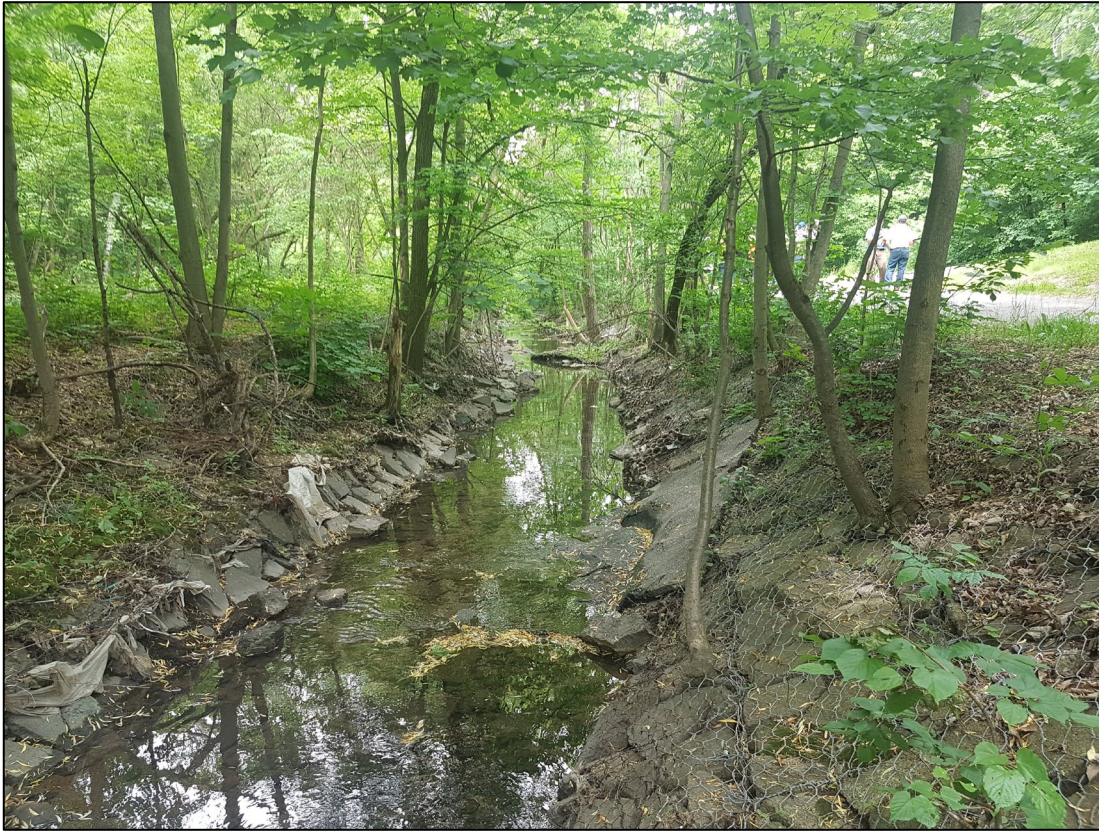
Duncan Creek Phase 2 – Deteriorated gabion lined channel (pre-construction)

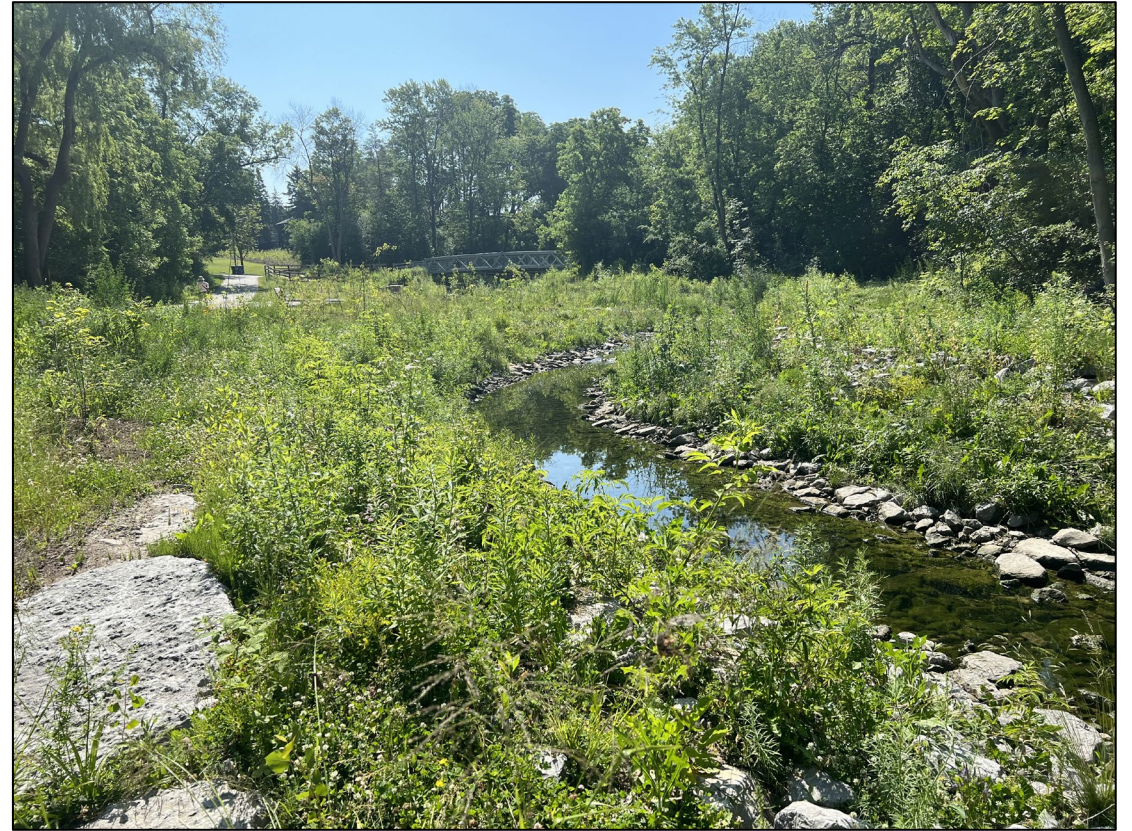
Duncan Creek Phase 2 – Rehabilitated creek corridor (post-construction)

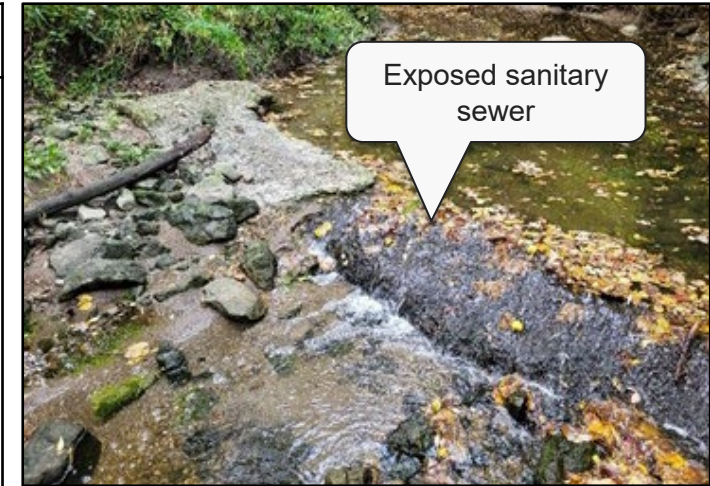
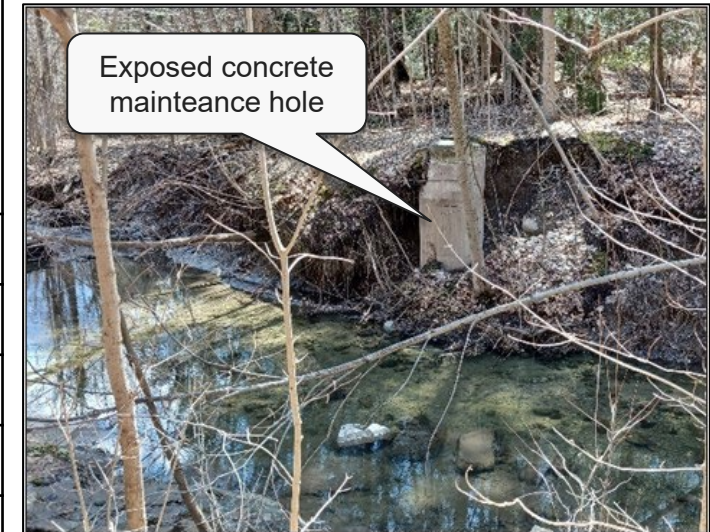
Project No.	Evaluation Details
1	<ul style="list-style-type: none"> Addresses identified erosion risks through an extended restoration design improving the geomorphic stability of the degraded channel. Achieves resource allocation and costing efficiencies by addressing multiple risks, located in close proximity to each other, through a single construction project. <p>Future implementation of the recommended natural channel design projects requires tree removal, to be followed by restoration and replanting with native trees and shrubs and pedestrian trail realignment to allow the stream to have a natural course and avoid future erosion</p>
3	<ul style="list-style-type: none"> Same as project No. 1 above.
4	<ul style="list-style-type: none"> Same as project No. 1 above.
6	<ul style="list-style-type: none"> Same as project No. 1 above.
7	<ul style="list-style-type: none"> Same as project No. 1 above.

10	<ul style="list-style-type: none"> Same as project No. 1 above.
11	<ul style="list-style-type: none"> Same as project No. 1 above.
