5 DATA COLLECTION AND FIELD INVESTIGATIONS

Project: Toronto Basement Flooding Study Area 58
 Title: Figure 5.1 (A)
 Roof Downspout Connectivity

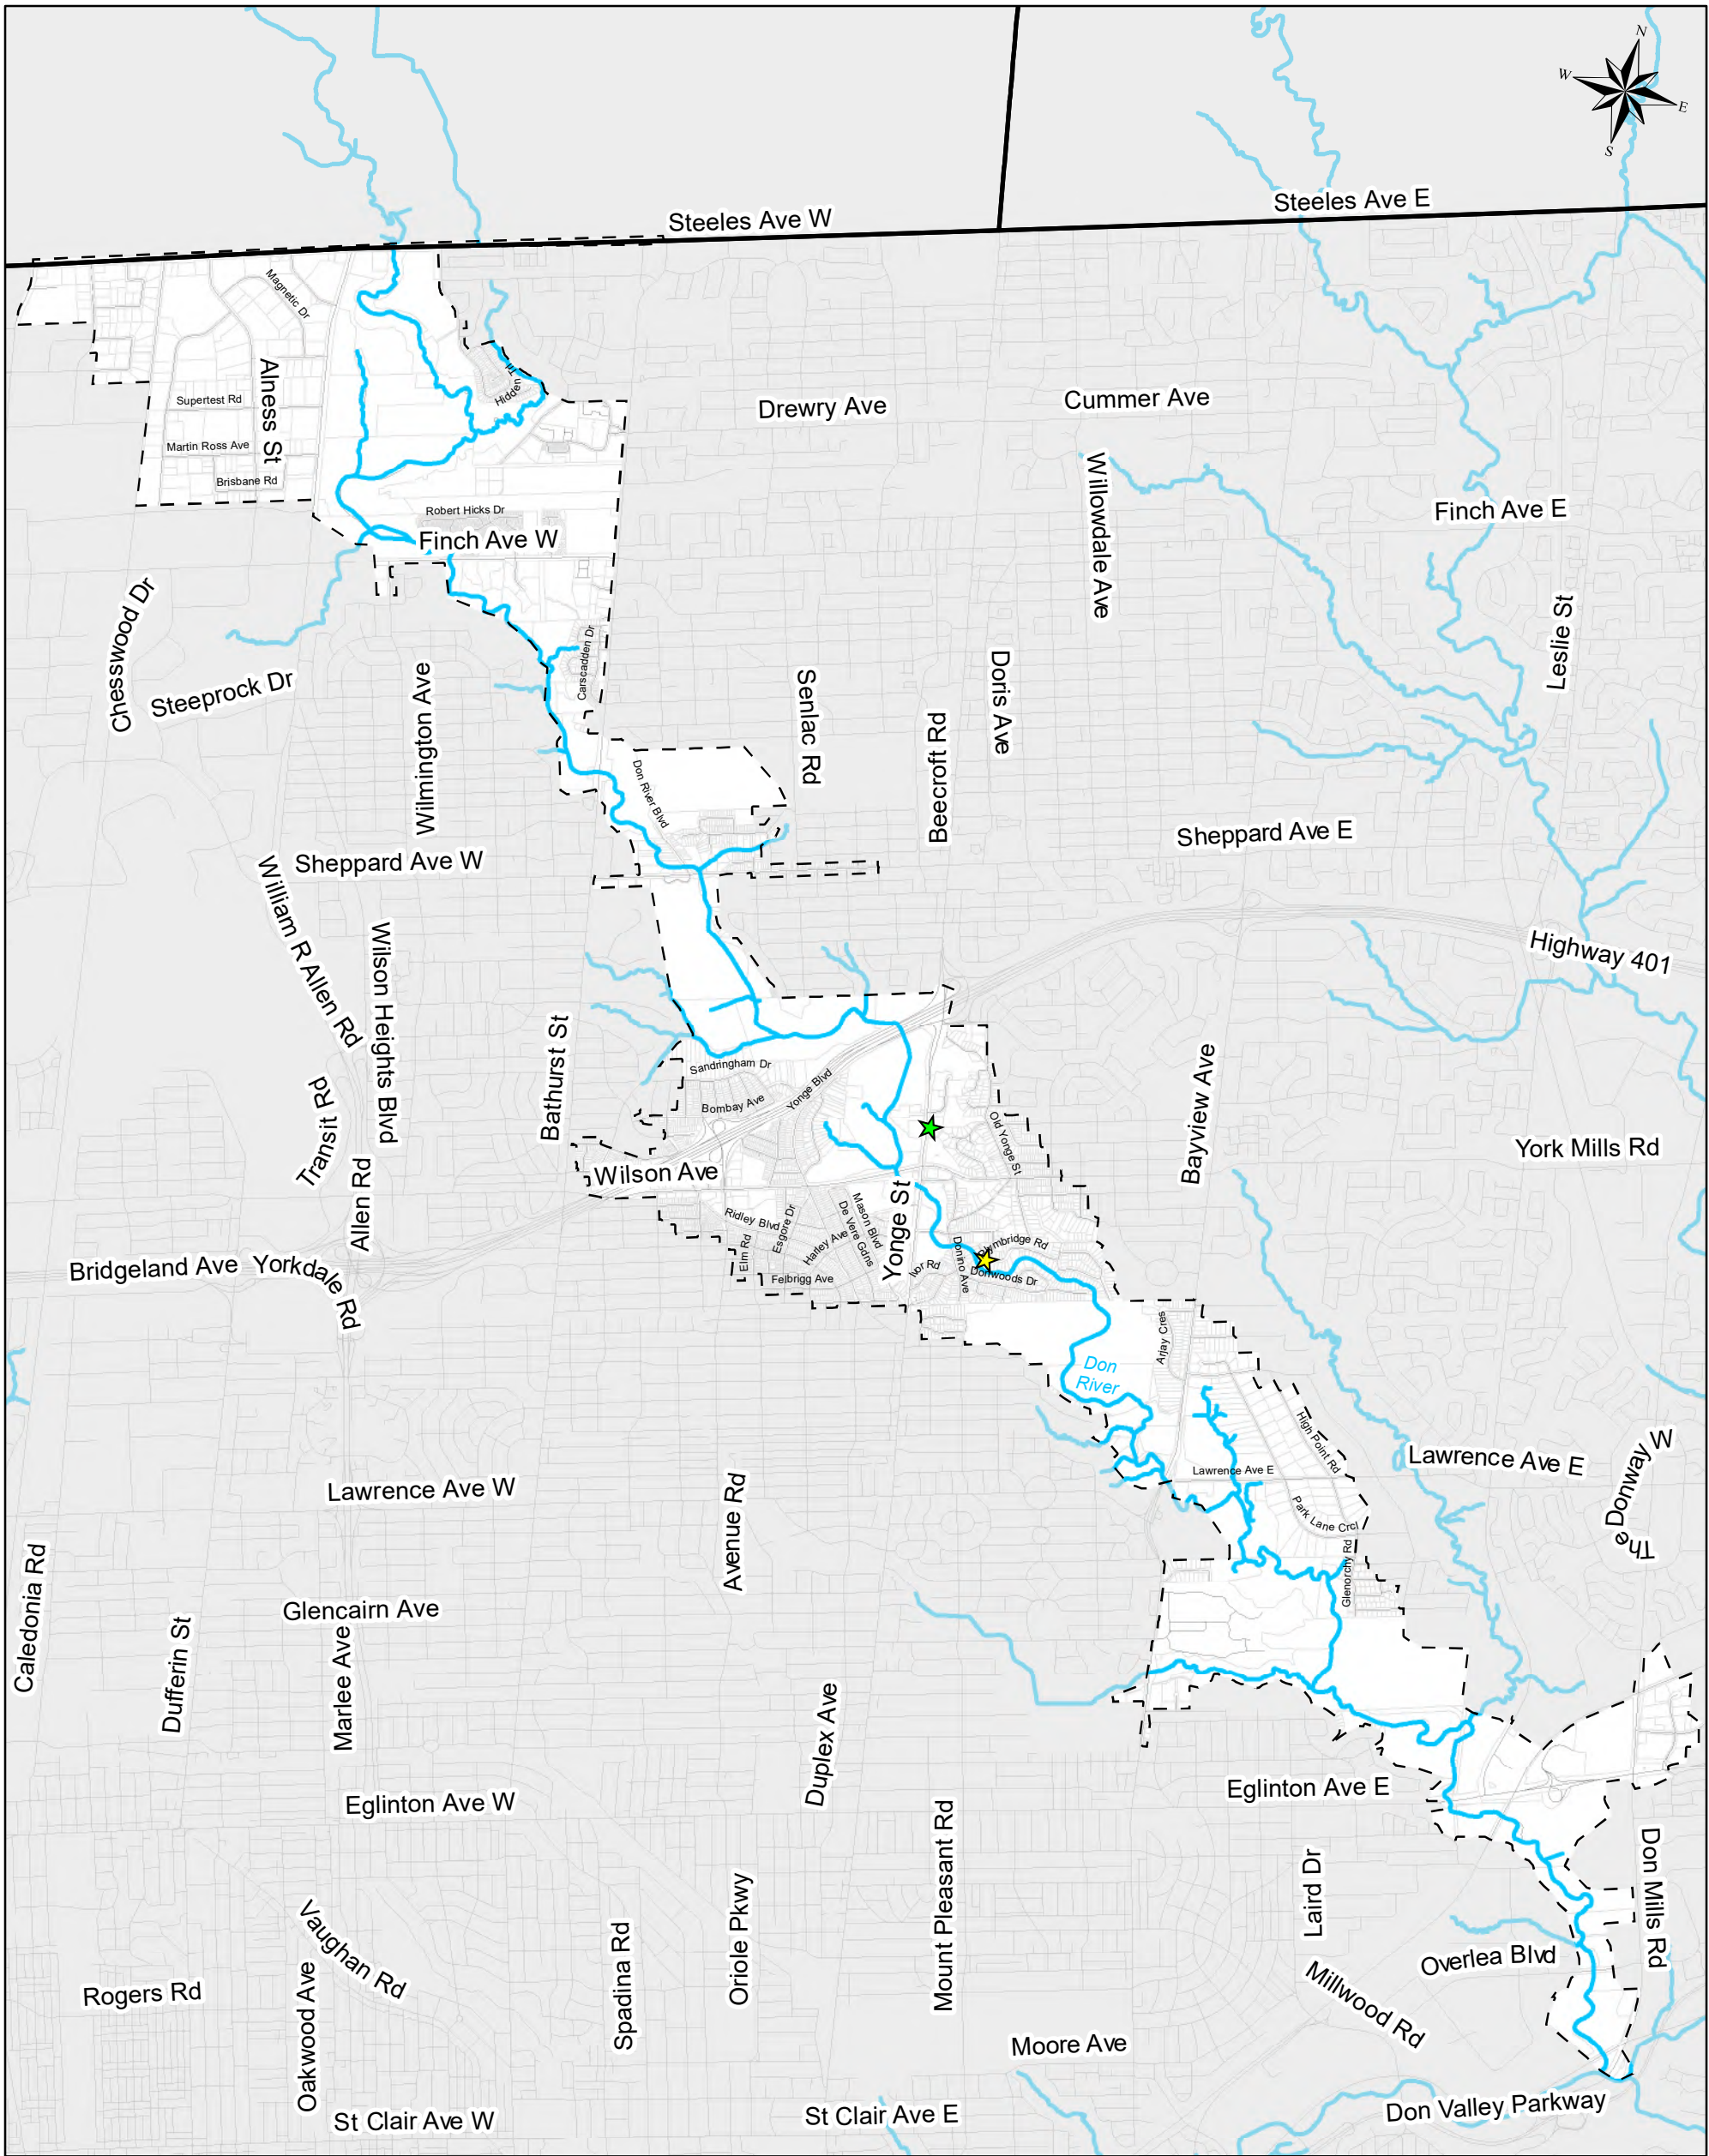
For the flow monitoring analysis, data from the closest rain gauges to the monitored areas were used. Rain gauge RG_44 (Fire Station 121) was used in the analysis of station 58-SAN-1. The rain gauge location is illustrated on **Figure 5.6**. The distance between RG_044 and station 58-SAN-1 is 908 m.

Only one sanitary flow monitoring station data was available. The station was installed in a 250mm sanitary sewer on Plymbridge Road on May 15, 2017, and removed on September 28, 2017, measuring sanitary flows for four (4) months. The flow monitor was localized with a drainage area of approximate 9.9ha, covering 1.8% of the local sewers. Considering that the coverage area of the flow monitor is only 1% of the study area, the flow data is not representative of the system of the entire study area. Thus, the flow data was not used for DWF calibration and validation.
