4 EXISTING CONDITIONS

4.1 Drainage Systems

Project: Toronto Basement Flooding Study Area 58
 Title: Figure 4.1 (A)
 Sanitary Sewer System

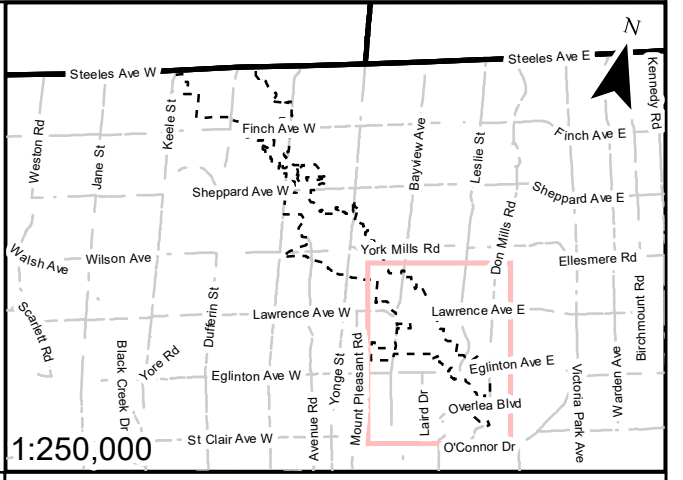
- Sanitary System Network:**
- Sanitary Sewer
 - Sanitary Trunk Sewer
 - Shallow Sanitary Sewers
 - Sanitary Nodes

The Capacity Study area is serviced by separated sewer systems, including approximately 64 km of sanitary sewers and 86 km of storm sewers, as illustrated in **Figure 4.1** and **Figure 4.2**. The sanitary sewer system in the study area discharges to the West Don sanitary trunk sewer (STS) that ultimately drains into the Ashbridges Bay wastewater treatment plant. The storm drainage system includes 62 storm outfalls along the West Don River branches and tributaries. Approximately 30% of the storm sewers are identified as shallow sewers.

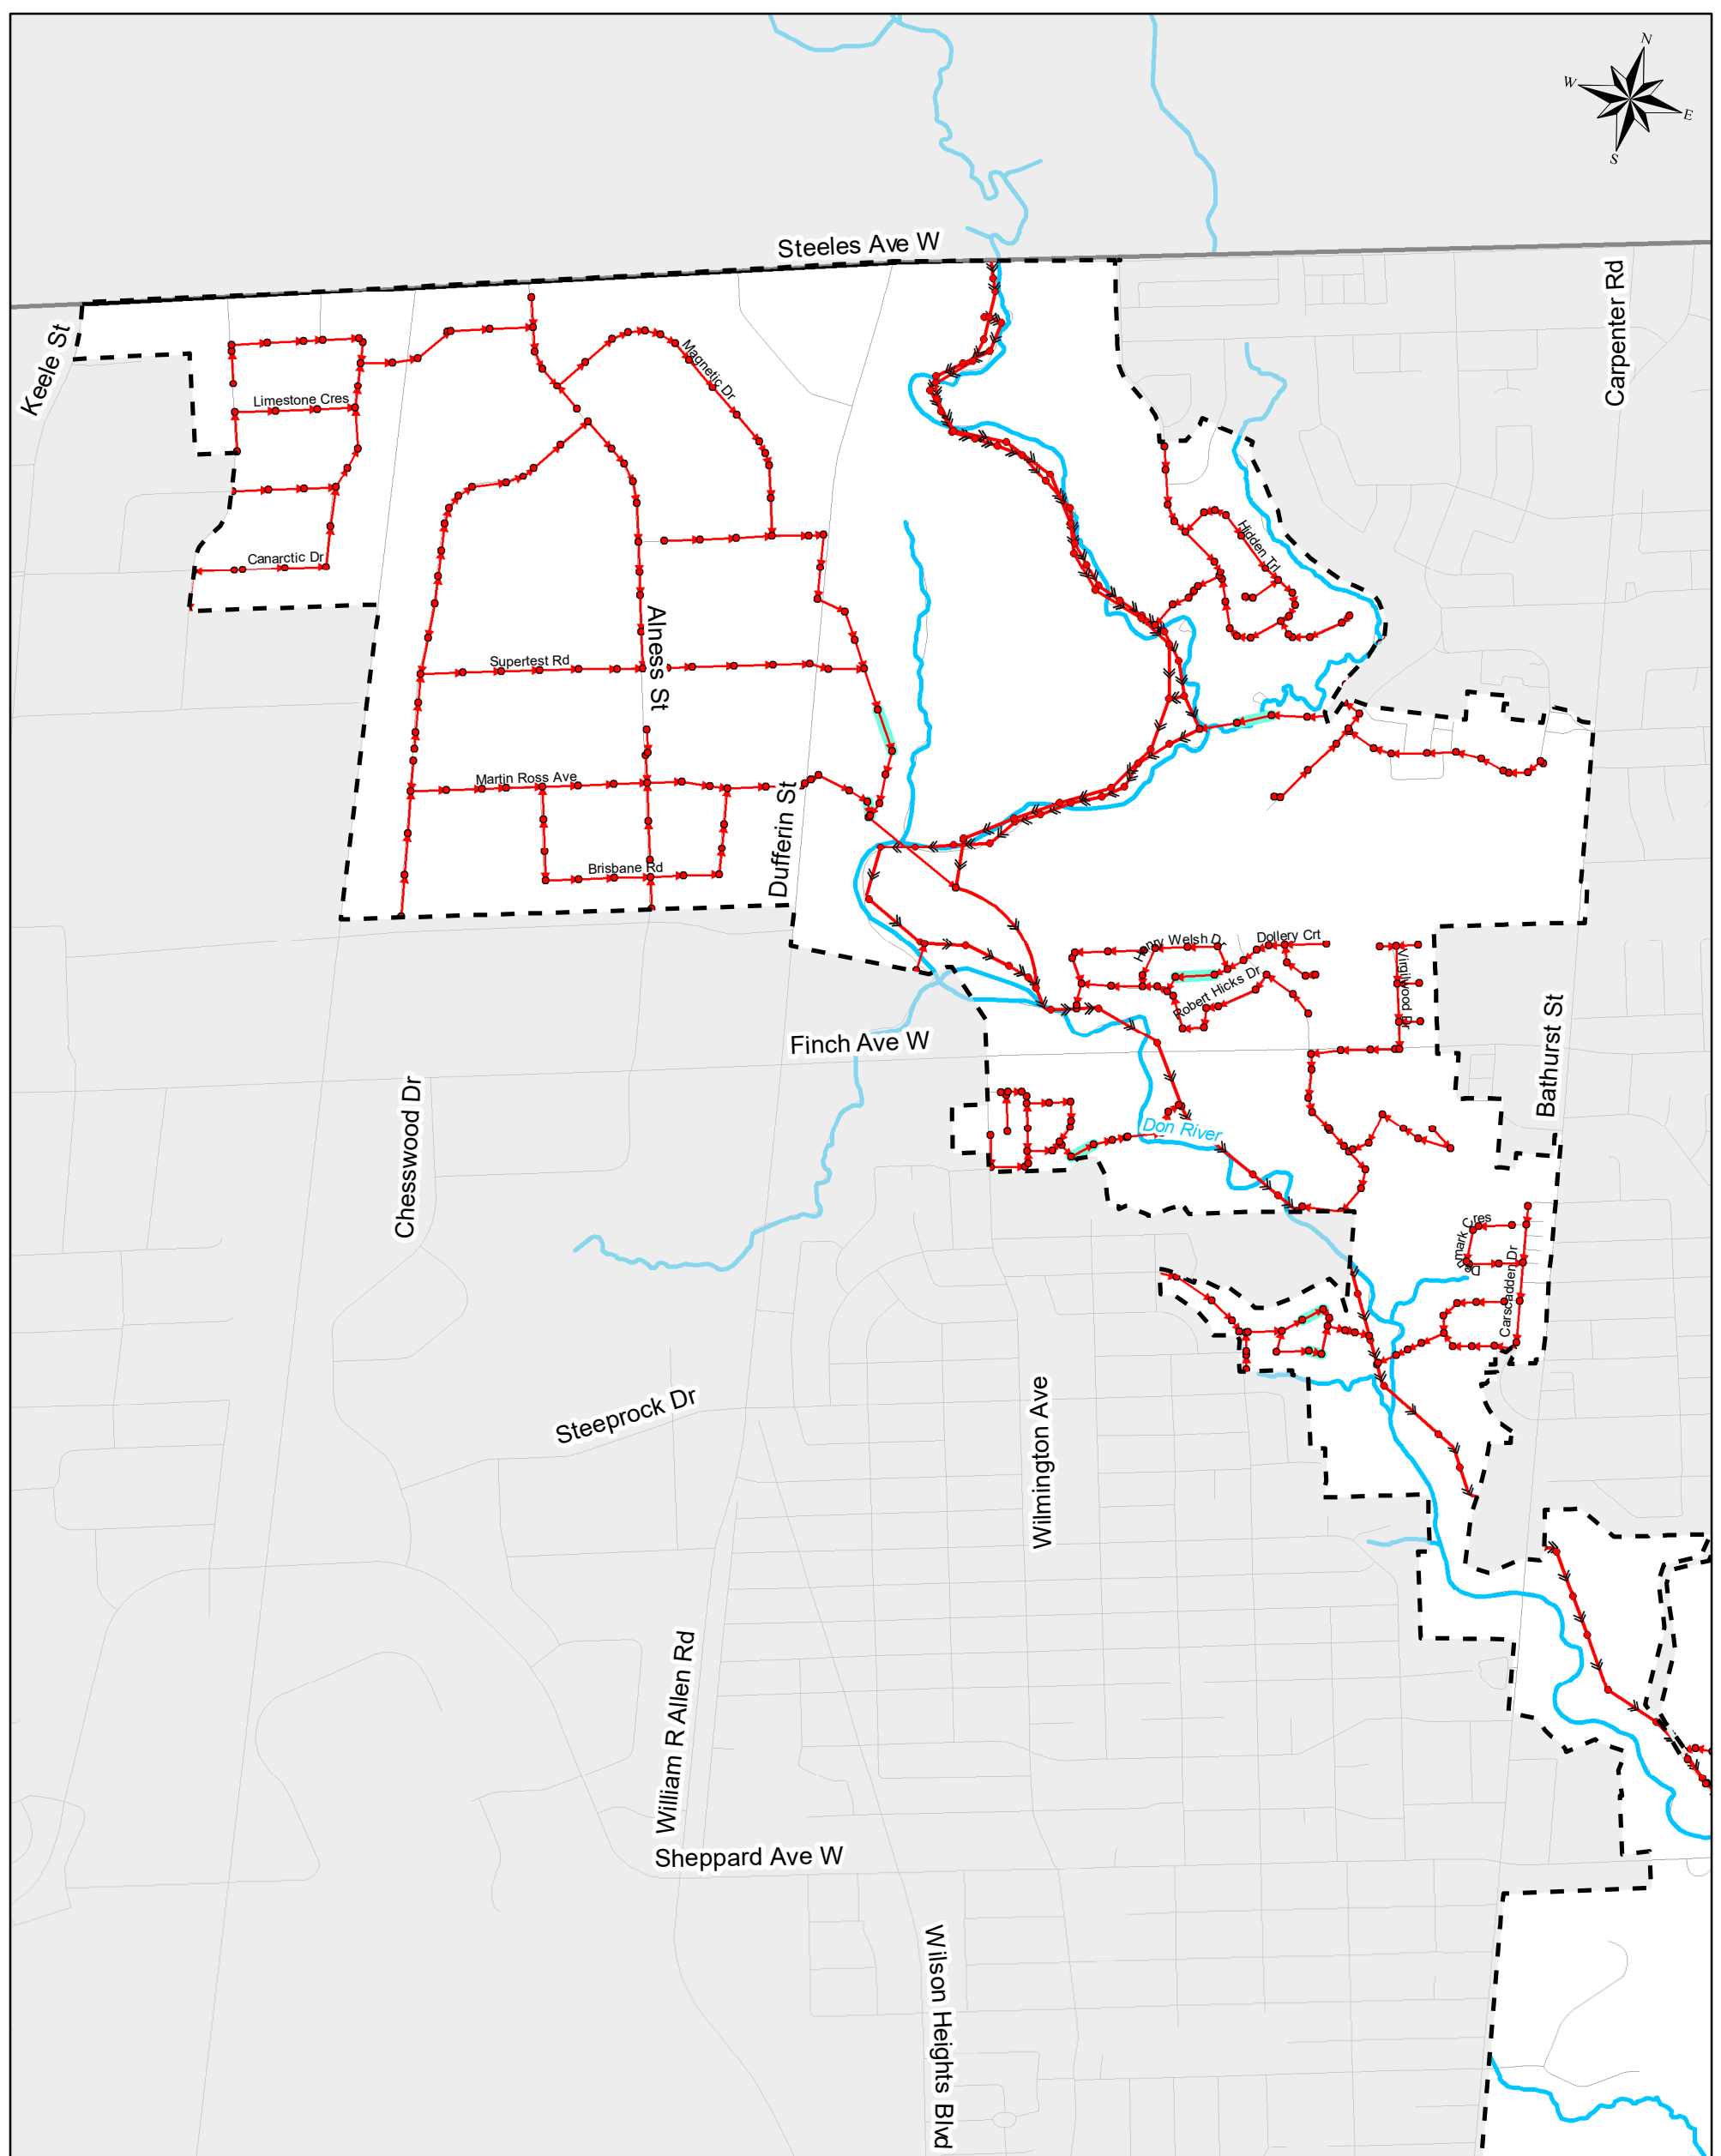
Project: Toronto Basement Flooding Study Area 58
 Title: Figure 4.5 (A)
 Groundwater Interaction with Sanitary Sewers

Groundwater levels were interpolated from available data of variable source quality. The groundwater depth variation was estimated to be between 1 m and 7.5 m mostly between Finch Ave. and Steeles Ave. areas along the Don River West Branch with most other areas with groundwater depth variation between 1m and 40m especially along the banks of the Don River West Branch. There is limited area for groundwater recharge due to the large presence of paved areas and rooftops. **Figure 4.5** illustrates that approximately 10.7% of the sanitary sewers (not including the Don STS) within the river valley have potential groundwater interactions (at groundwater elevation or within seasonal fluctuations) that may impact parts of the system within Area 58 where sewer invert elevations are within 1 m of the groundwater table. Any alternative replacing sewers where the groundwater table will impact storm or sanitary construction has the potential to require dewatering prior to construction.

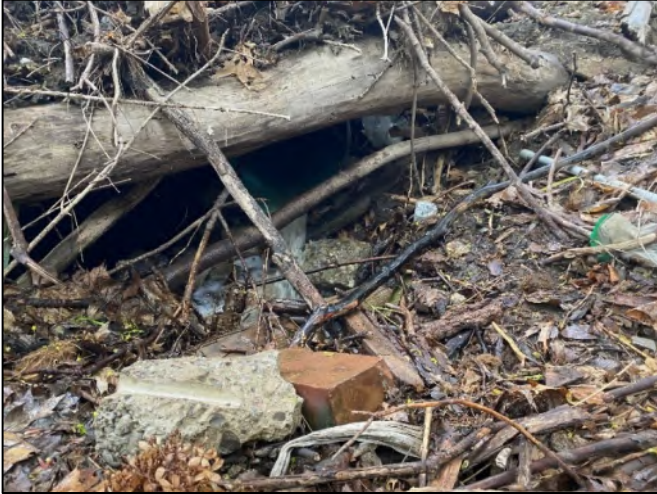
Photo 1: Site 58-28, main storm outfall

A majority of existing infrastructure at this site is located within the existing roadways, although there is also one location where the existing storm sewer outlets into a treed ravine feature (located between 372 and 380 Old Yonge Street). The natural area was reviewed by Aquafor staff in the field and found to contain a deciduous forest community with species including Norway and Sugar Maples (*Acer platanooides* and *A. saccharum*), Red Oak (*Quercus rubra*) and Basswood (*Tilia americana*). The ground layer was generally sparse with a few scattered urban species such as Winter Creeper (*Euonymus fortunei*), Garlic Mustard (*Alliaria petiolata*), Thicket Creeper (*Parthenocissus vitacea*), and Avens (*Geum* sp.). Overall, the valleyland was characterized as a mature woodland that was moderately influenced by the surrounding anthropogenic landscape.

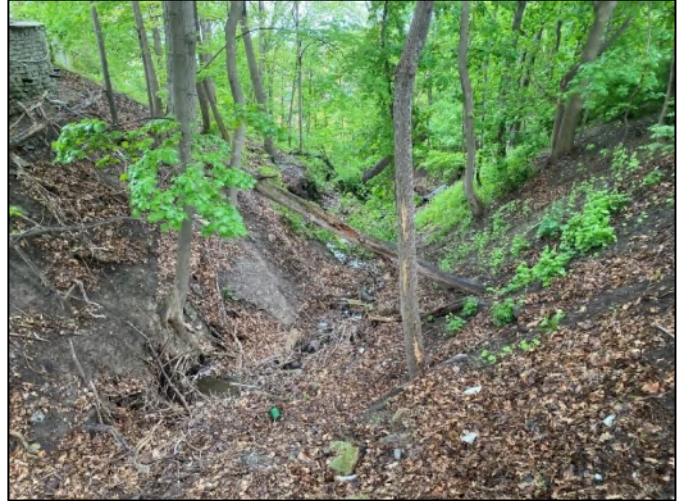
Photo 2: Site 58-28, typical habitat looking DS

Site	Subwatershed/ Watercourse	General Flow Regime	Site Location	Site Characteristics	Habitat Description	Substrate Composition	Bank Stability	Instream and Riparian Vegetation	Fish Barriers and Other Disturbances
A58-28	Don River West Branch (tributary)	Intermittent	Site A58-28 was located within a contributing feature to the West Branch of the Don River although separated by Yonge Street and a golf course. No clear connection to the watercourse was observed and it appeared as though the flow depended entirely on overland stormflow.	The site extended from two PVC storm pipes (Photo 1) from Old Yonge Street and the residential area of which it services. Average wetted width at the time of sampling was ~0.8 m. The average depth at crossovers was 30 mm and the maximum depth sampled was less than 50 mm. The site observed clear signs of erosion and downcutting (Photo 2), with soft soils and clear stormwater contributions, as well as encroaching residential properties and yard waste (Photo 3).	This site demonstrated characteristics of a cascade system, with a steepened gradient and step pool morphology. The steps were largely contributed by woody materials, of which consisted of cuttings from adjacent residences and yard waste. This woody material and dumping contributed to in-stream cover, with some cobbles contributed by concrete waste and rip rap. Overhanging cover was entirely contributed by established deciduous canopy immediately adjacent to the bank(s). This channel appeared to be entirely dependent on storm flow from the upstream outfalls and did not demonstrate any direct fish habitat.	This site was largely contributed by finer substrates from the over steepened banks. Gravel and cobble were observed in the few places. The maximum particle size was contributed by concrete wasting.	The banks consisted almost entirely of silt. Both banks observed downcutting, with a significant drop from the top of the residential lawns on either side to the watercourse.	Instream vegetation was non-existent. Riparian vegetation consisted of mixed deciduous trees. Banks were limited by encroaching residential areas on both banks.	The site was immediately downstream of the Old Yonge St crossing. Nutrients and pollutants were likely contributed by this crossing, as well as the greater residential area that the outfalls serviced. Other contributions were likely adjacent residences and observed yard waste that had accumulated in the corridor. As the channel was intermittent in nature, over steepened and only contributed to by the upstream outfalls, it is anticipated that no fish habitat was present.

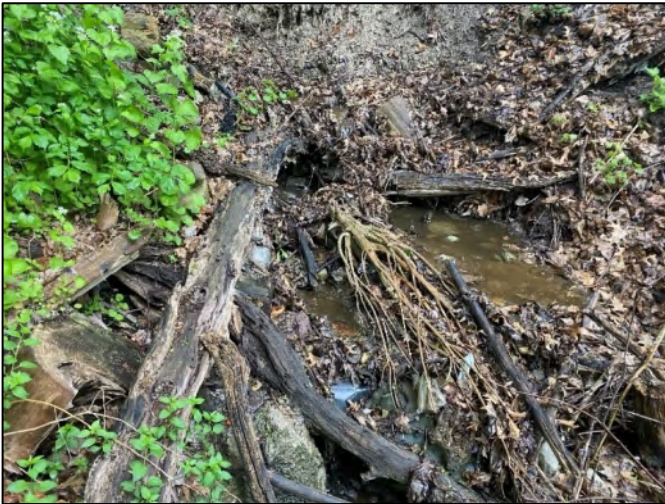
Photo 3: Site 58-28, accumulated yard waste and debris

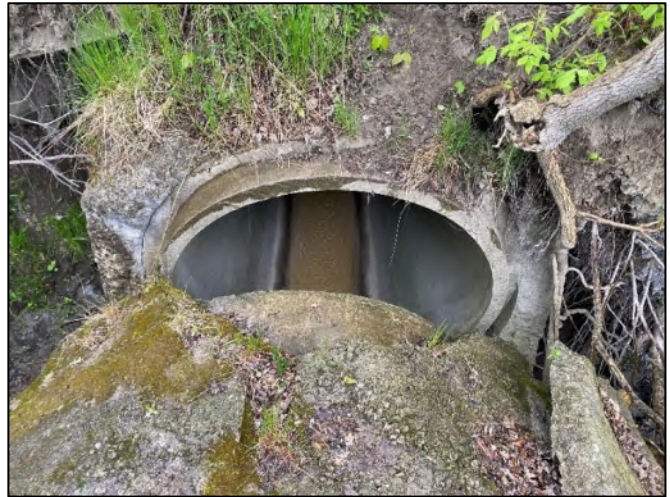
Photo 4: Site 58-41, failed outfall and eroding banks

The study area within the contributing feature to the West Don River did not demonstrate direct fish habitat, as the site was intermittent in nature, depending entirely on the contribution(s) from the storm outfalls beneath Old Yonge St and from the adjacent residential area. Overall, the study site was nearly buried beneath woody debris and yard waste contributed by the adjacent residences, with signs of major erosion and downcutting.

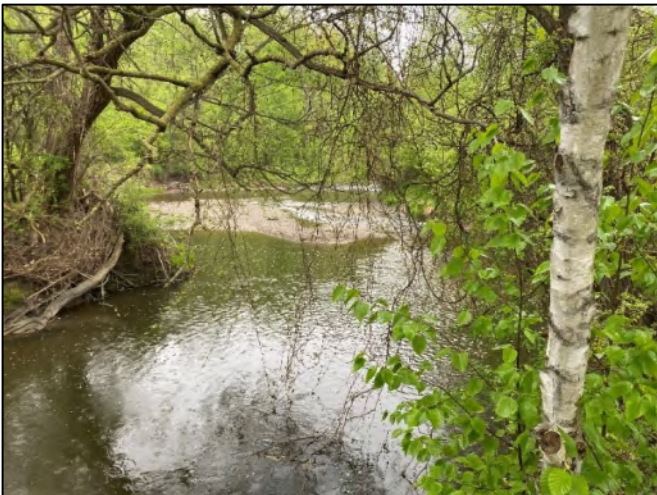
Photo 5: Site 58-41, typical habitat looking US from outfall

A58-41	Don River West Branch	Permanent	Site A58-41 was approximately 700 m downstream of the Eglinton Ave E crossing and was adjacent to the E.T. Seton Park and pedestrian trail. The site was contributed by an existing storm outfall that had failed (Photo 4).	Average wetted width was ~7 m. The average depth at crossovers was 60 mm and the maximum depth was greater than 1 m at the storm outfall. The site fell adjacent to a maintained park and pedestrian trail with a paved road within the riparian corridor on the north bank. Beyond the pedestrian path lay the manicured park land.	This site was largely contributed by a large, slow moving glide and pool immediately adjacent to the storm outfall and was delimited by two fast riffles at the up- and downstream extents (Photo 5 & Photo 6). The site was uniform in habitat characteristics, with evidence of engineering in the form of gabion retaining walls flanking the contribution from the outfall. Instream vegetation was very limited throughout.	Substrate was fairly well sorted, with gravels and cobbles consistent across the two riffles. Due to the depths of the pool at the storm outfall, pool substrates could not be confirmed. The maximum particle size observed was contributed by larger cobble, potentially resulting from fails gabion walls.	Both banks showed signs of instability, with steep bank angles observed throughout. Both banks were contributed by silts and erodible soils held together by mixed deciduous trees. Armouring was observed on the bank that the outfall was on, including concrete wing walls and gabion.	Instream vegetation was very limited. Riparian vegetation consisted of a well-established deciduous forest that provided the site with moderate cover. The aforementioned pedestrian path and manicured lawn limited riparian vegetation on the bank that the outfall fell on.	The site was well-buffered by the E.T. Seton park, however manicured lawn and trail encroached on the right bank. Eglinton Ave was immediately upstream of the site, along with a busy rail line crossing. Adjacent residential and commercial areas outside of the park lands likely contributed to nutrients and pollutant loading within the site and system. Other contributions were likely adjacent lawns and pedestrian paths, the storm water outfall on the right bank, as well as upstream land use. No significant barriers to fish were observed.

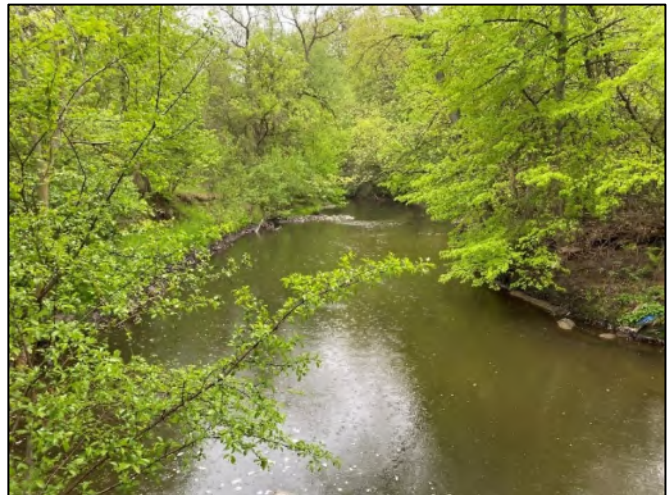
Photo 6: Site 58-41, typical habitat looking DS from outfall
