SOUTHWEST AGINCOURT TRANSPORTATION CONNECTIONS STUDY ENVIRONMENTAL ASSESSMENT ARBORIST REPORT

SOUTHWEST AGINCOURT TRANSPORTATION CONNECTIONS STUDY ARBORIST REPORT

PROJECT NO.: 19M-01888-00
DATE: NOVEMBER 10, 2023

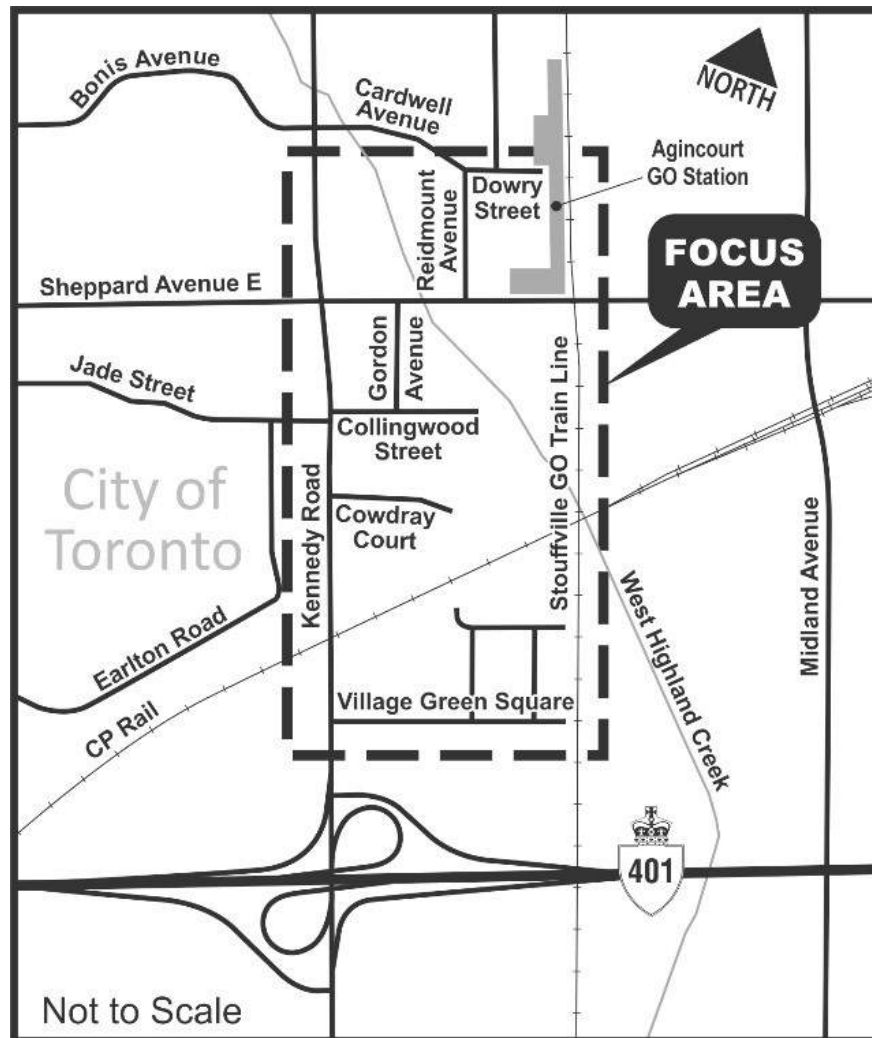
Figure 1: Focus Area

- The Focus Area is bound by Kennedy Road to the west, Dowry Street to the north, the Stouffville GO Train Line to the east, and Village Green Square to the south.
- All trees were inventoried within the Focus Area:
 - Trees of any size within 12m of the Focus Area within Ravine and Natural Feature By-law limits
 - Trees of any size within 6m of the Focus Area within City street’s rights-of-way (ROW) or City parkland; and
 - Trees 30cm or greater diameter-at-breast height (DBH) within 6m of the Focus Area on private property.
- The approximate limits are shown in Figure 1.

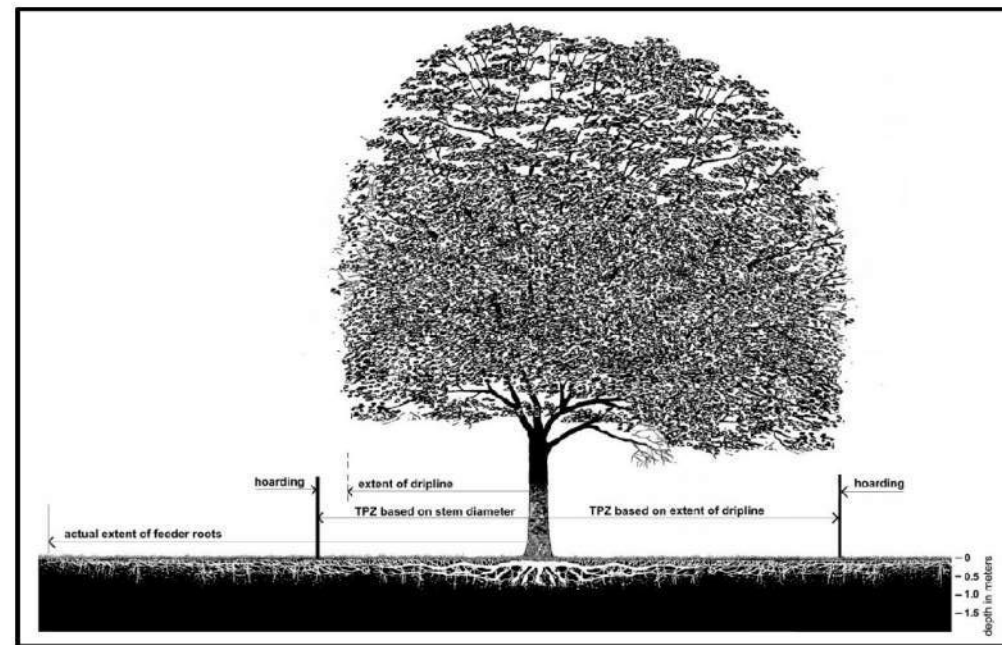
Figure 2: Minimum Tree Protection Zone (TPZ) Determination

- ¹Diameter at breast height (DBH) measurement of tree stem taken at 1.4 metres (m) above the ground.
²Minimum Tree Protection Zone distances are to be measured from the outside edge of the tree base.
³Diameter (30 cm) at which trees qualify for protection under the Private Tree By-law.
⁴The drip line is defined as the area beneath the outer most branch tips of a tree.
⁵Converted from ISA Arborists' Certification Study Guide, general guideline for tree protection barriers of 1 foot of diameter from the stem for each inch of stem diameter.

The diagram below shows how the TPZ is determined:
