KIPLING AVENUE

Accessibility-Focused Site Visits

August 2023

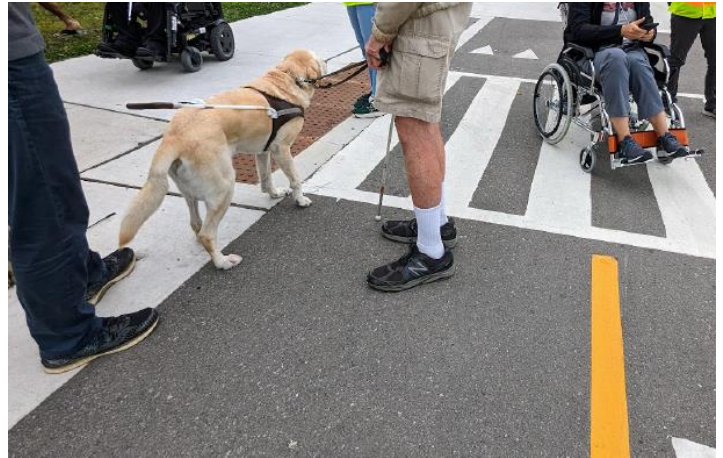
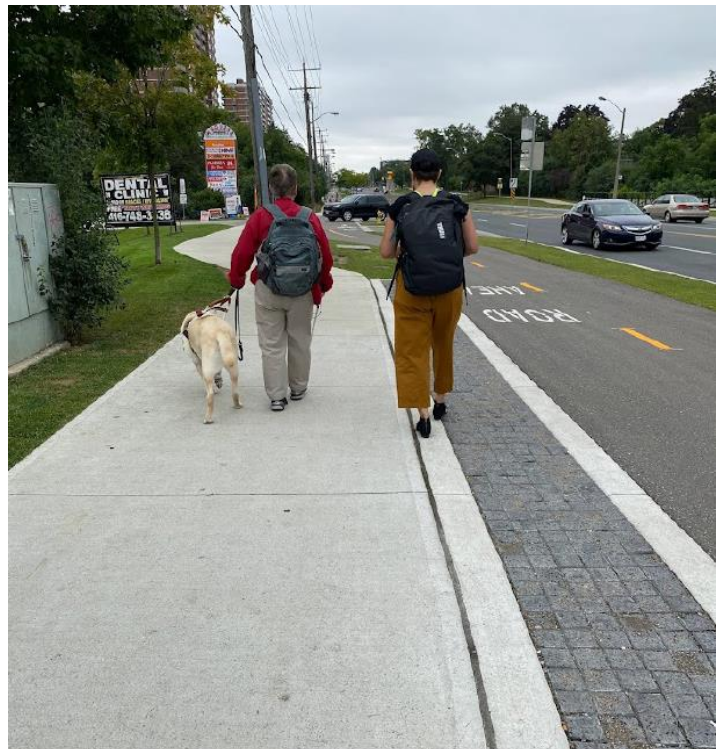
2.1

- **Detectability of Tactile Pavers:** There were mixed opinions on the effectiveness of tactile pavers next to the multi-use trail and the sidewalk. Some blind individuals, particularly cane users, noticed a distinct disparity between texture and shading, while others found no discernible difference between sidewalk and path.

- **Need for Cyclist Signage:** Safety concerns were raised about crossing the multi-use trail due to uncertainty about people on bicycles yielding to pedestrians. The addition of signage indicating where people cycling should stop was recommended.

- **TTC Shelter:** The structural design of the bus shelter, specifically focusing on the height of the map and the obstruction caused by the bench positioned in front of it were raised.

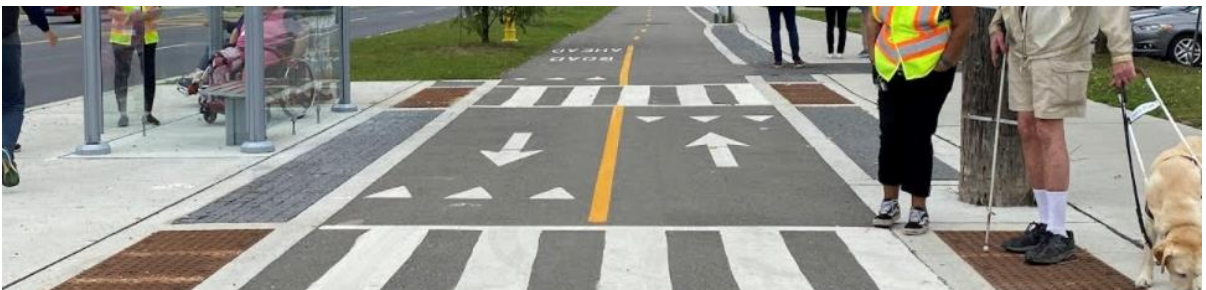
KIPLING AVENUE, NORTH OF ROWNTREE ROAD

- **Preference for Beveled Edges:** The purpose of tactile pavers was unclear to some. A change in elevation or a beveled curb was suggested as a more effective indicator.

- **Simplifying Paver Use:** Some participants felt the number of pavers was excessive and suggested their placement should be limited to adjacent to the sidewalk.

- **TTC Poles as Indicators:** The utility of a pole as a reference point for aligning oneself when crossing to the platform was discussed. Adjustments to the pole's location were suggested for better accessibility.

- **Orientation Challenges:** The spacious area posed orientation challenges, particularly for those disembarking from buses and heading toward the sidewalk, with no clear demarcation of the multi-use trail.

- **Importance of Audible Cues:** The setback of the sidewalk from the street could potentially complicate navigation across the multi-use trail, highlighting the potential need for audible cues to assist blind individuals.

- **TTC Shelter:** Enhance bus shelters by adding wheelchair ground markings, wider spaces, "through" exits for easy wheelchair movement, and designated areas where wheelchairs wait for bus boarding.

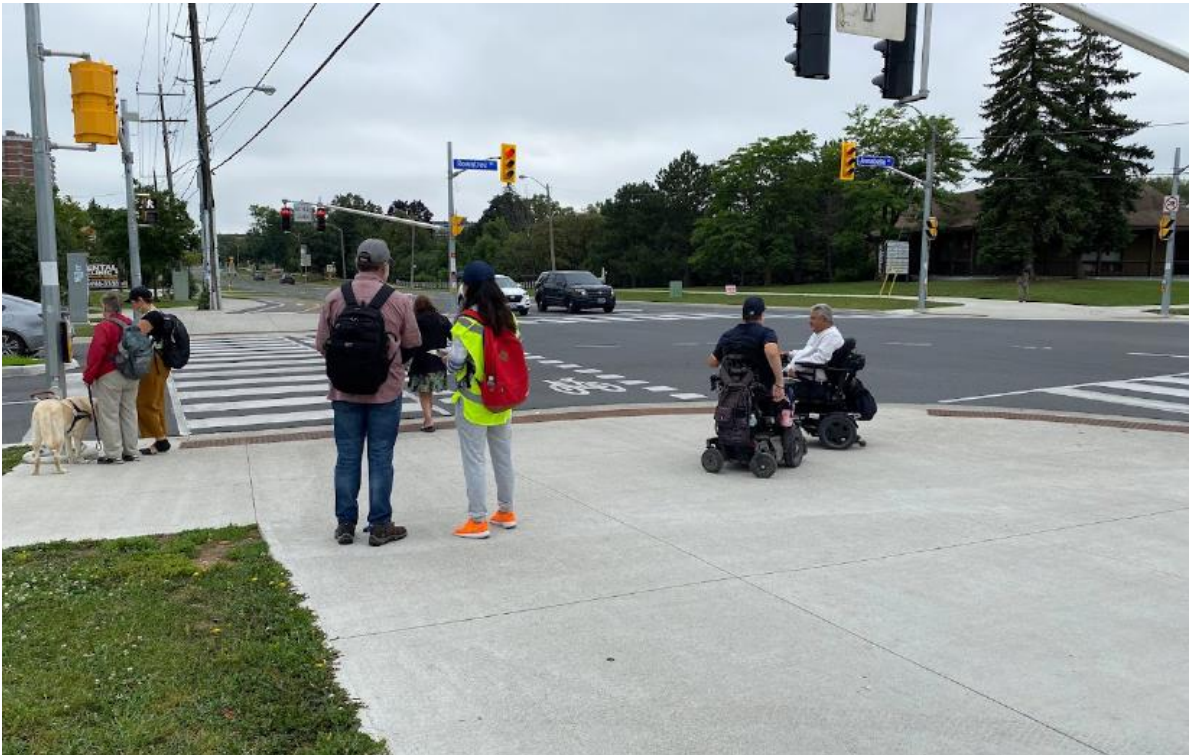
KIPLING AVENUE AND ROWNTREE ROAD/ANNABELLE DRIVE INTERSECTION

- **Steep Slope Accessibility:** Participants observed that while the curb's steepness made it detectable, it posed a challenge for wheelchair users.
- **Obstruction on the Multi-Use Trail (MUT):** There were several mentions of a hydro pole obstructing the MUT and sidewalk. Some participants suggested that the trail alignment should take priority over the hydro pole location.
- **Accessible Pedestrian Signals (APS) Concerns:** Misalignment between the APS and Tactile Walking Surface Indicators was noted.
- **Reviews of the APS were mixed:** participants highlighted issues with low volume, irregularly button placement and type and difficulty in operation.
- **Mixing Zone:** Adjacent to the intersection, the large mixing zone elicited mixed reactions, particularly from people with low vision who found it difficult to orient themselves and navigate through this shared space.

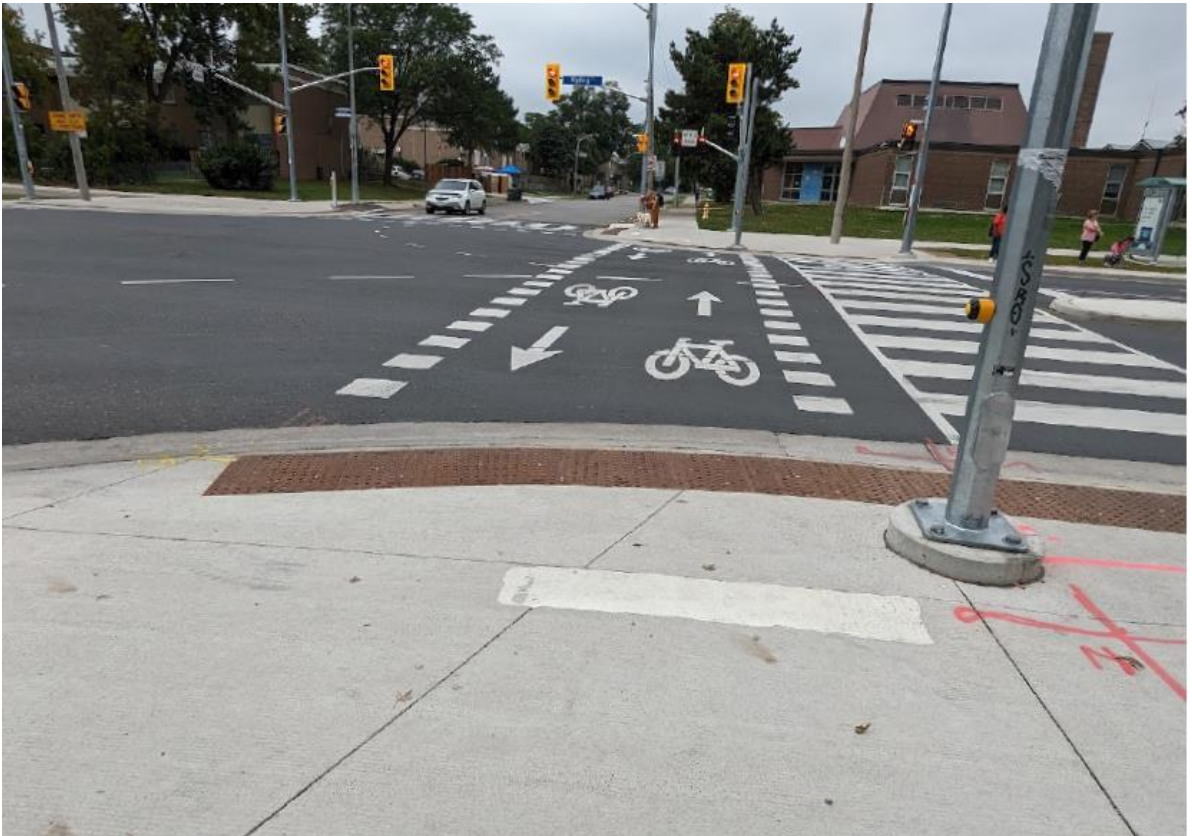
KIPLING AVENUE AND ROWNTREE ROAD/ANNABELLE DRIVE INTERSECTION

- **Curb Ramp:** The level area at the south-west corner of the intersection received mixed reactions. Some participants appreciated the absence of a perpendicular curb ramp, noting safety concerns about rolling off near the intersection. Others expressed worries about the high slopes of the ramps in the area.

- **Mixing Zone:** In the mixing zone, where people cycling cross the intersection and navigate the concrete area, there was confusion and concern about the shared use of the sidewalk by multiple users.

- **Signage:** The elephant feet markings and stop bar for people cycling were deemed unclear by participants, leading to a preference for additional signage.

- **Raised Crossing:** A raised crossing at this intersection was favoured by one participant, particularly for the benefit of blind individuals, to clearly indicate the presence of a crossing in the absence of a perpendicular curb ramp.

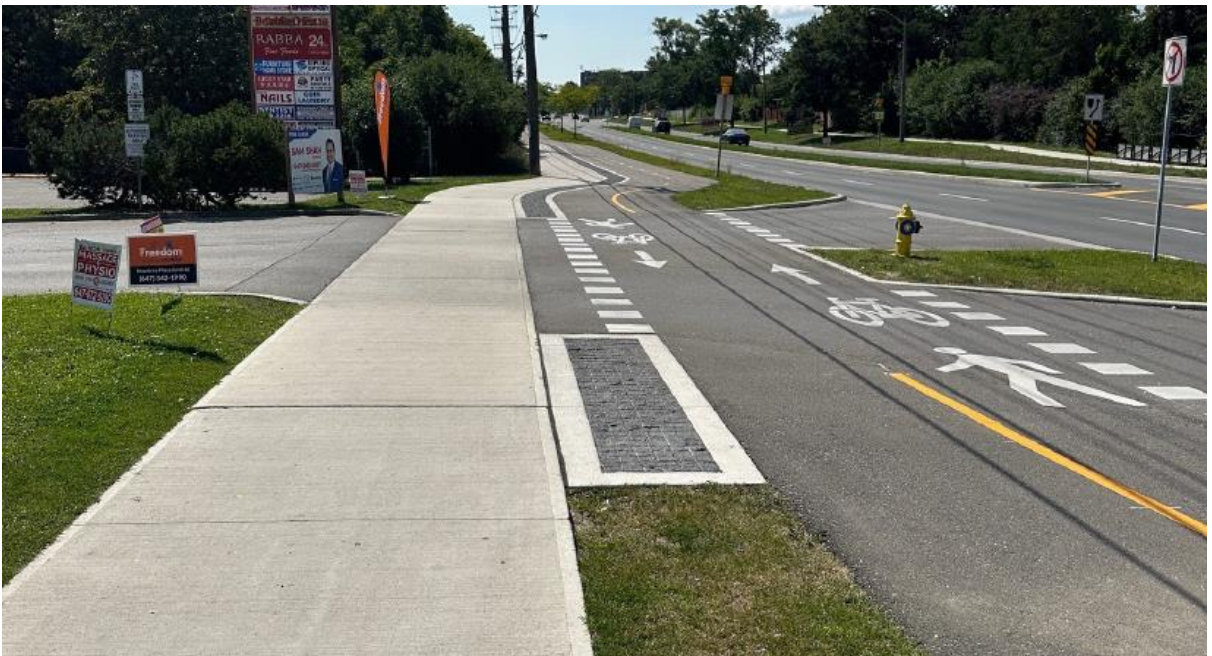
KIPLING AVENUE, SOUTH OF ROWNTREE ROAD

- **Clarity of Pavement Markings:** There was a consensus that the driveway markings were not clear. Suggestions included adding directional arrows for vehicles and aligning the top of pedestrian symbols more accurately with the yellow centerline.
- **Need for Additional Tactiles at Driveway:** Participants requested the addition of tactile indicators across driveways, highlighting the difficulty in detecting approaching driveways due to lack of clear indicators.
- **Requirement for More Signage:** Additional signage was advocated for, aimed at prompting both people cycling and drivers to yield to pedestrians.
- **Issues with Contrast:** Concerns were raised about the inadequate color contrast between the pavers and the sidewalk, which may affect visibility.
- **Preference for Raised Crossings:** One participant suggested that raised crossings are beneficial to both slow down drivers.

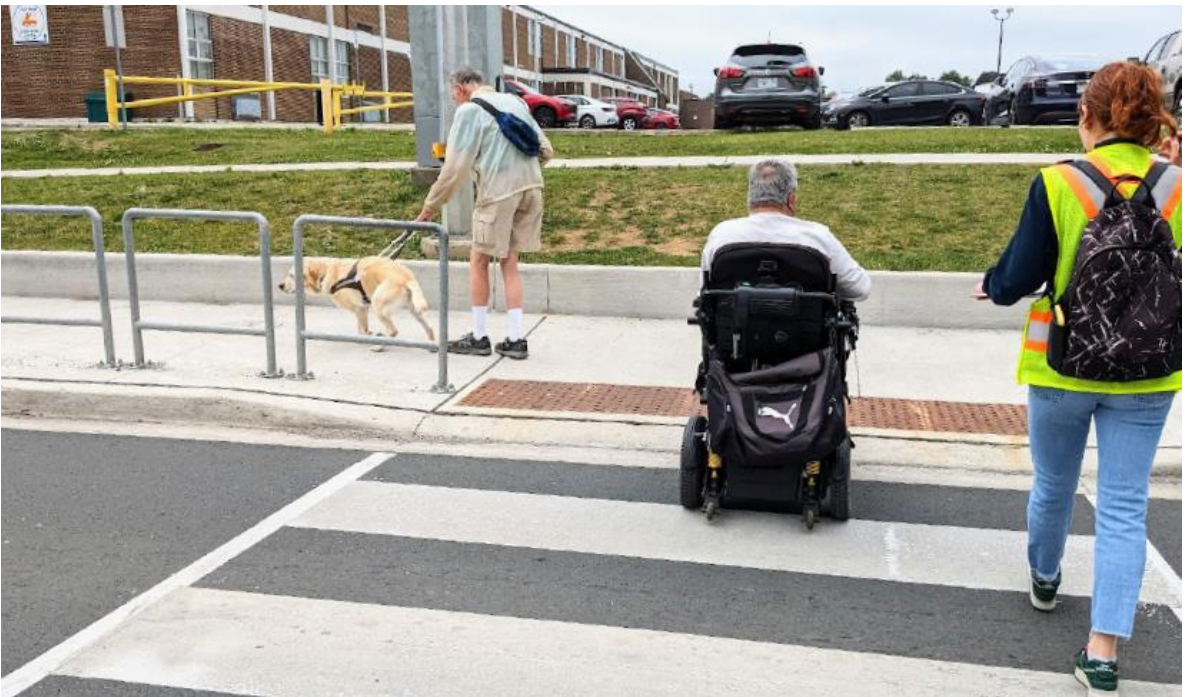
MID-BLOCK CROSSING ON KIPLING AVENUE, 150 METRES NORTH OF MOUNT OLIVE DRIVE

- **Challenging Curb Ramp:** The curb ramp presented challenges for wheelchair users, with several noting its slope made sidewalk access feel unsafe.
- **Accessing push button:** Difficulties in accessing the pushbutton raised safety concerns.
- **Shorelining along the sidewalk curb:** A blind participant found the curb sufficiently tall to use as a guide, with a technique known as shorelining, to navigate effectively.
