# Cultural Heritage Report: Existing Conditions and Preliminary Impact Assessment

## Eglinton East Light Rail Transit Transit Project Assessment Process and Design Update

### City of Toronto, Ontario

#### Draft Report

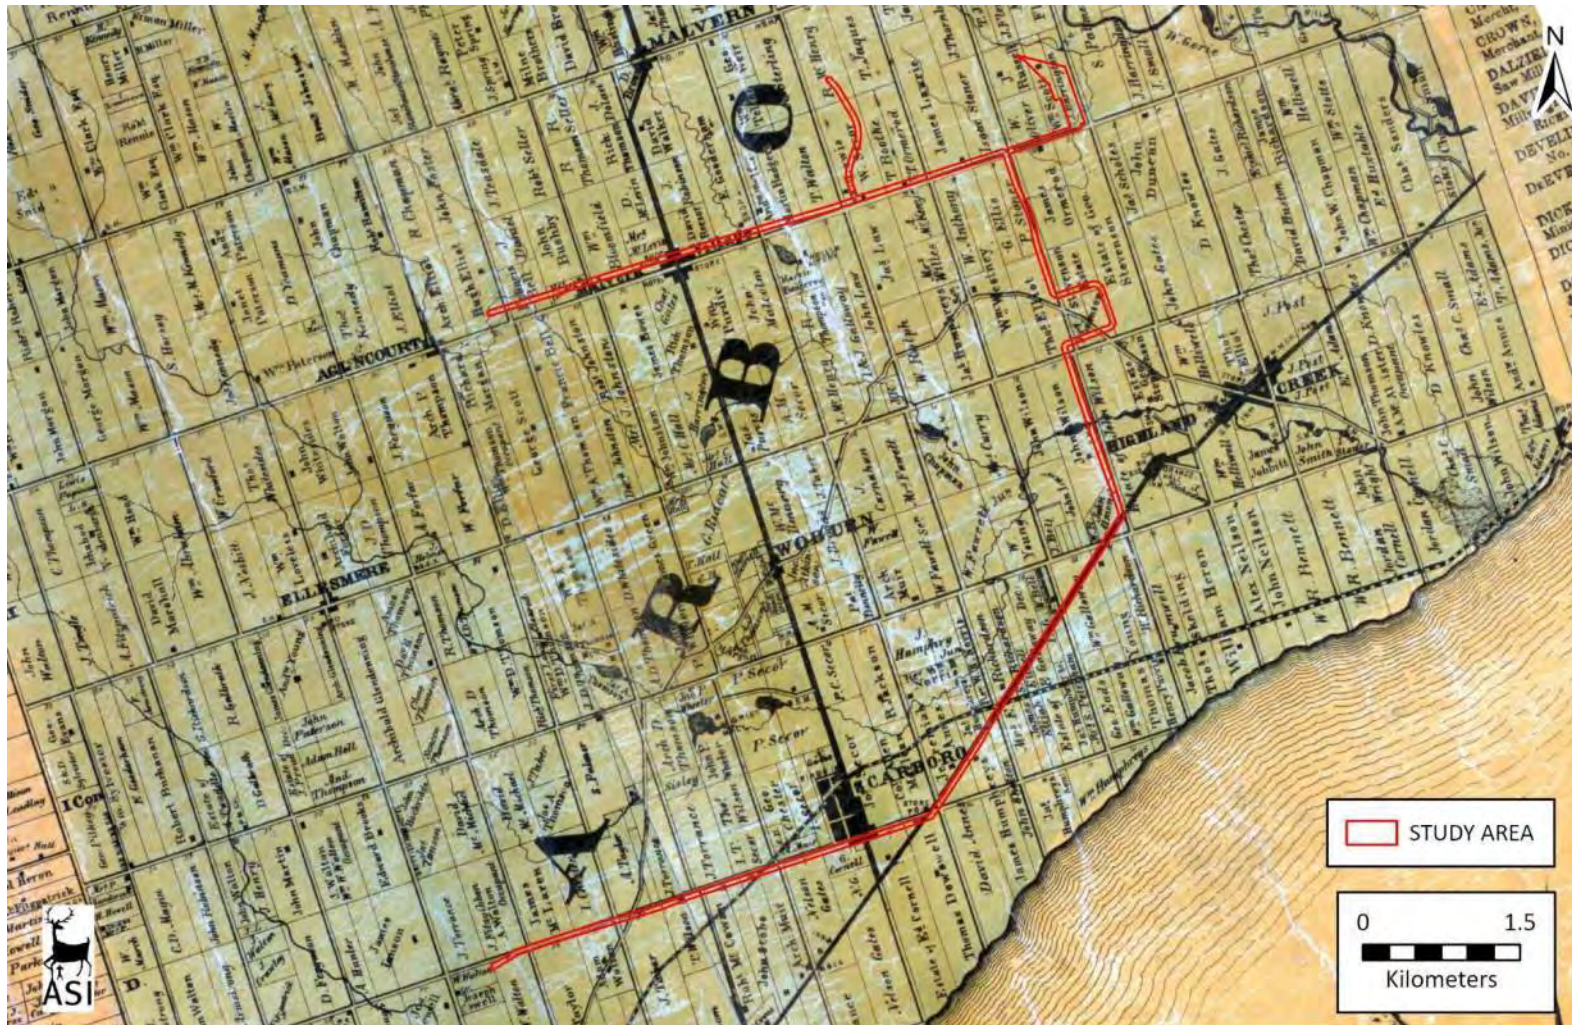
Figure 2: The study area overlaid on the 1860 Map of the County of York. Base Map: (Tremaine, 1860).

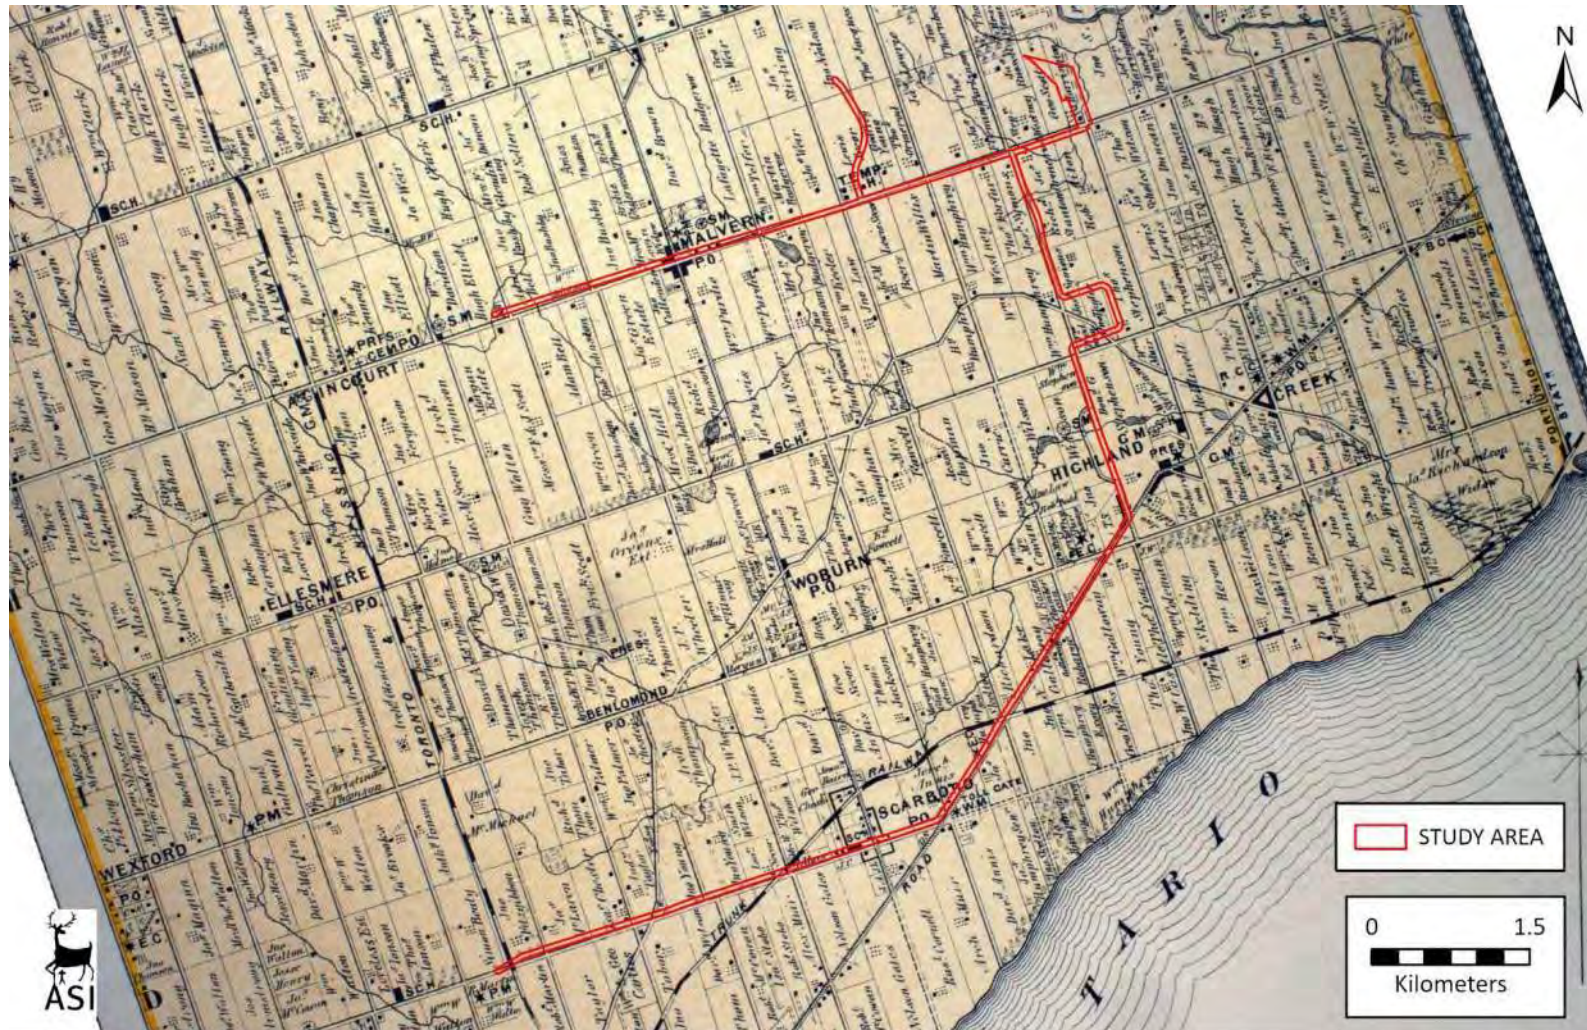
Figure 3: The study area overlaid on the 1878 *Illustrated Historical Atlas of the County of York*. Base Map: (Miles & Co., 1878).

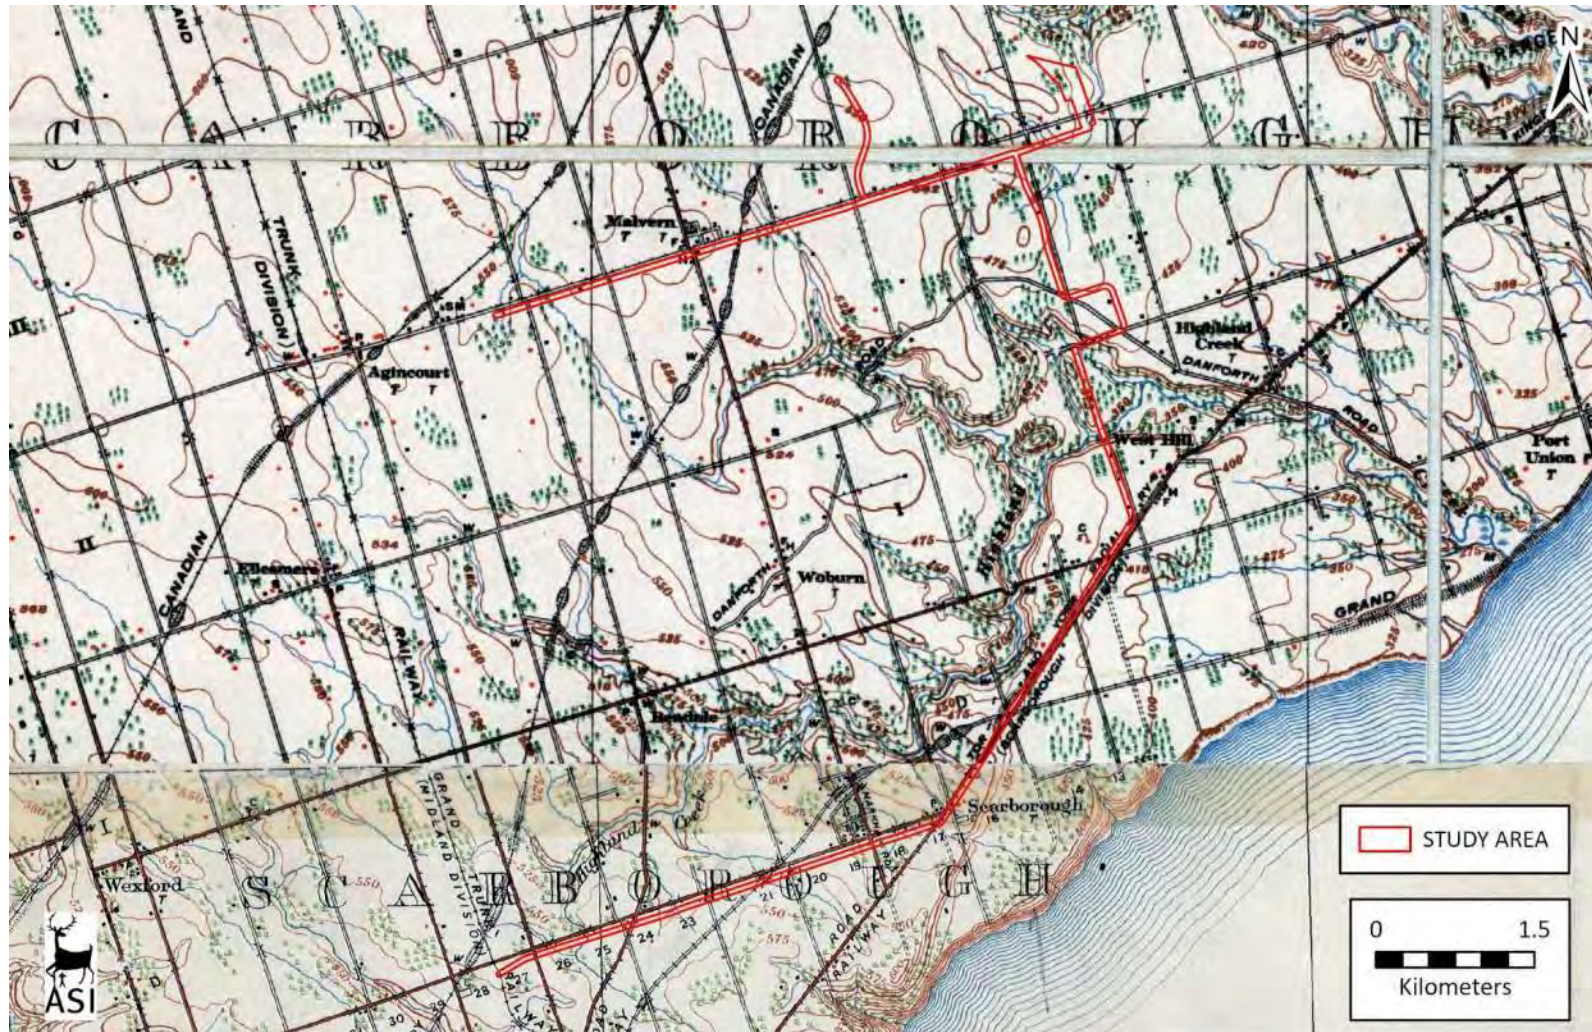
Figure 4: The study area overlaid on the 1914-1915 topographic maps of Markham and Toronto. Base Map: (Department of Militia and Defence, 1914, 1915).

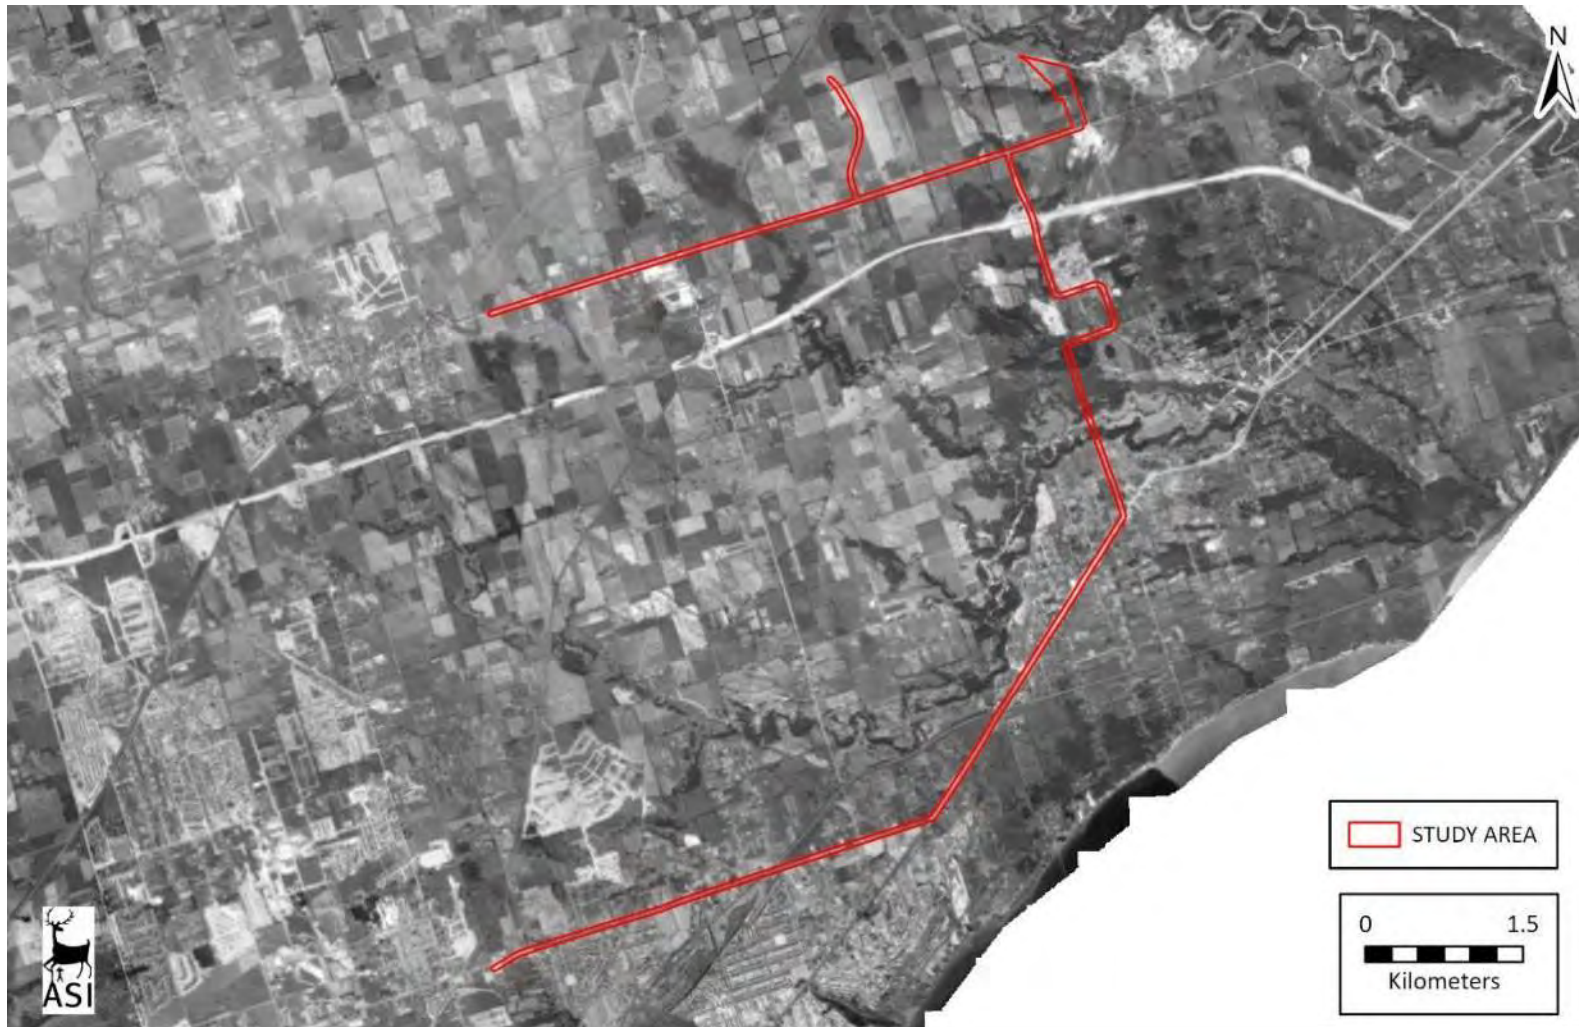
Figure 5: The study area overlaid on the 1954 aerial photographs of the City of Toronto. Base Map: (Hunting Survey Corporation Limited, 1954).

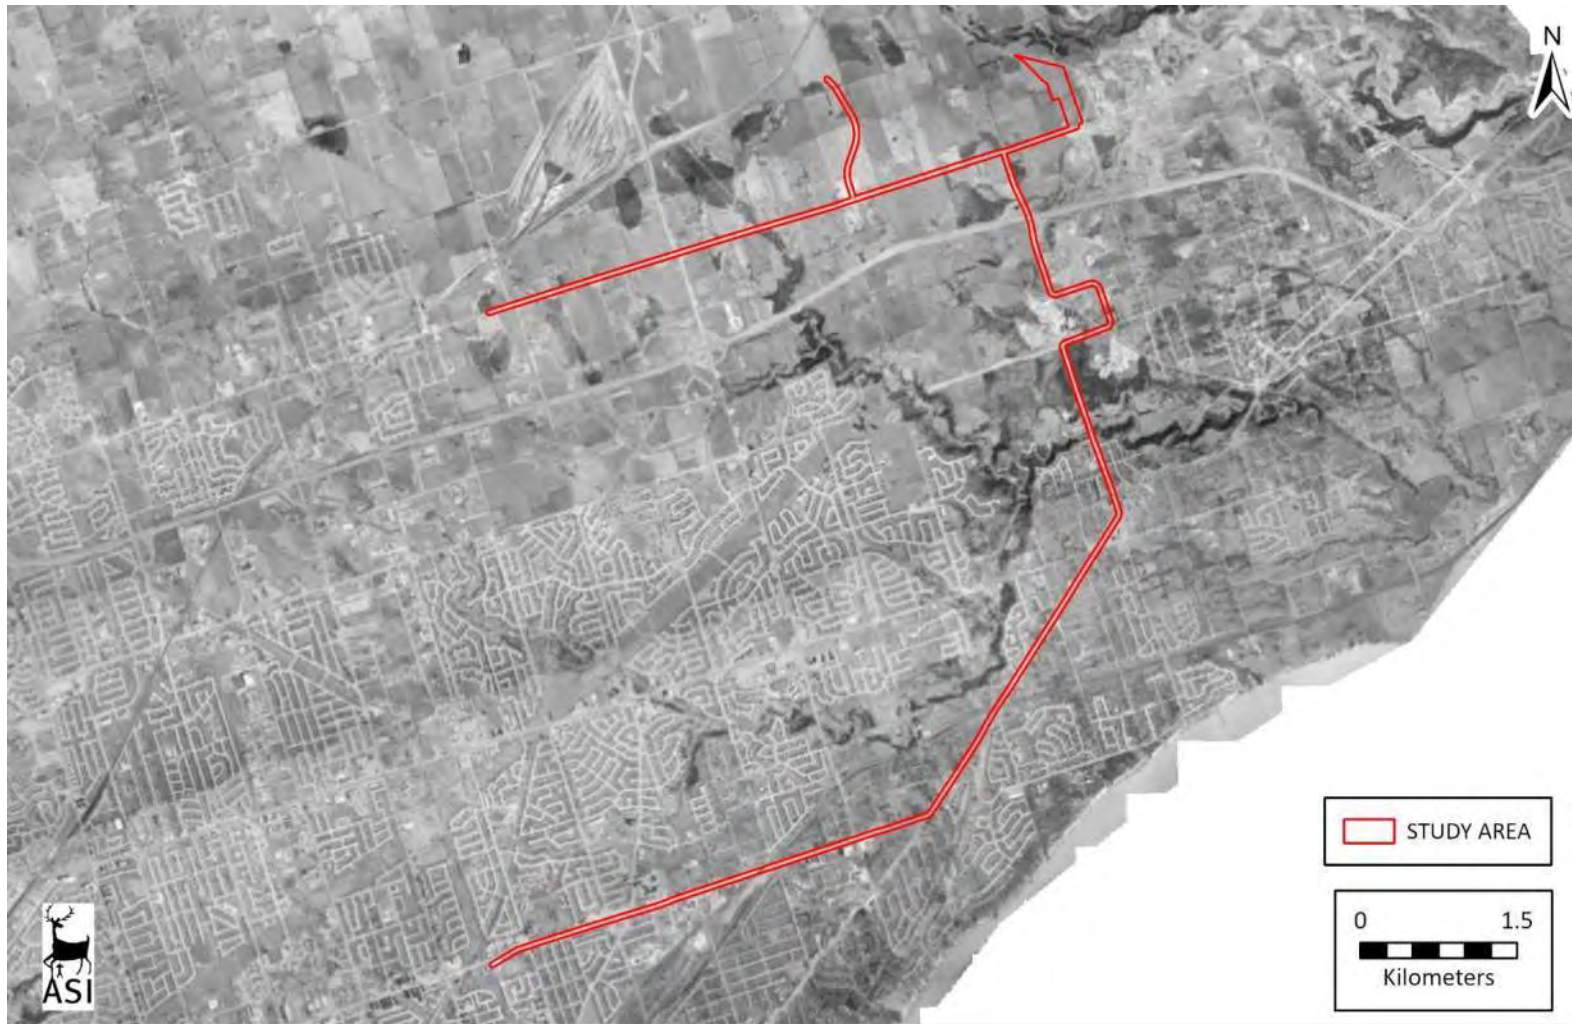
Figure 6: The study area overlaid on the 1965 aerial photographs of the City of Toronto. Base Map: (City of Toronto Archives, no date).

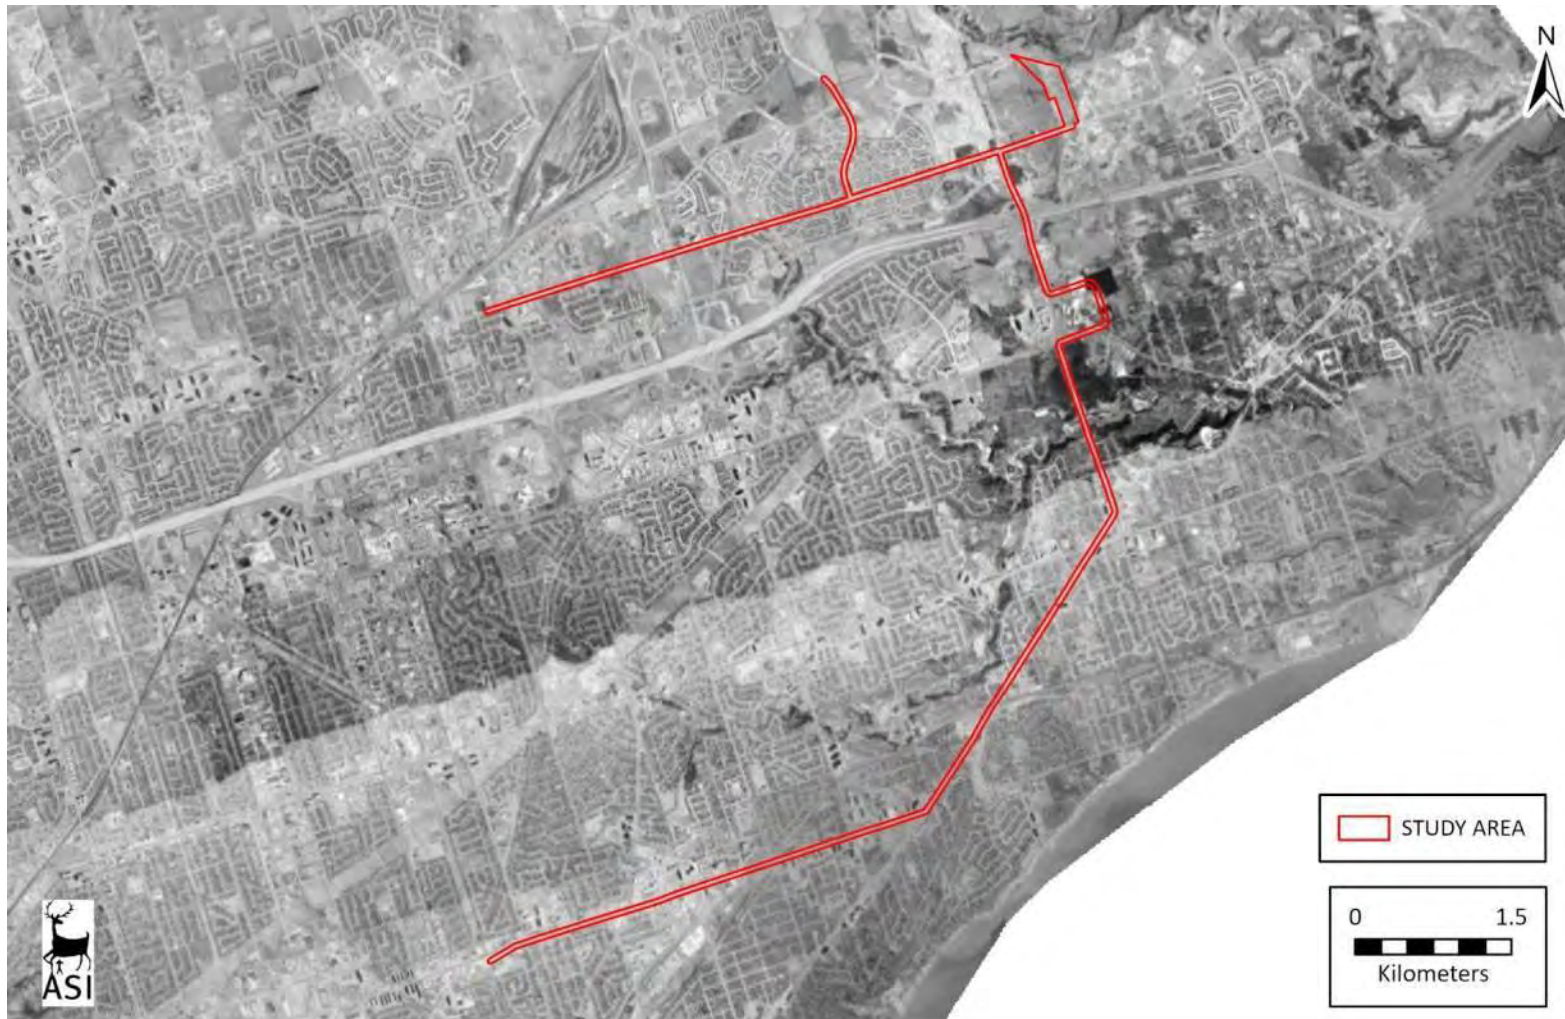
Figure 7: The study area overlaid on the 1978 aerial photographs of the City of Toronto. Base Map: (City of Toronto Archives, no date).

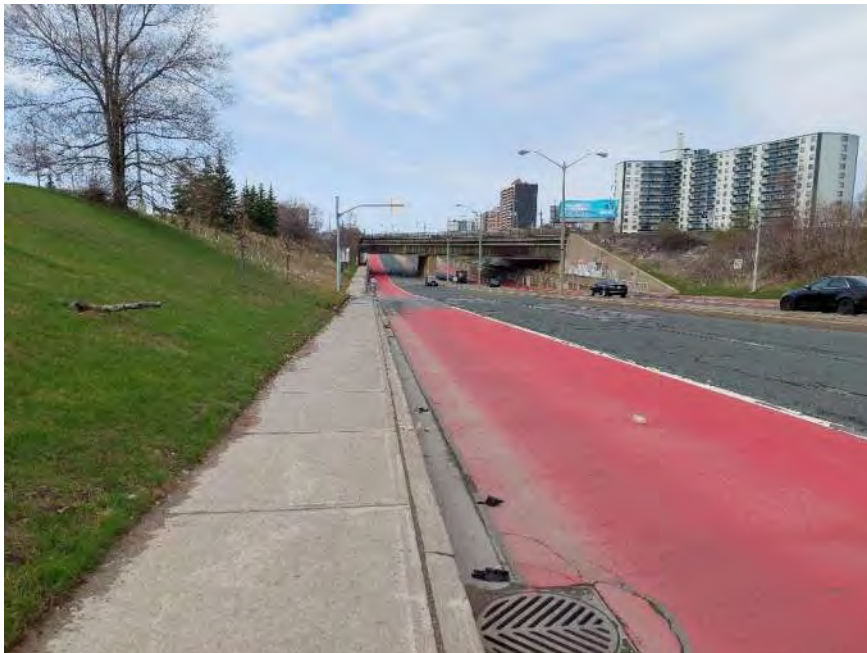
Eglinton Avenue East by a bridge that was constructed in 1962 (City of Toronto, 2022).<sup>2</sup>

<sup>2</sup> Due to their age of construction and their common types, these bridges do not have potential to retain cultural heritage value or interest based on the Municipal Heritage Bridges Cultural, Heritage and Archaeological Resources Assessment Checklist (Municipal Engineers Association, 2014).

Plate 3: Eglinton Avenue East with the bridge carrying the Lakeshore East rail corridor, looking west (A.S.I., 2023).

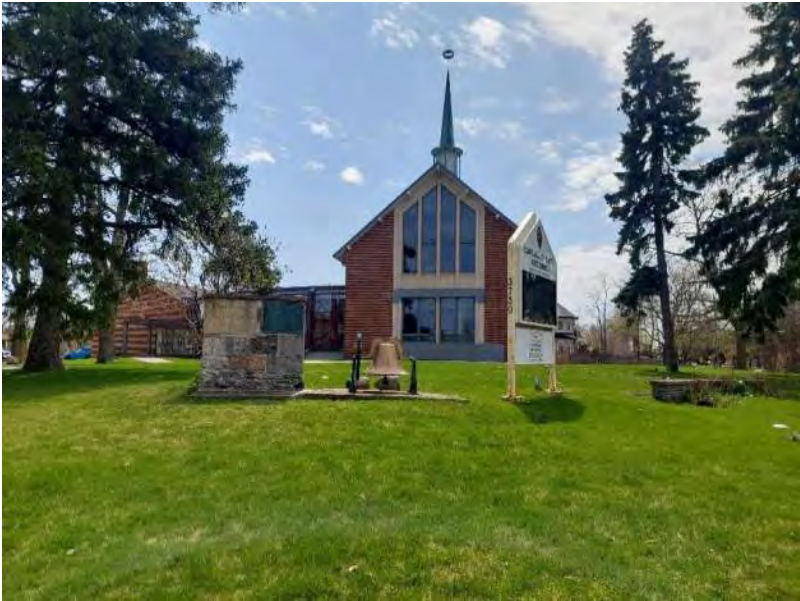
| Feature I.D. | Type of Property | Address or Location | Heritage Status and Recognition | Description of Property and Known or Potential C.H.V.I. | Photographs/ Digital Image |
|---|---|---|---|--|--|
| B.H.R. 1 | Church | 3739 Kingston Road | Potential B.H.R. – Identified during background research and field review | <p>The church, known as the Scarborough Bluffs United Church, is located at the southeast corner of the intersection of Kingston Road and Scarborough Golf Club Road. The potential heritage attributes include the church building and the plaque for George H. Dix which is part of a memorial that is built out of some of the foundations of the second church built on the site and includes the former church bell (Read the Plaque, n.d.). The current church was constructed in 1960 and incorporates a portion of one of the previous churches on the property in its western elevation (ACO Toronto, 2022).</p> <p>The 1914-1915 topographic maps (Figure 4) depicts a stone/brick church in the location of the current structure.</p> <p>The property has the potential to retain C.H.V.I. for its design value as a representative mid-century church building in Scarborough, associative value with the Scarborough Bluffs United Church congregation, and contextual value for supporting the characteristics of the suburban setting at the intersection of Kingston Road and Scarborough Golf Club Road.</p> | <div><p>Plate 26: View to the church and memorial (A.S.I., 2023)</p></div> |

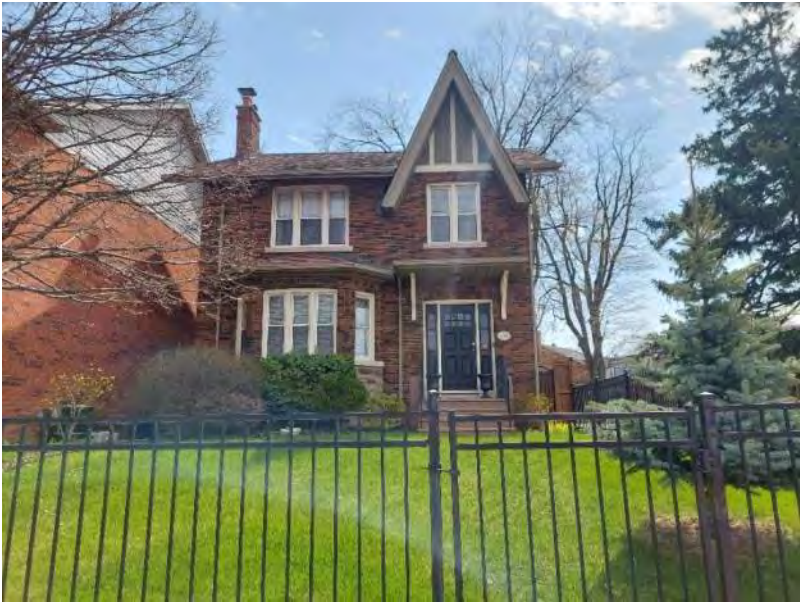
| Feature I.D. | Type of Property | Address or Location | Heritage Status and Recognition | Description of Property and Known or Potential C.H.V.I. | Photographs/ Digital Image |
|---|---|---|--|---|--|
| B.H.R. 2 | Residence | 3741 Kingston Road | Potential B.H.R. – Identified during background research and field review | <p>The early twentieth-century residence is located on the south side of Kingston Road to the east of Scarborough Golf Club Road. The potential heritage attributes include the two-storey brick house with square footprint and two-storey rear addition. The house has a cross gable roof and a bay window along the northern elevation.</p> <p>The 1954 aerial photograph (Figure 5) shows a residence in the location of the extant structure.</p> <p>The property has the potential to retain C.H.V.I. for its design value as a representative early-twentieth century residence in Scarborough and contextual value for supporting the suburban setting of Kingston Road to the east of Scarborough Golf Club Road.</p> | <p>Plate 27: View to the residence (A.S.I., 2023)</p> |

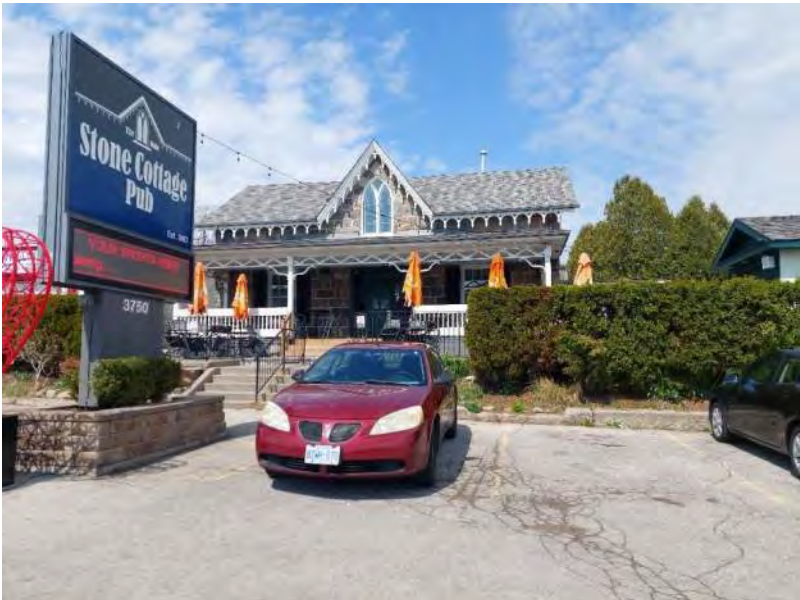
| Feature I.D. | Type of Property | Address or Location | Heritage Status and Recognition | Description of Property and Known or Potential C.H.V.I. | Photographs/ Digital Image |
|---|---|---|--|---|--|
| B.H.R. 3 | Former Residence (Presently Commercial) | 3750 Kingston Road | Known B.H.R. – Designated under Part IV of the <i>Ontario Heritage Act</i> (Bylaw 18102) | <p>The former residence, now the Stone Cottage Pub, is located on the north side of Kingston Road to the east of Scarborough Golf Club Road. The known heritage attributes include the one-and-half storey fieldstone house with a rectangular footprint, central gable, and Gothic arched window beneath the central gable. The residence has associations with Jeremiah Annis as the owner of the house, and along with his two sons were members of the Scarborough Council (Borough of Scarborough, 1978). For further information and full description of its known C.H.V.I., please see the bylaw available via this <a href="#">link</a>.</p> <p>The 1914-1915 topographic maps (Figure 4) depicts a stone/brick residence in the location of the current structure.</p> | <p>Plate 28: View to the former residence (A.S.I., 2023)</p> |

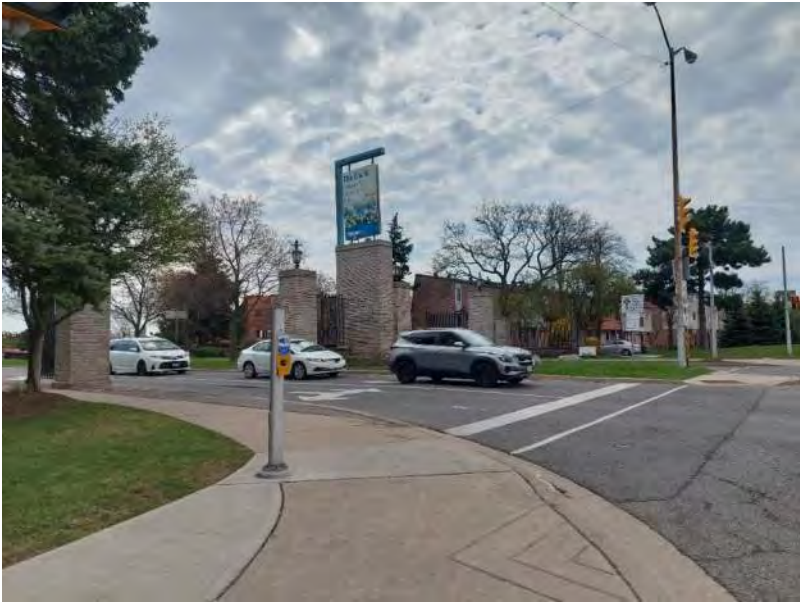
| Feature I.D. | Type of Property | Address or Location | Heritage Status and Recognition | Description of Property and Known or Potential C.H.V.I. | Photographs/ Digital Image |
|---|---|---|---|--|--|
| B.H.R. 4 | Entryway | Guildwood Parkway and Kingston Road | Potential B.H.R. – Identified in Previous Report (Archaeological Services Inc., 2009) | <p>The Stanley Barrack Gates are located at the southeast corner of the intersection of Guildwood Parkway and Kingston Road. The potential heritage attributed include the stone pillars, wrought iron gates, metal fencing, and light fixtures atop the pillars. A datestone states “1957”. The gates were relocated from Stanley Barracks to this location when the officer’s quarters were demolished in the 1950’s (Scarborough Historical Society, n.d.c). According to staff at the City of Toronto, Spencer Clark of the Guild Inn had purchased the gates in 1953, consisting of two larger carriage gates, two smaller pedestrian gates, and the curved iron fences that flanked them. Some of this was incorporated into the entrances at Guildwood Parkway and Kingston Road, some was incorporated into a smaller entrance to the Guild Inn, and some was put in a stone storage compound (personal communication 22 January 2024).</p> <p>The 1965 aerial photograph (Figure 6) depicts the gates at the intersection of Guildwood Parkway and Kingston Road.</p> <p>The gates have the potential to retain C.H.V.I. for their historical associations with Stanley Barracks and the Guild Inn and their contextual value for supporting the entrance to the Guild Inn property since the time of their installation.</p> | <div></div> <p>Plate 29: View to the gates (A.S.I., 2023)</p> |

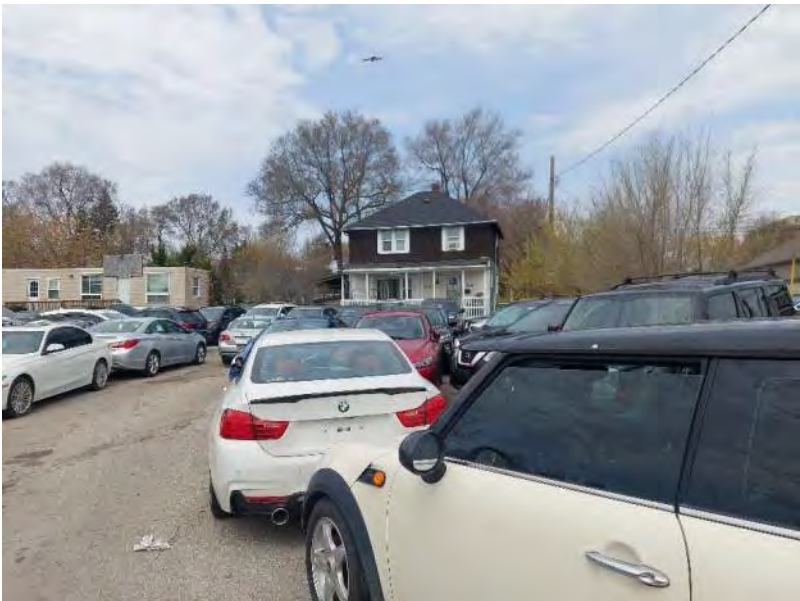
| Feature I.D. | Type of Property | Address or Location | Heritage Status and Recognition | Description of Property and Known or Potential C.H.V.I. | Photographs/ Digital Image |
|---|---|---|--|---|--|
| B.H.R. 5 | Former Residence (Presently Commercial) | 4234 Kingston Road | Potential B.H.R. – Identified in Previous Report (Archaeological Services Inc., 2009) | <p>The former residence is located at the northwest corner of the intersection of Kingston Road and Adams Drive. The potential heritage attributes include the two-storey residence with a square footprint and hipped roof. The house has been clad in clapboard siding and has an internal brick chimney.</p> <p>The 1954 aerial photograph (Figure 5) shows a residence in the location of the extant structure.</p> <p>The property has the potential to retain C.H.V.I. for its design value as a representative early-twentieth century residence in Scarborough and contextual value for supporting the suburban setting of Kingston Road to the west of Adams Drive.</p> | <p>Plate 30: View to the former residence (A.S.I., 2023)</p> |

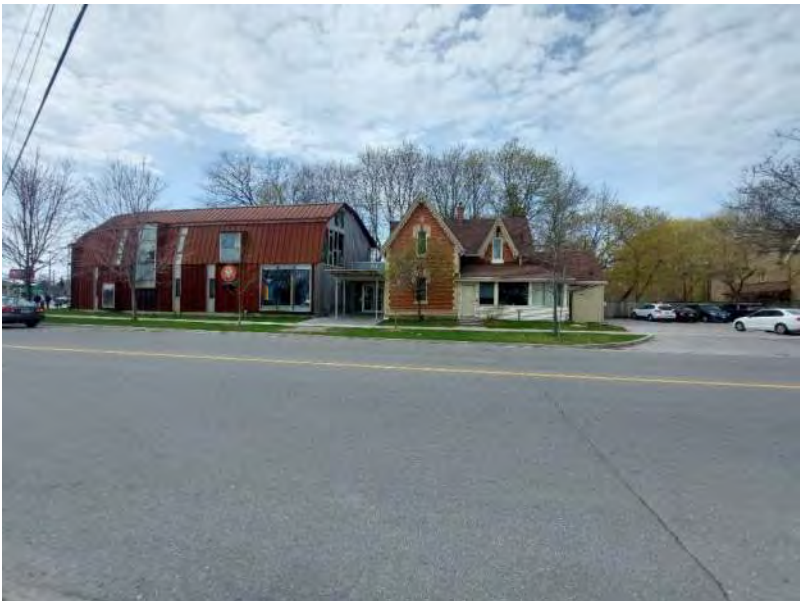
| Feature I.D. | Type of Property | Address or Location | Heritage Status and Recognition | Description of Property and Known or Potential C.H.V.I. | Photographs/ Digital Image |
|---|---|---|--|---|--|
| B.H.R. 6 | Former Residence (Presently a Community Facility) | 156 Galloway Road | Known B.H.R. – Designated under Part IV of the <i>Ontario Heritage Act</i> (Bylaw 20972) | <p>The former nineteenth-century brick residence is located at the northwest corner of the intersection of Galloway Road and Kingston Road. The known heritage attributes include the one-and-a-half storey brick residence with a T-shaped footprint and cross gable roof. The house has elements of the Gothic Revival style with its red and buff brick and bargeboard along the eaves. The house is associated with Richard Eade (Borough of Scarborough, 1982). For further information, please see the bylaw available via this <a href="#">link</a>. In 2011, a southern extension was added to the building. This modern addition fronts on to the corner of Galloway Road and Kingston Road. The property is now known as Ghesig House and was built for Native Child and Family Life Services of Toronto.</p> <p>The 1878 map (Figure 3) depicts a residence in the vicinity of the extant structure.</p> | <p>Plate 31: View to the former residence (A.S.I., 2023)</p> |

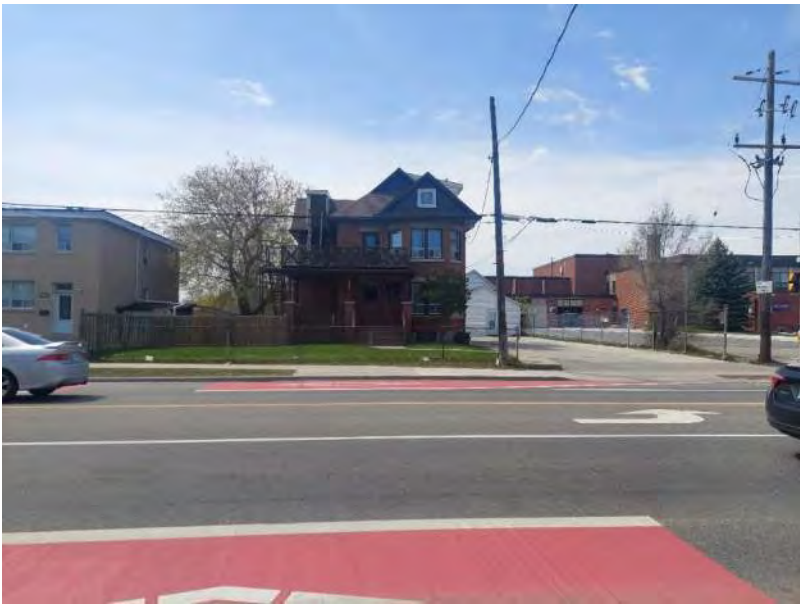
| Feature I.D. | Type of Property | Address or Location | Heritage Status and Recognition | Description of Property and Known or Potential C.H.V.I. | Photographs/ Digital Image |
|---|---|---|---|---|--|
| B.H.R. 7 | Residence | 344 Morningside Avenue | Potential B.H.R. – Identified in Previous Report (Archaeological Services Inc., 2009) | <p>The residence is located on the west side of Morningside Avenue and to the north of Beath Street. The potential heritage attributes include the two-and-a-half storey brick residence with an irregular footprint and cross gable roof. The house has a covered porch and bay along the eastern elevation.</p> <p>The 1914-1915 topographic maps (Figure 4) depicts a frame residence in the vicinity of the current structure.</p> <p>The property has the potential to retain C.H.V.I. for its design value as a representative early-twentieth century residence in Scarborough and contextual value for supporting the residential setting of Morningside Avenue to the north of Beath Street.</p> | <p>Plate 32: View to the residence (A.S.I., 2023)</p> |

**Direct impacts** to B.H.R. 7 are anticipated through removal of the structure on this property and the construction of a traction power sub-station (T.P.S.S.) on the property. This will result in **adverse direct impacts** to potential heritage attributes. The preferred option would be to avoid the removal of the potential B.H.R. Should it be determined that there is no other technically feasible option other than to remove the building, it is recommended that a C.H.E.R. be undertaken during the T.P.A.P. to determine if this potential B.H.R. has C.H.V.I. If

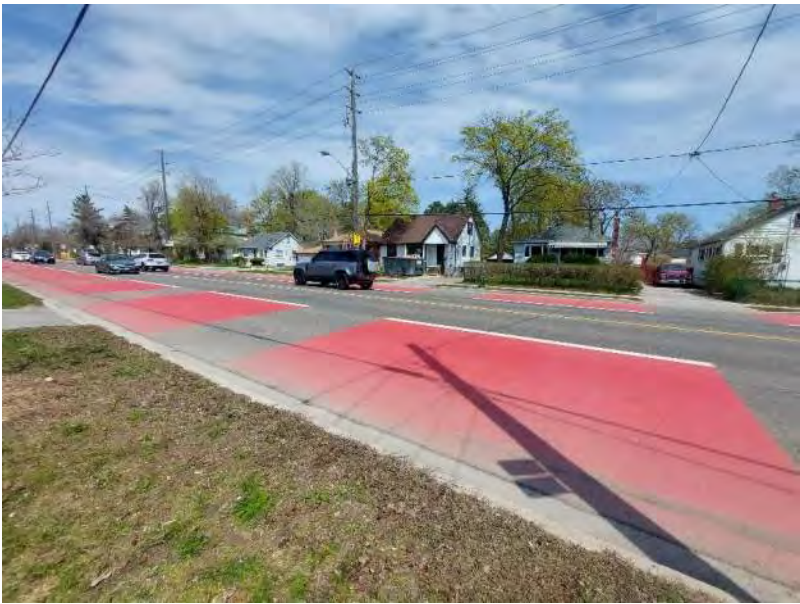
| Feature I.D. | Type of Property | Address or Location | Heritage Status and Recognition | Description of Property and Known or Potential C.H.V.I. | Photographs/ Digital Image |
|---|---|---|---|---|--|
| C.H.L. 1 | Post-War Streetscape | Morningside Avenue from Fairwood Crescent to Tefft Road | Potential C.H.L. – Identified in Previous Report (Archaeological Services Inc., 2009) | <p>The post-war streetscape is located along both the east and west sides of Morningside Avenue generally from Tefft Road to Fairwood Crescent. The potential heritage attributes include the variety of residences which are indicative of post-war residential design, the properties have well-proportioned massing, harmonized setbacks, and incorporation of different, while complimentary floor plans, roof designs, and exterior materials (Archaeological Services Inc., 2009).</p> <p>The 1954 aerial photograph (Figure 5) shows the streetscape with residences lining Morningside Avenue.</p> <p>The streetscape has the potential to retain C.H.V.I. for its design value as a representative post-war streetscape in Scarborough, historical value for its development following the Second World War, and contextual value for contributing to the surrounding character of the area.</p> | <p>Plate 33: View of the east side of the post-war streetscape along Morningside Avenue (A.S.I., 2023)</p> |

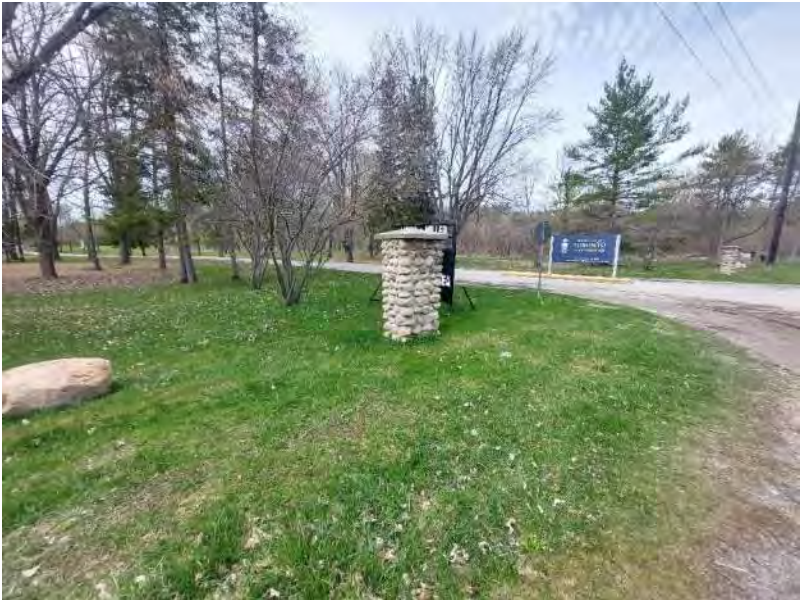
| Feature I.D. | Type of Property | Address or Location | Heritage Status and Recognition | Description of Property and Known or Potential C.H.V.I. | Photographs/ Digital Image |
|---|---|---|--|--|--|
| C.H.L. 2 | Former Estate (Presently Institution) | 130 Old Kingston Road | Known C.H.L. – Designated under Part IV of the <i>Ontario Heritage Act</i> (Bylaw 302-1998 and 744-2001) | <p>The former estate property is now associated with the University of Toronto. It is located on the north side of Old Kingston Road to the east of Manse Road. The known heritage attributes include the Miller Lash Estate/McLean House and the Miller Lash Carriage House. The Miller Lash Estate/McLean House was constructed 1913-1914 as a summer estate. The former house is a quasi-bungalow, with concrete and fieldstone walls has elements of the Arts and Crafts architectural style. A stone structure, believed to be a former icehouse, was located to the north of the former house. For additional information, please see the bylaw for Miller Lash Estate/McLean House available via this <a href="#">link</a>. The Miller Lash Carriage House was also constructed 1913-1914, complements the Arts and Crafts style of the residence, and has walls clad with fieldstone. For additional information, please see the bylaw for Miller Lash Carriage House available via this <a href="#">link</a>.</p> <p>The 1954 aerial photograph (Figure 5) shows a residence in the location of the extant structure.</p> | <p>Plate 34: View to the entrance of the property (A.S.I., 2023)</p> |

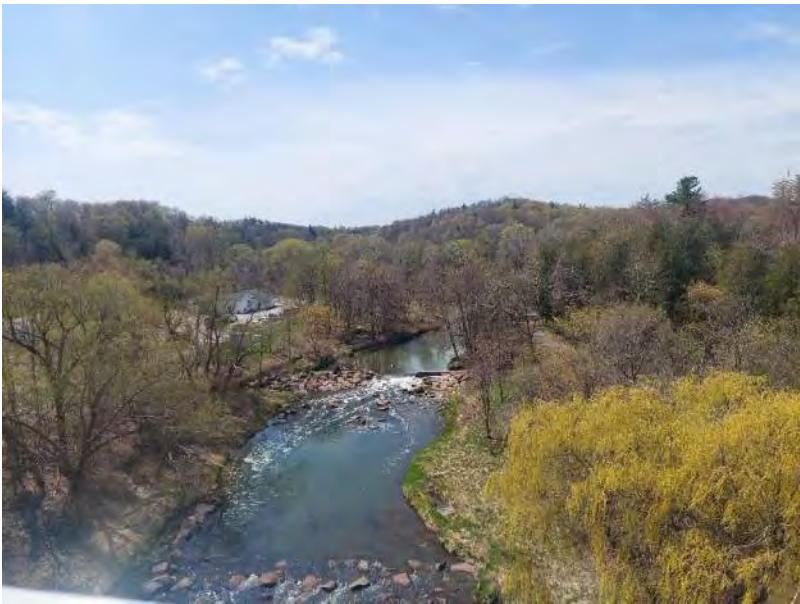
| Feature I.D. | Type of Property | Address or Location | Heritage Status and Recognition | Description of Property and Known or Potential C.H.V.I. | Photographs/ Digital Image |
|---|---|---|--|--|--|
| C.H.L. 3 | Watercourse | Highland Creek | Potential C.H.L. – Identified in Previous Report (Archaeological Services Inc., 2009) | <p>Highland Creek intersects with the study area at Morningside Avenue between Fairwood Crescent and Ellesmere Road within the Highland Creek valley. Highland Creek has the potential to retain C.H.V.I. as it is significant as a transportation corridor, and as a hunting, fishing and gathering place, and for influencing settlement patterns by Indigenous peoples for thousands of years. The potential heritage attributes include its association with Indigenous people and Euro-Canadian settlers, its role in influencing settlement patterns, along with the Highland Creek watercourse itself, banks, and the valley.</p> <p>The 1860 map (Figure 2) depicts Highland Creek following a similar alignment to its present orientation.</p> | <p>Plate 35: View of Highland Creek (A.S.I., 2023)</p> |

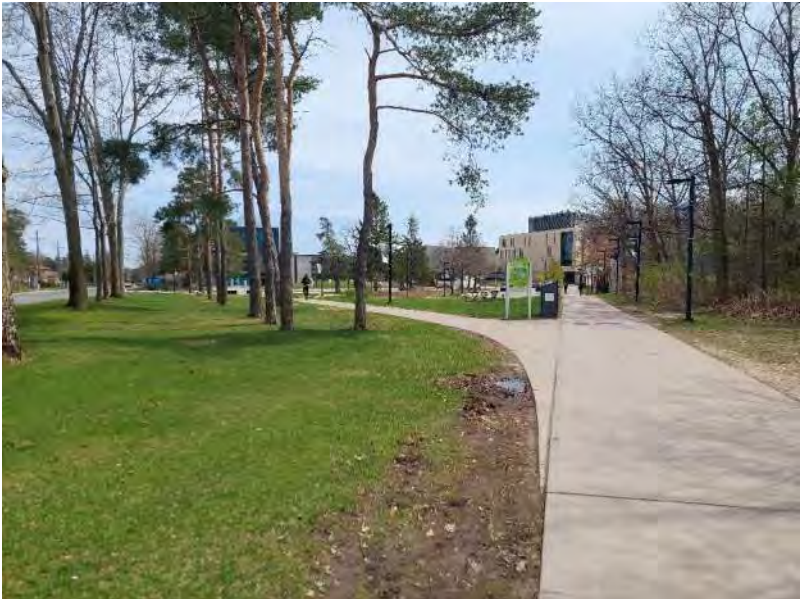
| Feature I.D. | Type of Property | Address or Location | Heritage Status and Recognition | Description of Property and Known or Potential C.H.V.I. | Photographs/ Digital Image |
|---|---|--|---|--|---|
| C.H.L. 4 | University Campus | University of Toronto Scarborough Campus; 1265 Military Trail, Toronto | Potential C.H.L. – Identified in Previous Report (Archaeological Services Inc., 2022) | <p>The University of Toronto Scarborough Campus is located on 300 acres of land in Highland Creek valley to the east of Morningside Avenue and south of Ellesmere Road. The campus has potential to have historical associations with the Lash family and design value associated with the buildings and landscape of the campus. potential heritage attributes of the campus include the historical, design, and contextual values of the property. The campus was founded on agricultural lands of Miller Lash’s summer estate (C.H.L. 2). The original Scarborough College building was designed by architect John Andrews. The Andrews Building is considered an iconic example of mid-twentieth-century Brutalist architecture. In the Master Plan for the campus (2011), it identified the following cultural heritage elements that would be protected as part of the university’s heritage: the Miller Lash House; and the Science and Humanities Wings of the Andrews Building (Archaeological Services Inc., 2022).</p> <p>The 1965 aerial photograph (Figure 6) shows the university campus under construction.</p> | <p>Plate 36: View of the university campus (A.S.I., 2023)</p> |
