# Cultural Heritage Report: Existing Conditions and Preliminary Impact Assessment

## Eglinton East Light Rail Transit Transit Project Assessment Process and Design Update

### City of Toronto, Ontario

#### Draft Report

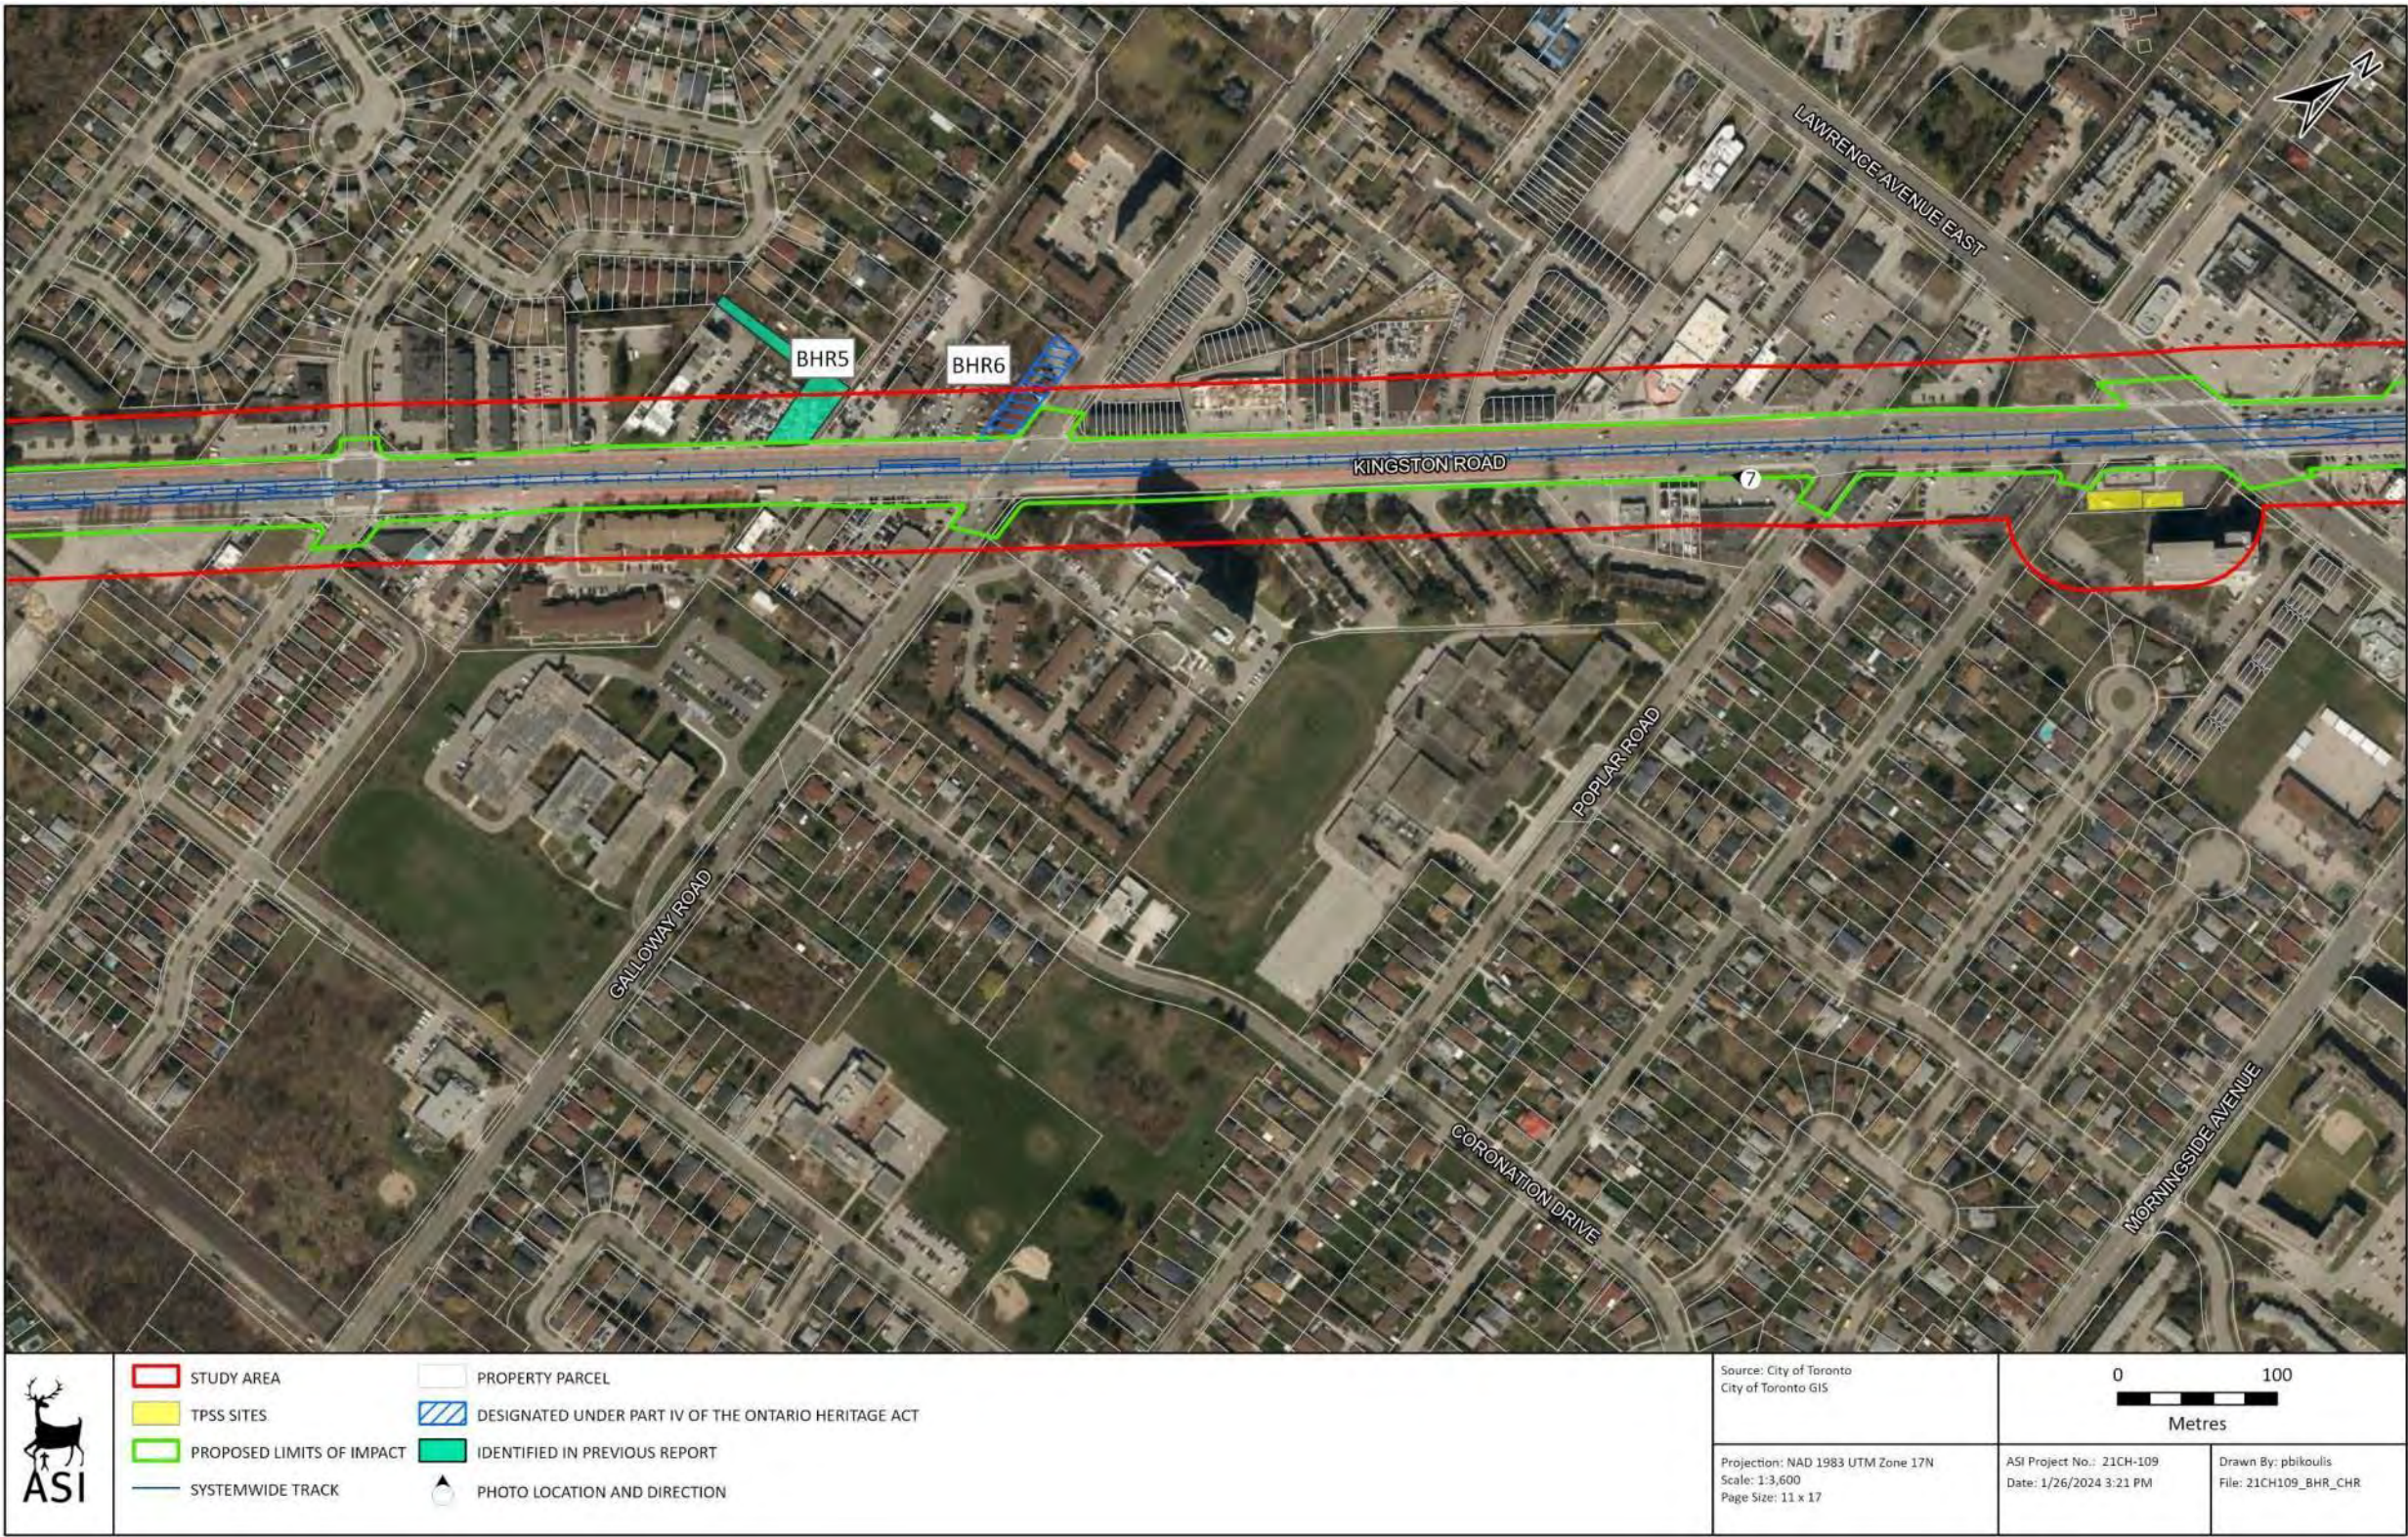
Figure 15: Location of Identified Built Heritage Resources (B.H.R.) and Cultural Heritage Landscapes (C.H.L.) in the Study Area (Sheet 6)

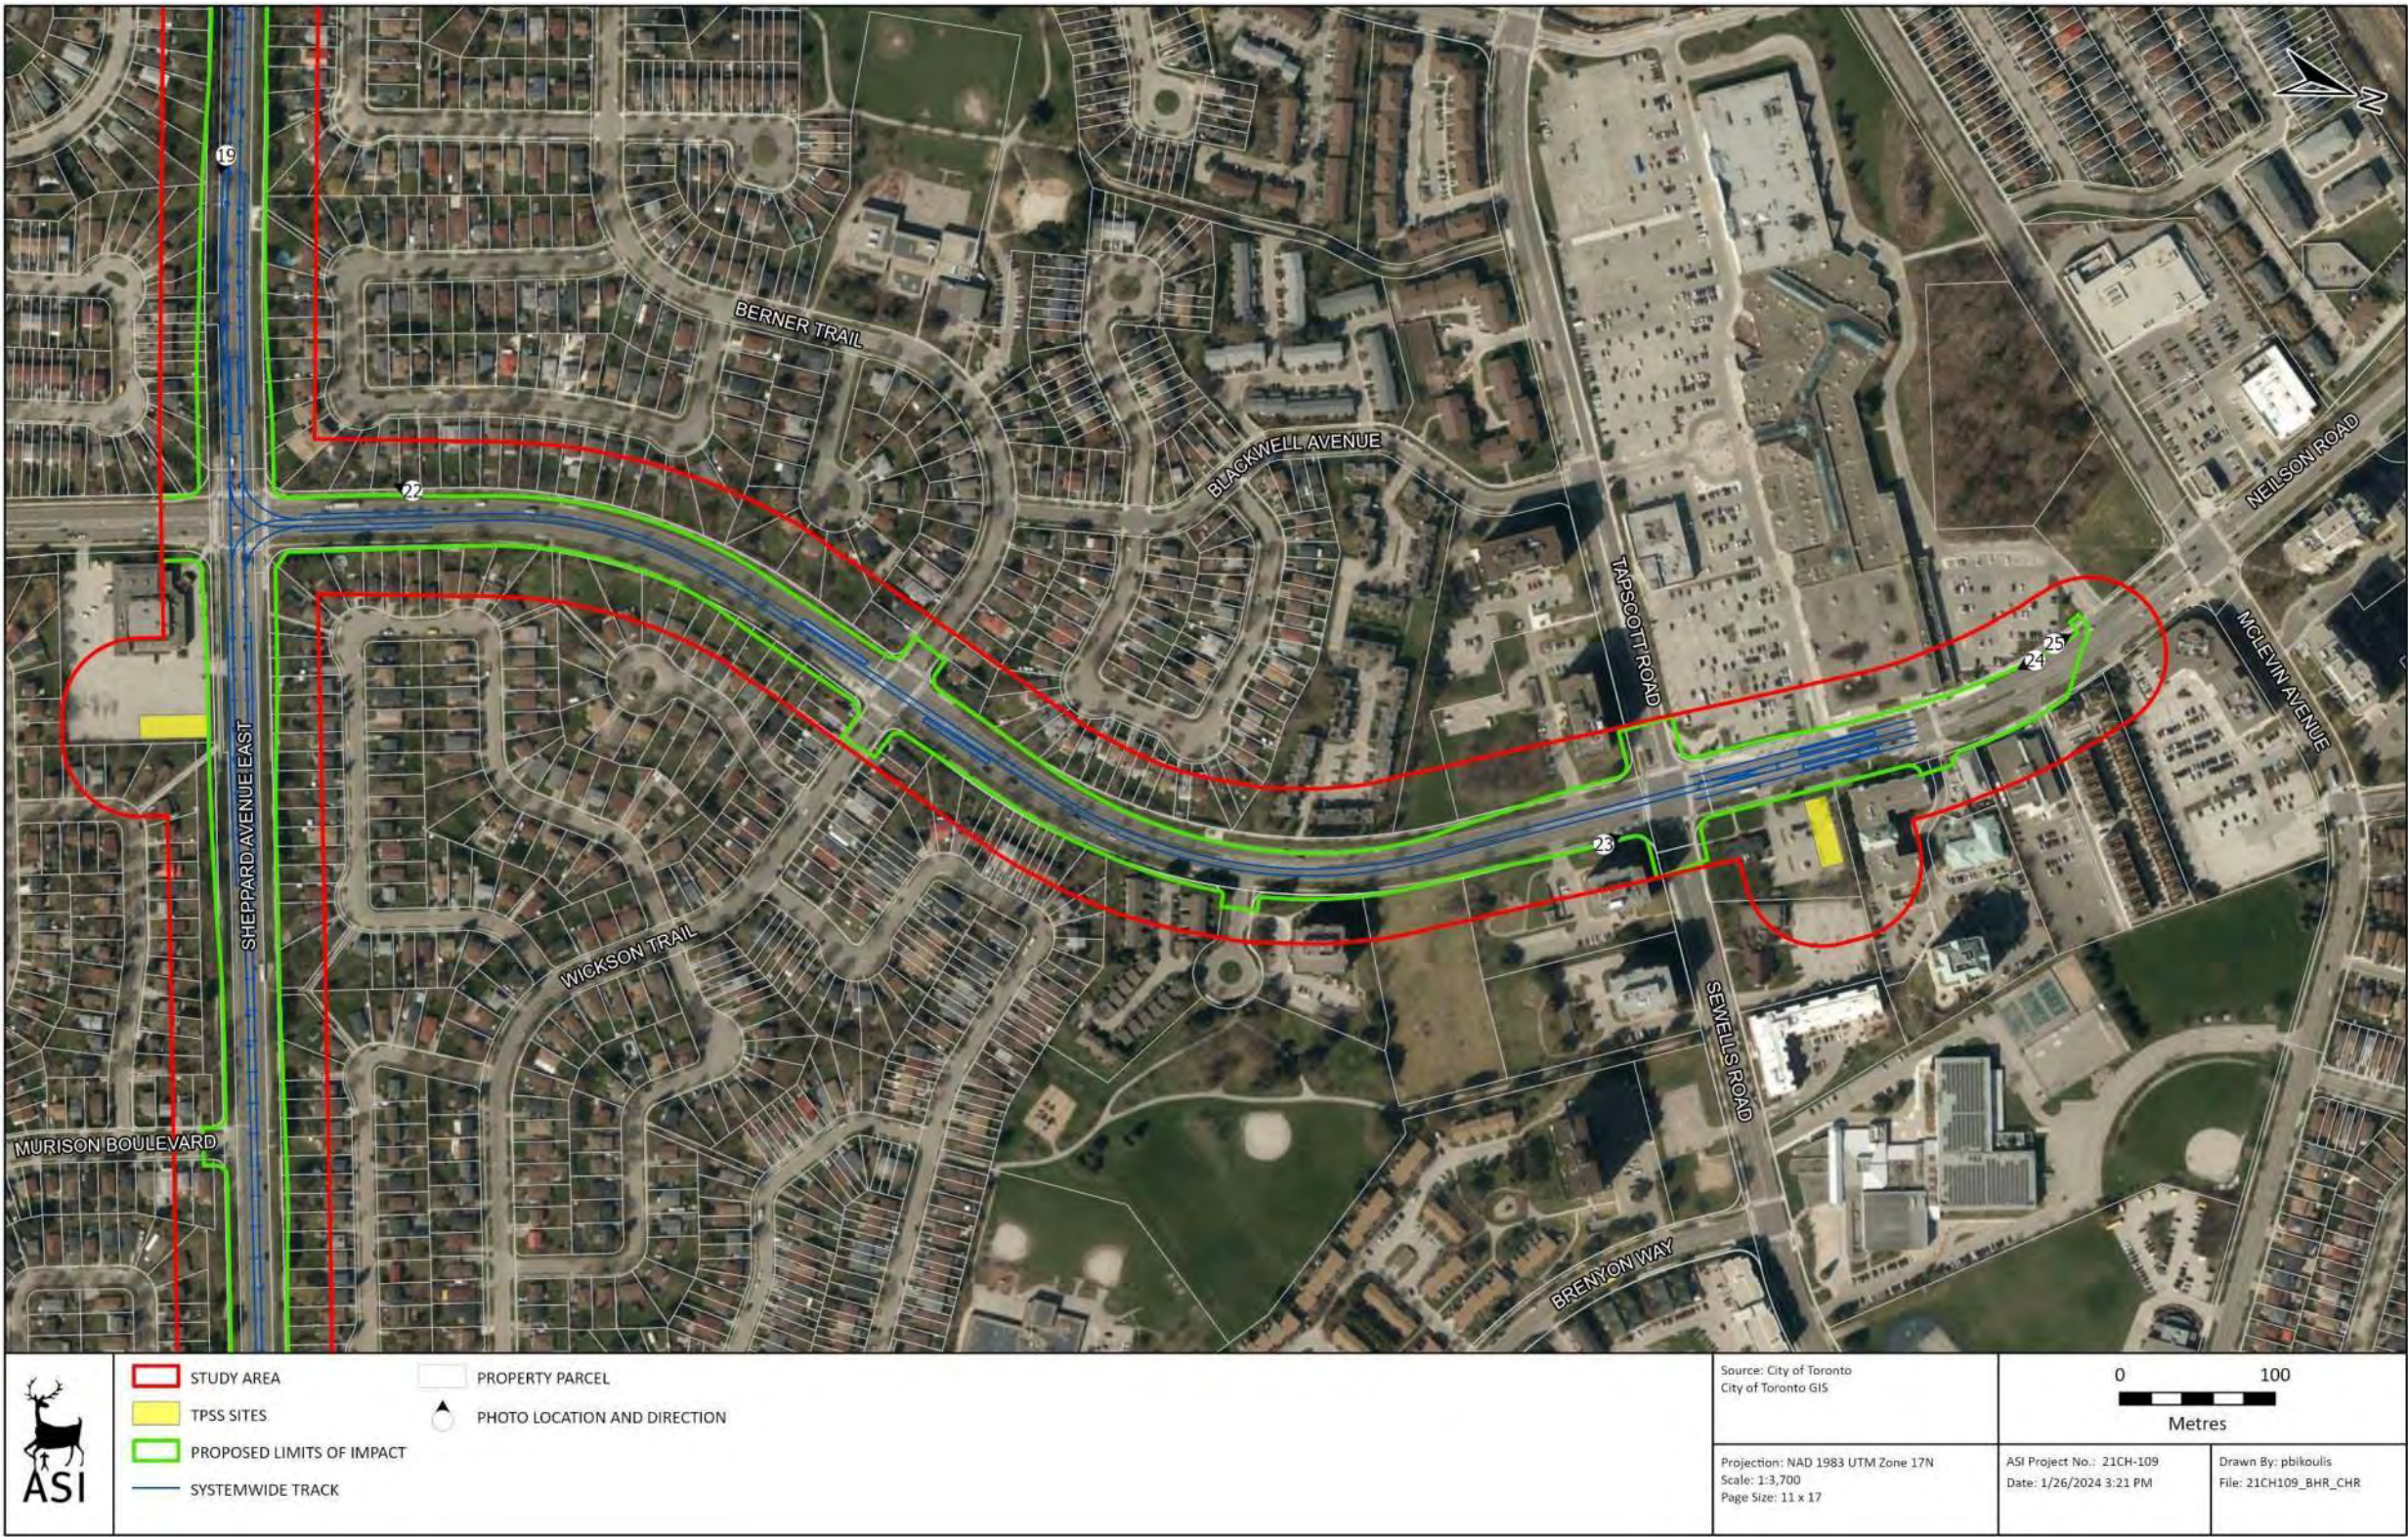
Figure 21: Location of Identified Built Heritage Resources (B.H.R.) and Cultural Heritage Landscapes (C.H.L.) in the Study Area (Sheet 12)
