**PHASE ONE ENVIRONMENTAL SITE ASSESSMENT
PROPOSED EGLINTON EAST LRT PROJECT
SCARBOROUGH, ONTARIO
FOR
HDR CORPORATION**

PML Ref.: 23TX013
April 9, 2024

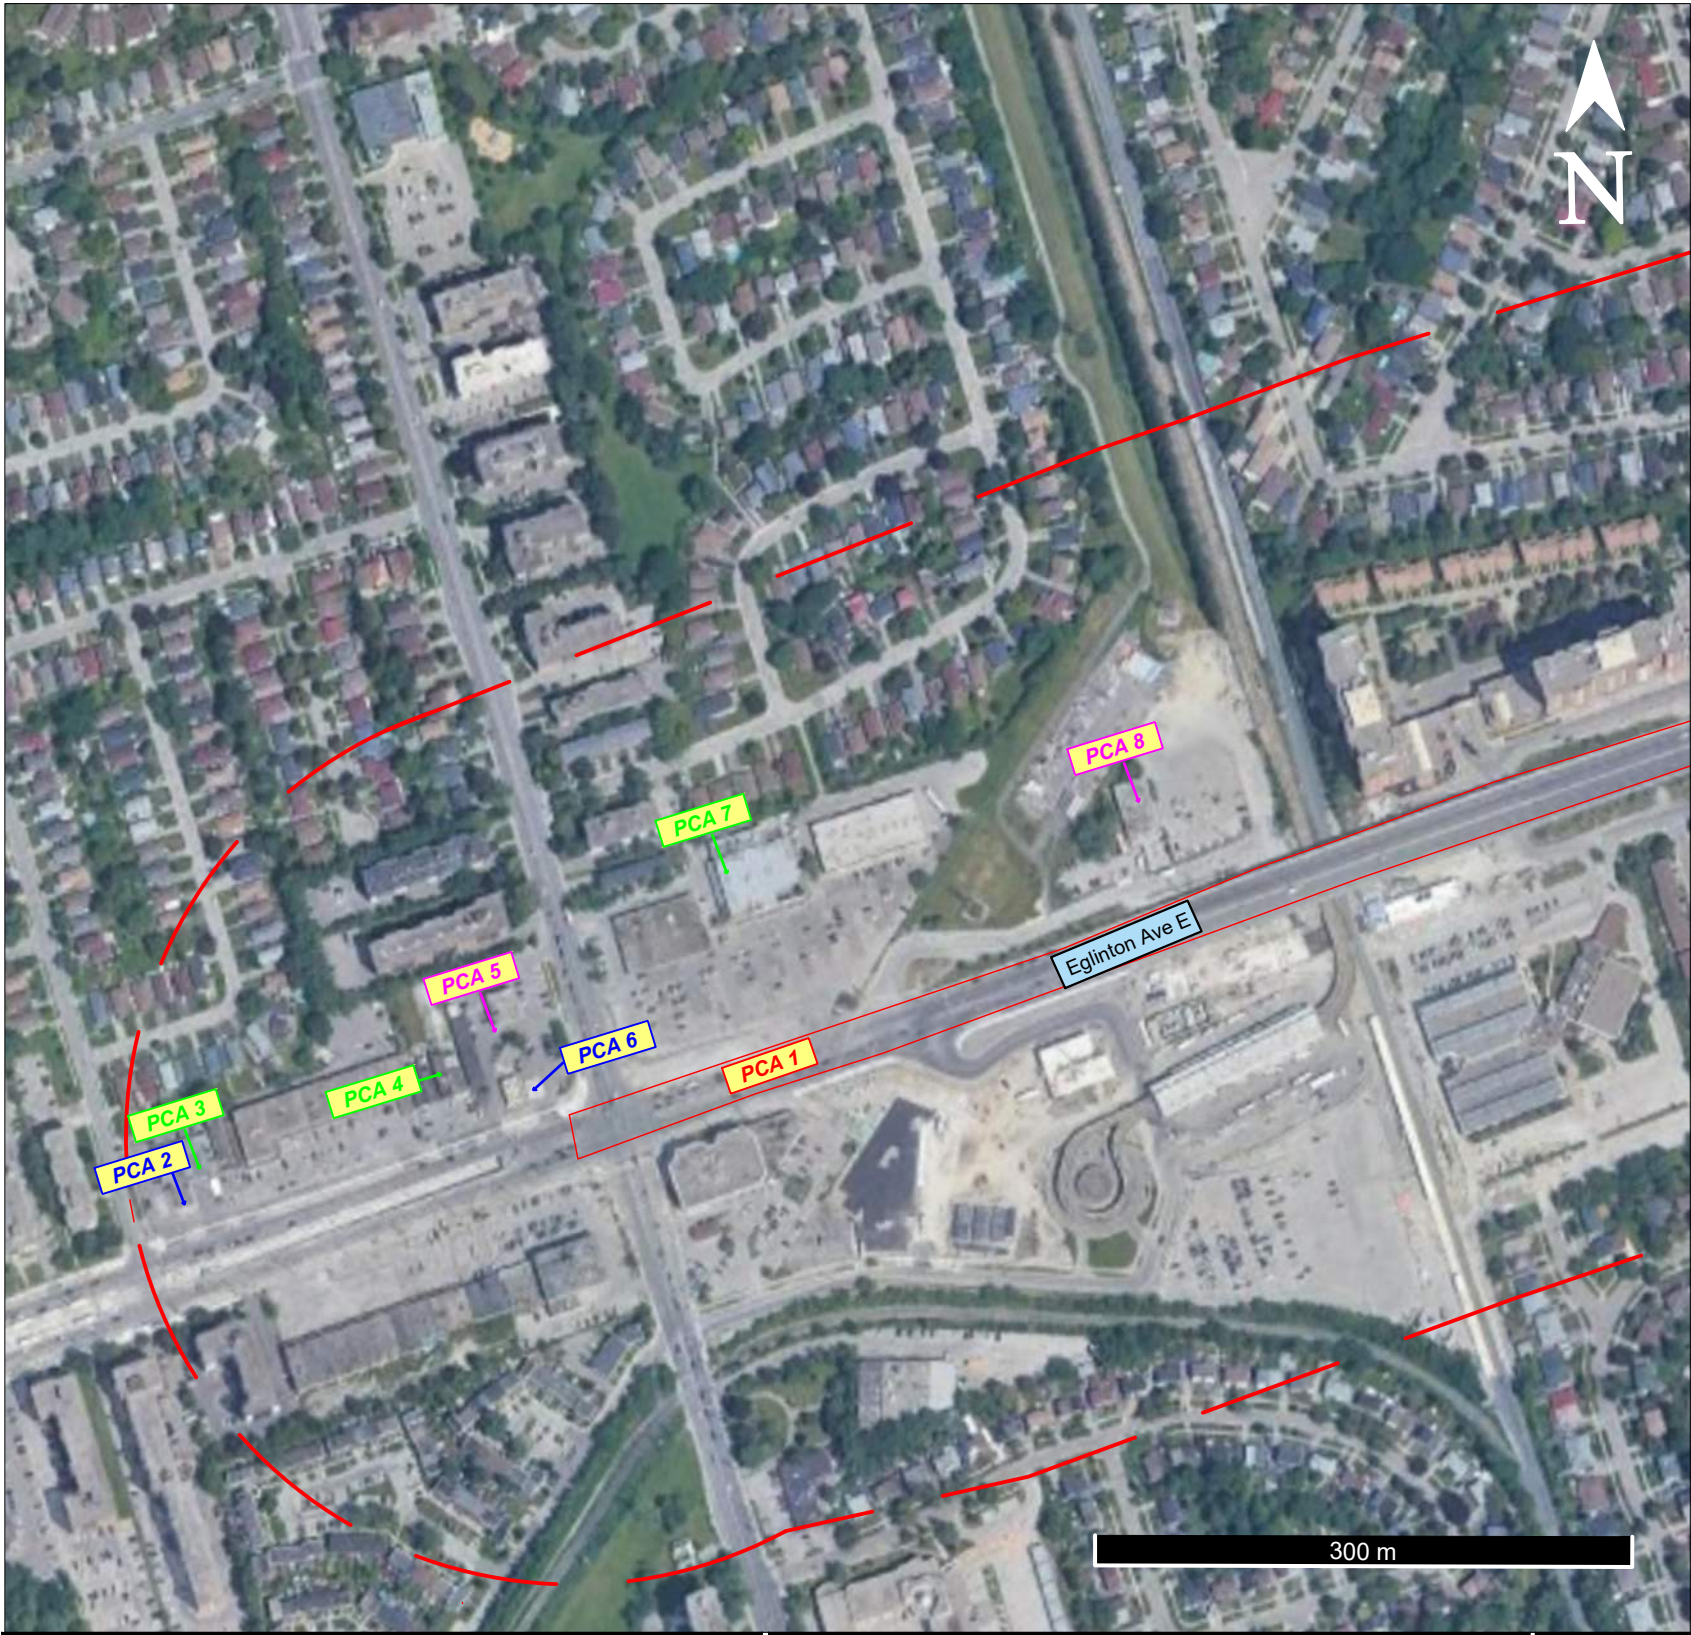
DRAWN	A.S./K.T.	DATE	SCALE	PML REF.	DWG. NO.
CHECKED	S.T	SEPTEMBER 2023	AS SHOWN	23TX013	1-A
APPROVED	M.A.

Potentially Contaminating Activities (PCAs):

POTENTIALLY CONTAMINATING ACTIVITY (PCA)	LOCATION	PCA DESCRIPTION
IN/ON/UNDER THE SITE		
PCA 1 Item-30: Importation of fill material of unknown quality	The Site	Fill materials associated with historical development/use of the Site
IN/ON/UNDER THE STUDY AREA		
PCA 2 Item -28: Gasoline and associated products storage in fixed tanks	2372 Eglinton Ave E, approximately 50m north of Eglinton Ave E	A gas station noted during the site visit
PCA 3 Item -50: Soap and Detergent Manufacturing, Processing and Bulk Storage	2432 Eglinton Ave E, approximately 50m North of Eglinton Ave E	A laundromat noted during the site visit
PCA 4 Item -50: Soap and Detergent Manufacturing, Processing and Bulk Storage	2422 Eglinton Ave E, approximately 20m North of Eglinton Ave E	A car wash centre noted during site visit
PCA 5 Item -10: Commercial autobody shops	2424 Eglinton Ave E, approximately 20m North of Eglinton Ave E	An autobody shop noted during the site visit

PCA 6 Item -28: Gasoline and associated products storage in fixed tanks	2424 Eglinton Ave E, approximately 10m North of Eglinton Ave E	A gas station noted during the site visit
PCA 7 Item -50: Soap and Detergent Manufacturing, Processing and Bulk Storage	2372 Eglinton Ave E, approximately 30m North of Eglinton Ave E	A laundromat noted during the site visit
PCA 8 Item -10: Commercial autobody shops	2438 Eglinton Ave E, approximately 20m North of Eglinton Ave E	An autobody shop noted during the site visit

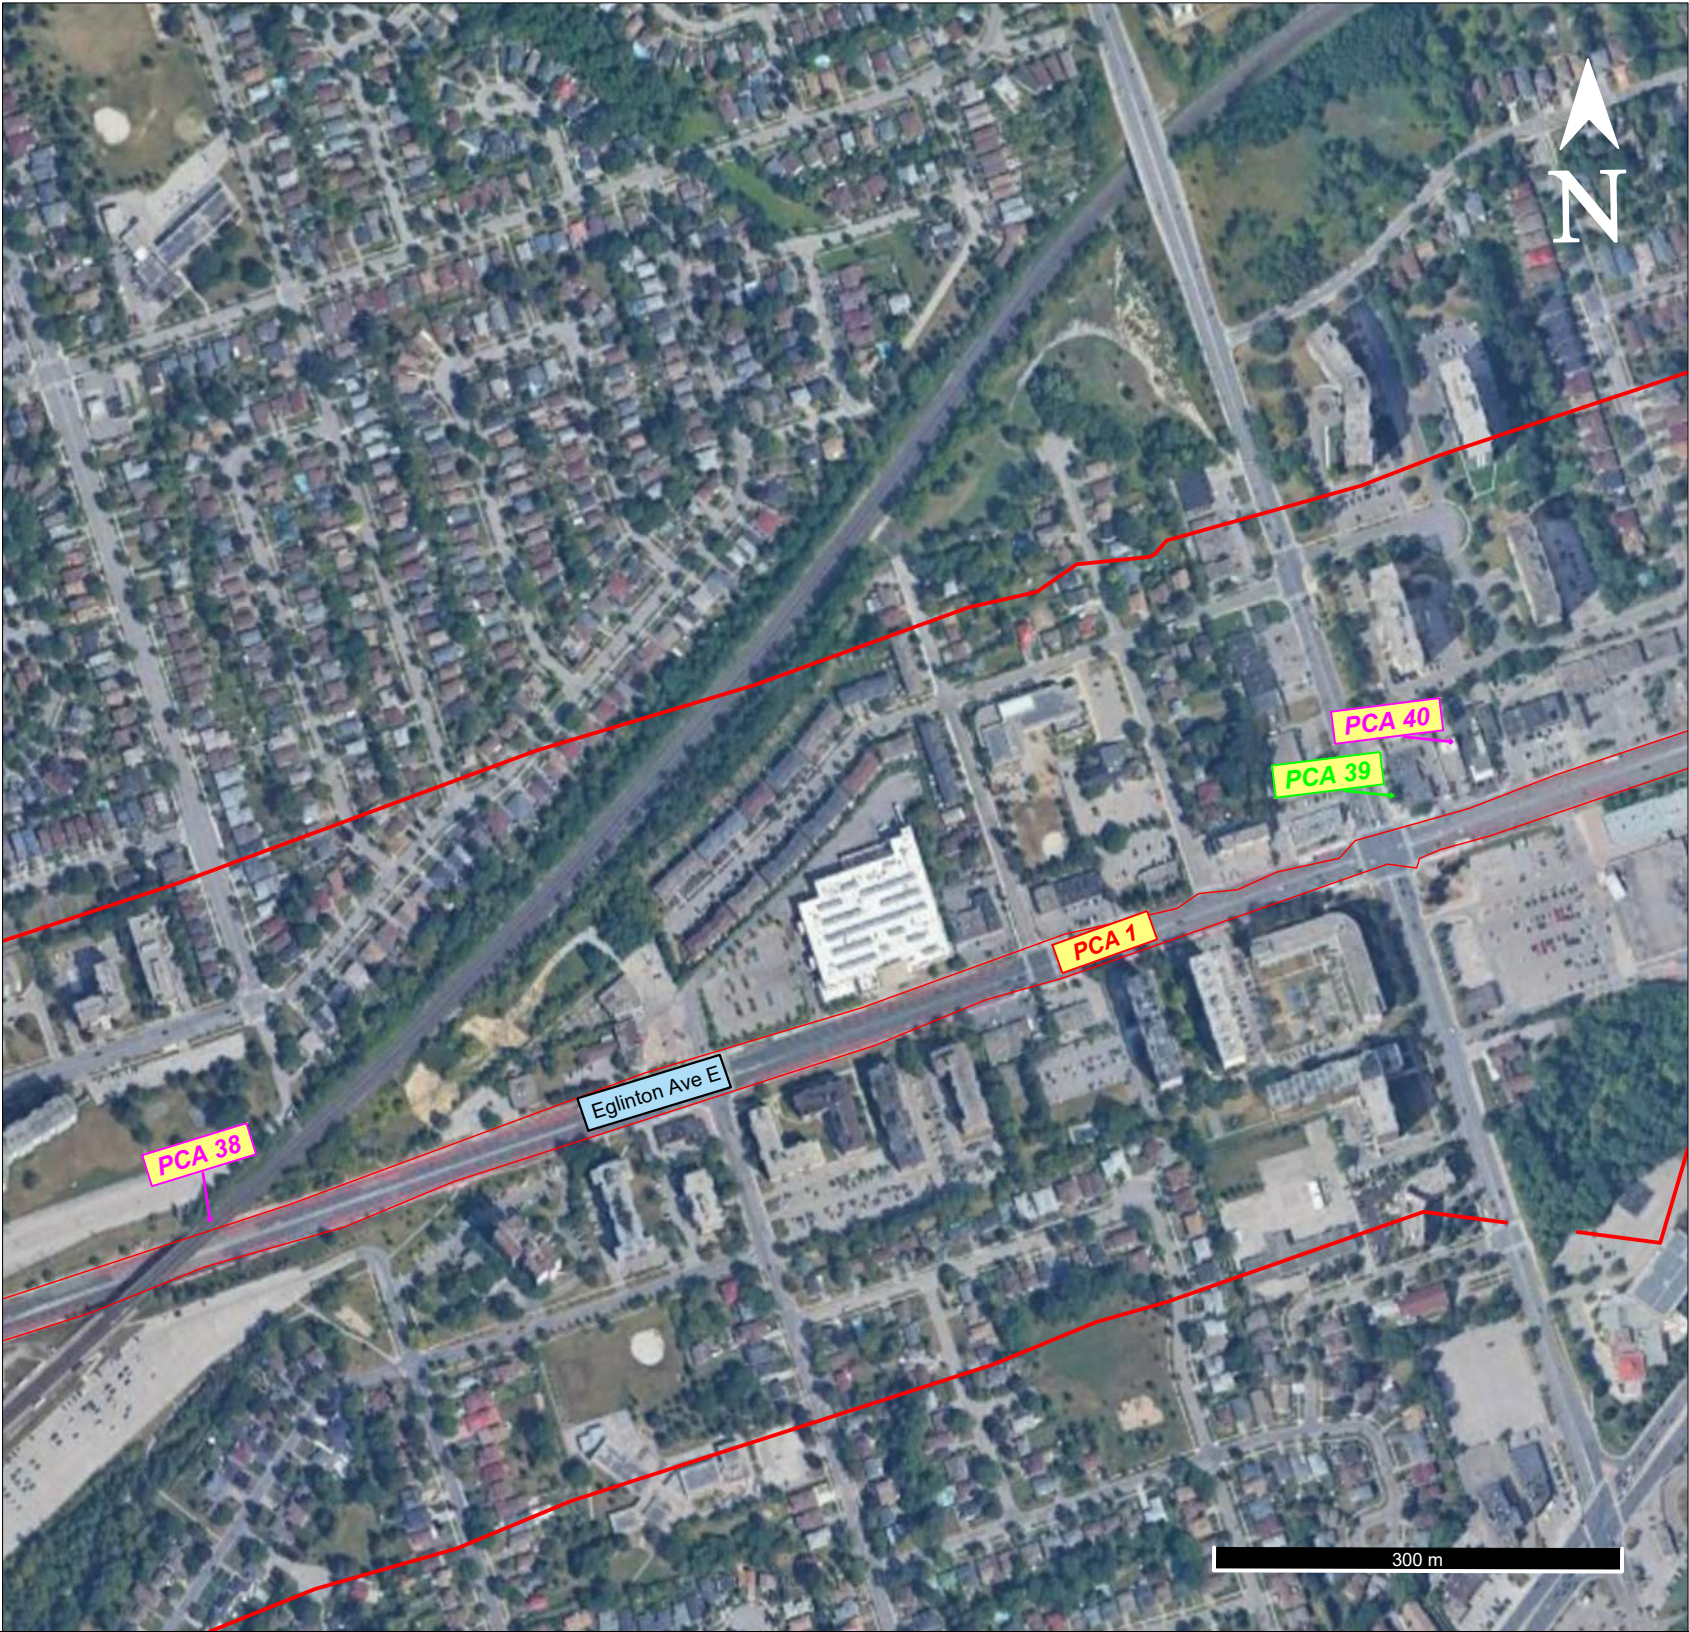
DRAWN	A.S./K.T.	DATE	SCALE	PML REF.	DWG. NO.
CHECKED	S.T	SEPTEMBER 2023	AS SHOWN	23TX013	1-D
APPROVED	M.A.

Potentially Contaminating Activities (PCAs):		
POTENTIALLY CONTAMINATING ACTIVITY (PCA)	LOCATION	PCA DESCRIPTION
IN/ON/UNDER THE STUDY AREA		
PCA 1 Item-30: Importation of fill material of unknown quality	The Site	Fill materials associated with historical development/use of the Site
PCA 38 Item -46: Rail Yards, Tracks and Spurs	Railway corridor located 30m North of Eglinton Ave E	Railway corridor noted during the site visit
PCA 39 Item -50: Soap and Detergent Manufacturing, Processing and Bulk Storage	3200 Eglinton Ave E, approximately 30m North of Eglinton Ave E	A laundromat noted during the site visit
PCA 40 Item -10: Commercial autobody shops	3204 Eglinton Ave E, approximately 60 m North of Eglinton Ave E	An autobody shop noted during the site visit

POTENTIALLY CONTAMINATING ACTIVITIES (PCAs)
ON THE SITE AND WITHIN THE STUDY AREA

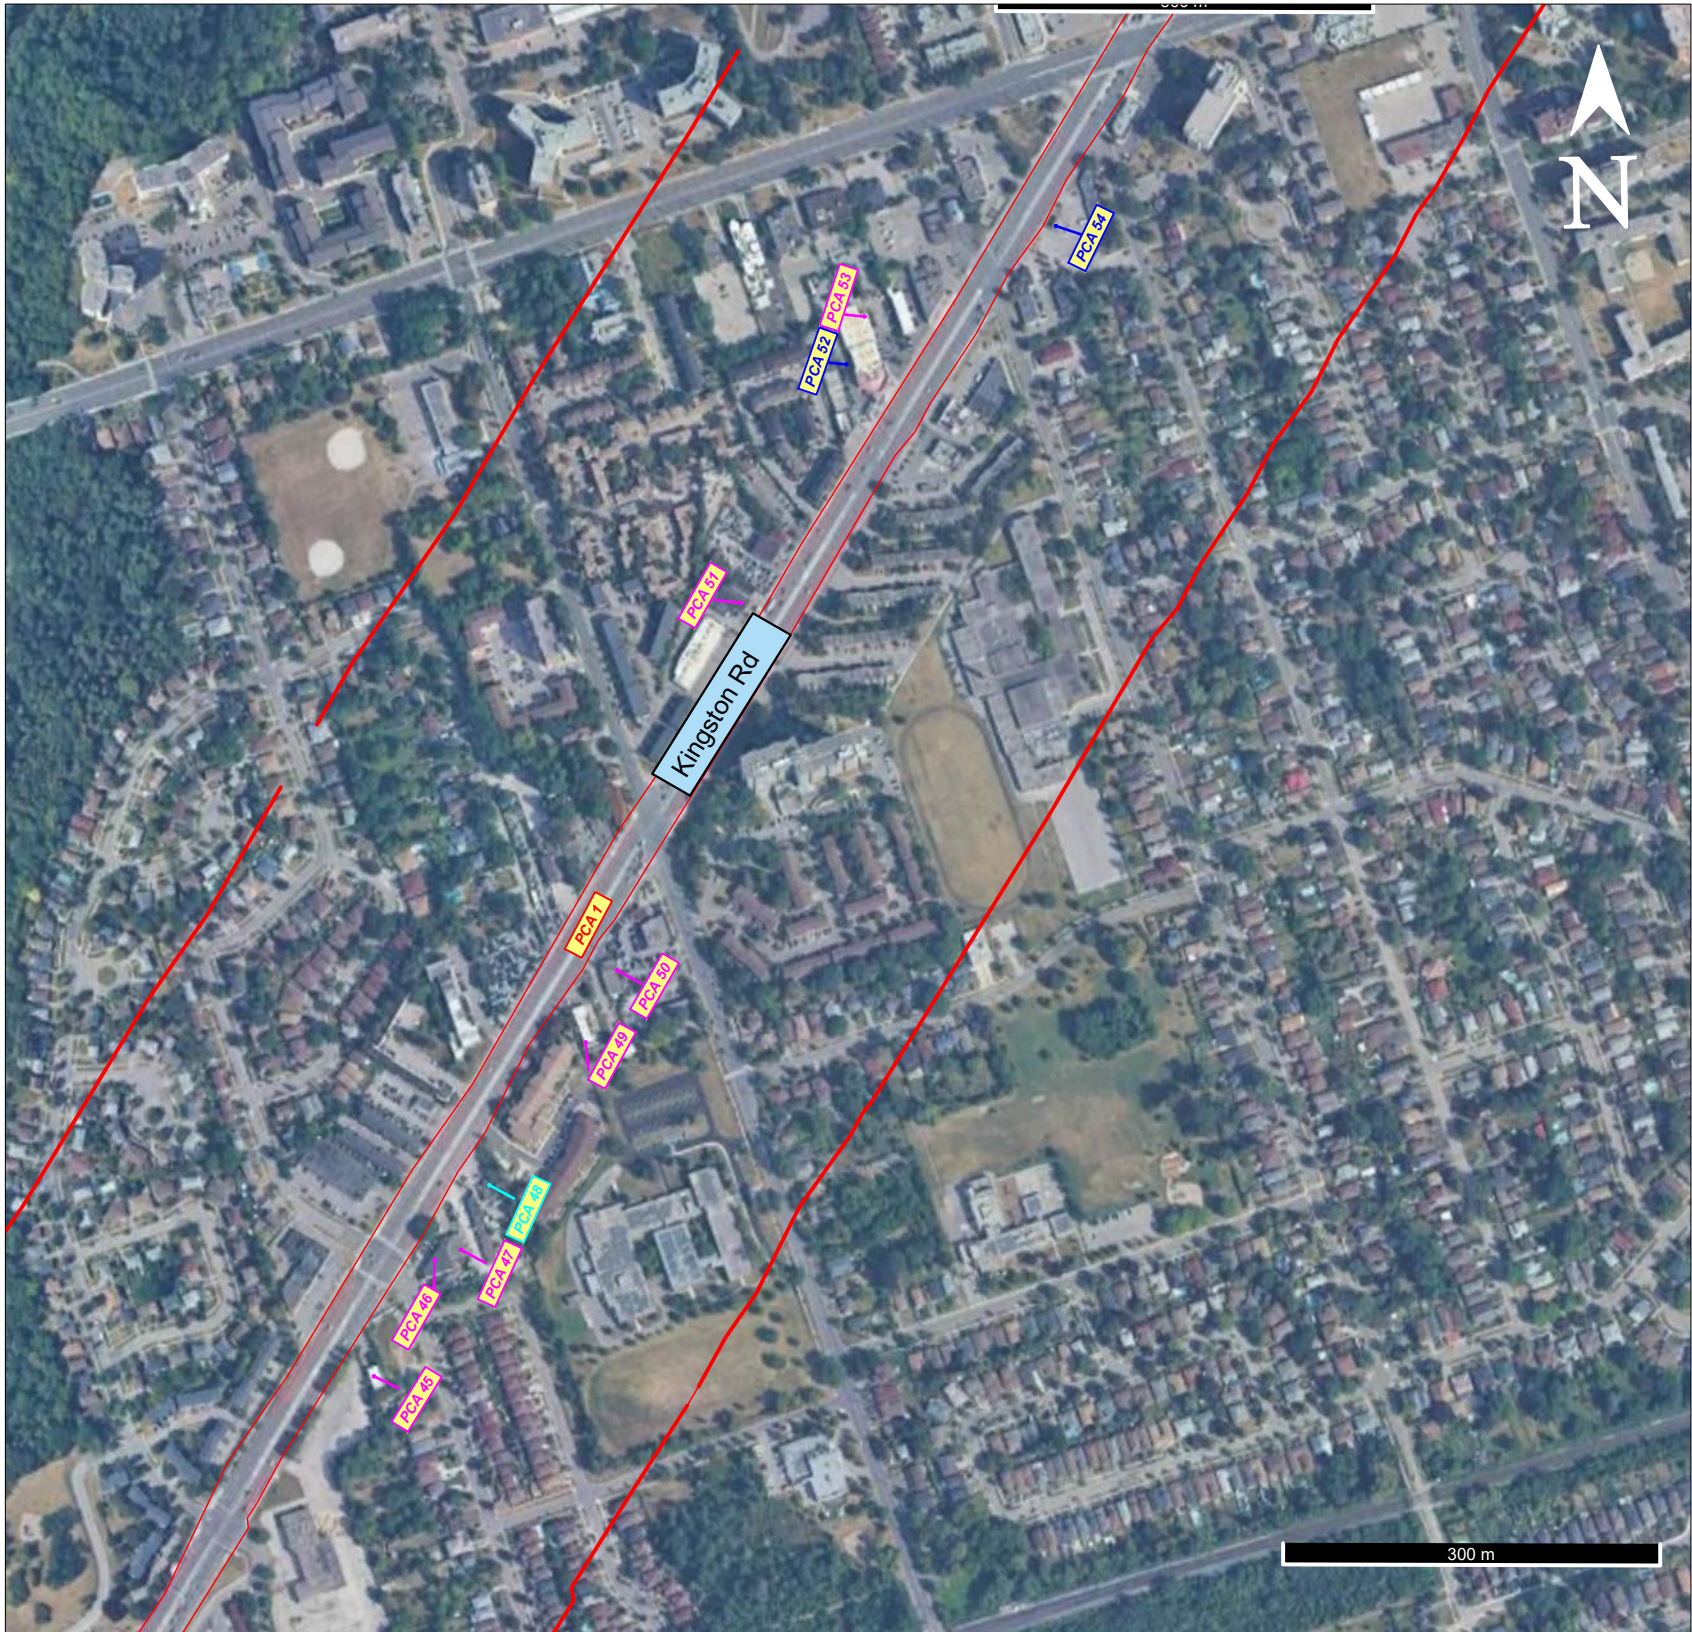
DRAWN	A.S./K.T.	DATE	SCALE	PML REF.	DWG. NO.
CHECKED	S.T	SEPTEMBER 2023	AS SHOWN	23TX013	1 F
APPROVED	M.A.

Potentially Contaminating Activities (PCAs):

POTENTIALLY CONTAMINATING ACTIVITY (PCA)	LOCATION	PCA DESCRIPTION
IN/ON/UNDER THE STUDY AREA		
PCA 1 Item-30: Importation of fill material of unknown quality	The Site	Fill materials associated with historical development/use of the Site
PCA 45 Item -10: Commercial autobody shops	4141 Kingston Rd, approximately 40m East of Kingston Road	An autobody shop noted during the site visit
PCA 46 Item -10: Commercial autobody shops	4185 Kingston Rd, approximately 30m East of Kingston Road	An autobody shop noted during the site visit
PCA 47 Item -10: Commercial autobody shops	4187 Kingston Rd, approximately 50 m Southeast of Kingston Rd	An autobody shop noted during the site visit
PCA 48 Item -8: Chemical Manufacturing, Processing and Bulk Storage	4191 Kingston Rd, approximately 40m Southeast of Kingston Rd	A chemical storage was noted during the site visit
PCA 49 Item -10: Commercial autobody shops	4229 Kingston Rd, approximately 30m East of Kingston Road	An autobody shop noted during the site visit

PCA 50 Item -10: Commercial autobody shops	4233 Kingston Rd, approximately 20m East of Kingston Rd	An autobody shop noted during the site visit
PCA 51 Item -10: Commercial autobody shops	4294 Kingston Rd, approximately 30m West of Kingston Road	An autobody shop noted during the site visit
PCA 52 Item -28: Gasoline and associated products storage in fixed tanks.	4334 Kingston Rd, approximately 60m West of Kingston Road	A gas station noted during the site visit
PCA 53 Item -10: Commercial autobody shops	4334 Kingston Rd, approximately 60m West of Kingston Road	An autobody shop noted during the site visit
PCA 54 Item -28: Gasoline and associated products storage in fixed tanks.	4187 Kingston Rd, approximately 50 m Southeast of Kingston Rd	A gas station noted during the site visit

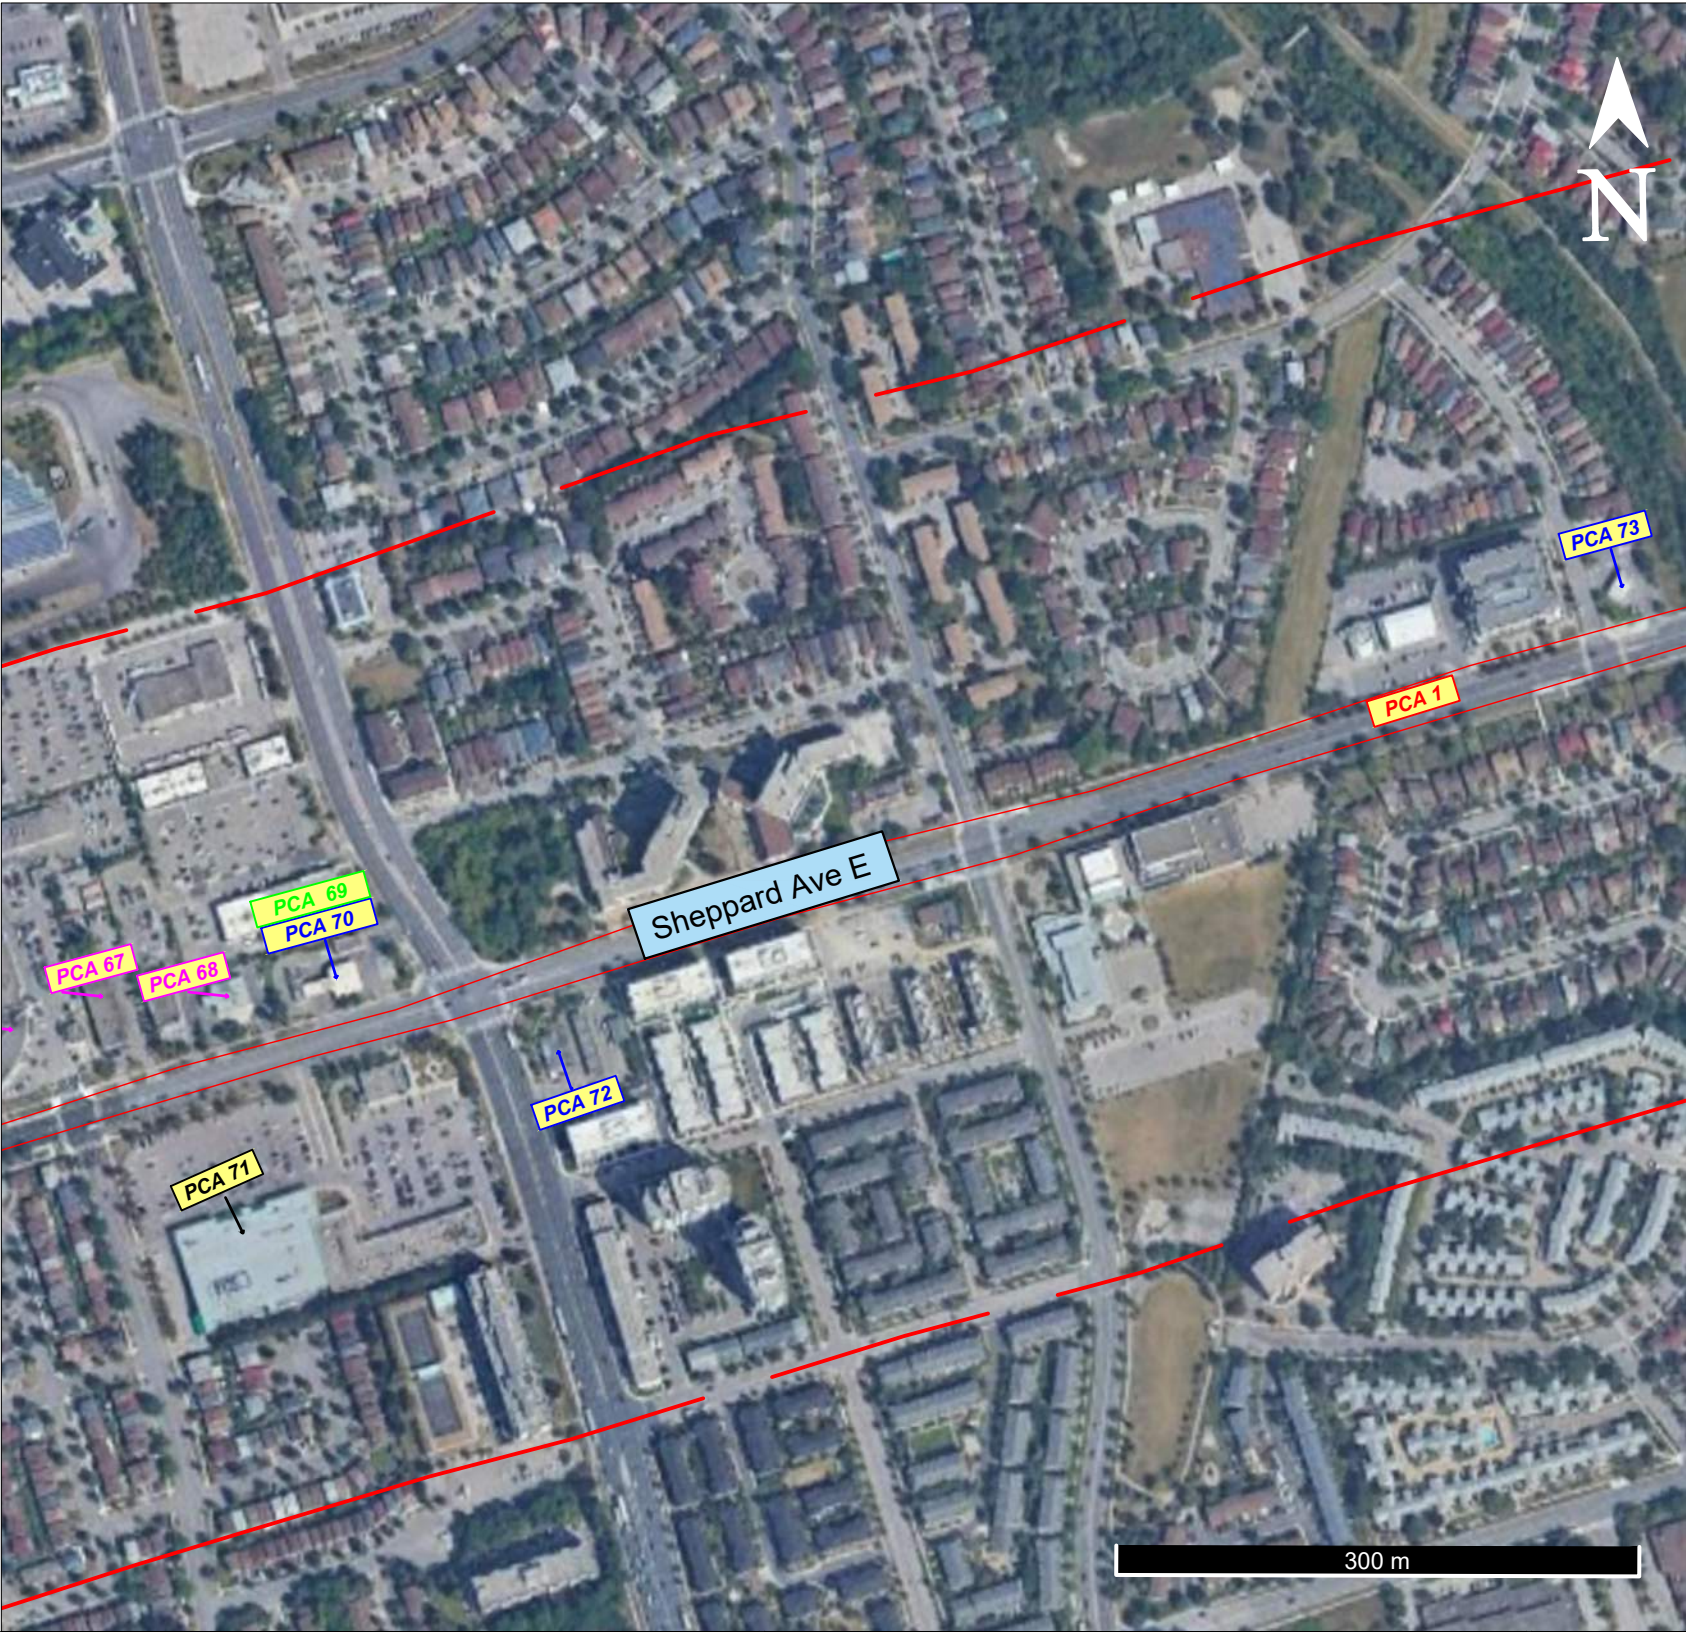
Potentially Contaminating Activities (PCAs):

POTENTIALLY CONTAMINATING ACTIVITY (PCA)	LOCATION	PCA DESCRIPTION
IN/ON/UNDER THE STUDY AREA		
PCA 1 Item-30: Importation of fill material of unknown quality	The Site	Fill materials associated with historical development/use of the Site
PCA 67 Item -10: Commercial autobody shops	5070 Sheppard Ave E, approximately 60m North of Sheppard Ave E	An autobody shop noted during the site visit
PCA 68 Item -10: Commercial autobody shops	5080 Sheppard Ave E, approximately 30m North of Sheppard Ave E	An autobody shop noted during the site visit
PCA 69 Item -50: Soap and Detergent Manufacturing, Processing and Bulk Storage	5110 Sheppard Ave E, approximately 50m North of Sheppard Ave E	A car wash centre noted during site visit
PCA 70 Item -28: Gasoline and associated products storage in fixed tanks.	5110 Sheppard Ave E, approximately 30m North of Sheppard Ave E	A gas station noted during the site visit
PCA 71 Item -37: Operation of Dry-Cleaning Equipment	5089 Sheppard Ave E, approximately 100m south of Sheppard Ave E	A dry cleaning centre noted during the site visit

PCA 72 Item -28: Gasoline and associated products storage in fixed tanks	1641 Markham Road, approximately 50m South of Sheppard Ave E	A gas station noted during the site visit
PCA 73 Item -28: Gasoline and associated products storage in fixed tanks	5818 Sheppard Ave E, approximately 30m North of Sheppard Ave E	A gas station noted during the site visit
