### **Natural Heritage Report**

### EGLINTON EAST LIGHT RAIL TRANSIT TRANSIT PROJECT ASSESSMENT PROCESS

OCTOBER 2023

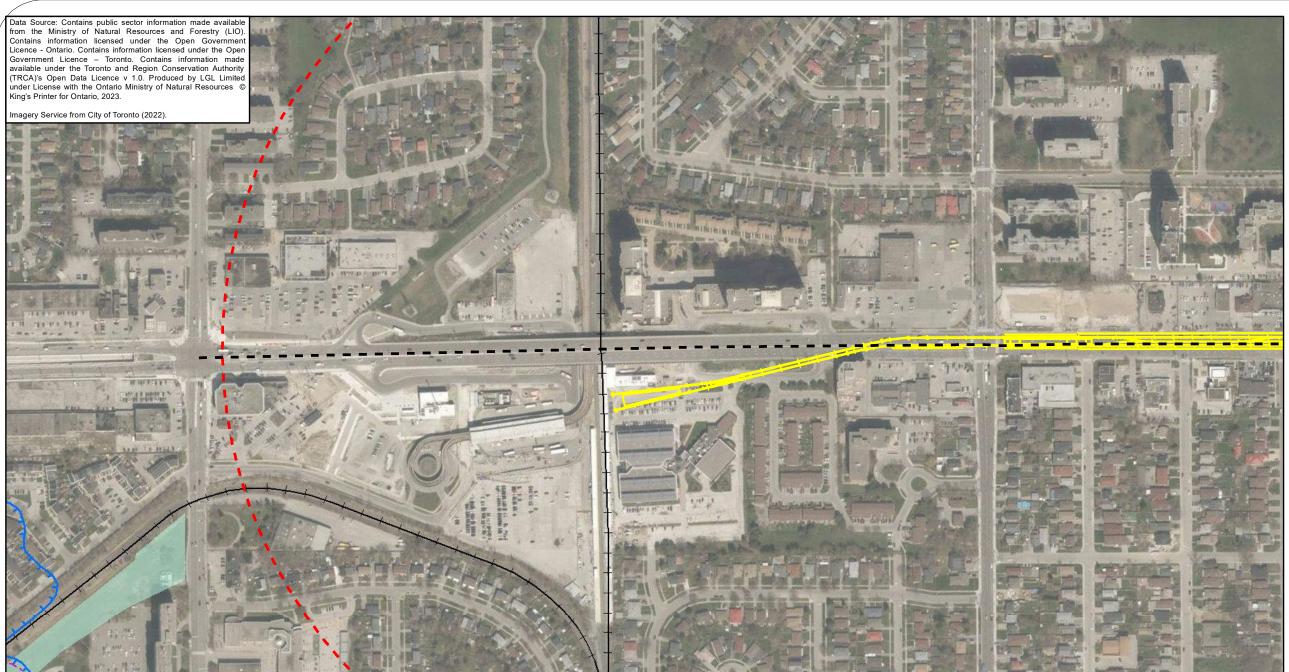
Overall, vegetation communities within the Morningside Park ESA support high quality habitat and a large number of native and specialized plant species. Four of the vegetation communities identified within the Morningside Park ESA lands are considered locally rare by TRCA including Willow Organic Thicket Swamp (SWT3-2), Red Maple-Conifer Organic Mixed Swamp (SWM5-1), White Cedar Organic Conifeorus Swamp (SWC3), and White Cedar-Conifer Mineral Coniferous Swamp (SWC1-2). All of the communities identified within the Morningside Park ESA are delinated in **Figure 3** and described in **Table 2**.
