Construction Update: January 10, 2025

Gardiner Expressway Strategic Rehabilitation: Dufferin Street to Strachan Avenue | Community Update

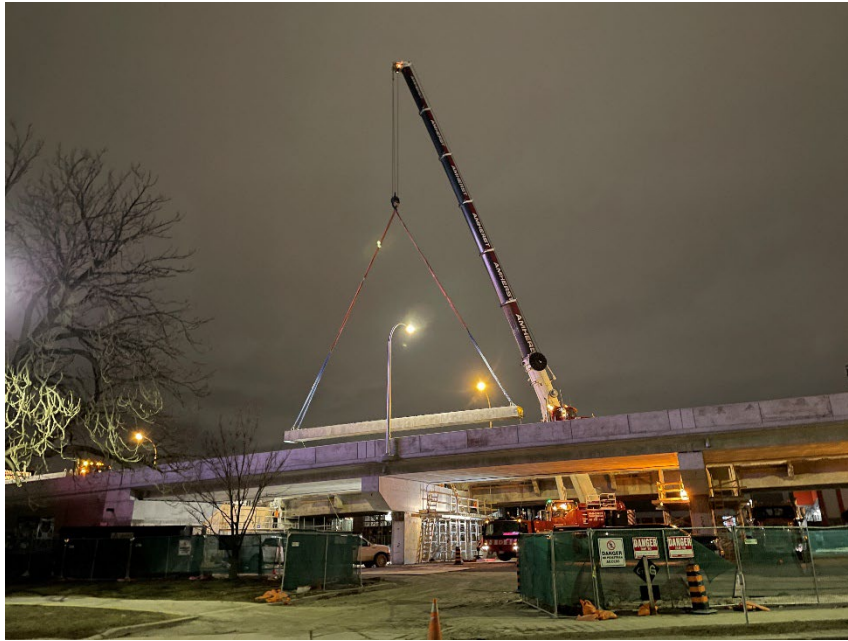
A large crane can be seen lifting one precast concrete girder into place from a temporary lane closure on the expressway.

- Stage 2 girder installation from West Abutment to Bent 5 (approx. 220m to approx. 130m west of GO Station) took place from January 5th to January 9th, 2025, occurring nightly from 11:00 PM to 4:59 AM.

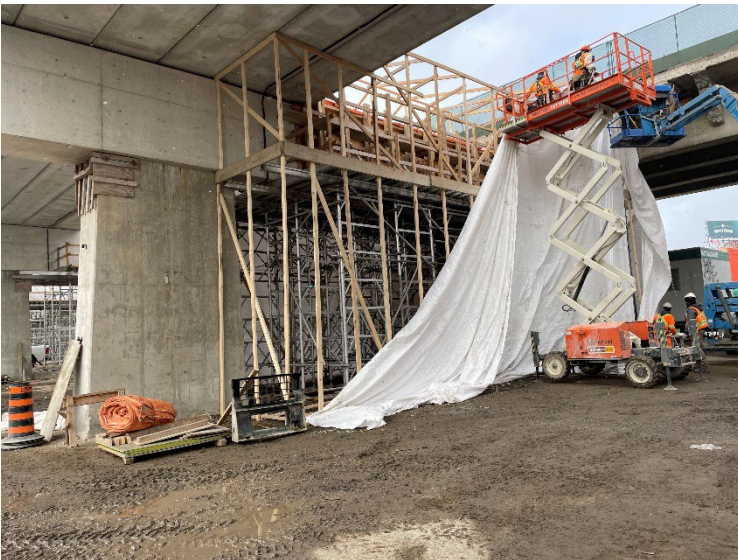
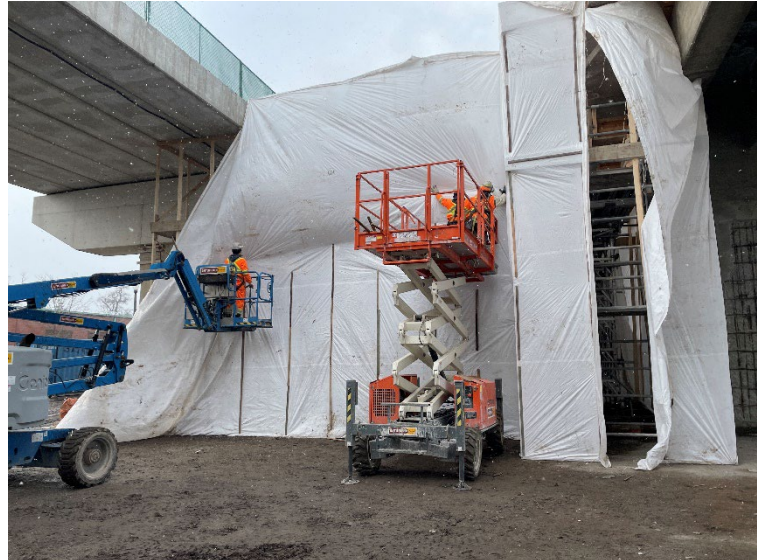
The two images above depict crews setting up the tent enclosure to protect the concrete during cold weather conditions, while the concrete cures. Scaffolding (support system for formwork) for bent cap reconstruction is ongoing.

- Stage 2 concrete placement for bent caps from Bent 6 to Bent 11 (approx. 110m to approx. 20m west of GO station) started on January 6th, 2025.
- Stage 2 scaffolding installation for bent cap construction ongoing at Bent 26 and Bent 27 (approx. 265m to approx. 285m east of GO Station).
- Stage 2 reinforcement and formwork installation for Bent Caps ongoing from Bent 17 to 19 (approx. 100m to approx. 135m east of GO Station).
- Stage 2 partial depth concrete removals for top of bent caps ongoing at Bent 31 to Bent 35 (hand chipping during the day).

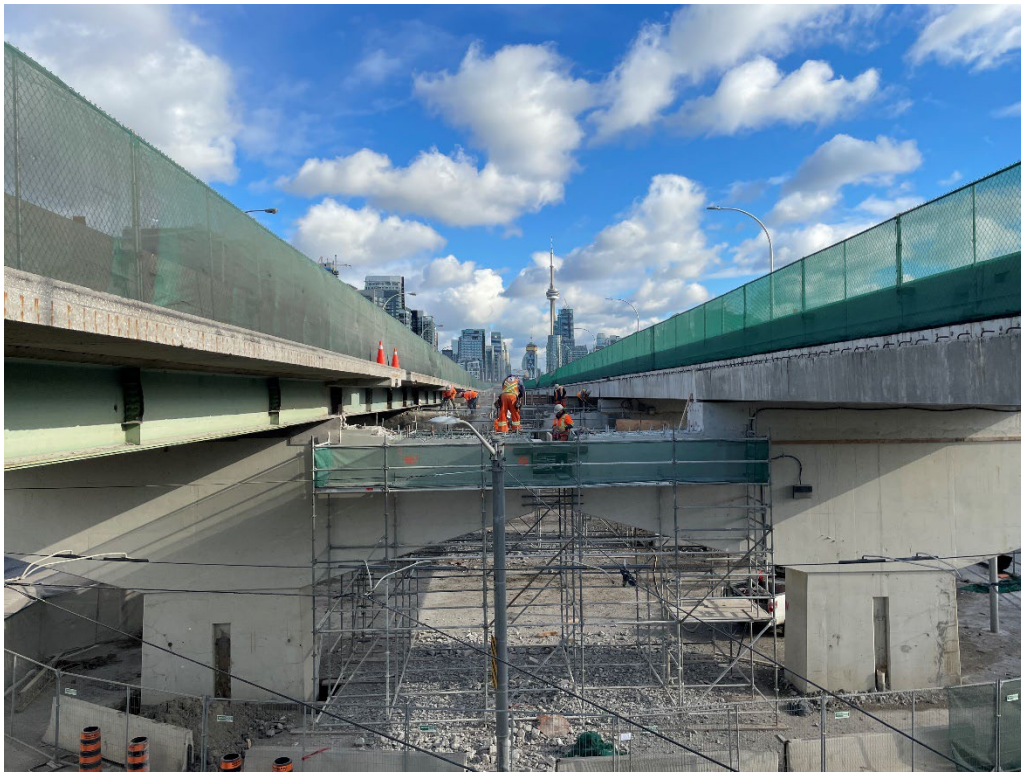
Partial depth removal of Bent caps from Bent 31 to Bent 35 with the use of a hand held chipping tool at the top of the bents.
