CITY OF TORONTO

Functional Design Report

Milne Bridge (No. 813) on Old Finch Avenue
Rouge Park Bridges Transportation Master Plan

February 2025 - 19-1924

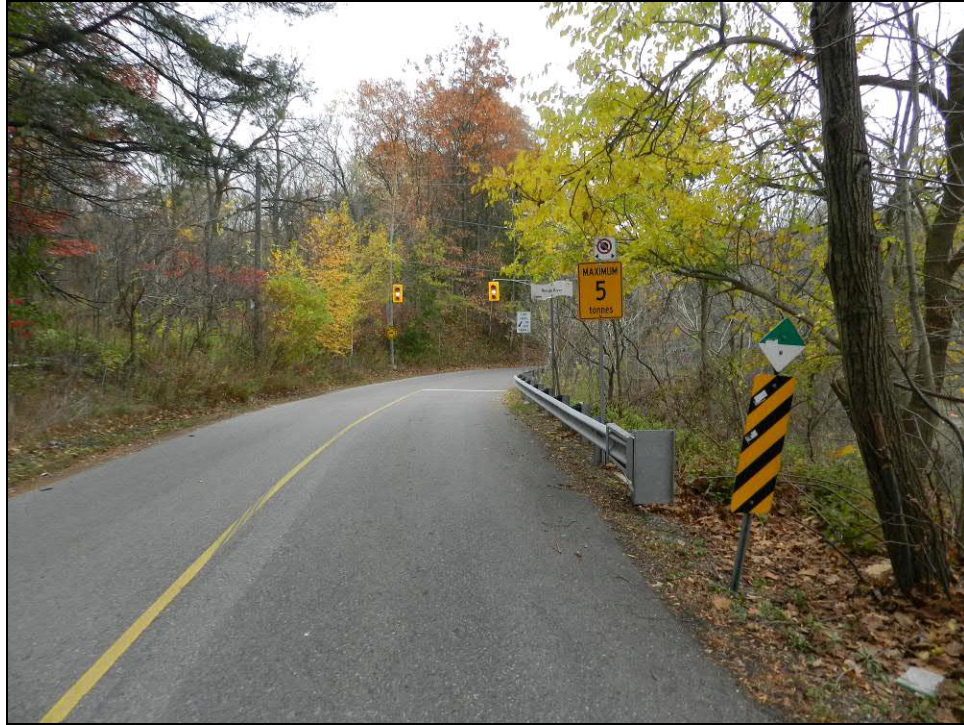
Southbound Approach to Traffic Signals

The roadway approaches have tight curves and the bridge width (approximately 3.6 m wide) allows only one lane of traffic on the bridge at a time. Traffic at the far end of the bridge cannot be seen by approaching traffic, which necessitates the use of traffic signals at both ends of the bridge. See **Appendix A** for the General Arrangement drawing of the bridge. At the bridge, the tight horizontal curves, combined with a bump transition at the north end of the bridge tends to slow the operating speed of traffic substantially with several southbound vehicles observed to slow or stop before driving onto the bridge deck. The bridge has no skew angle and no crown on the deck.

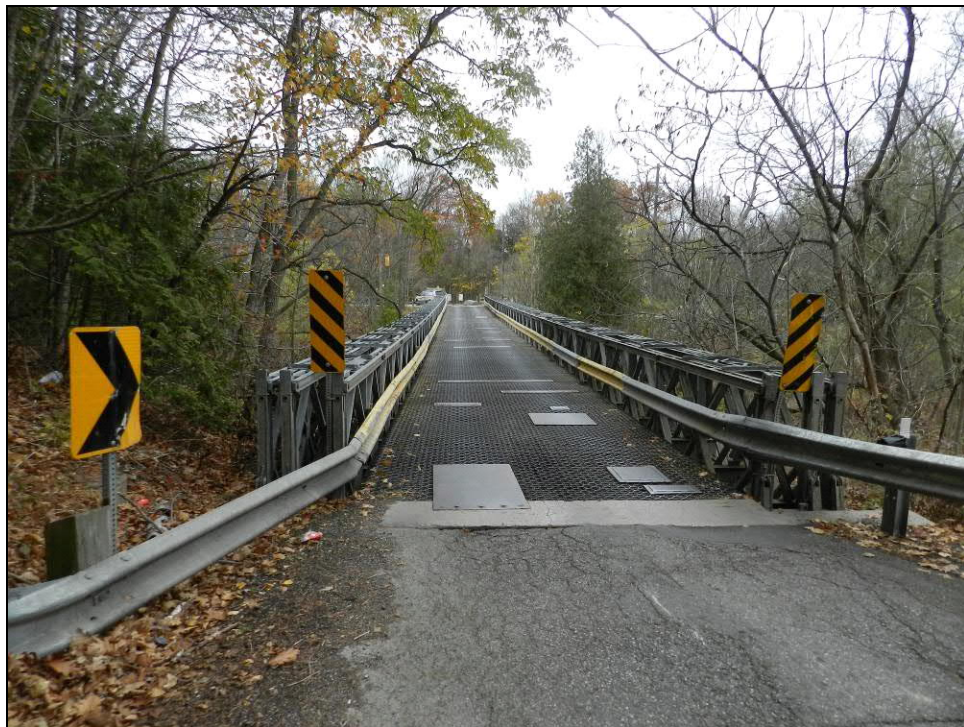
View Looking South (Note Plate Repairs to Deck)

The deck grating has been damaged numerous times and repaired with flat plate. The deck panels are loose, causing significant noise under traffic, with abrasion observed and loose bolted connections. The deck appears to be at or near the end of its useful service life.

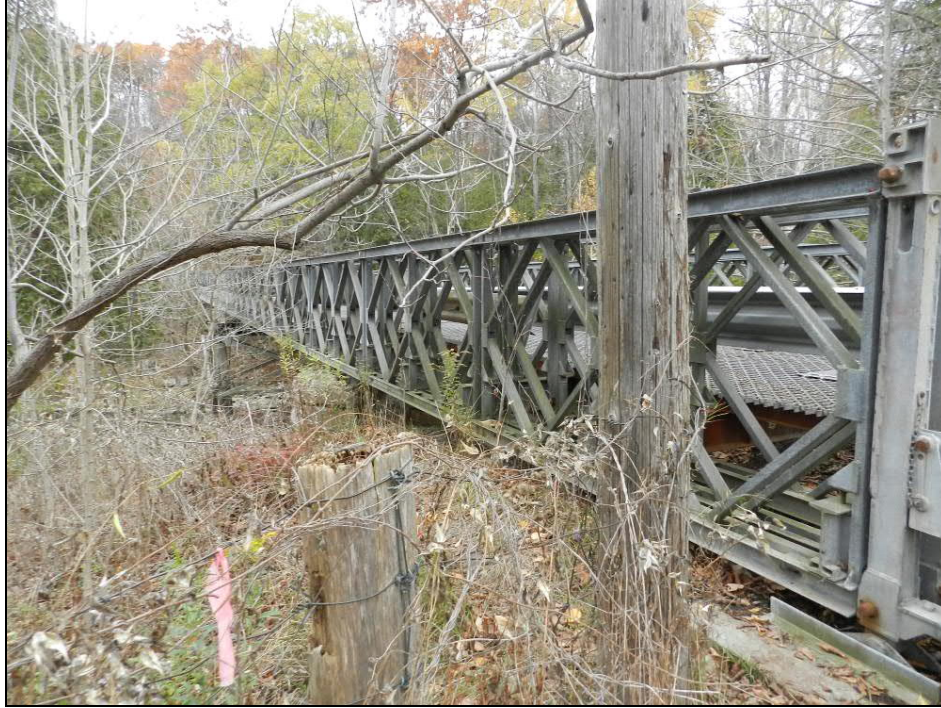
West Side of Bridge
