CITY OF TORONTO

# Functional Design Report

Hillside Bridge (No. 806) on Meadowvale Road  
Rouge Park Bridges Transportation Master Plan

February 2025 - 19-1924

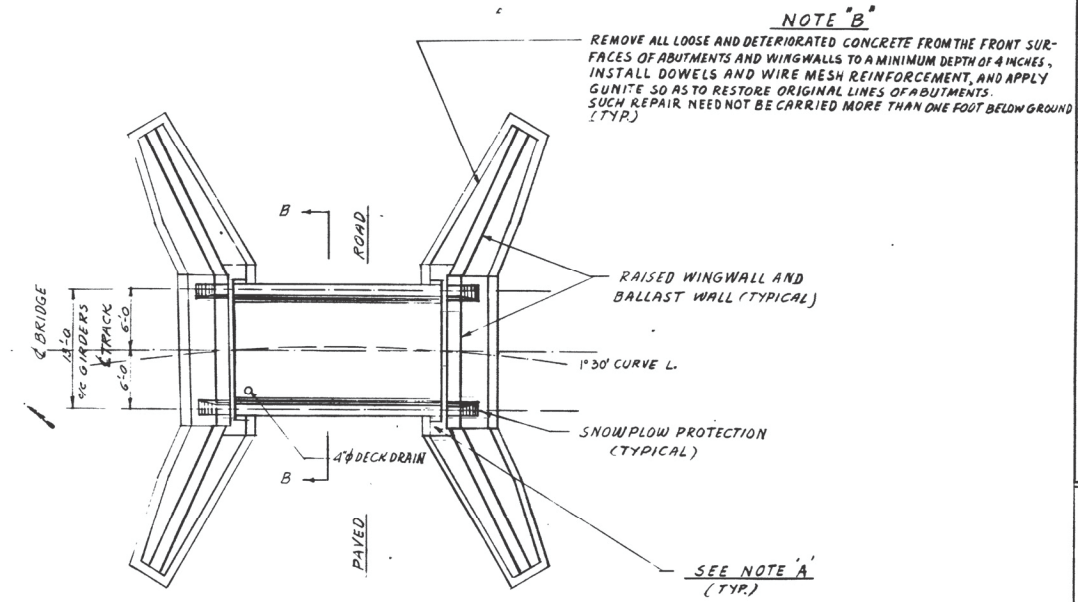
PLAN

NOTE "B"  
REMOVE ALL LOOSE AND DETERIORATED CONCRETE FROM THE FRONT SURFACES OF ABUTMENTS AND WINGWALLS TO A MINIMUM DEPTH OF 4 INCHES, INSTALL DOWELS AND WIRE MESH REINFORCEMENT, AND APPLY GUNITE SO AS TO RESTORE ORIGINAL LINES OF ABUTMENTS. SUCH REPAIR NEED NOT BE CARRIED MORE THAN ONE FOOT BELOW GROUND (TYP.)

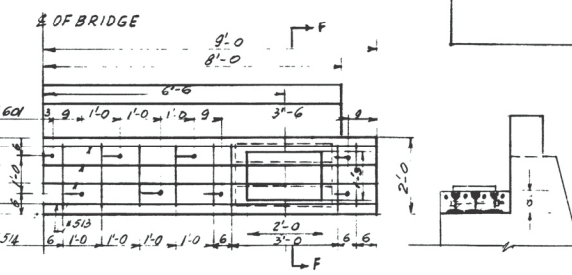
HALF PLAN OF BRIDGE SEAT  
(SEE NOTE "A" SECTION C-C)  
SCALE 1/2"=1'-0"

NOTE "A"  
REMOVE 6 INCH THICK CONCRETE ENCASUREMENT AROUND RAIL GRILLAGES, INSTALL DOWELS AND REINFORCING, AND POUR NEW ENCASUREMENT

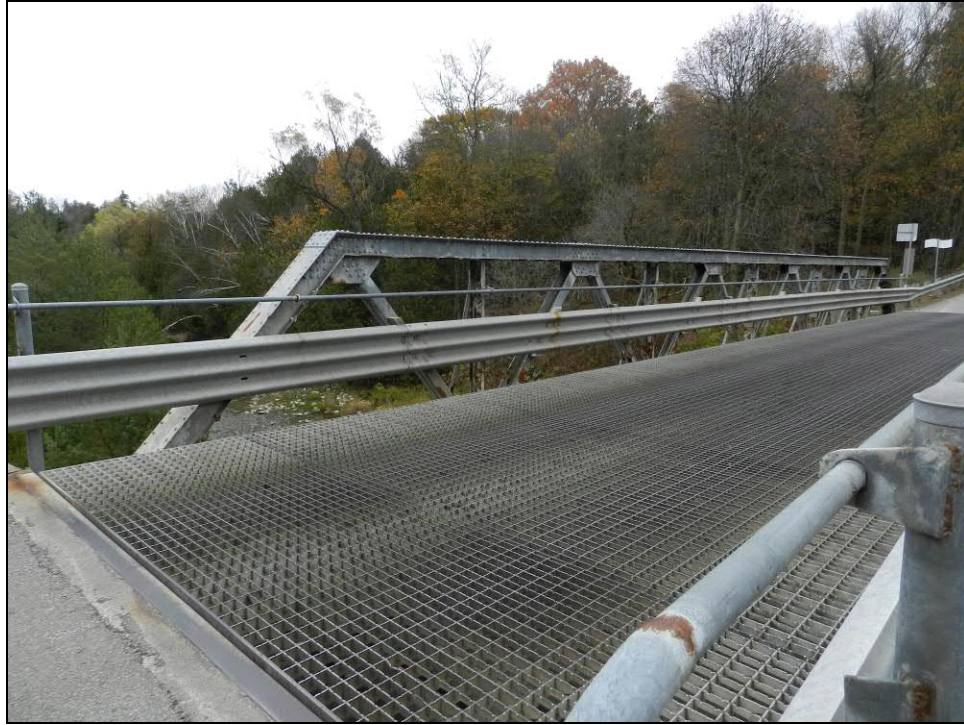
Bridge Deck, Guide Rail and Railing

The existing galvanized steel open grate decking and stringers were installed during the 1986 rehabilitation and the decking may be nearing the end of its expected service life. The fatigue analysis report completed in 2017 indicated that there was potential for some truss members to develop fatigue cracking under full CL3-625-ONT loading. A regular monitoring and maintenance program would be required for the remainder of the service life to address ongoing deterioration at critical locations and inspect the structure for fatigue cracking.

The ability to upgrade the traffic barrier on the bridge is limited by the lack of supporting steel framing. The current steel guide rail that is mounted on the trusses offers negligible protection to the structure from a vehicle collision. A direct collision could damage the truss to an irreparable state and may cause collapse and injury or loss of life. This condition has existed for the entire service life of the bridge, so it represents a case of ongoing risk acceptance in the rehabilitation.
