Functional Design Report

Sewell's Road Bridge (No. 812) on Sewell's Road Rouge Park Bridges Transportation Master Plan

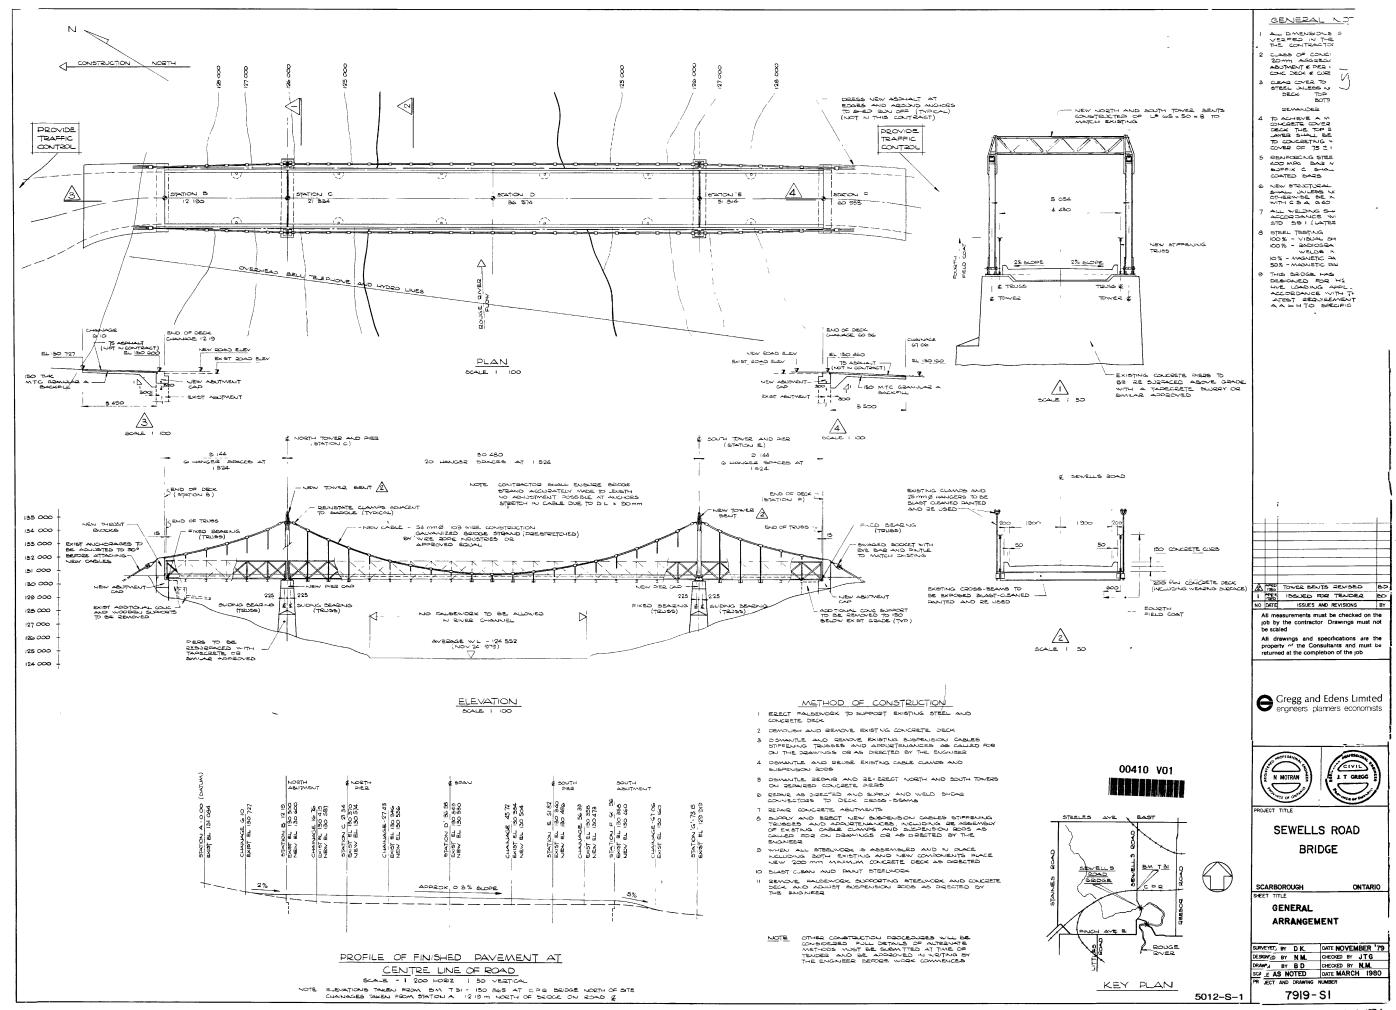
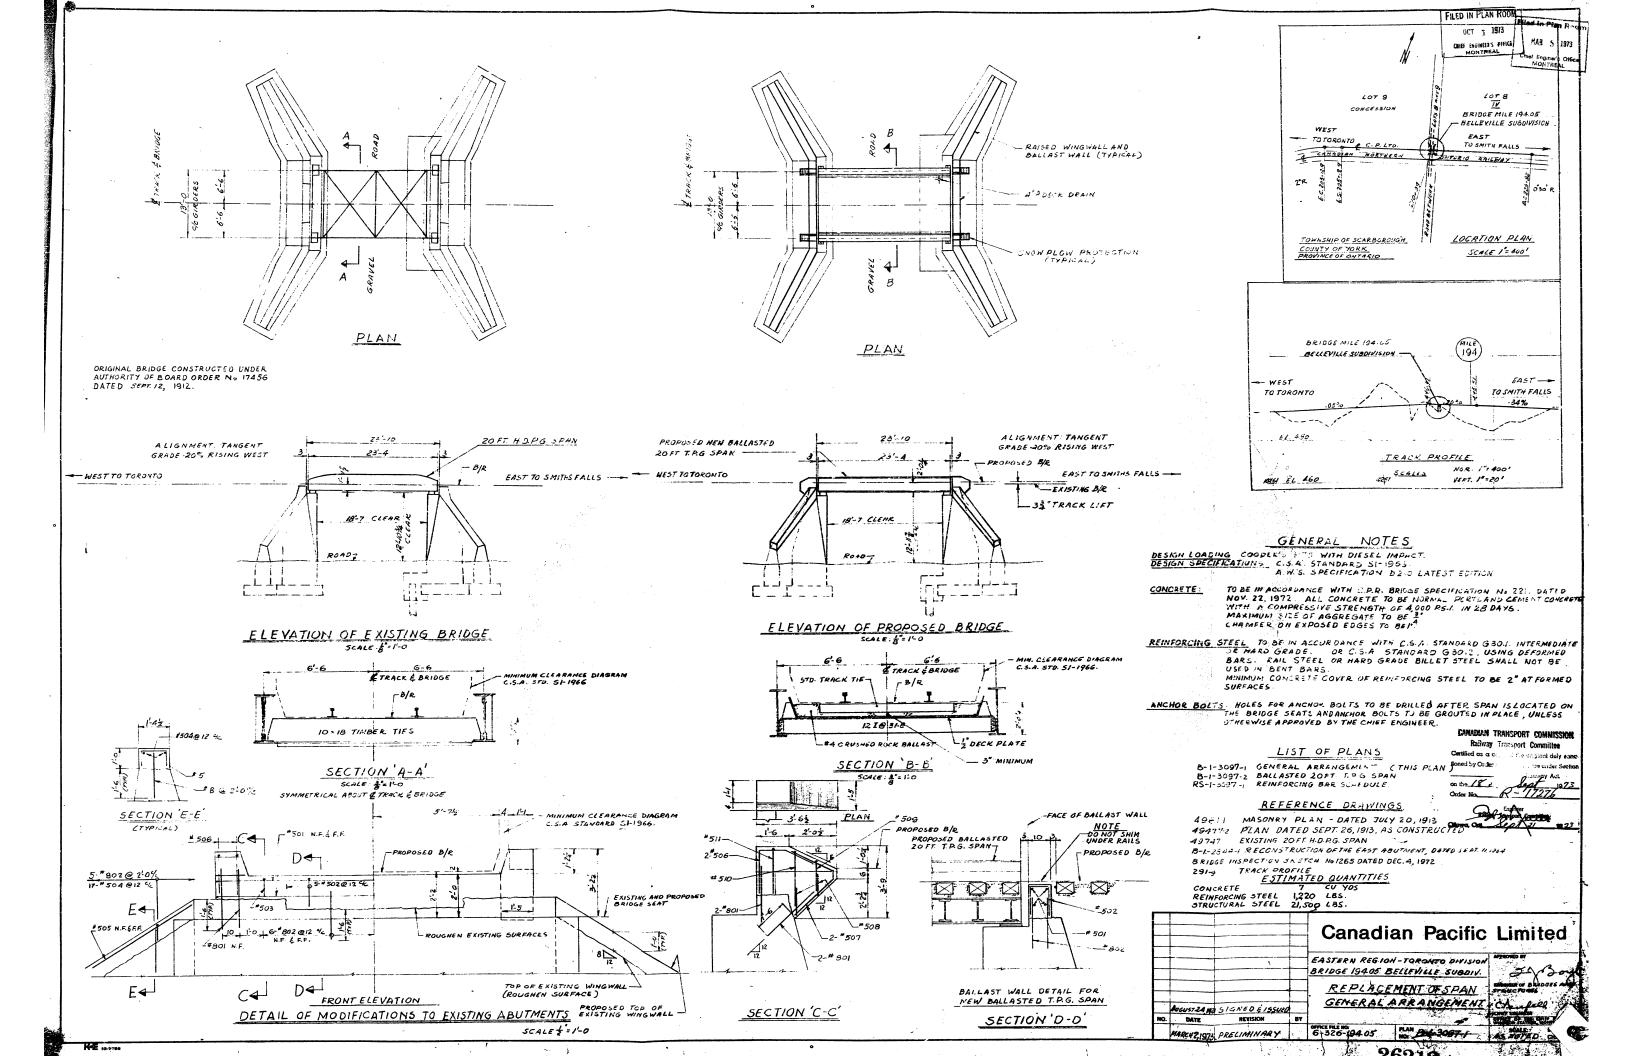
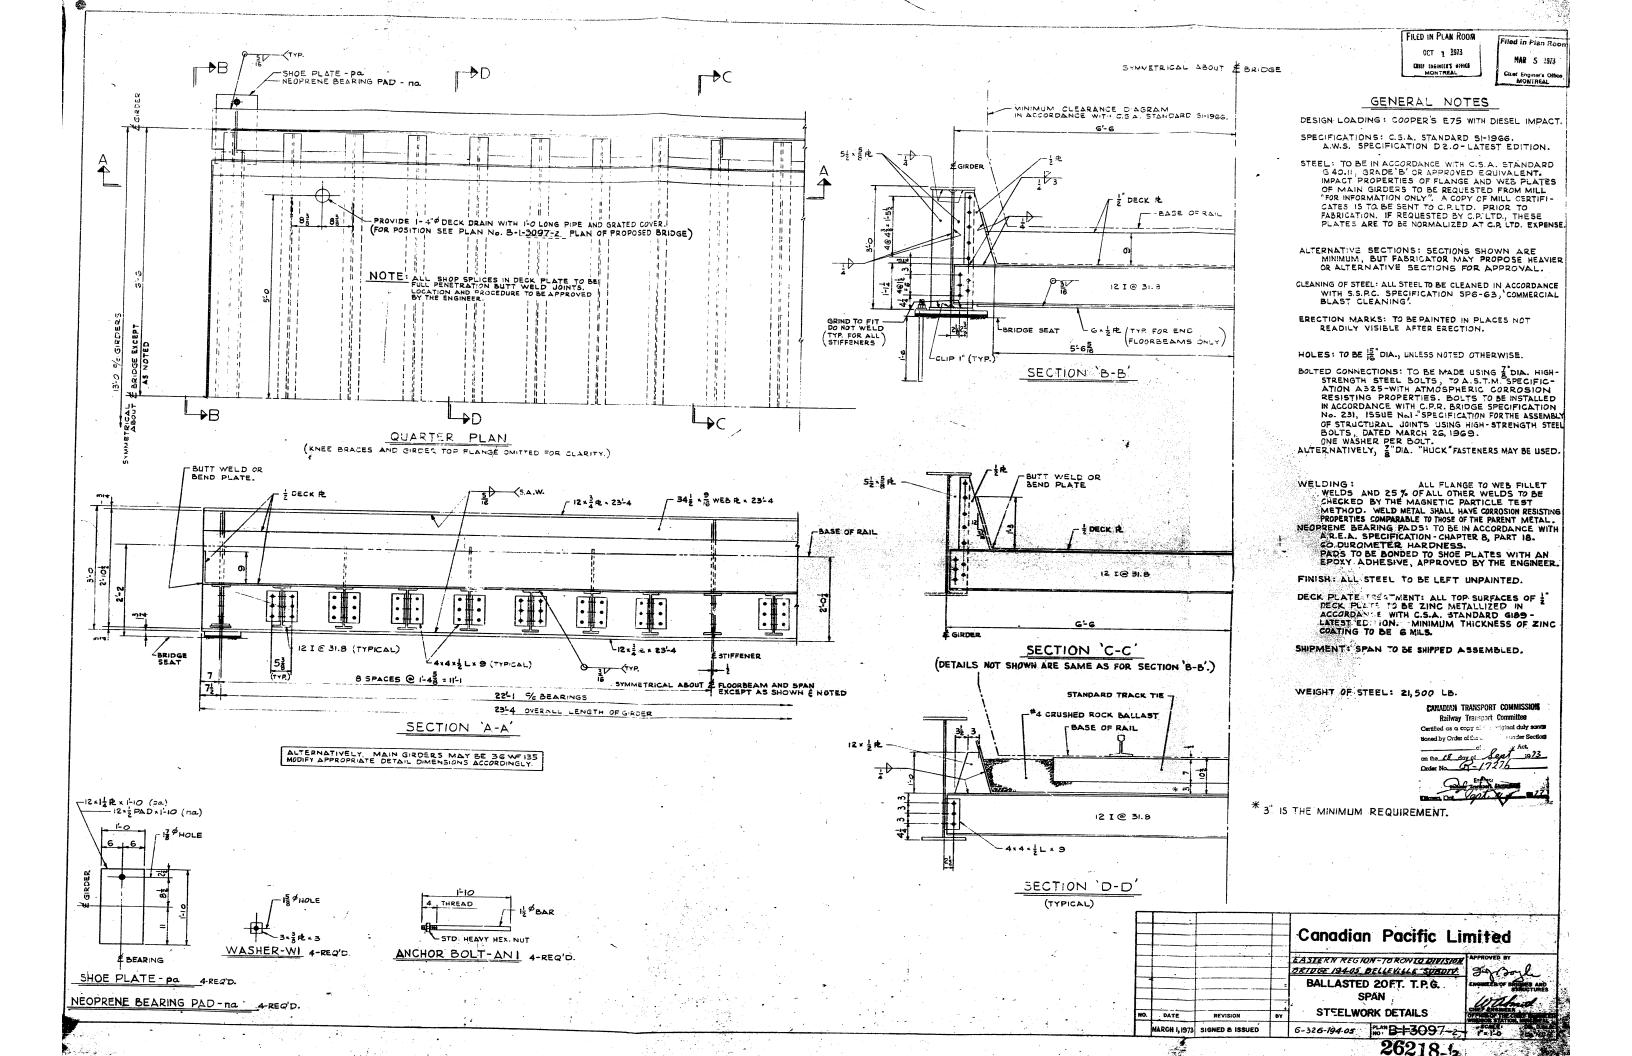
Drawings of Existing Bridges

The substructure is comprised of conventional closed concrete U-shaped abutments founded on spread footings.

There are two concrete piers supporting the steel towers. The foundation type is not known.

- Drawings 5012-S-1 to 5012-S-5, "Sewell's Road Bridge [Rehabilitation]", Gregg and Edens Limited, 1980.
- Drawing 5012-S-6, "Repairs to Sewell's Road Bridge", Gregg and Edens Limited, 1987.
- Drawing 812-S5012-7 and 812-S5012-8, "812 Sewell's Road Over Rouge River, Bridge Repairs",
- CP Rail File No. 26218-1, "CP Rail Subway over Sewell's Road, Belleville Subdivision, Mileage 194.05", 1973.

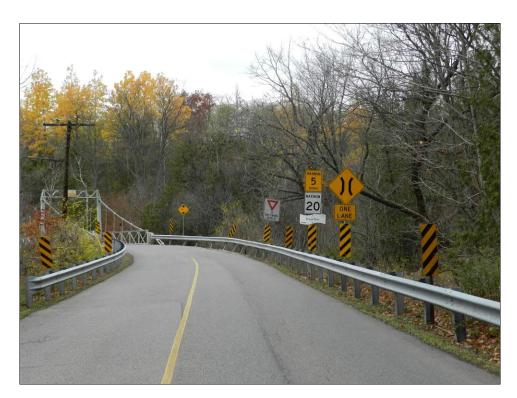
South Approach

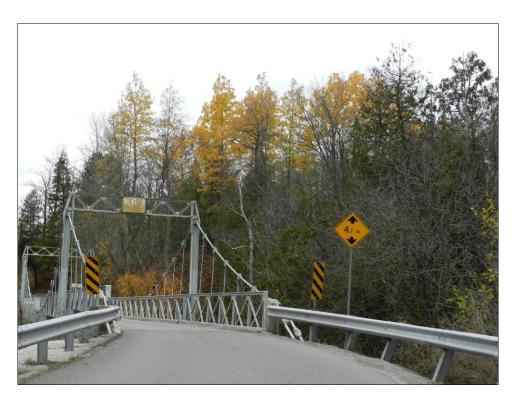
South Approach at Bridge

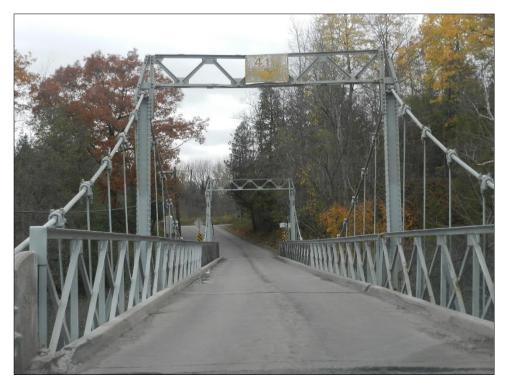
Bridge Deck, Looking North

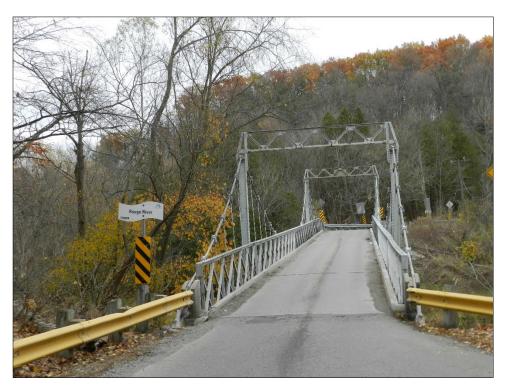
Bridge Deck Looking South

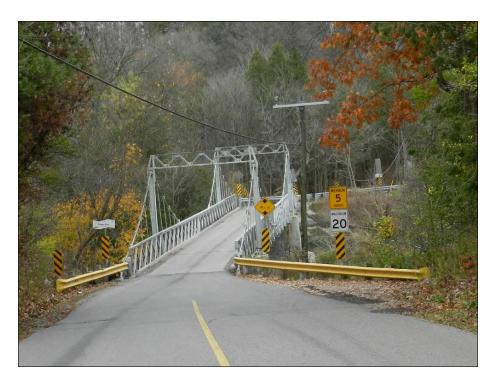
North Approach

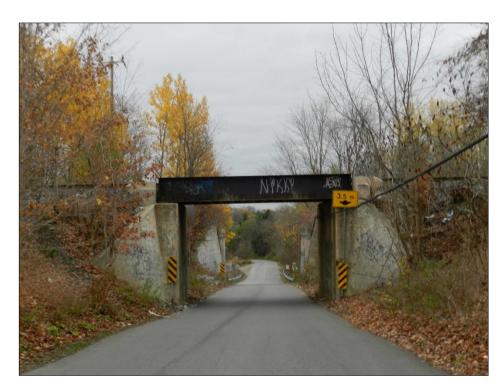
CP Rail Bridge over Sewell's Road, Looking South

The CP Rail crossing over Sewell's Road will continue to present a vertical clearance constraint on truck access, including fire trucks. As an interim solution, until the CP structure is replaced (under a separate study), it is proposed that the roadway be lowered over an approximate length of 30 to 40 m at each approach using retaining walls to increase the clearance. This would require further investigation. The use of foundation insulation is anticipated, to provide frost protection. Based on the existing clearance of 3.5 m, a lowering of the road by 0.6 m to 0.7 m may be sufficient to allow fire trucks and most other vehicles to pass under the CP Rail bridge.

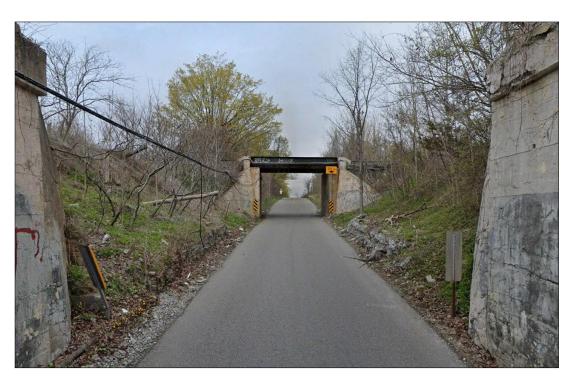
CP Rail Bridge over Sewell's Road, Looking North (note abandoned bridge abutments in foreground)

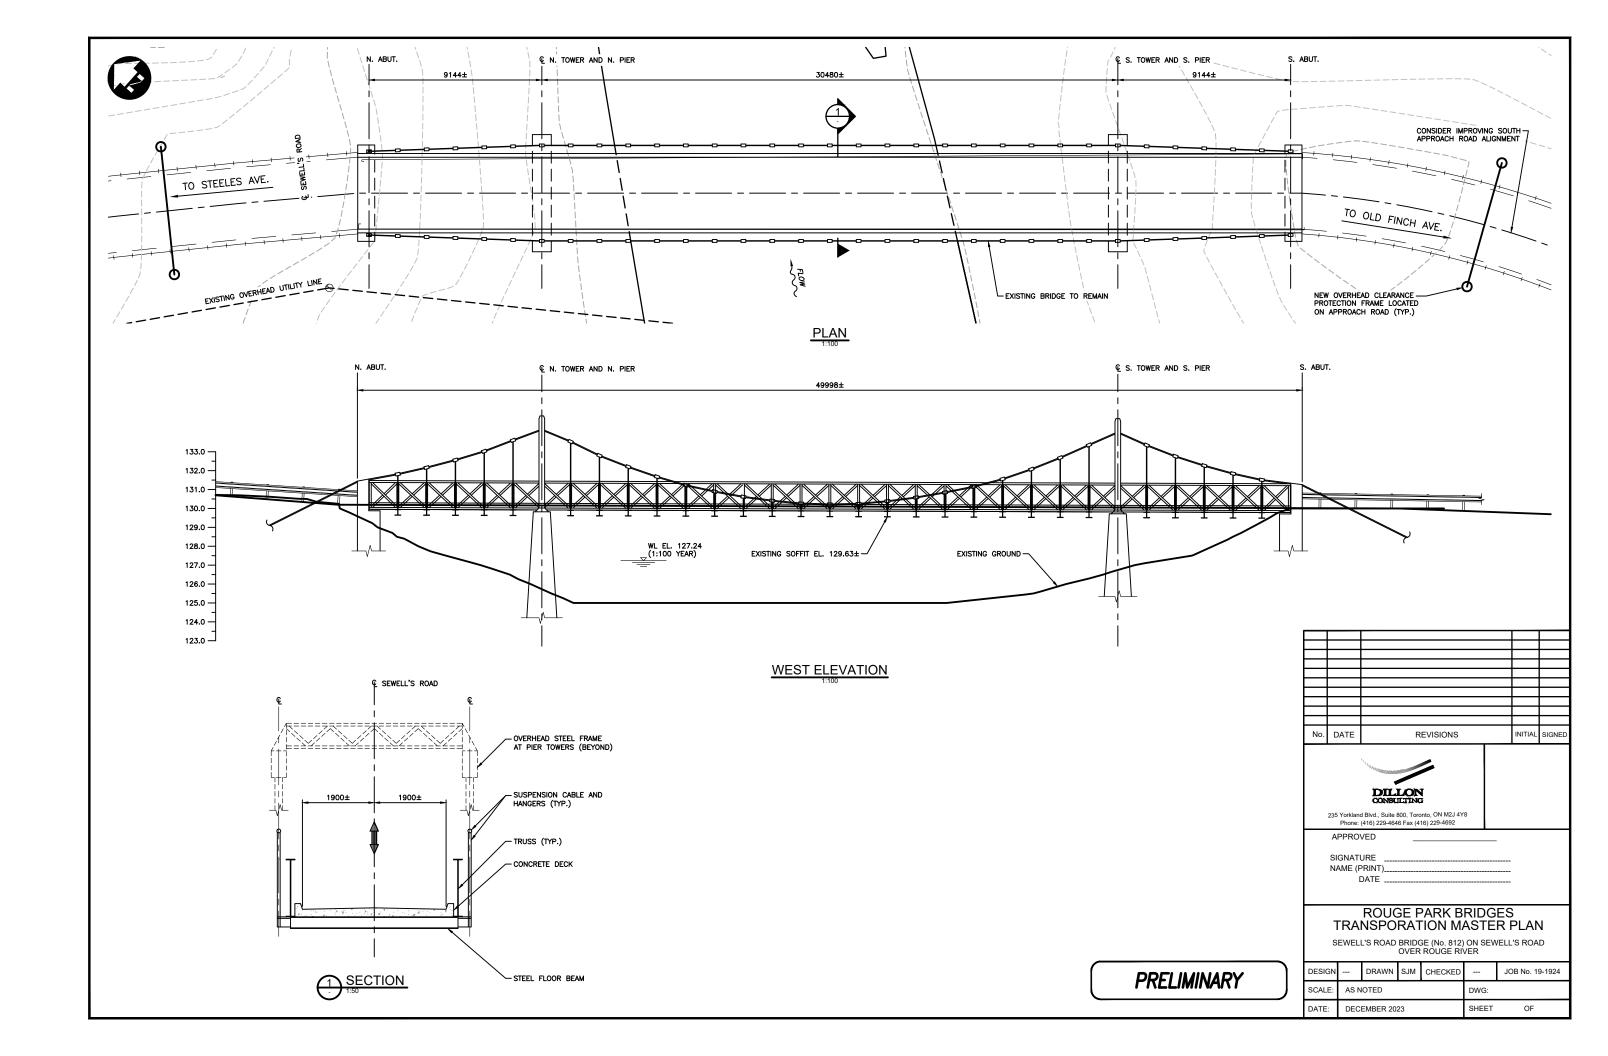
General Arrangement Drawing for the Recommended Alternative

A preliminary general arrangement drawing of the recommended alternative is provided in Appendix C, and a cost estimate is provided in Appendix D.

Specific locations requiring steel repair will be confirmed during future design phases of this project, but are expected to focus on the connections to mitigate pack rust and the effects of 'rust jacking'. Section loss is reported at one hanger connection point, which will be addressed.

The structure was recoated in 2013 and the 2021 Bridge Inspection Form lists the entire coated area as being in excellent condition. However, localized coating failures should be expected and repaired with localized blasting and recoating.

Steel beam guide rail sections can be installed on the existing stiffening trusses to reduce localized impact damage to the truss members. Installation of a proper crash-tested barrier system does not appear to be feasible within the limited roadway width.

The 2021 Bridge Inspection Form lists abrasion at the deck ends, a delamination on the deck soffit, and medium to severe scaling and a spall at the North pier. These locations and any additional areas of medium to severe concrete deterioration will be addressed with partial-depth concrete removals and new patch repairs.
