# **BLOOR STREET WEST**

## **ARMADALE AVENUE AND OLD MILL DRIVE**

### **Accessibility-Focused Site Visits**

June 2024

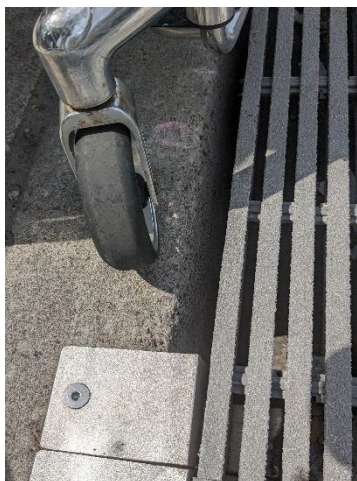
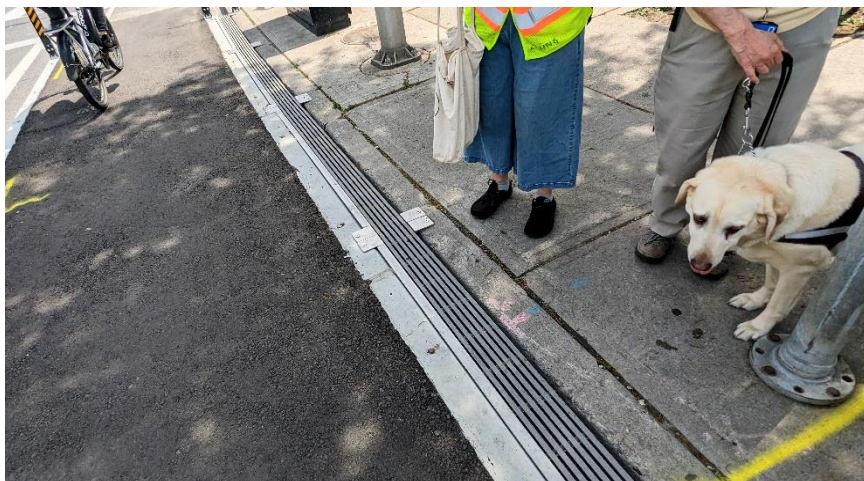
BLOOR STREET WEST, WEST OF JANE STREET

- **Design and Functionality:**
  - The grate cover received mixed feedback.
    - Positive aspects included its general functionality, but there were concerns about wheels getting caught, especially for manual wheelchair users.

- Ensuring the grate is flush with the surrounding surface is crucial and will be extended to close the gap at the sidewalk edge.
  - Participants expressed the need for more prominent and clear signage to guide people cycling and pedestrians at platforms and intersections.

- **Detectability for Cane Users:**
  - Concerns were raised about the detectability of the grate cover for cane users.
  - Ensuring that the grate is easily detectable and does not pose a tripping hazard is crucial for safe navigation.

- Suggestions for tactile or auditory indicators to help blind and low sight individuals detect the platform.
  - The importance of distinct tactile patterns and sounds to indicate platform presence and transitions between different surfaces.

- Some participants found the metal surfaces more detectable and preferable over plastic due to distinct sounds and vibrations.

- Suggestions for wayfinding aids, such as larger signs and tactile maps, to assist blind and low sighted individuals.
  - Suggestions included installing poles with audible signals or tactile guidelines to provide a clear indication of safe standing areas on platforms to avoid collisions with people cycling.

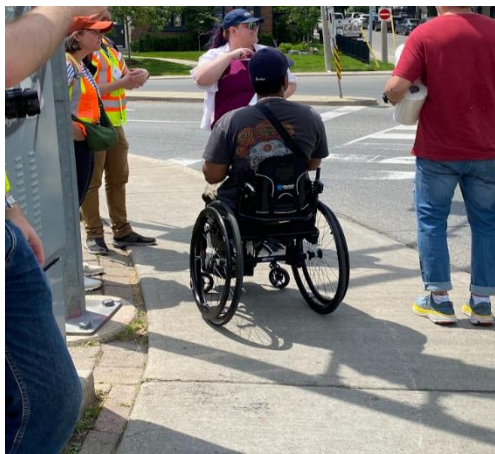
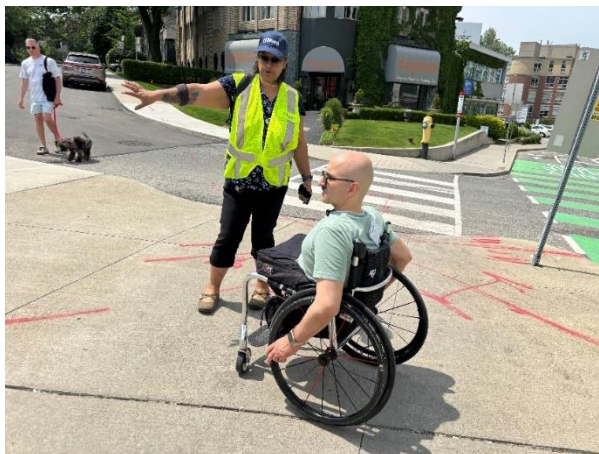
BLOOR STREET WEST AND MOSSOM ROAD

- **Tactile Indicators:**
  - Tactile indicators at this intersection are vital for guiding blind and low-sighted pedestrians through its complex design.

- However, the current placement and consistency of these indicators are often inadequate, making navigation more difficult.
  - Temporary ramps and tactile surfaces, when present, are frequently insufficient or entirely missing, posing additional challenges for individuals who are blind, have sight loss, or use wheelchairs.

- **Design Issues:**
  - At this specific intersection, the refuge islands and curb cuts present barriers that obstruct access, making it challenging for wheelchair users to navigate safely.

- To address this, extending the centre islands and ensuring they do not block curb cuts would be helpful.
  - Additionally, there was a noticeable issue with distinguishing when pedestrians are on the island versus when they have fully crossed the street, underscoring the need for clearer tactile and auditory cues at this location.

- **Accessibility Features:**
  - Ensuring that pedestrian islands are equipped with tactile walking surfaces and APS can significantly improve navigation and safety for blind and low sighted individuals.

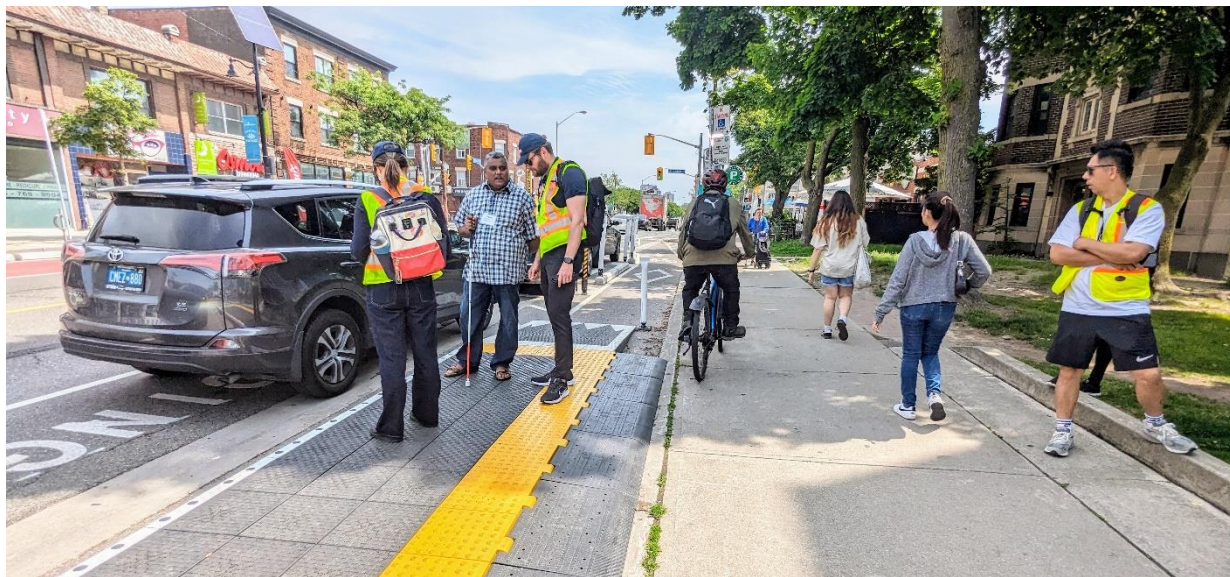
BLOOR STREET WEST, WEST OF ARMADALE AVENUE

- **Platform Design:**
  - The modular platform received positive feedback for its accessible design, but concerns were raised about potential conflicts with people cycling.

- Participants emphasized the need for better tactile and auditory indicators to help blind and low sighted users detect these platforms.
- **Safety and Usability:**

- **Winter Conditions:**
  - The modular platforms are generally better in winter compared to the metal gap plate cover, but ensuring they are kept clear of snow and ice is crucial for maintaining accessibility.

- **Material and Durability:**
  - The modular ZICLA platform was appreciated for better traction and durability compared to the metal grates, which could become slippery under certain conditions.

- While the platform design is generally good, ensuring that people cycling yield to pedestrians and improving signage and enforcement are necessary to prevent conflicts and enhance safety.
