CITY OF TORONTO

Functional Design Report (Draft)

Stotts Bridge (No. 803) on Twyn Rivers Drive
Rouge Park Bridges Transportation Master Plan

February 2025 - 19-1924

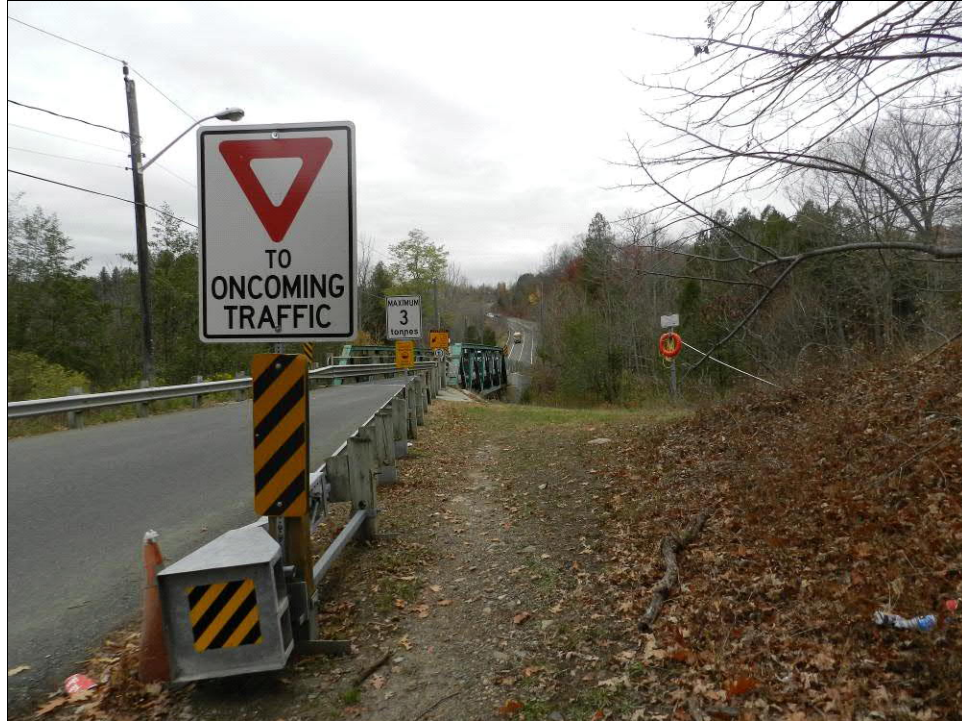
East Approach

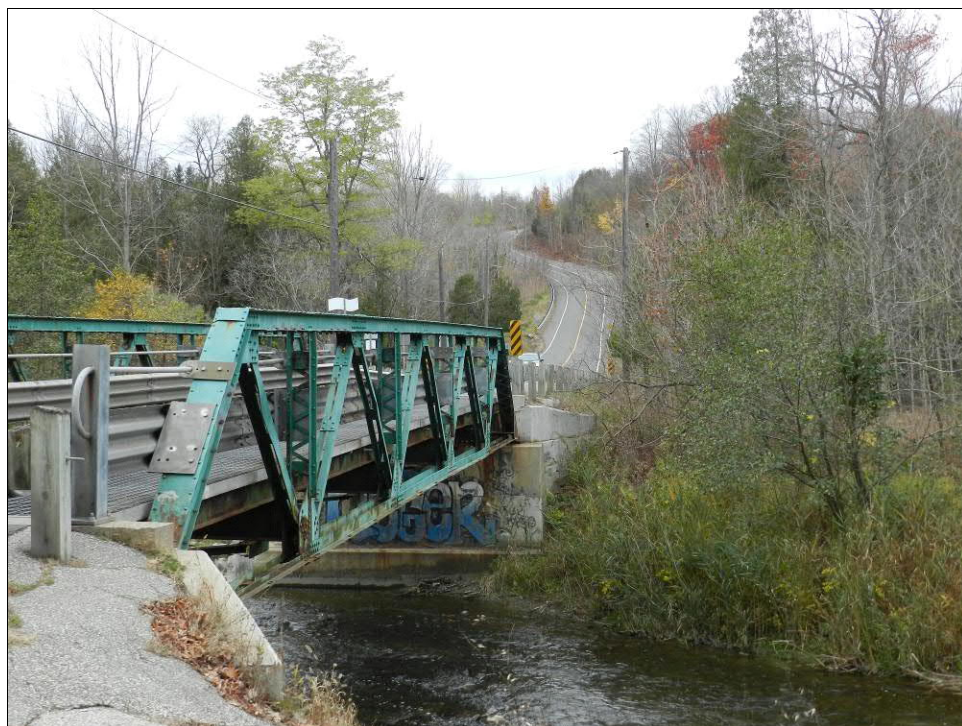
North Side of Bridge

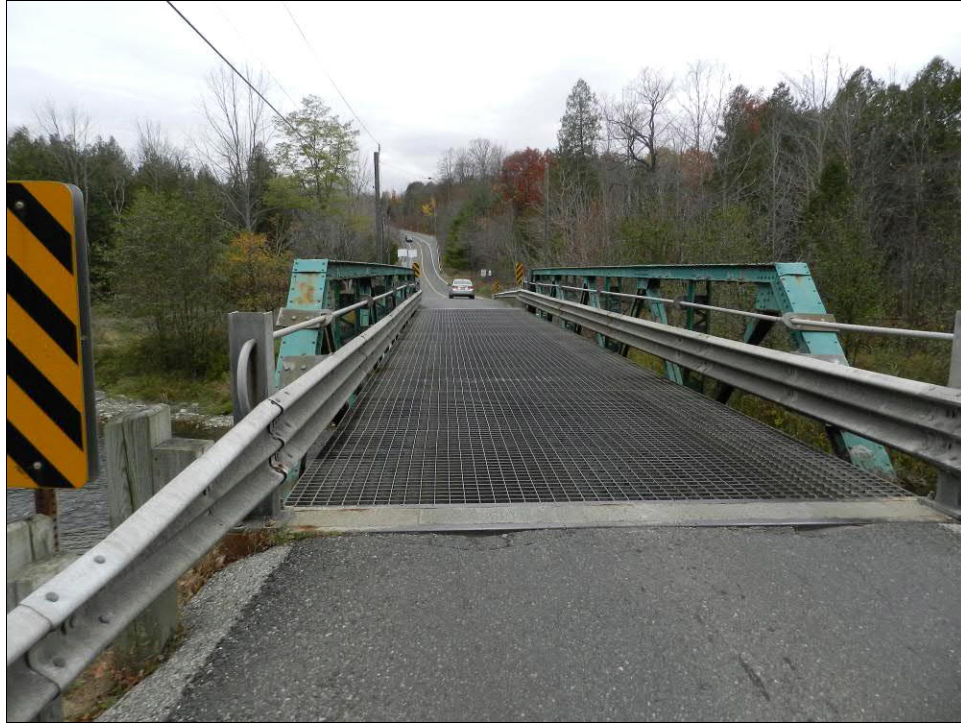
Deck, Looking East

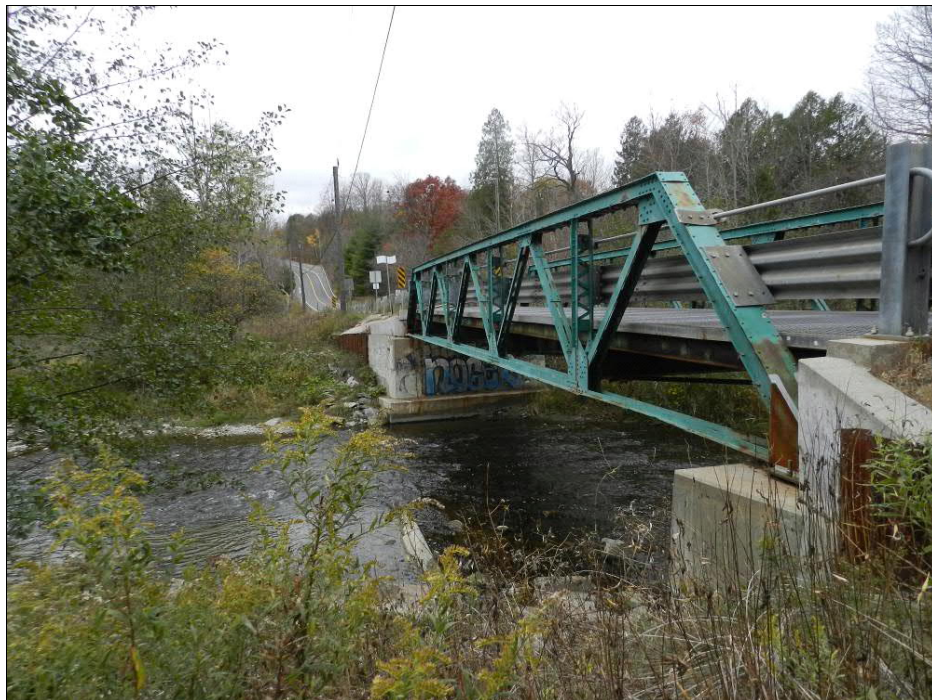
South Side of Bridge

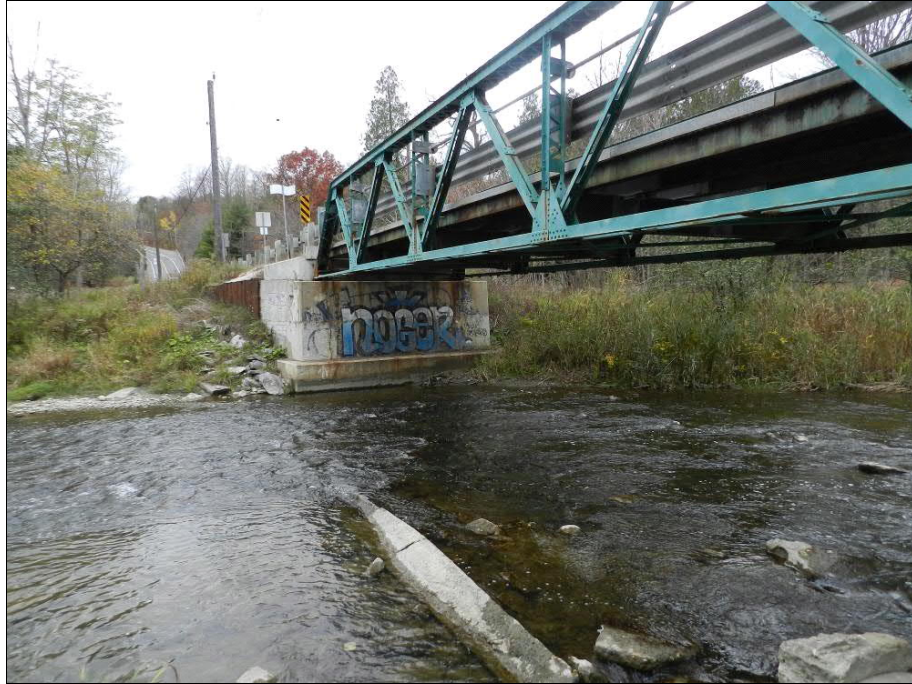
South Side of Bridge Looking West

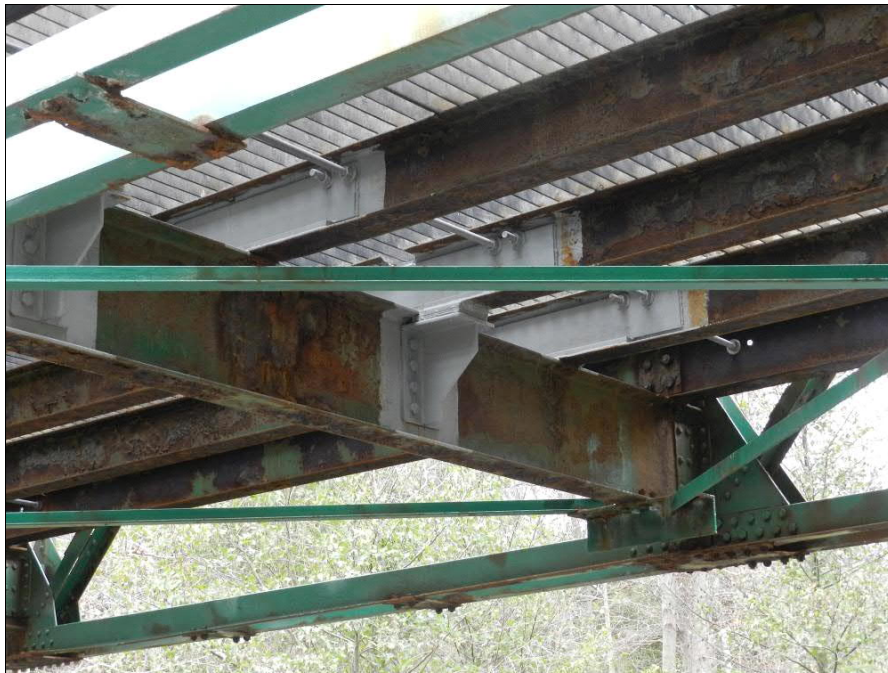
Underside of Bridge

The primary truss gusset plate connections are severely corroded and require repair. Depending on the extent of section loss, jacking of the structure may be required to repair the severe deterioration of the gusset plates, shoe plates, and bottom chord.

The bridge has been observed to have rust jacking between members which is difficult to remedy without disassembly in a major rehabilitation context.
