APPENDIX C
Characterization and Development of Alternatives
(Phase 2)

Ecological Characterization

Ecological Field Methods

ECOLOGICAL CHARACTERIZATION METHODOLOGY

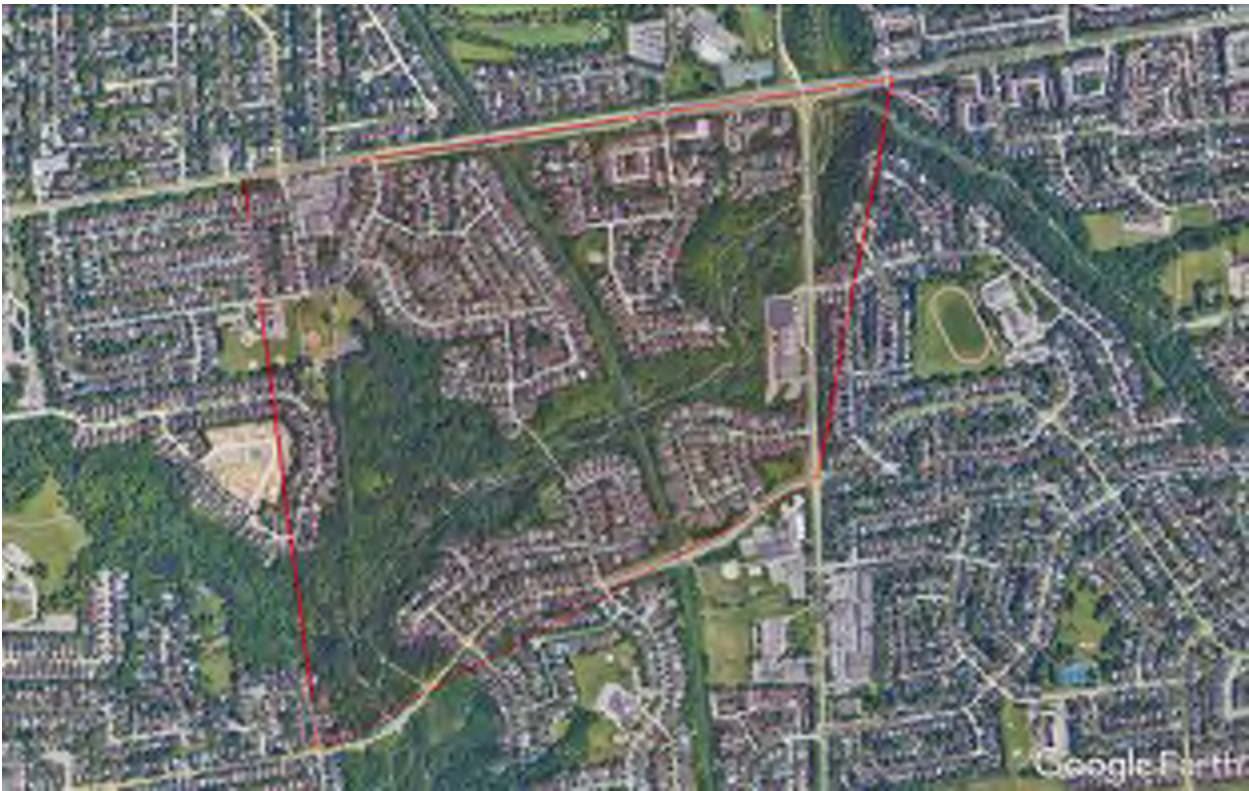
I am helping out with the natural heritage portion of the German Mills Geomorphic Systems Master Plan being conducted by the City of Toronto and as such we are conducting a background natural heritage review. The study area is roughly from Steeles Ave E and Leslie St to Cummer Ave where it crosses the Don River. Below is a map of the study area.

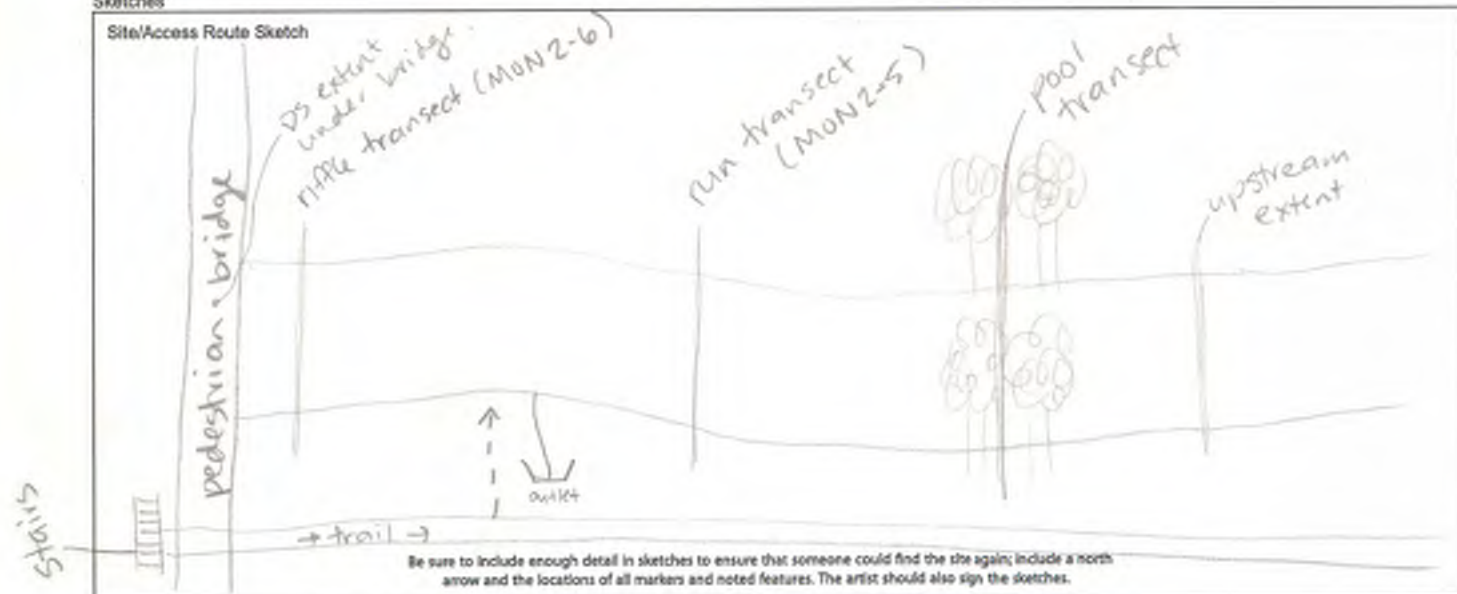
Site/Access Route Sketch

riffle transect in line w MON2-6
run transect in line w MON2-5
pool transect does not match geomorph monitoring.
most of monitoring site has canopy cover shading creek.

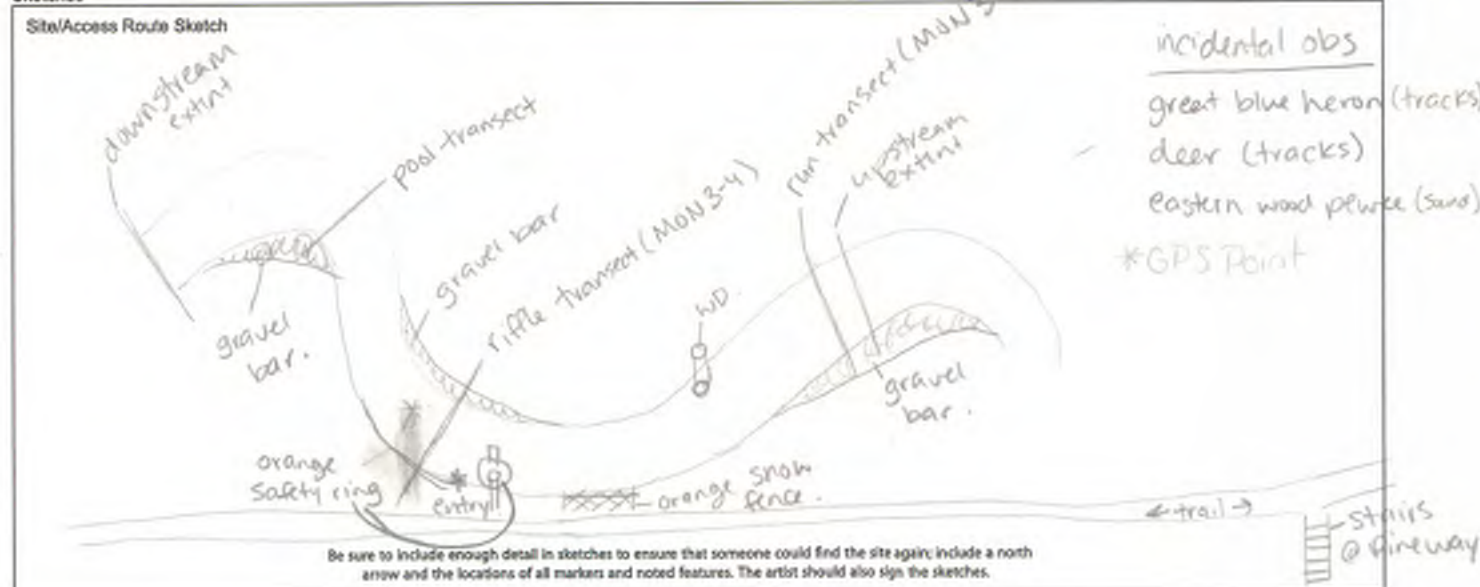
Sketches

run @ MON3-3
pool does not line up w geomorph monitoring
riffle @ MON3-4
- many fish visible in creek

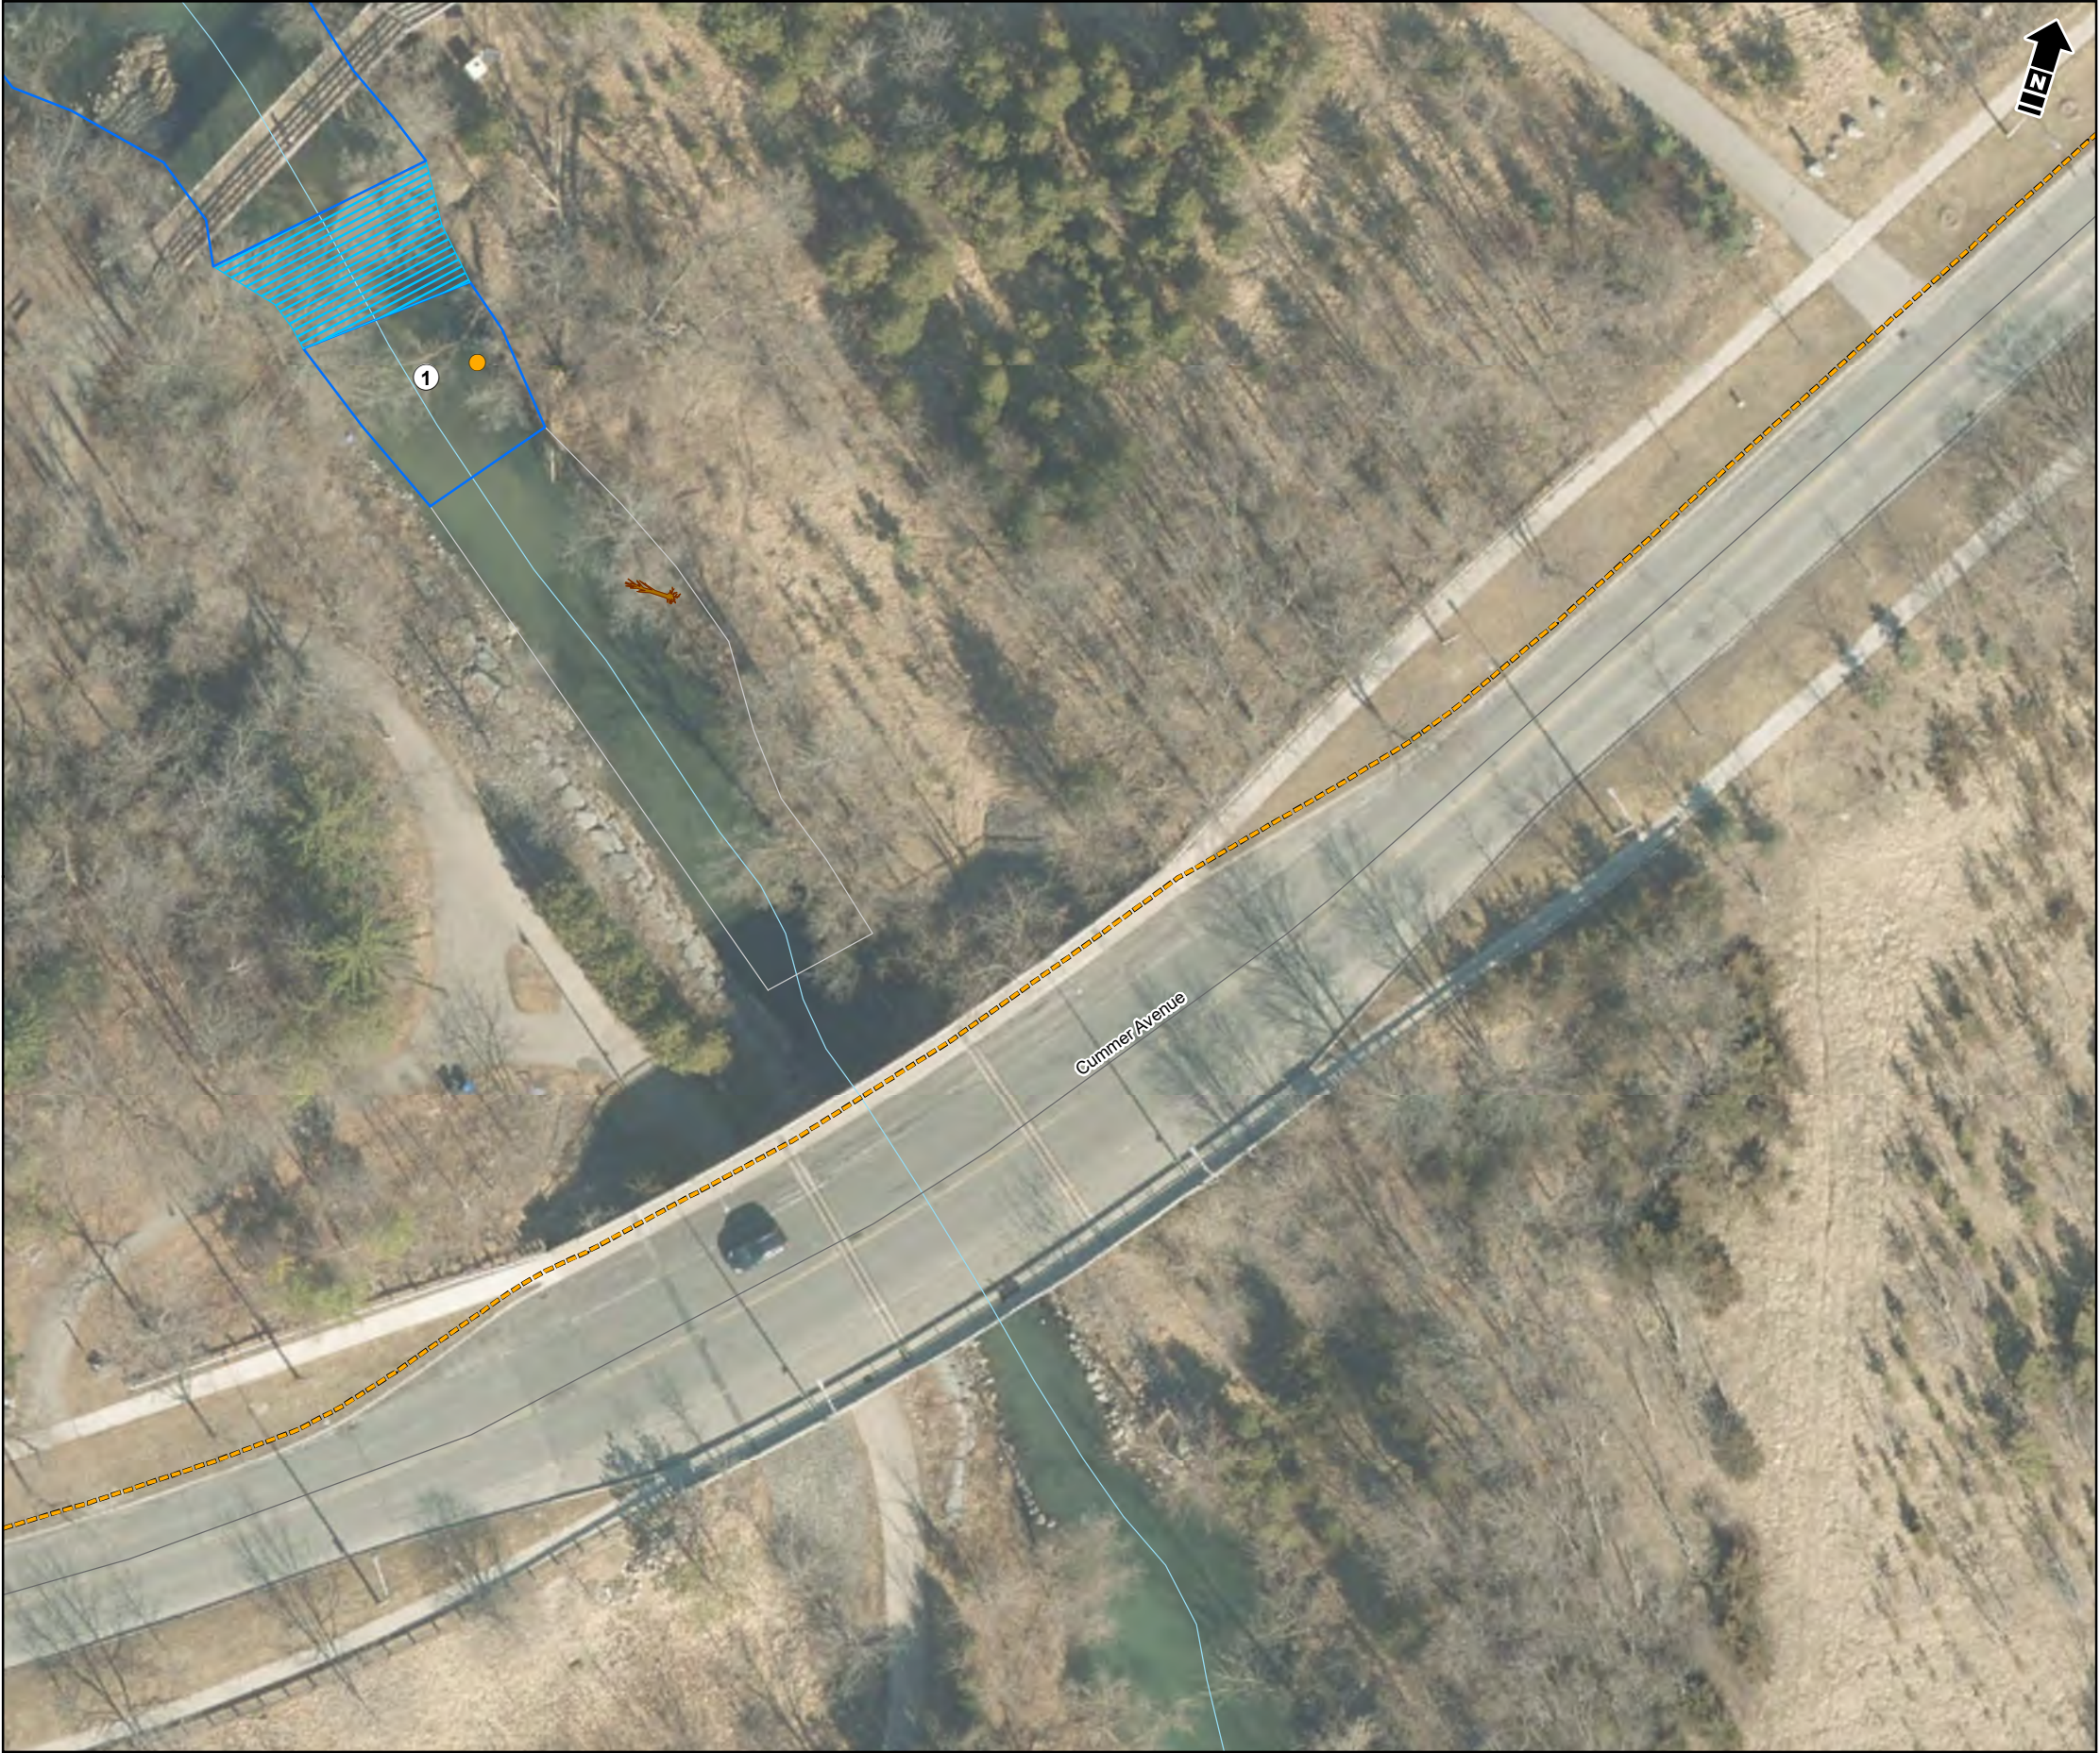
Notes:
1. Pool with a wetted width of 10.1m and wetted depth of 79cm. Armour stone on left bank, right bank heavily vegetated. Sandy with consolidated substrate.

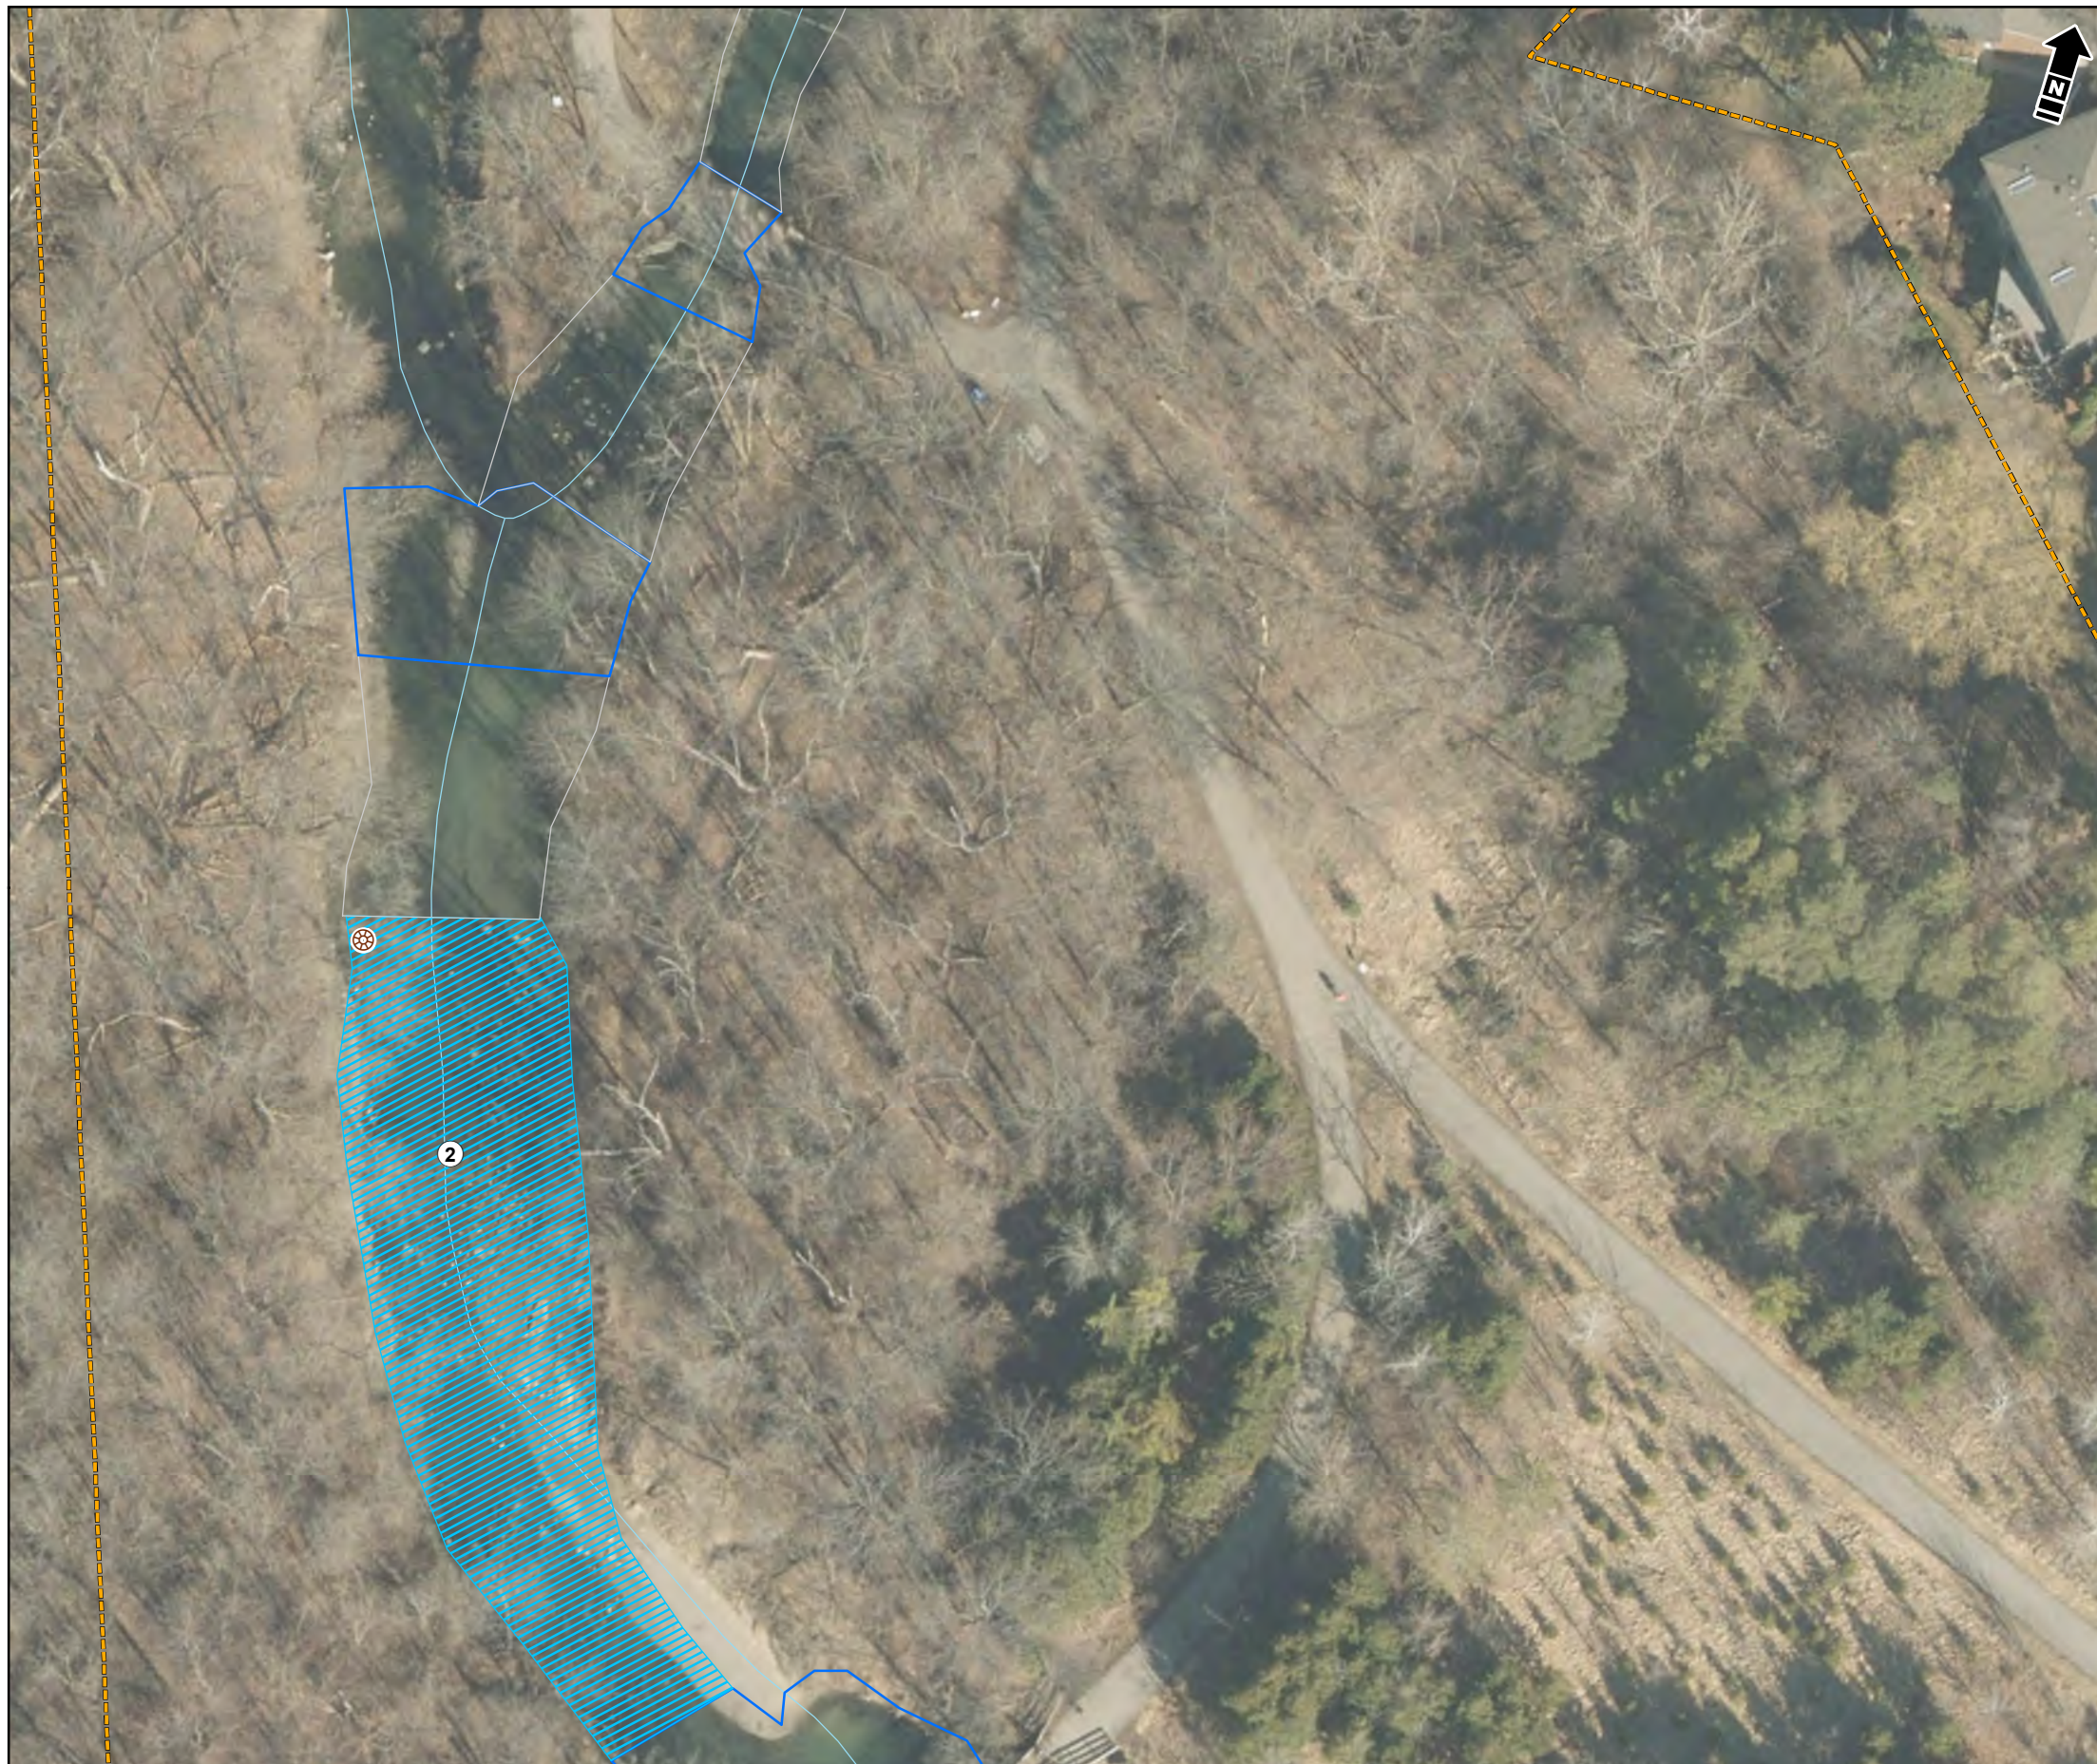
Figure C8b

Notes:
2. Riffle with a wetted depth of 18 cm. Left bank heavily vegetated with undercut, right bank heavily vegetated. Large cobble substrate.

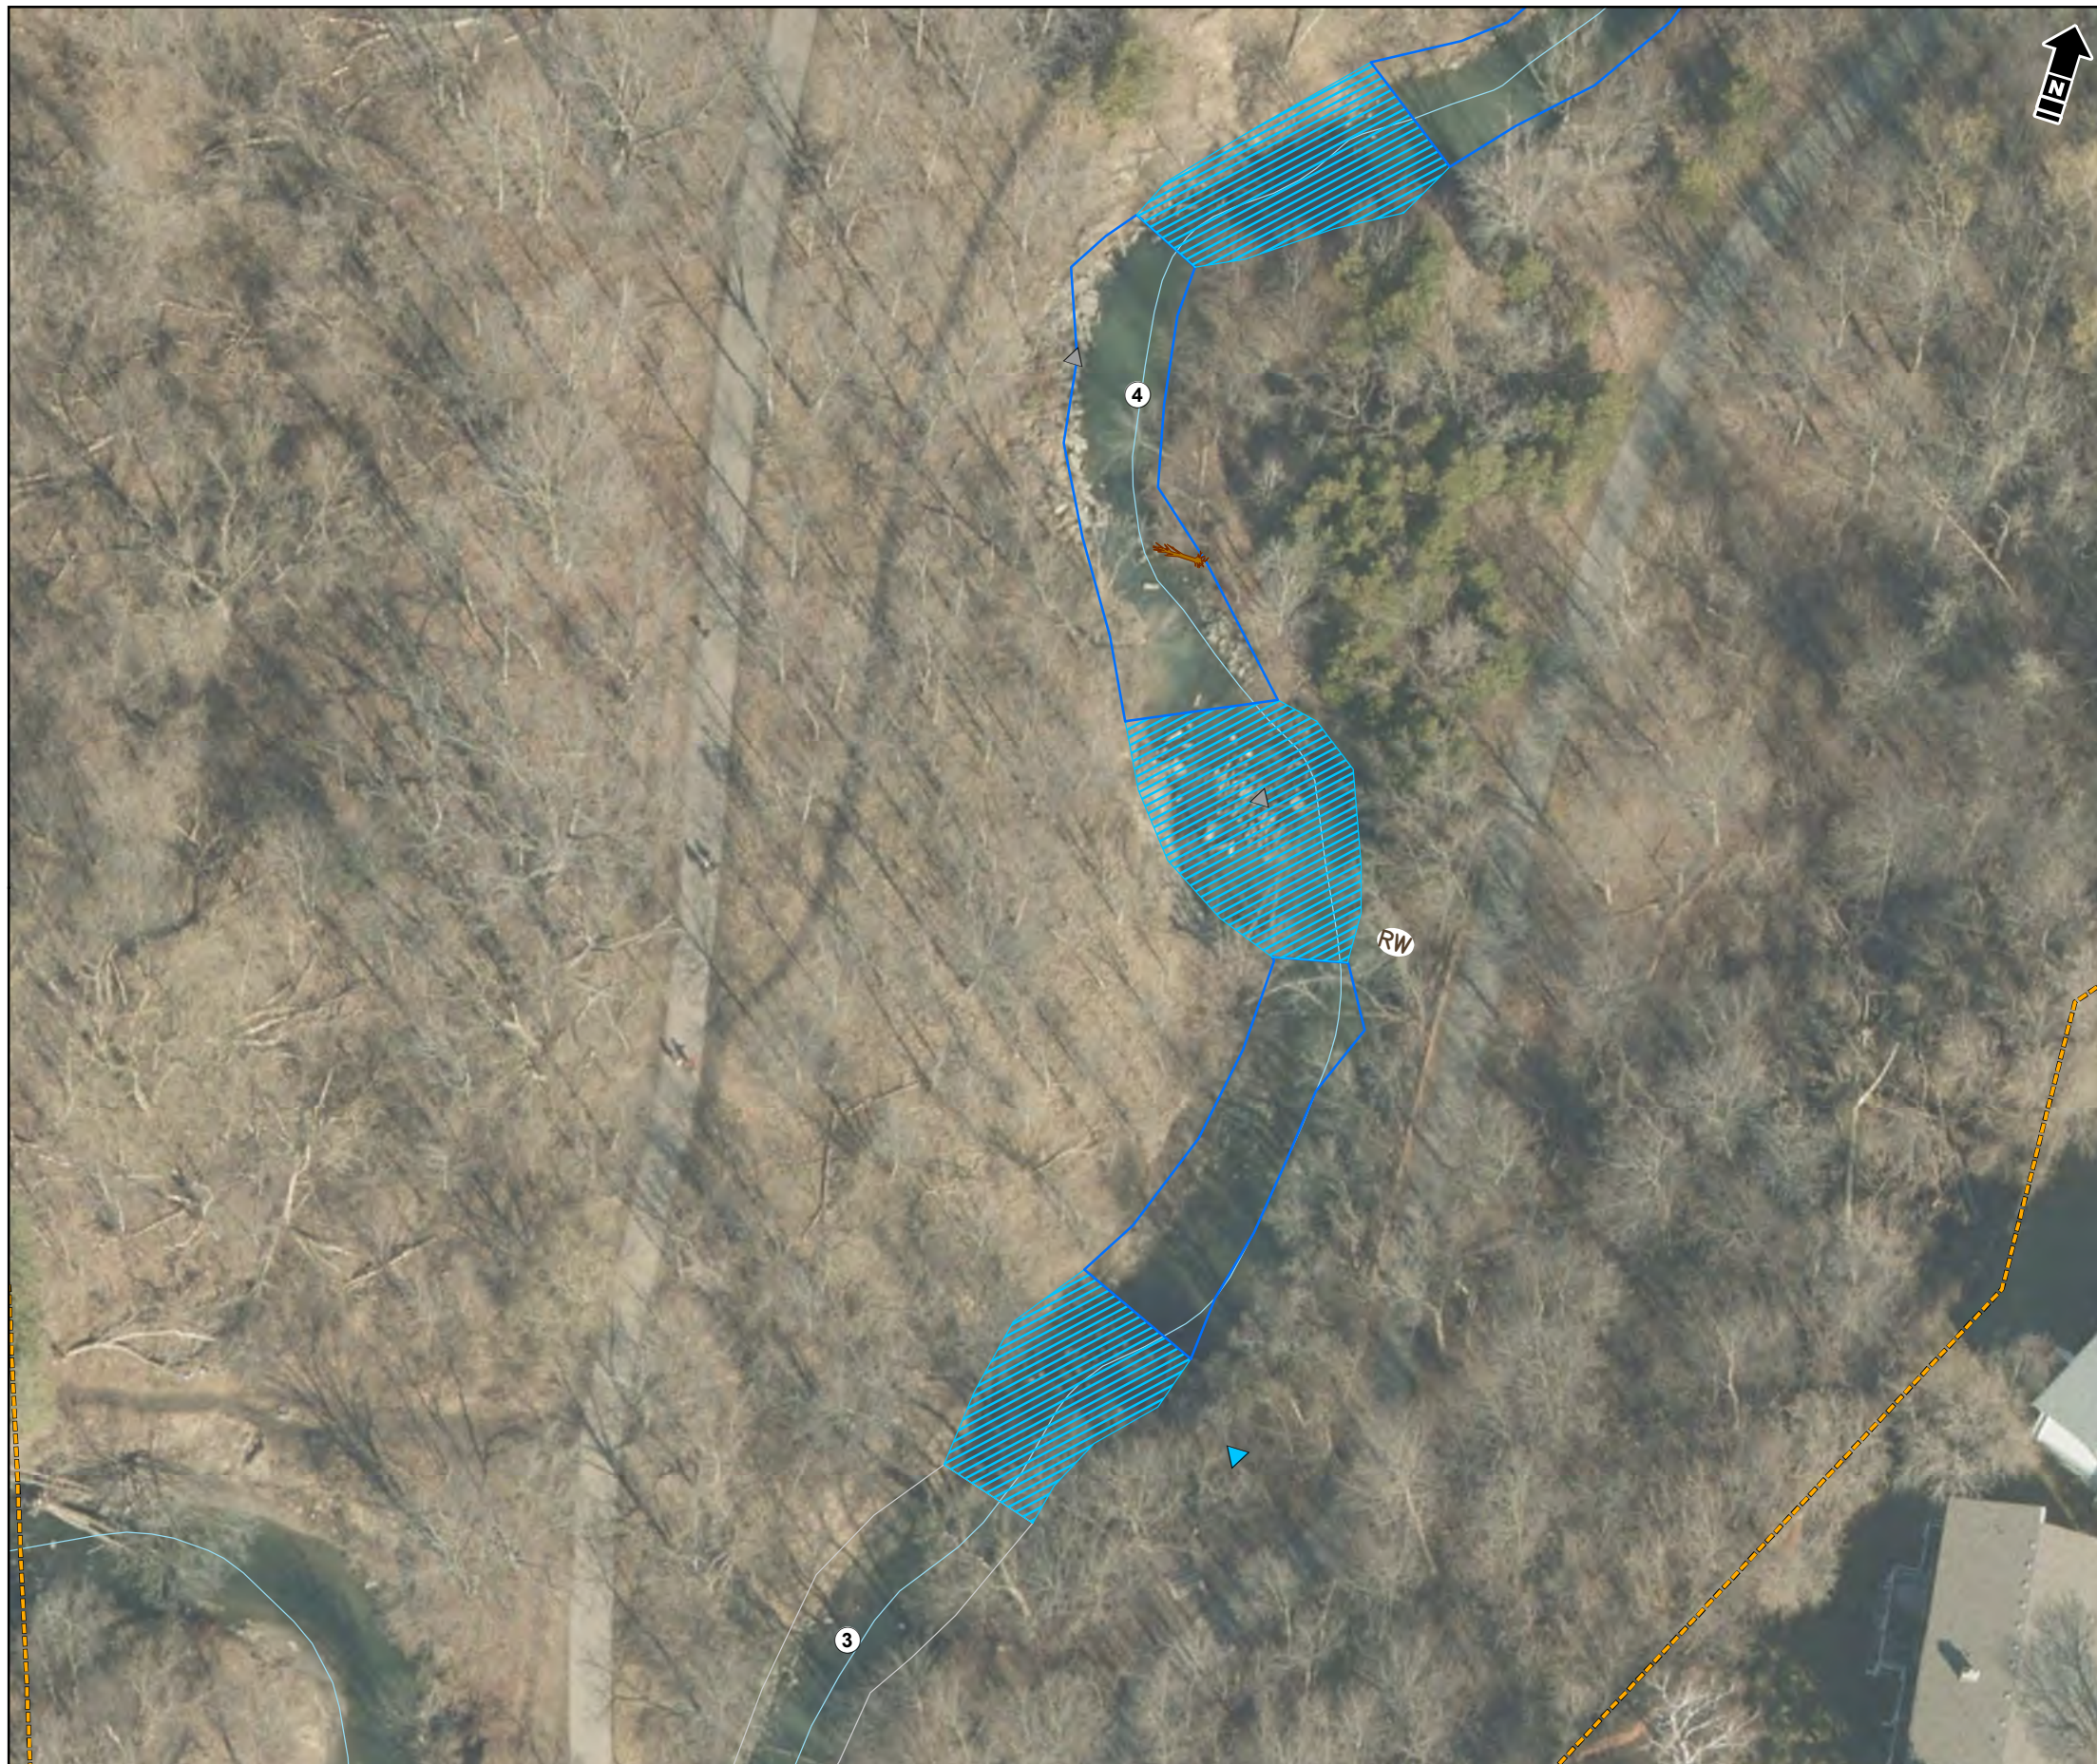
C8c

3. Run with a wetted width of 7.6m and wetted depth of 25cm. Both banks heavily vegetated. Sandy gravel substrate.
4. Pool with a wetted depth of approximately 1m. Banks vegetated with embedded concrete chunks. Sand substrate with concrete chunks.

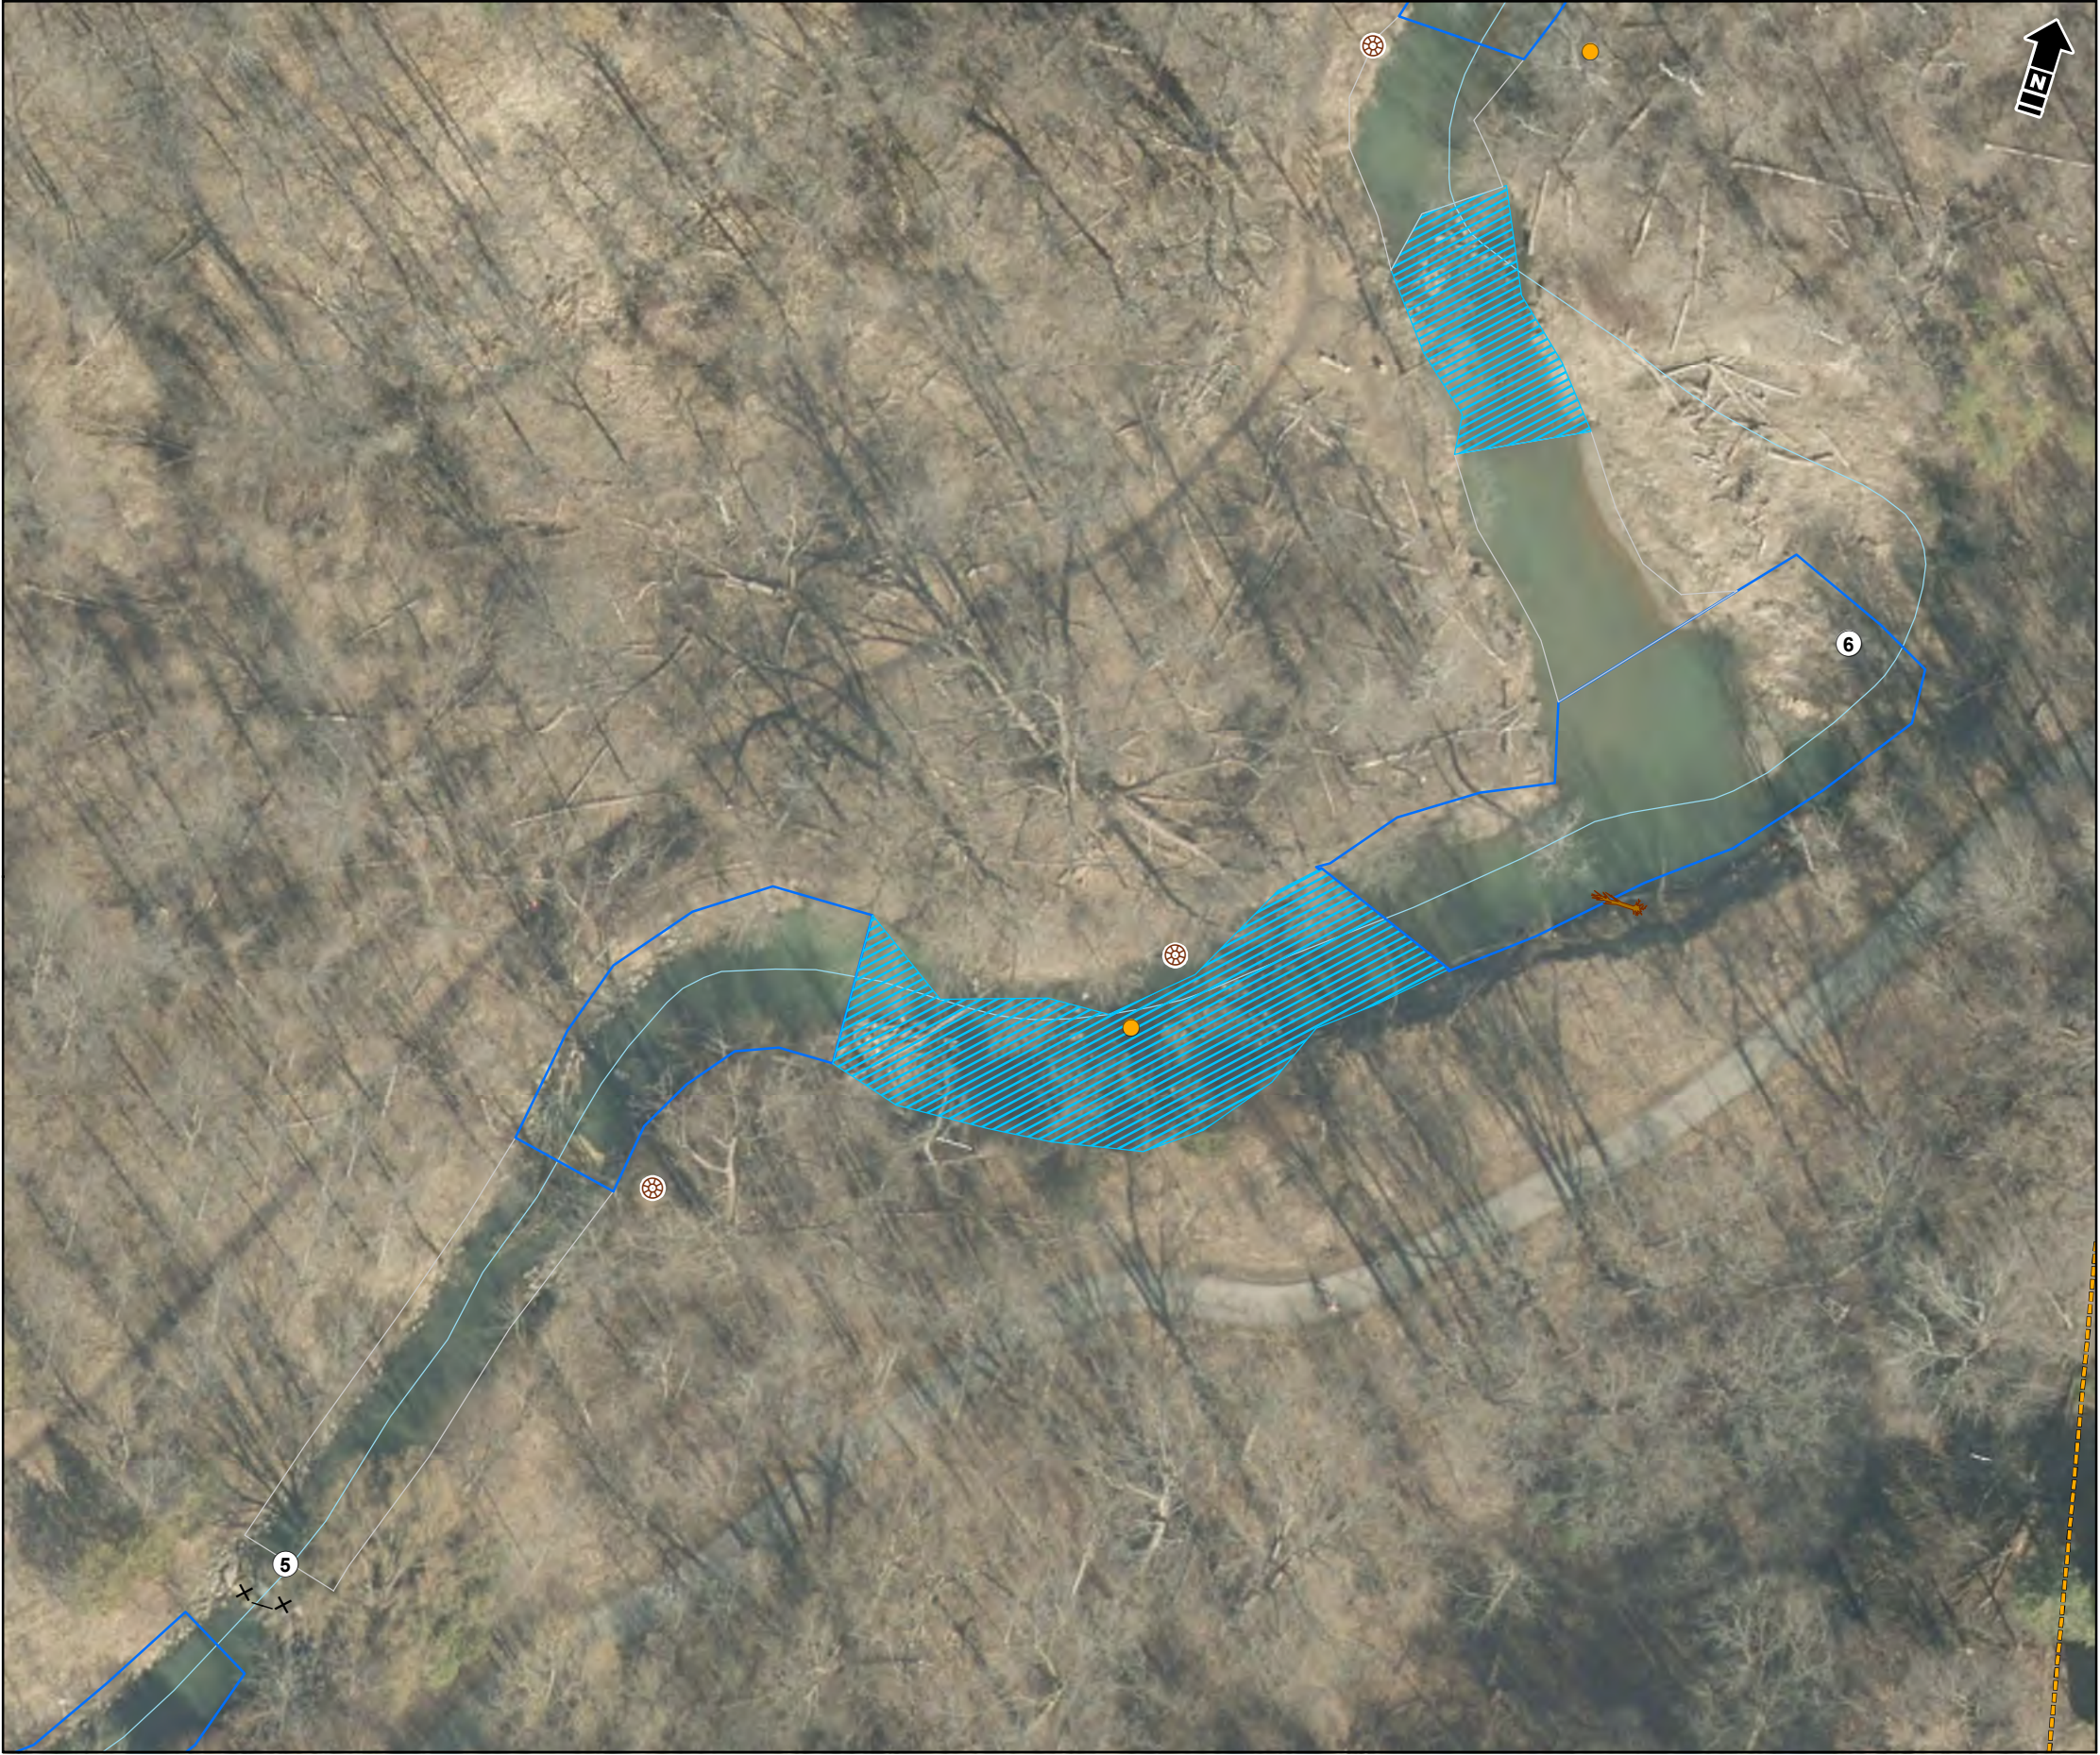
Notes:
5. Potential fish barrier: A boulder weir with a drop of 65cm from top of water to upstream level.
6. Pool with an inlet with a wetted depth of approximately 1.2m. Banks eroded and vegetated. Substrate unconsolidated.

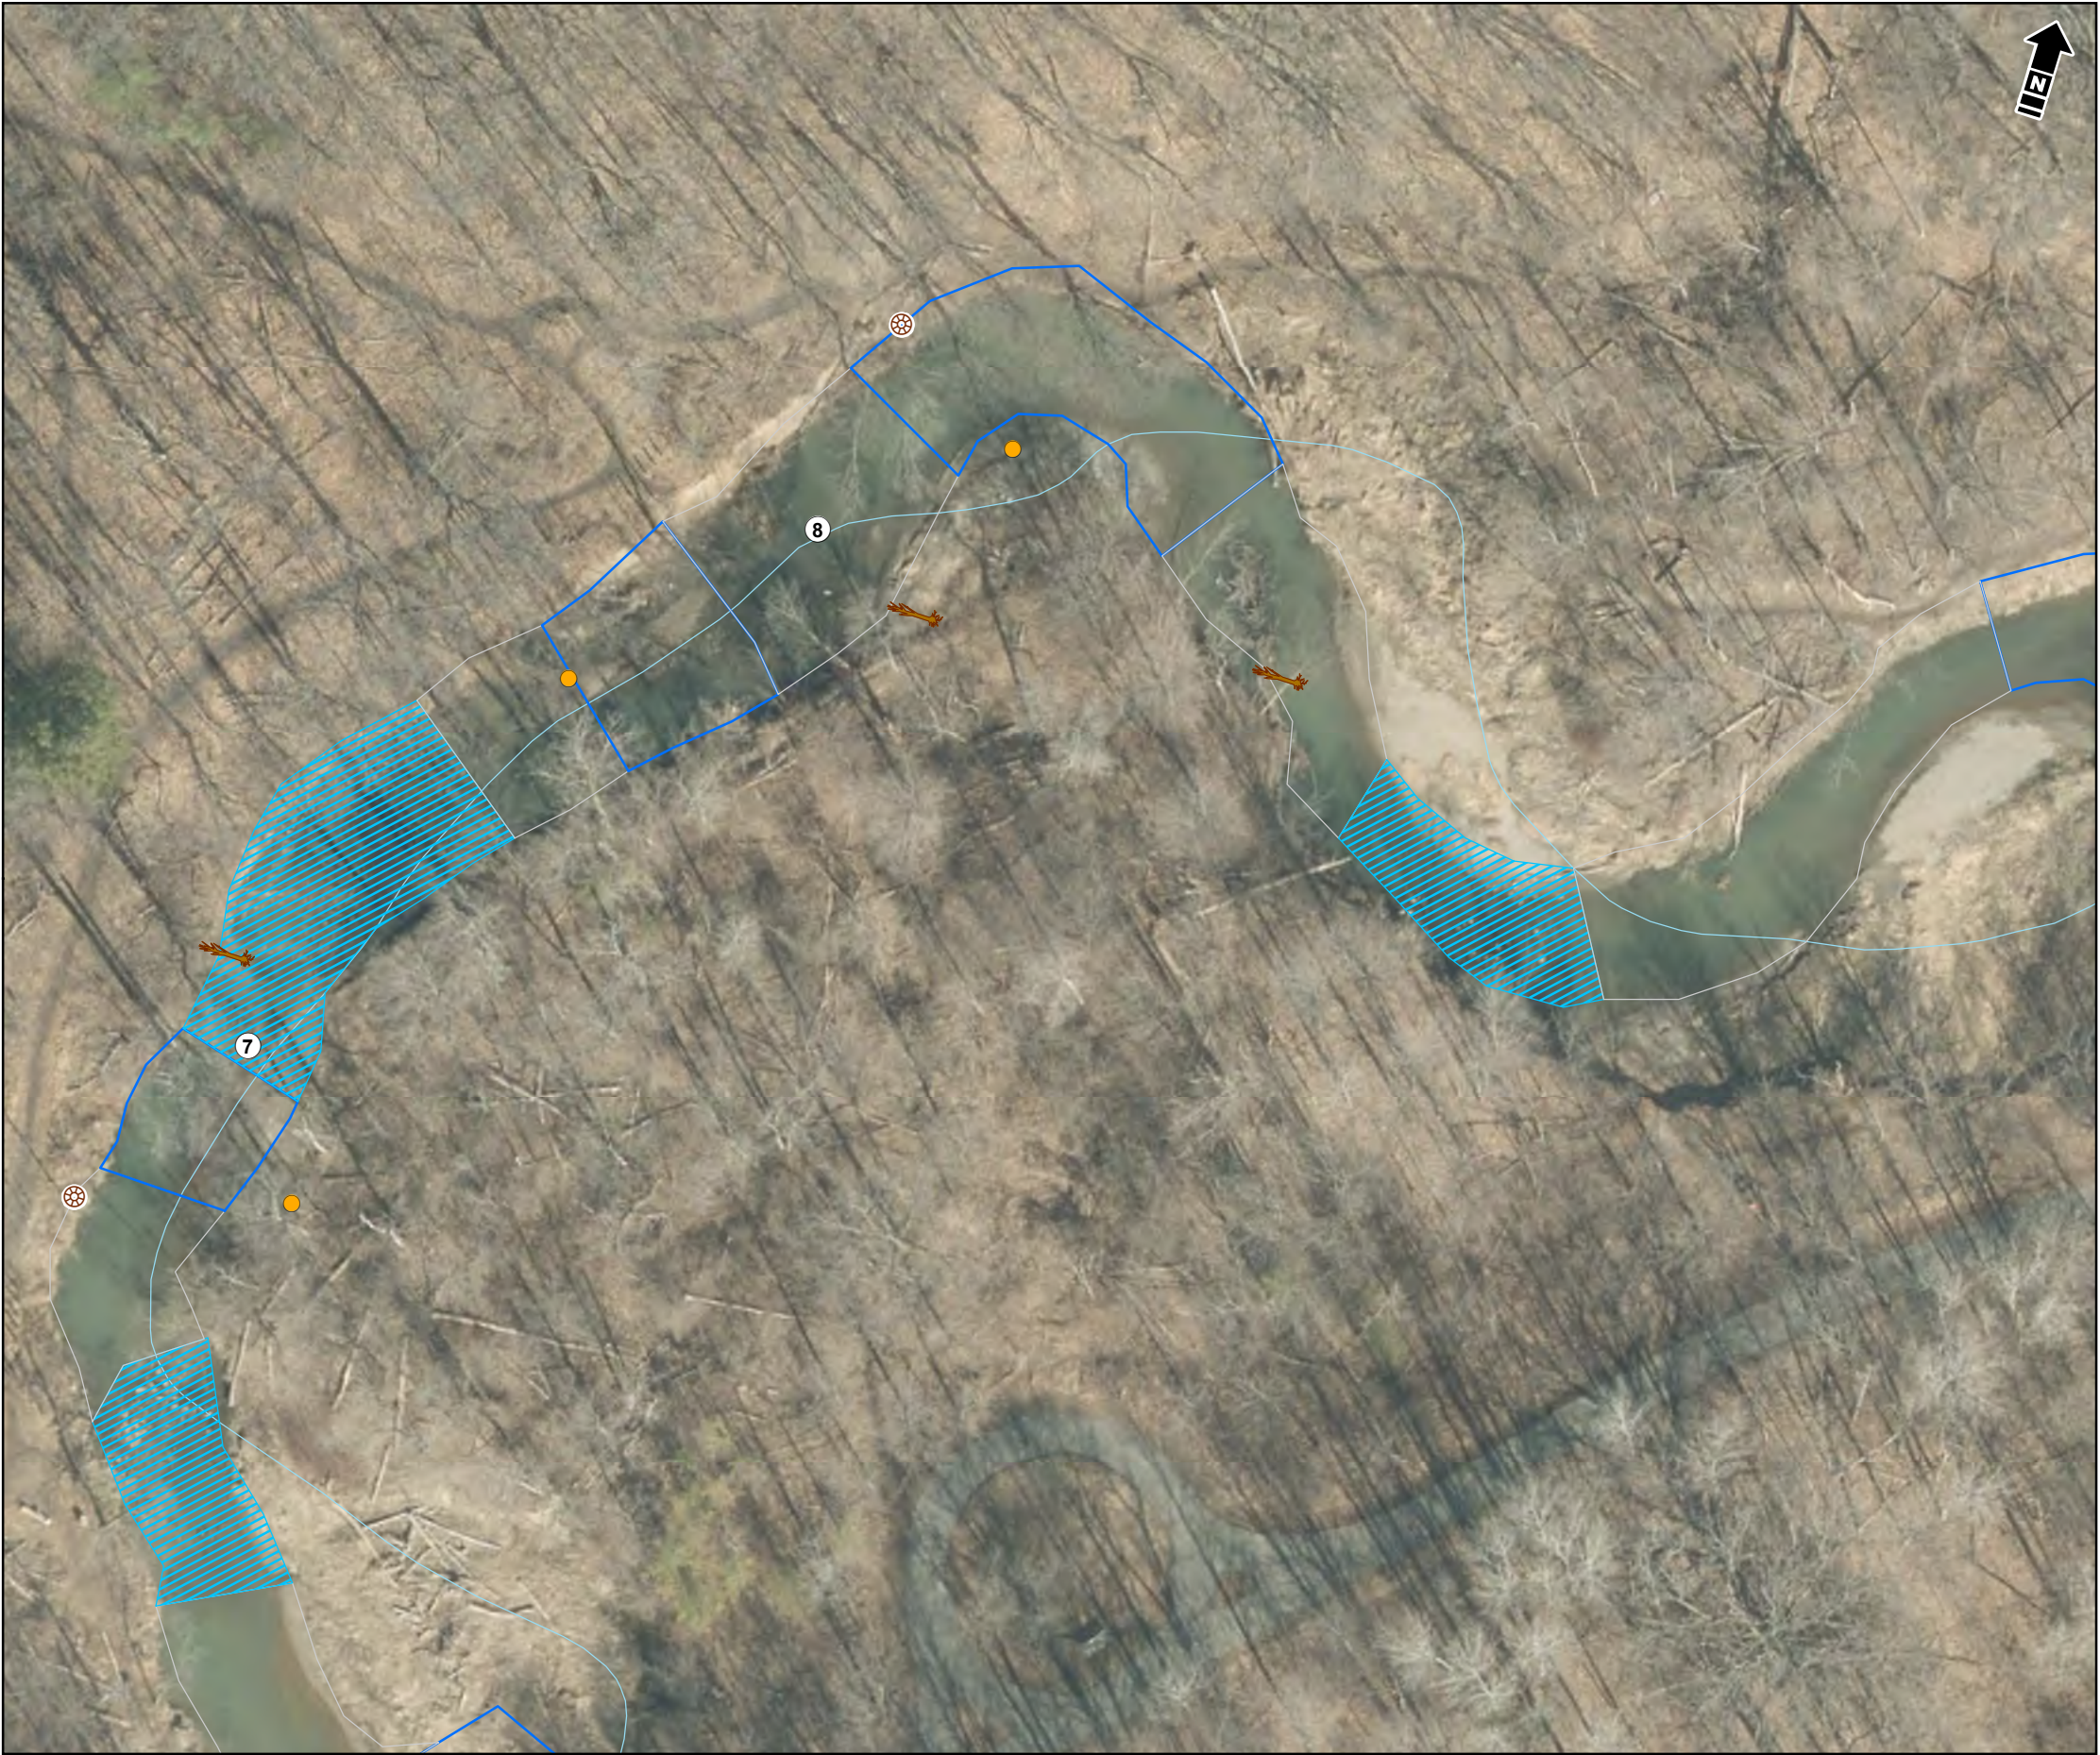
Notes:
7. A riffle (left side) with a wetted depth of 13 cm, and a pool (right side) with a depth of 50 cm and a total wetted width of 8.6m. Banks eroded and vegetated. Substrate large gravel to the left and sand to the right side.
8. Run with a wetted depth of 22cm. Eroded left bank. Sandy gravel substrate.
