APPENDIX C
Characterization and Development of Alternatives
(Phase 2)

Ecological Characterization

Ecological Field Methods

ECOLOGICAL CHARACTERIZATION METHODOLOGY

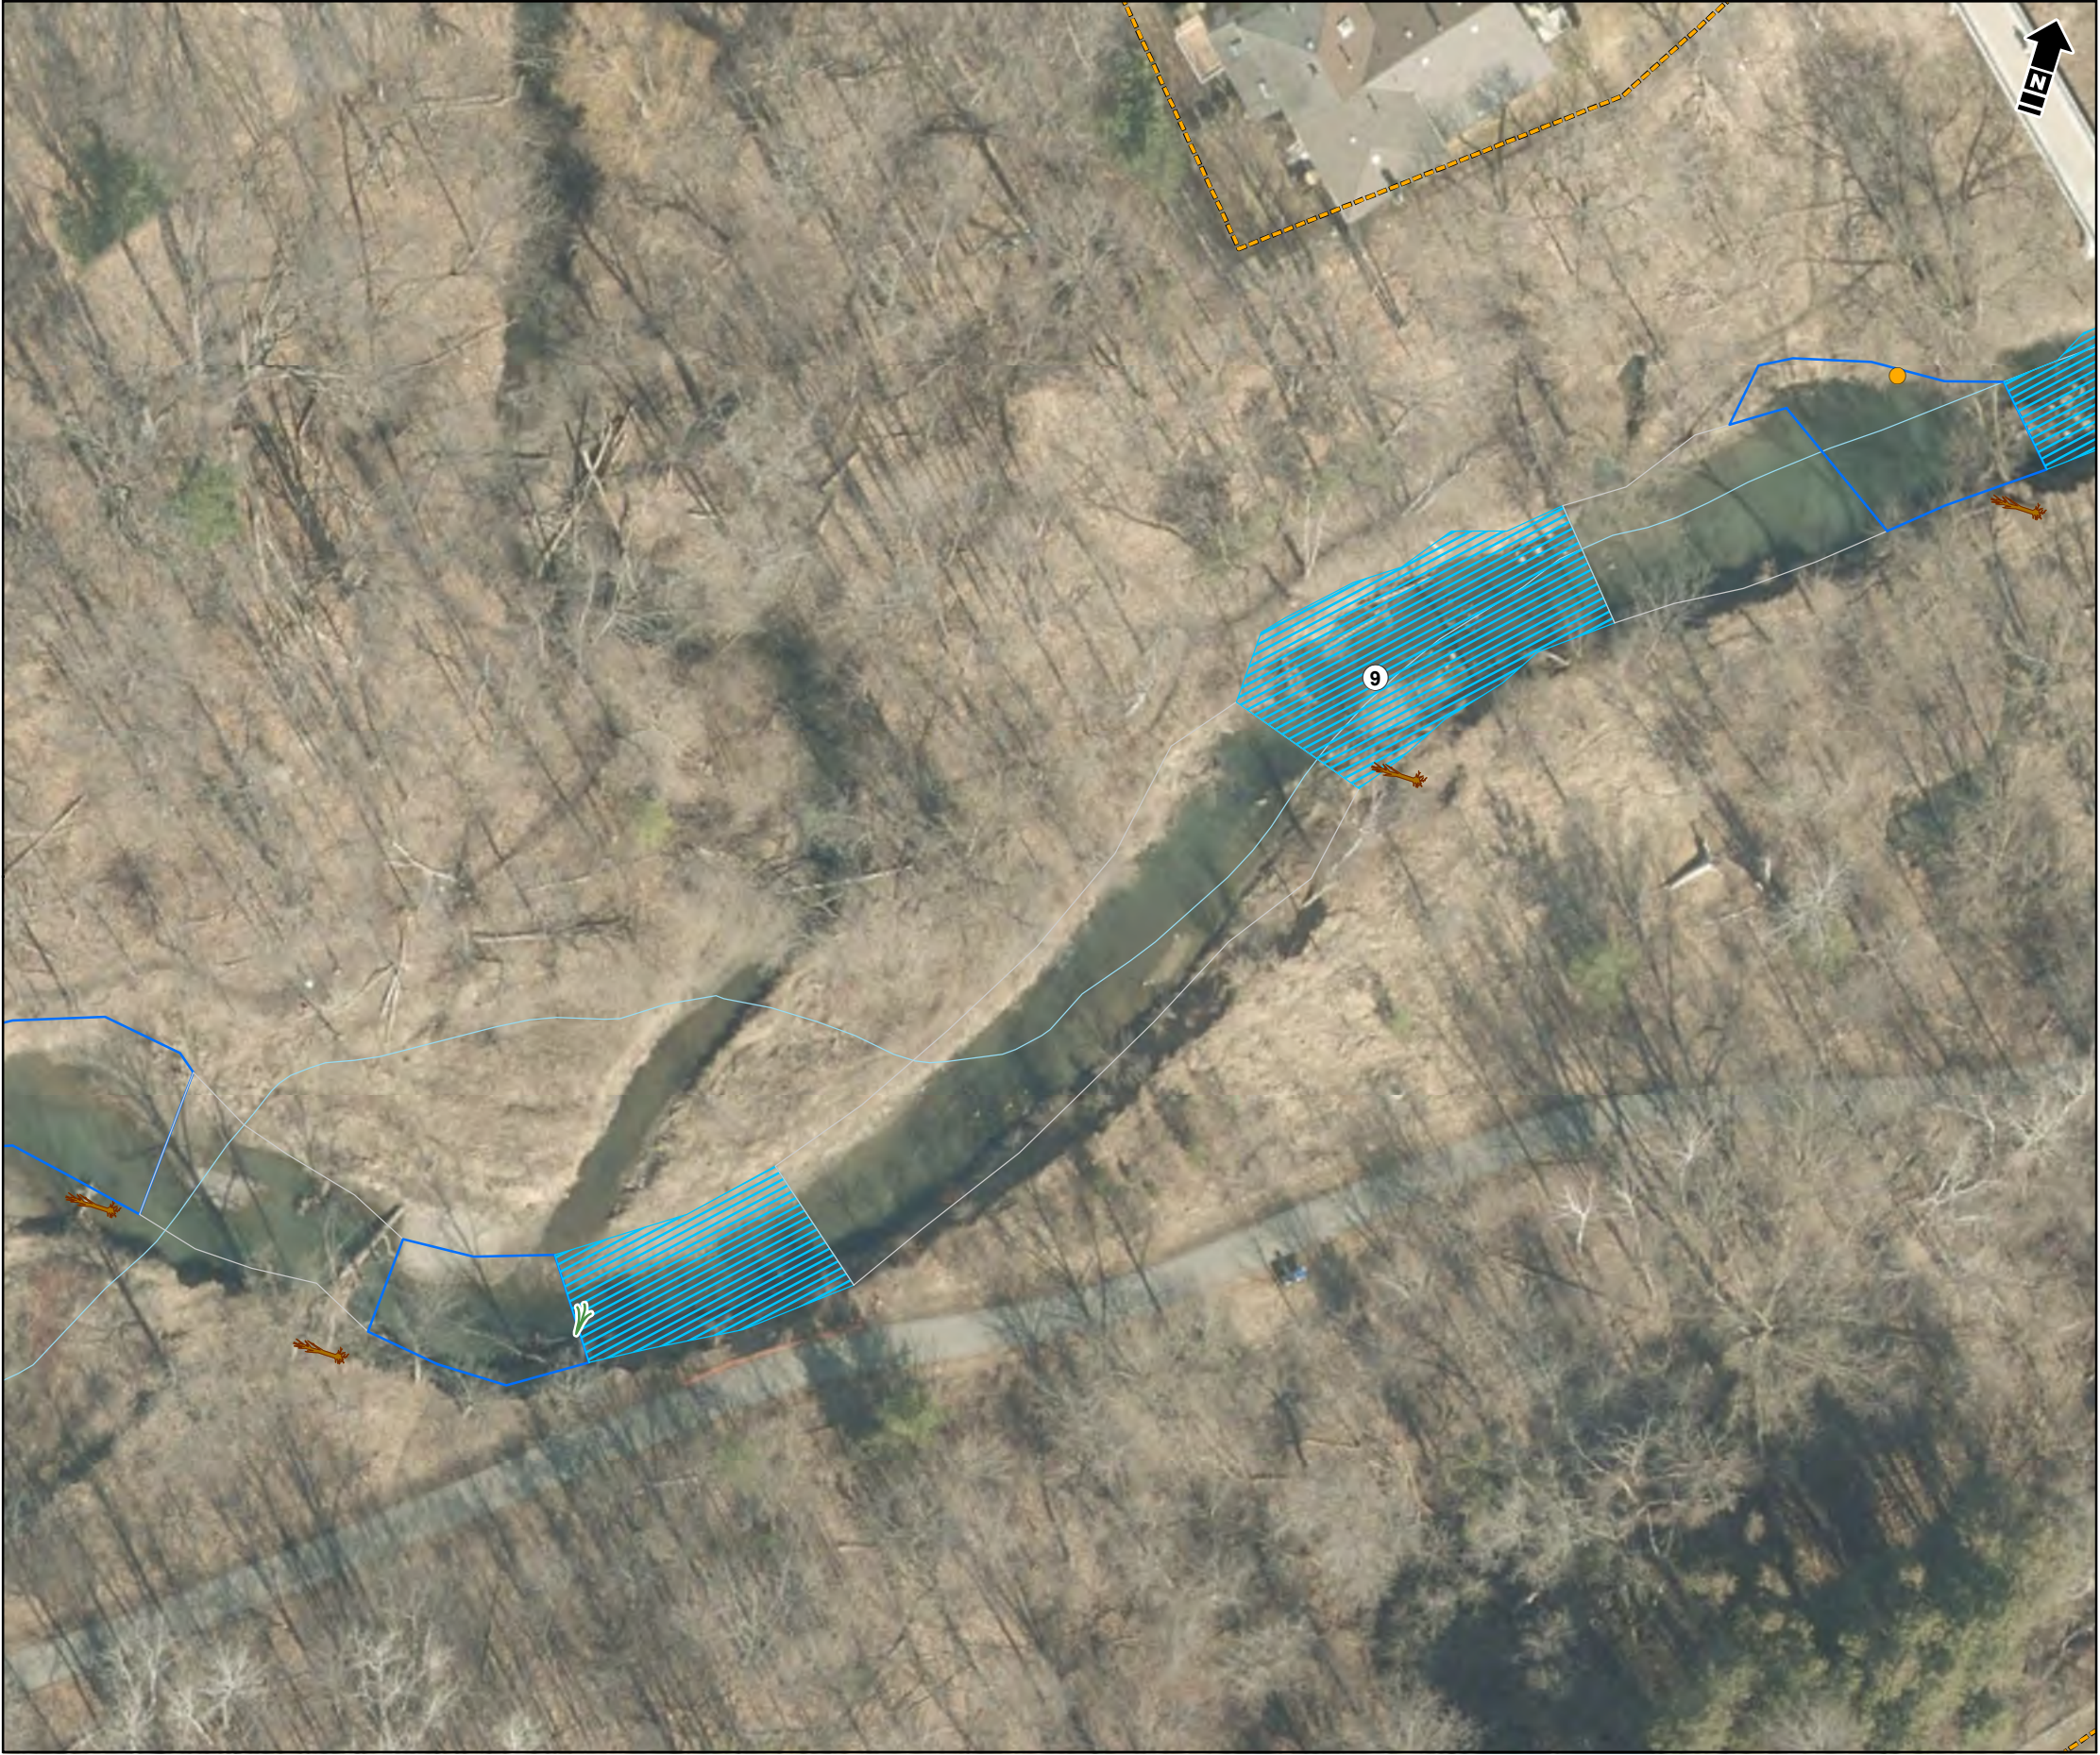
Notes:
9. Riffle with a wetted width of 9.5 m and a wetted depth of 11cm. Banks vegetated. Small cobble and gravel substrate.

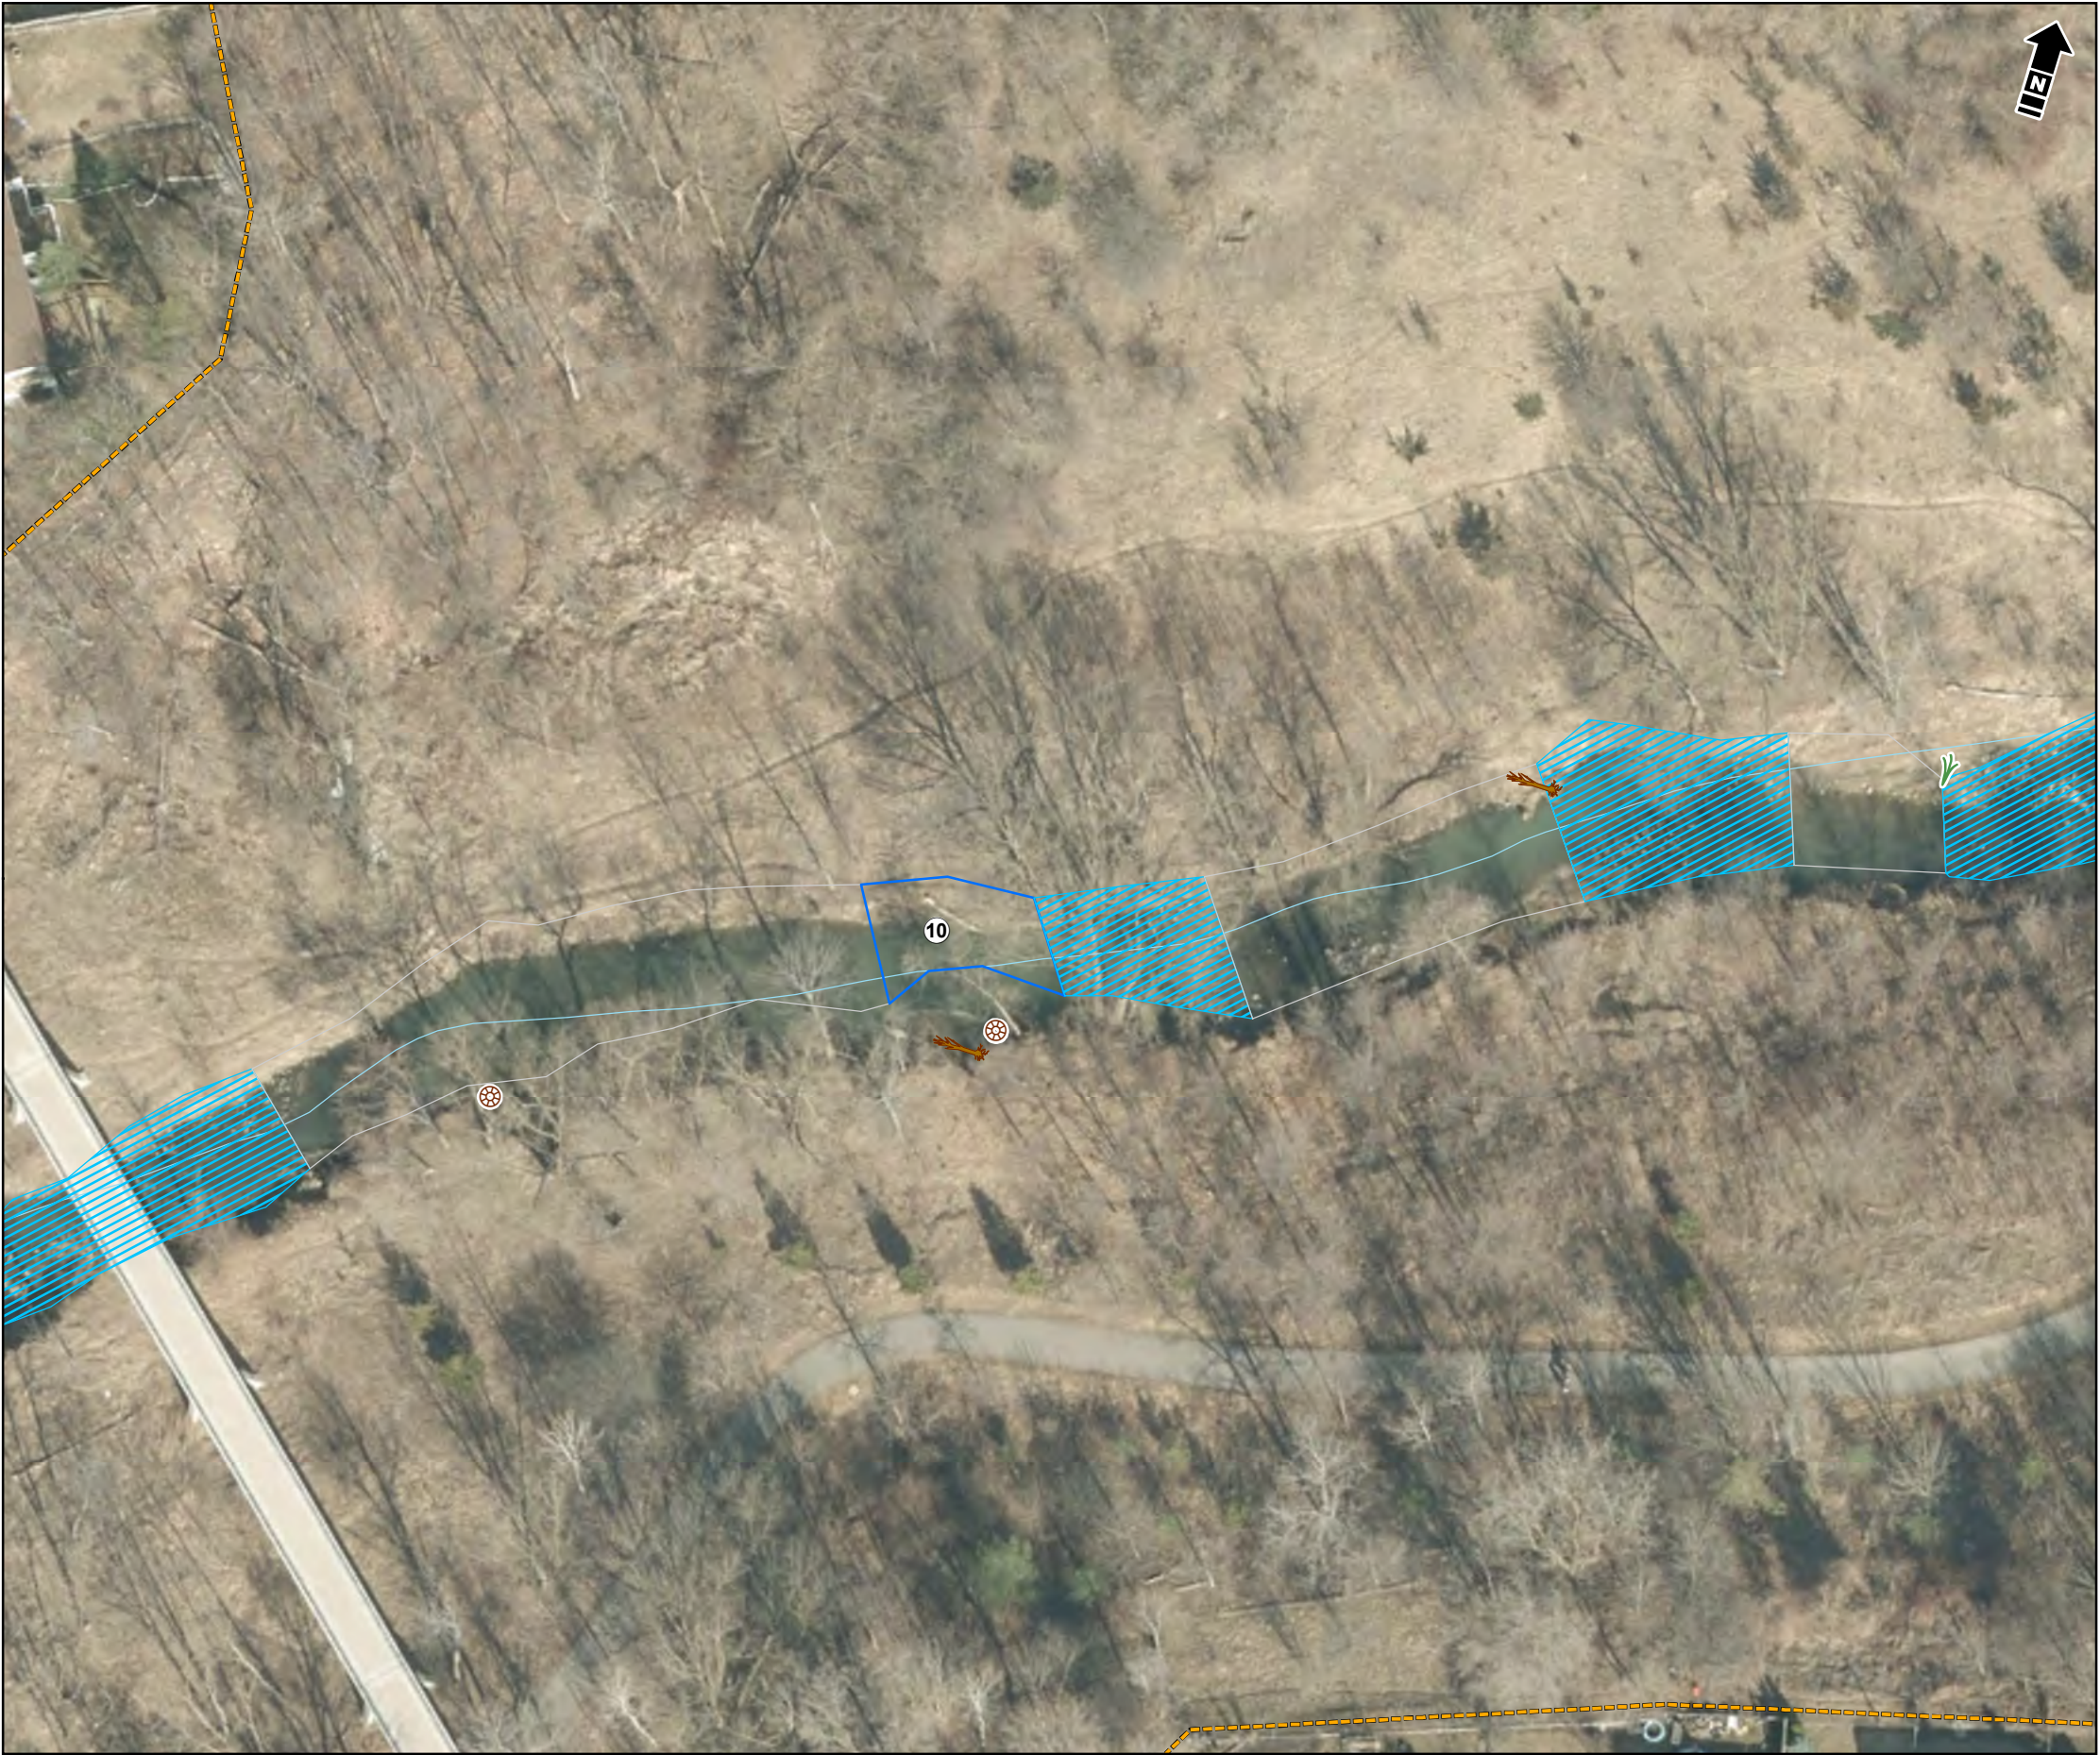
Notes:
10. Pool with a wetted depth of 95cm. Overhanging deciduous vegetation on banks.
Sandy gravel substrate.

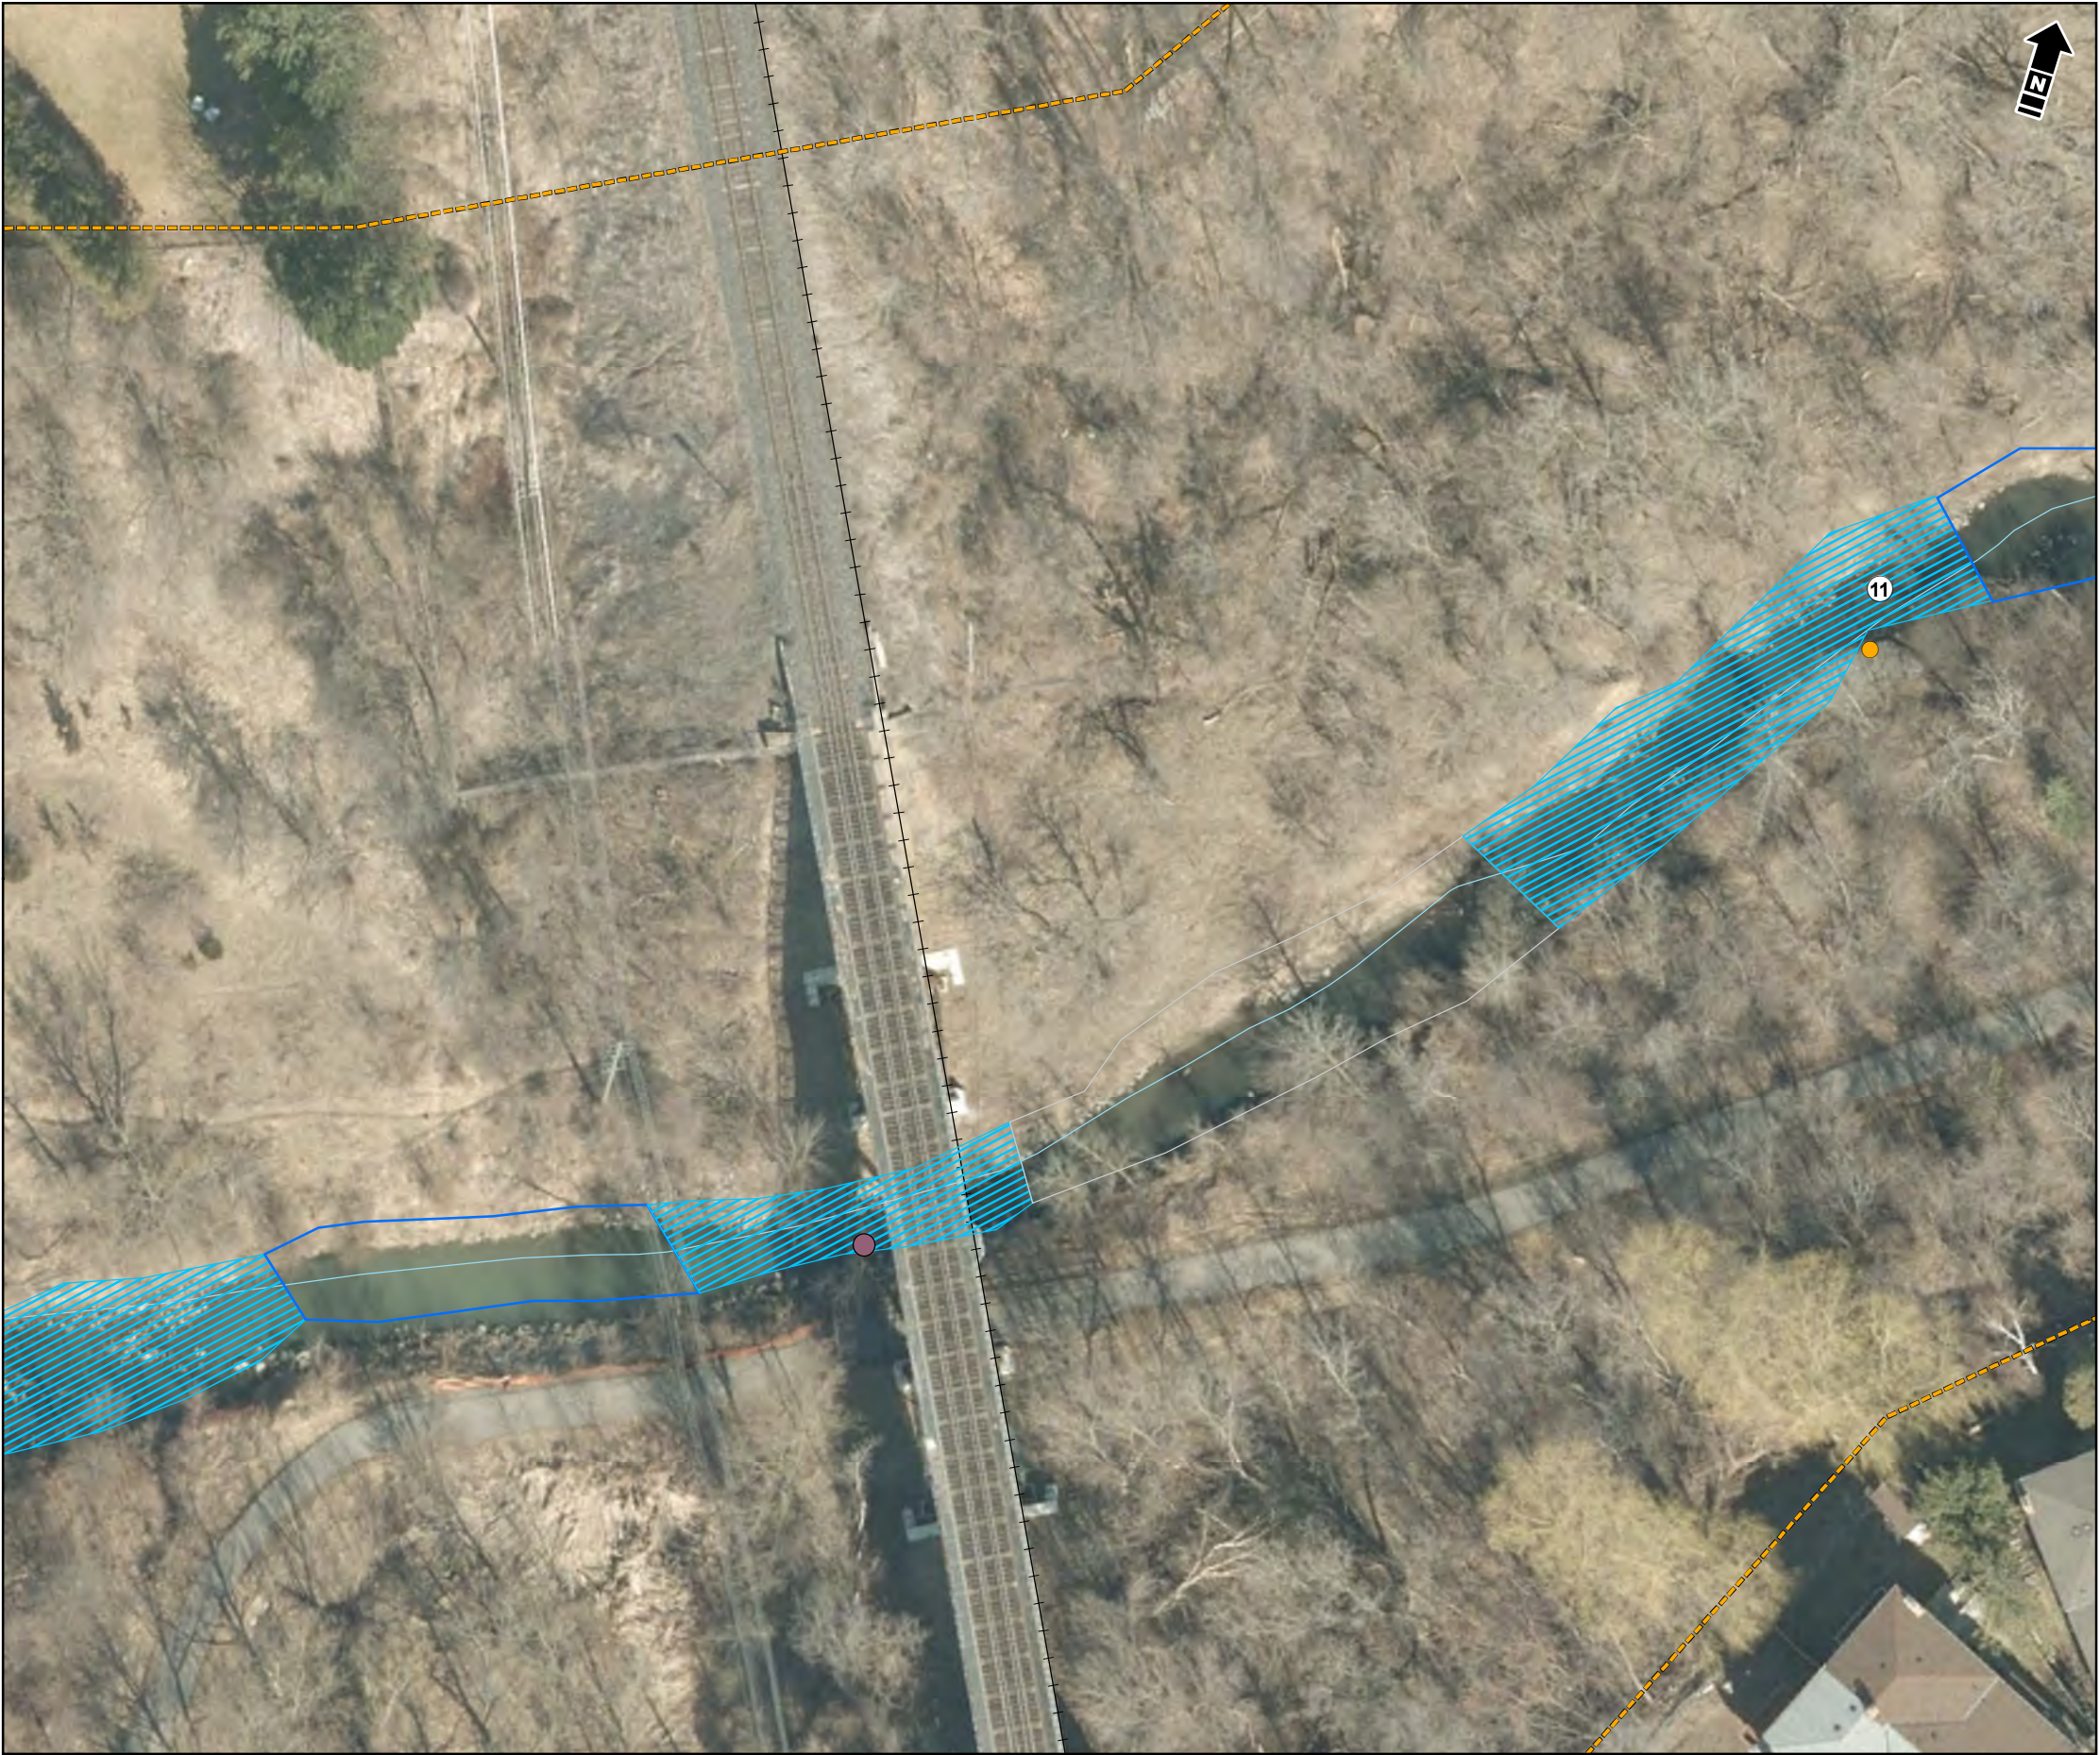
Notes:
11. Riffle with a wetted width of 5.1m and a wetted depth of 15cm. Small cobble bar on the left bank. Small boulders and large cobble substrate.

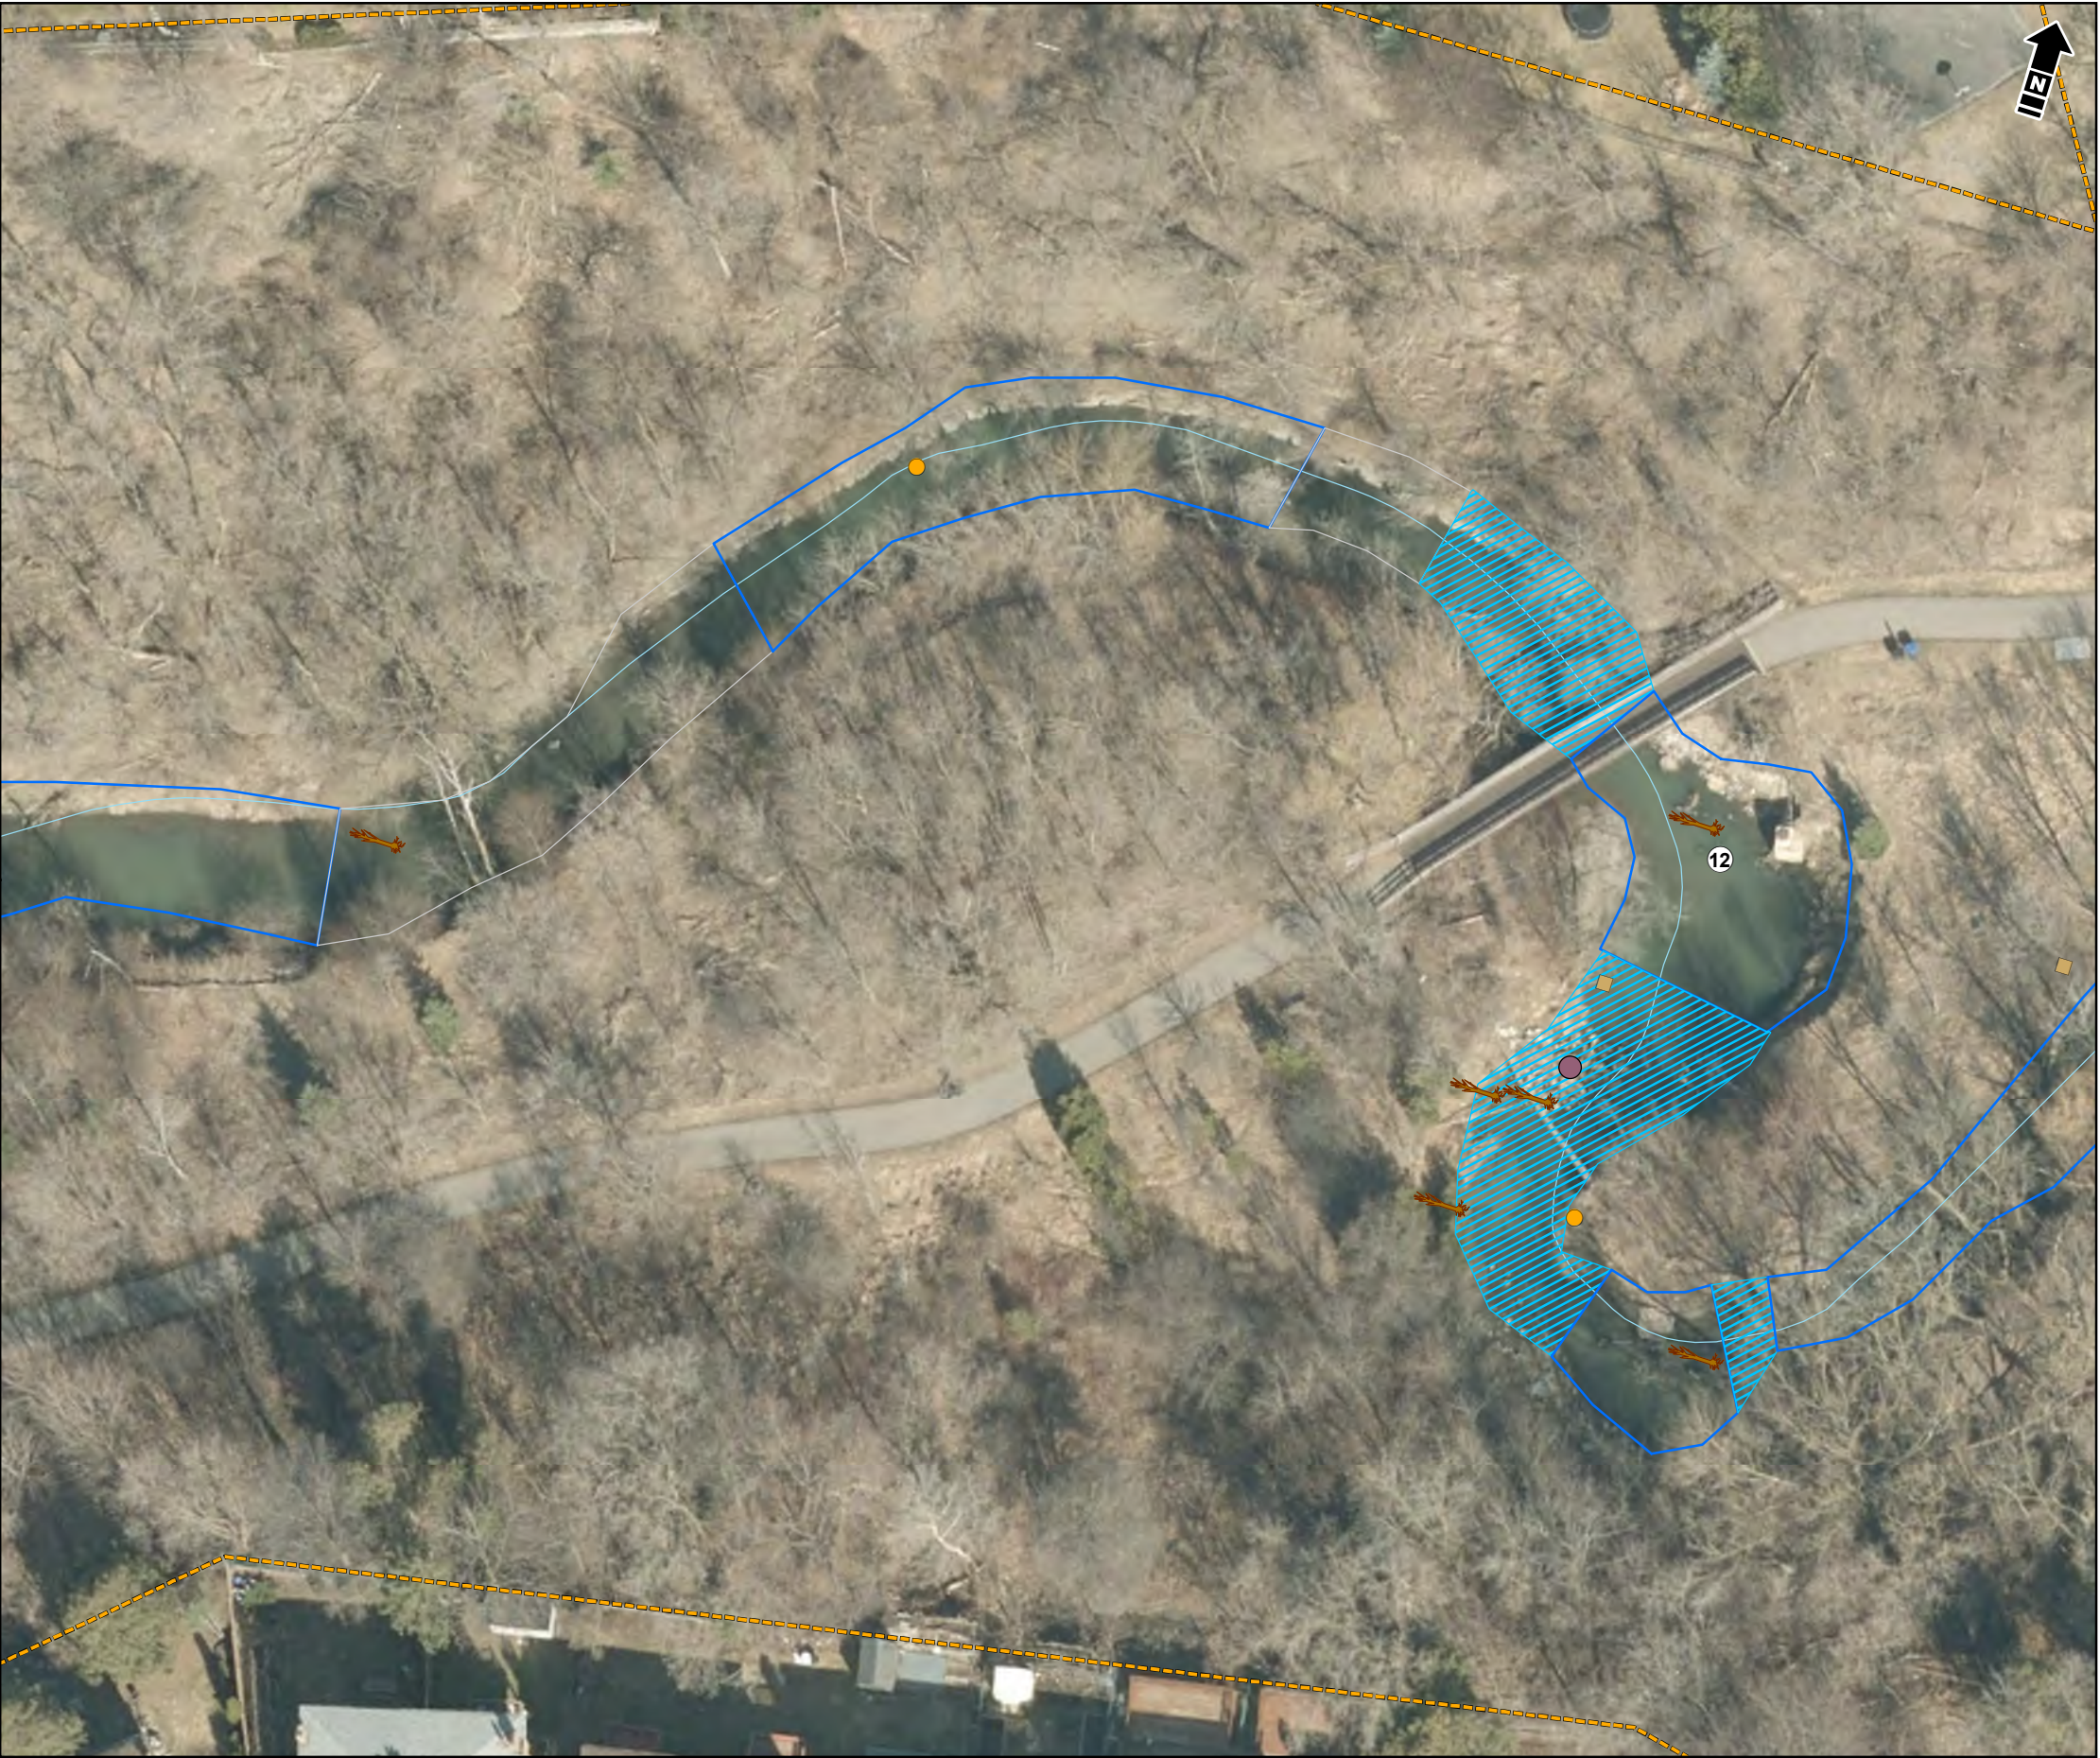
Figure C8h

Notes:
12. Pool with a wetted depth of over 1m. Banks eroded. Sandy substrate.

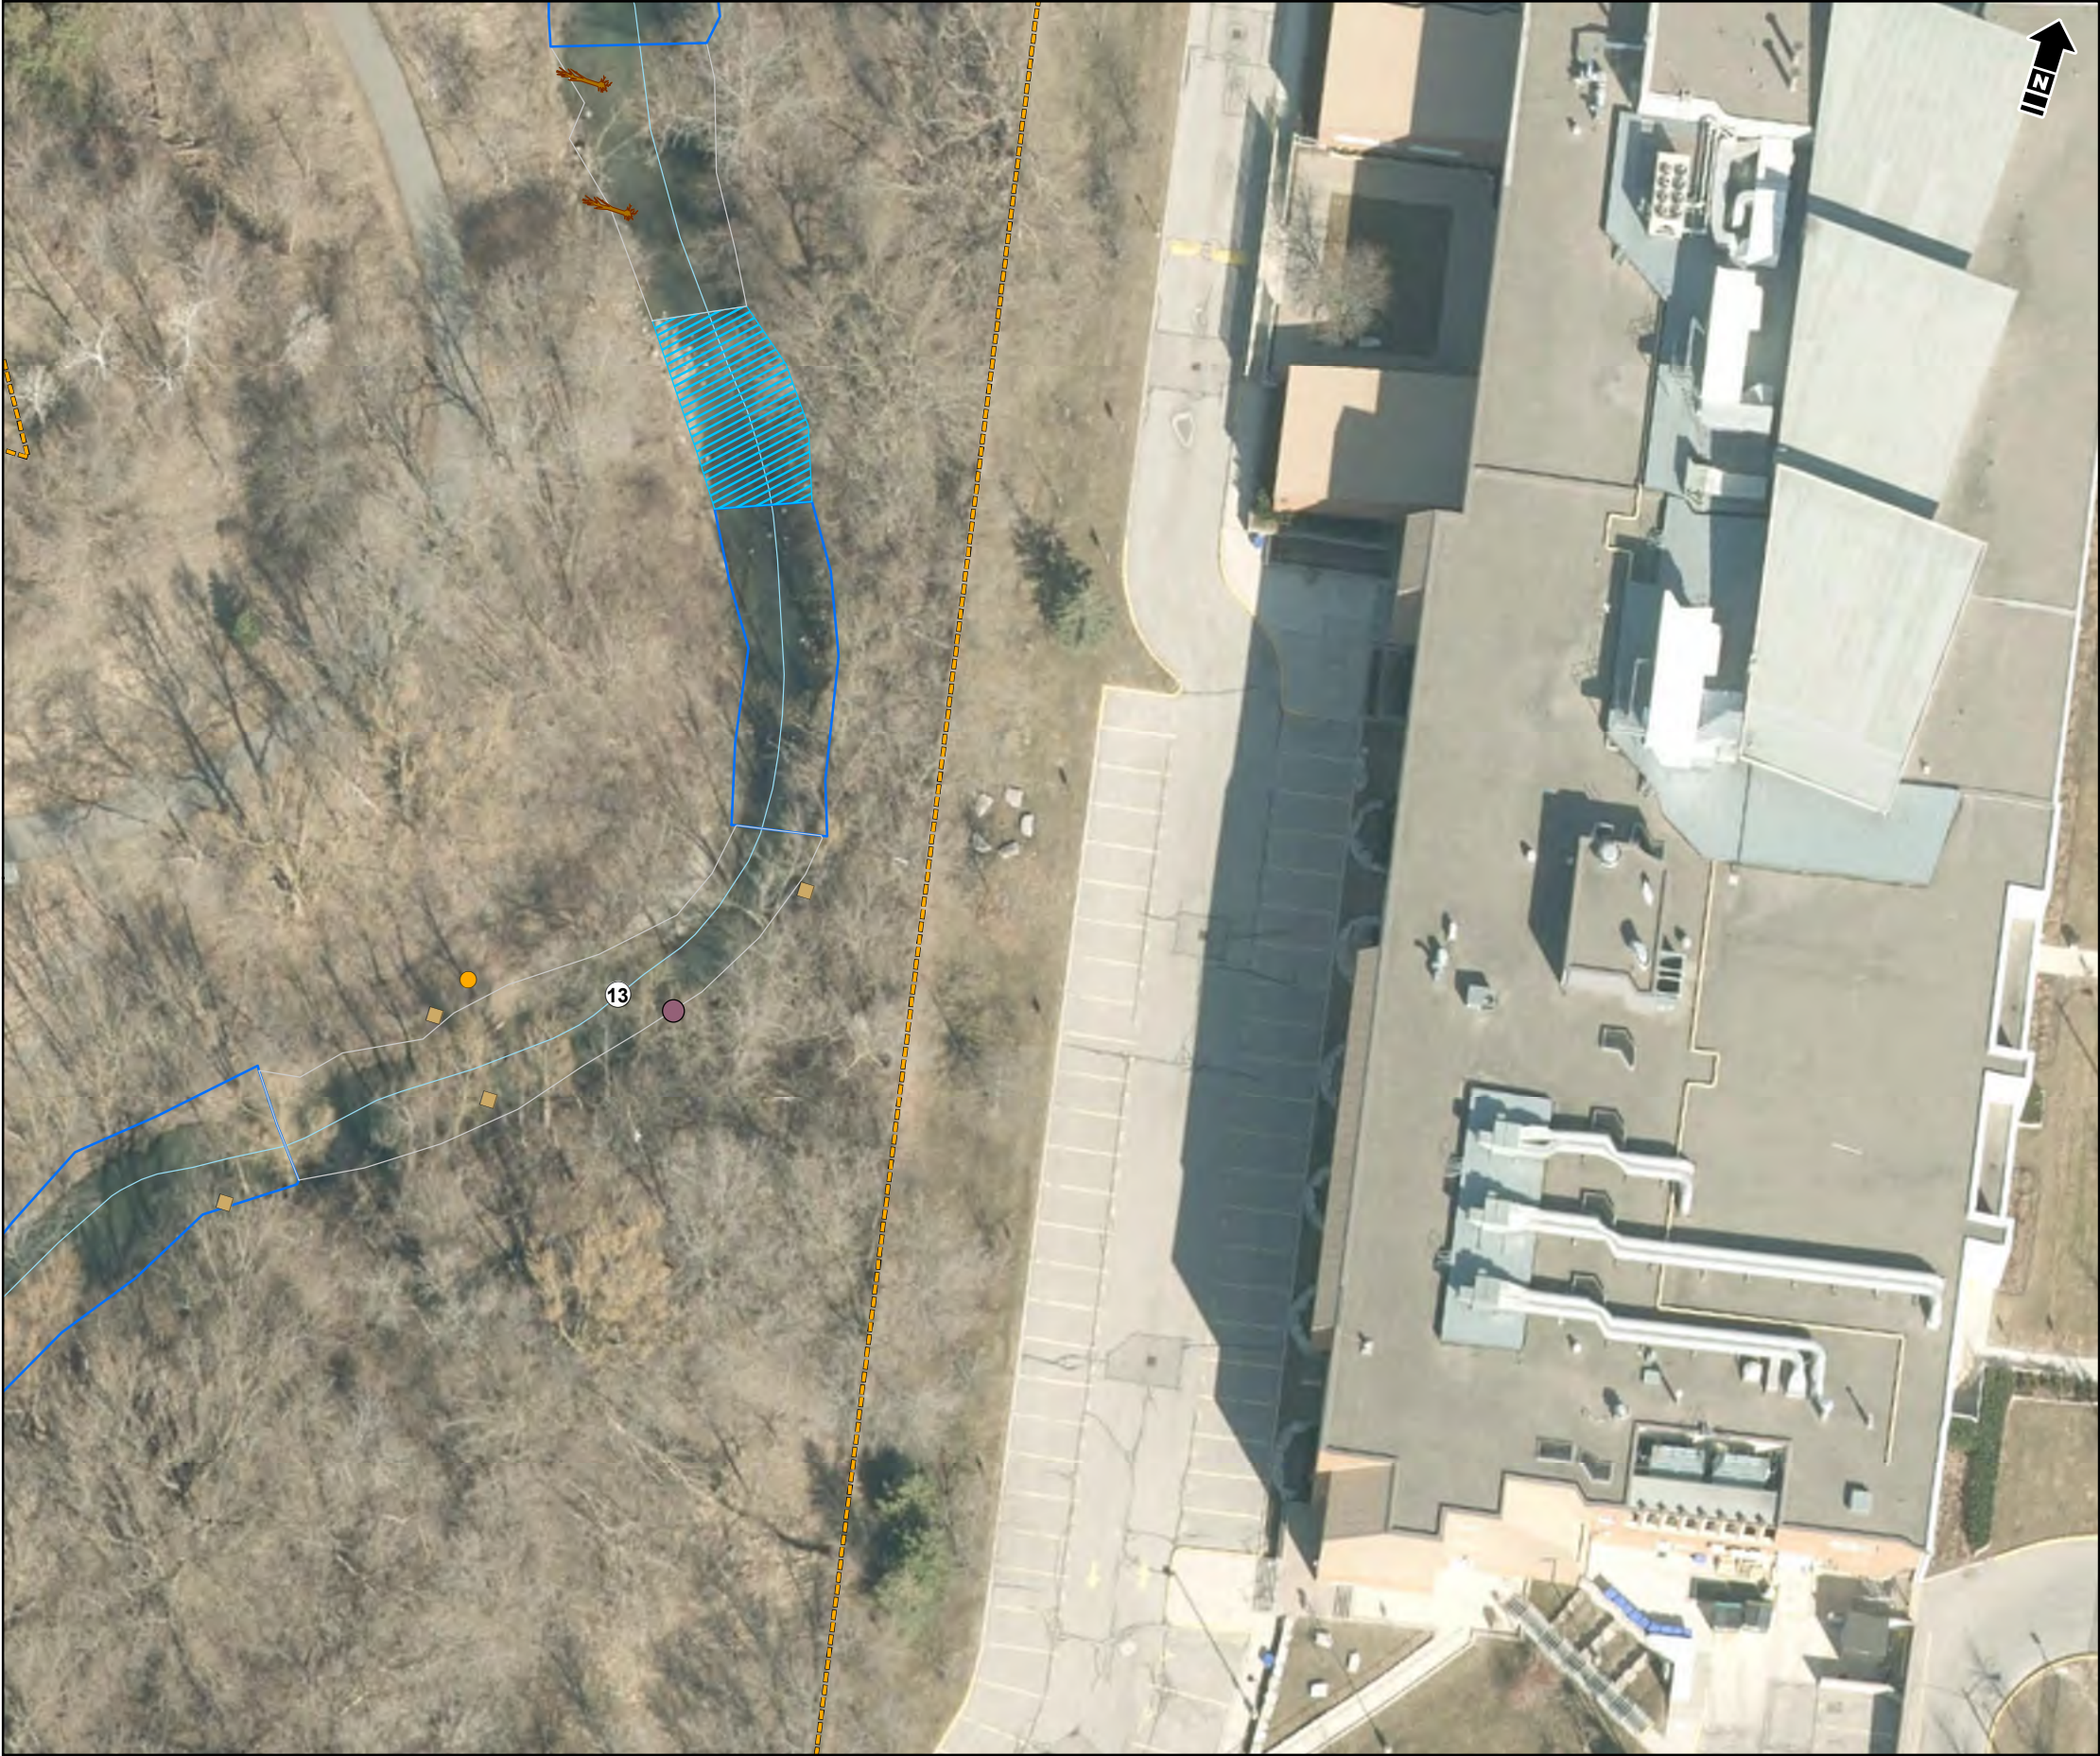
Figure C8i

Notes:
13. Run with some pools concentrated along the banks with a wetted depth of 24-34 cm. Sandy gravel substrate.

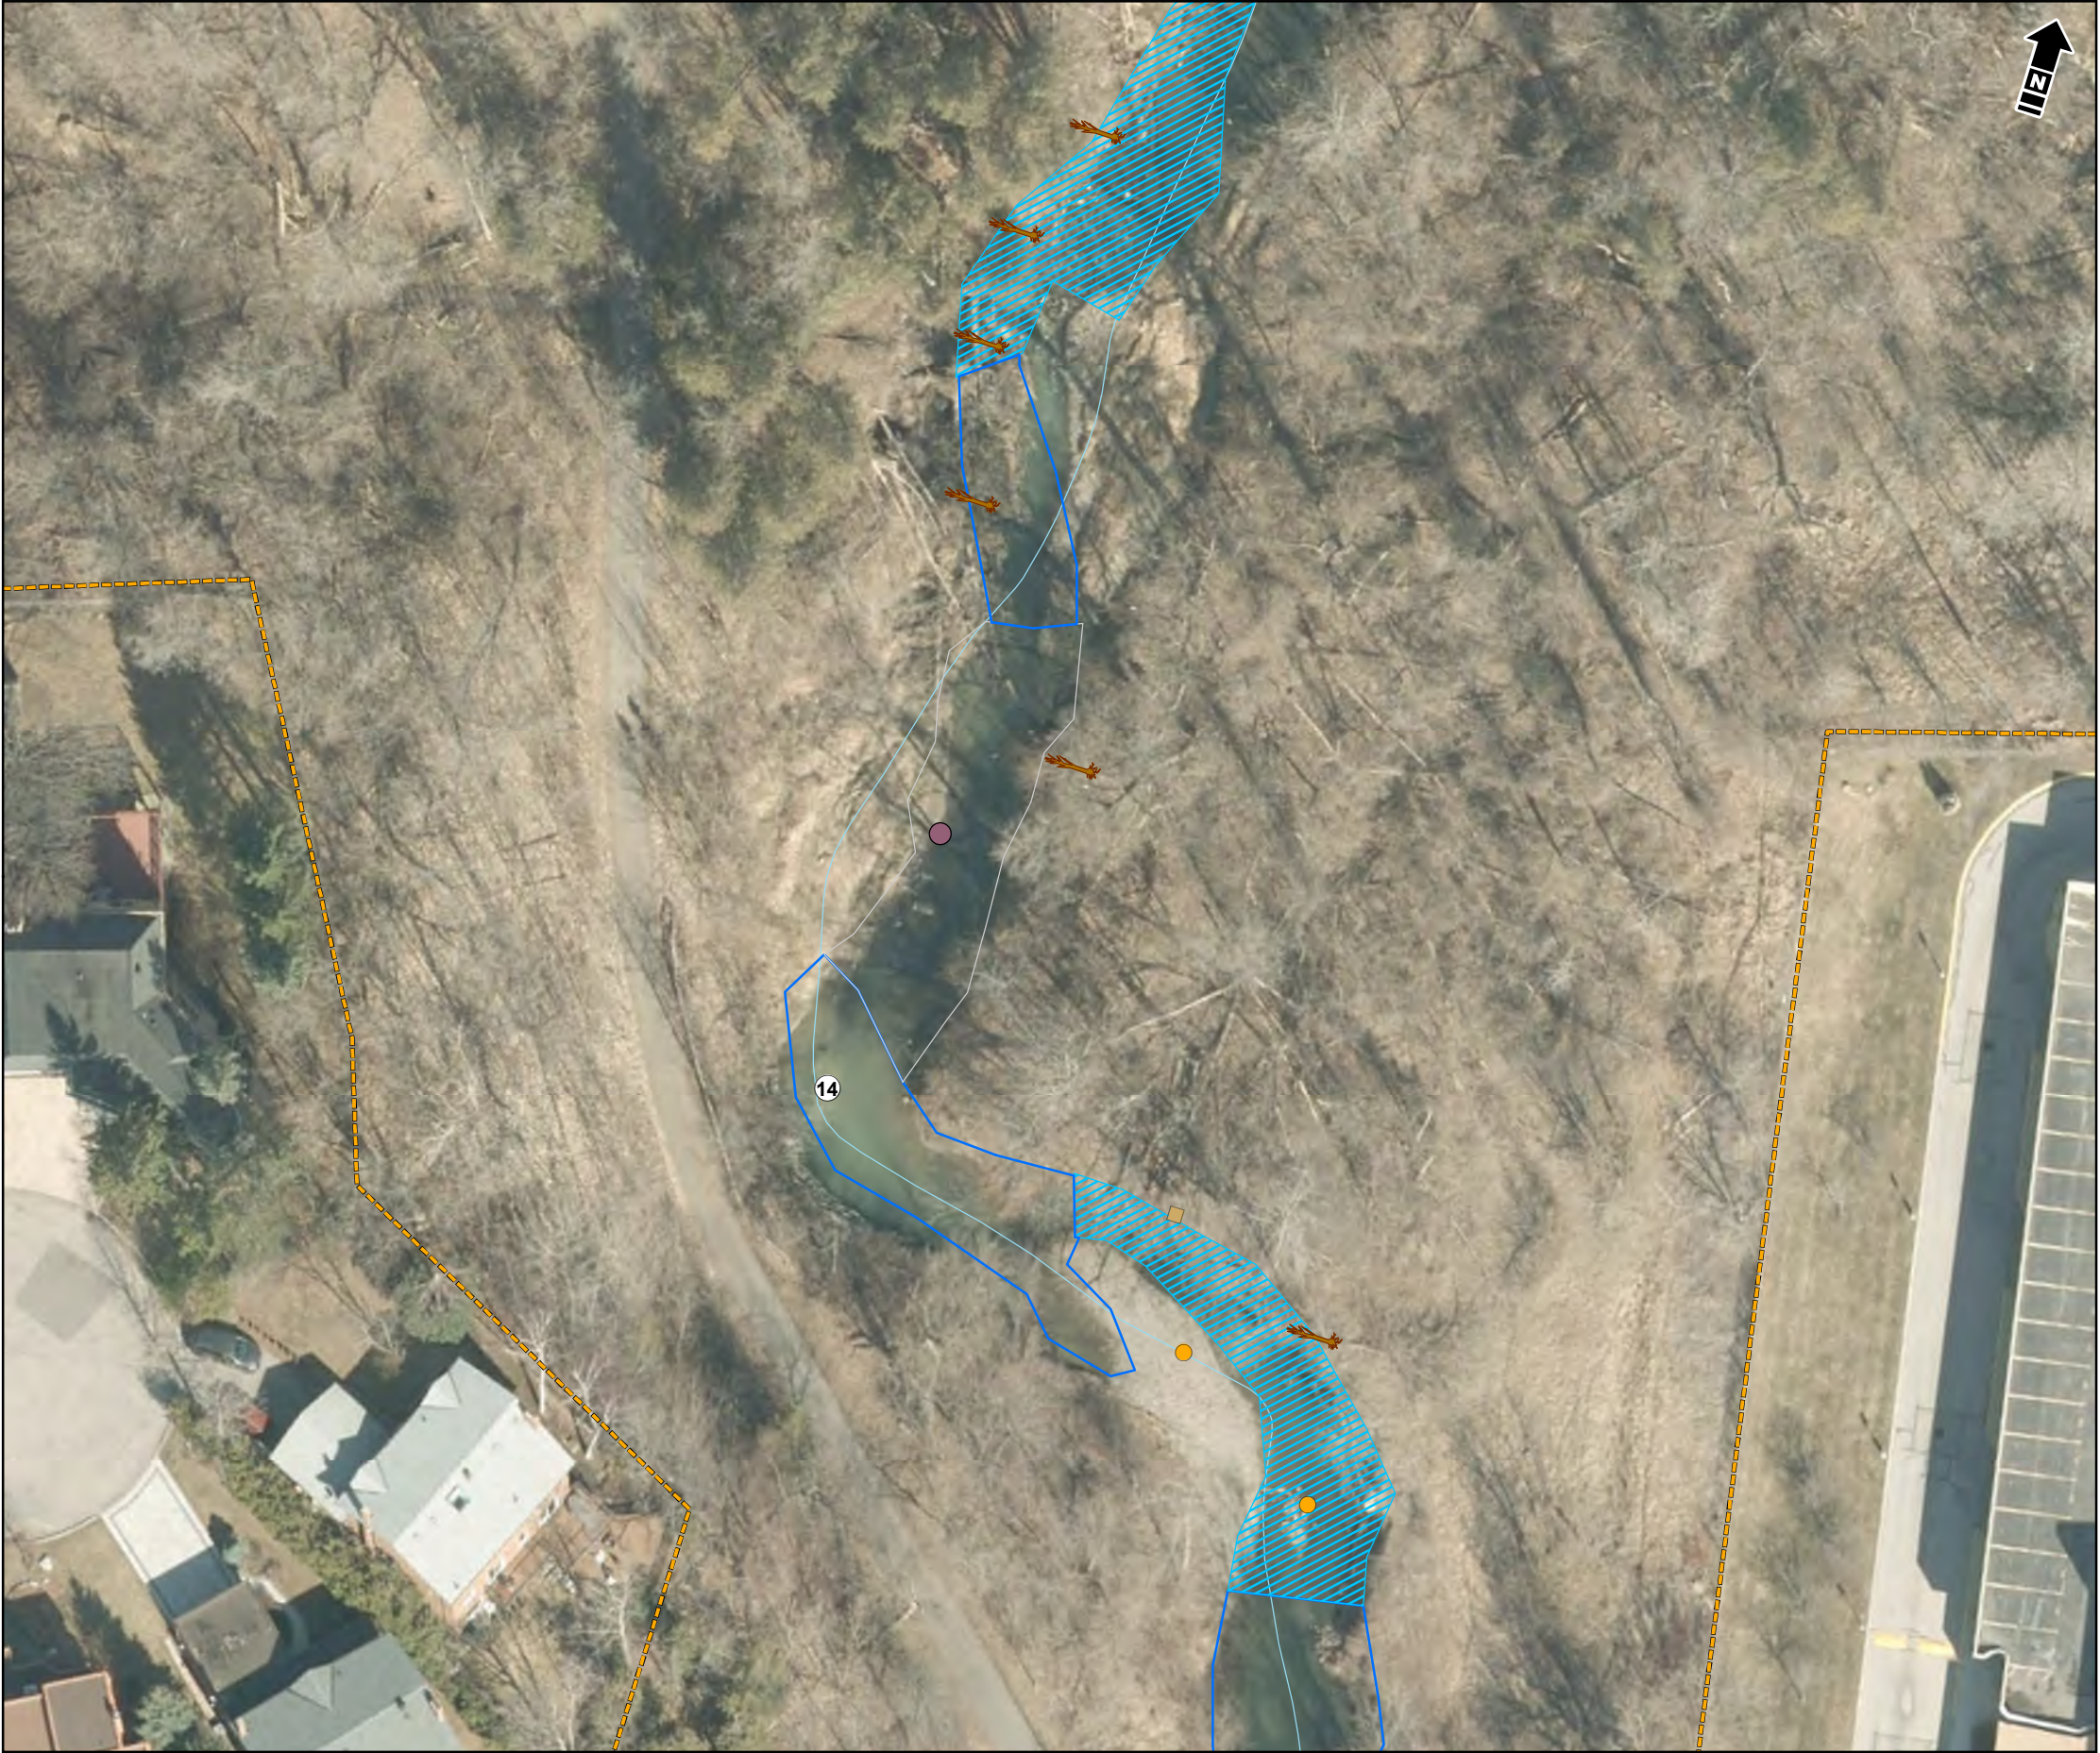
Notes:
14. Pool with a wetted depth of over 2m. Left bank armourstone, right bank eroded.
Sandy gravel substrate.
