APPENDIX C
Characterization and Development of Alternatives
(Phase 2)

Ecological Characterization

Ecological Field Methods

ECOLOGICAL CHARACTERIZATION METHODOLOGY

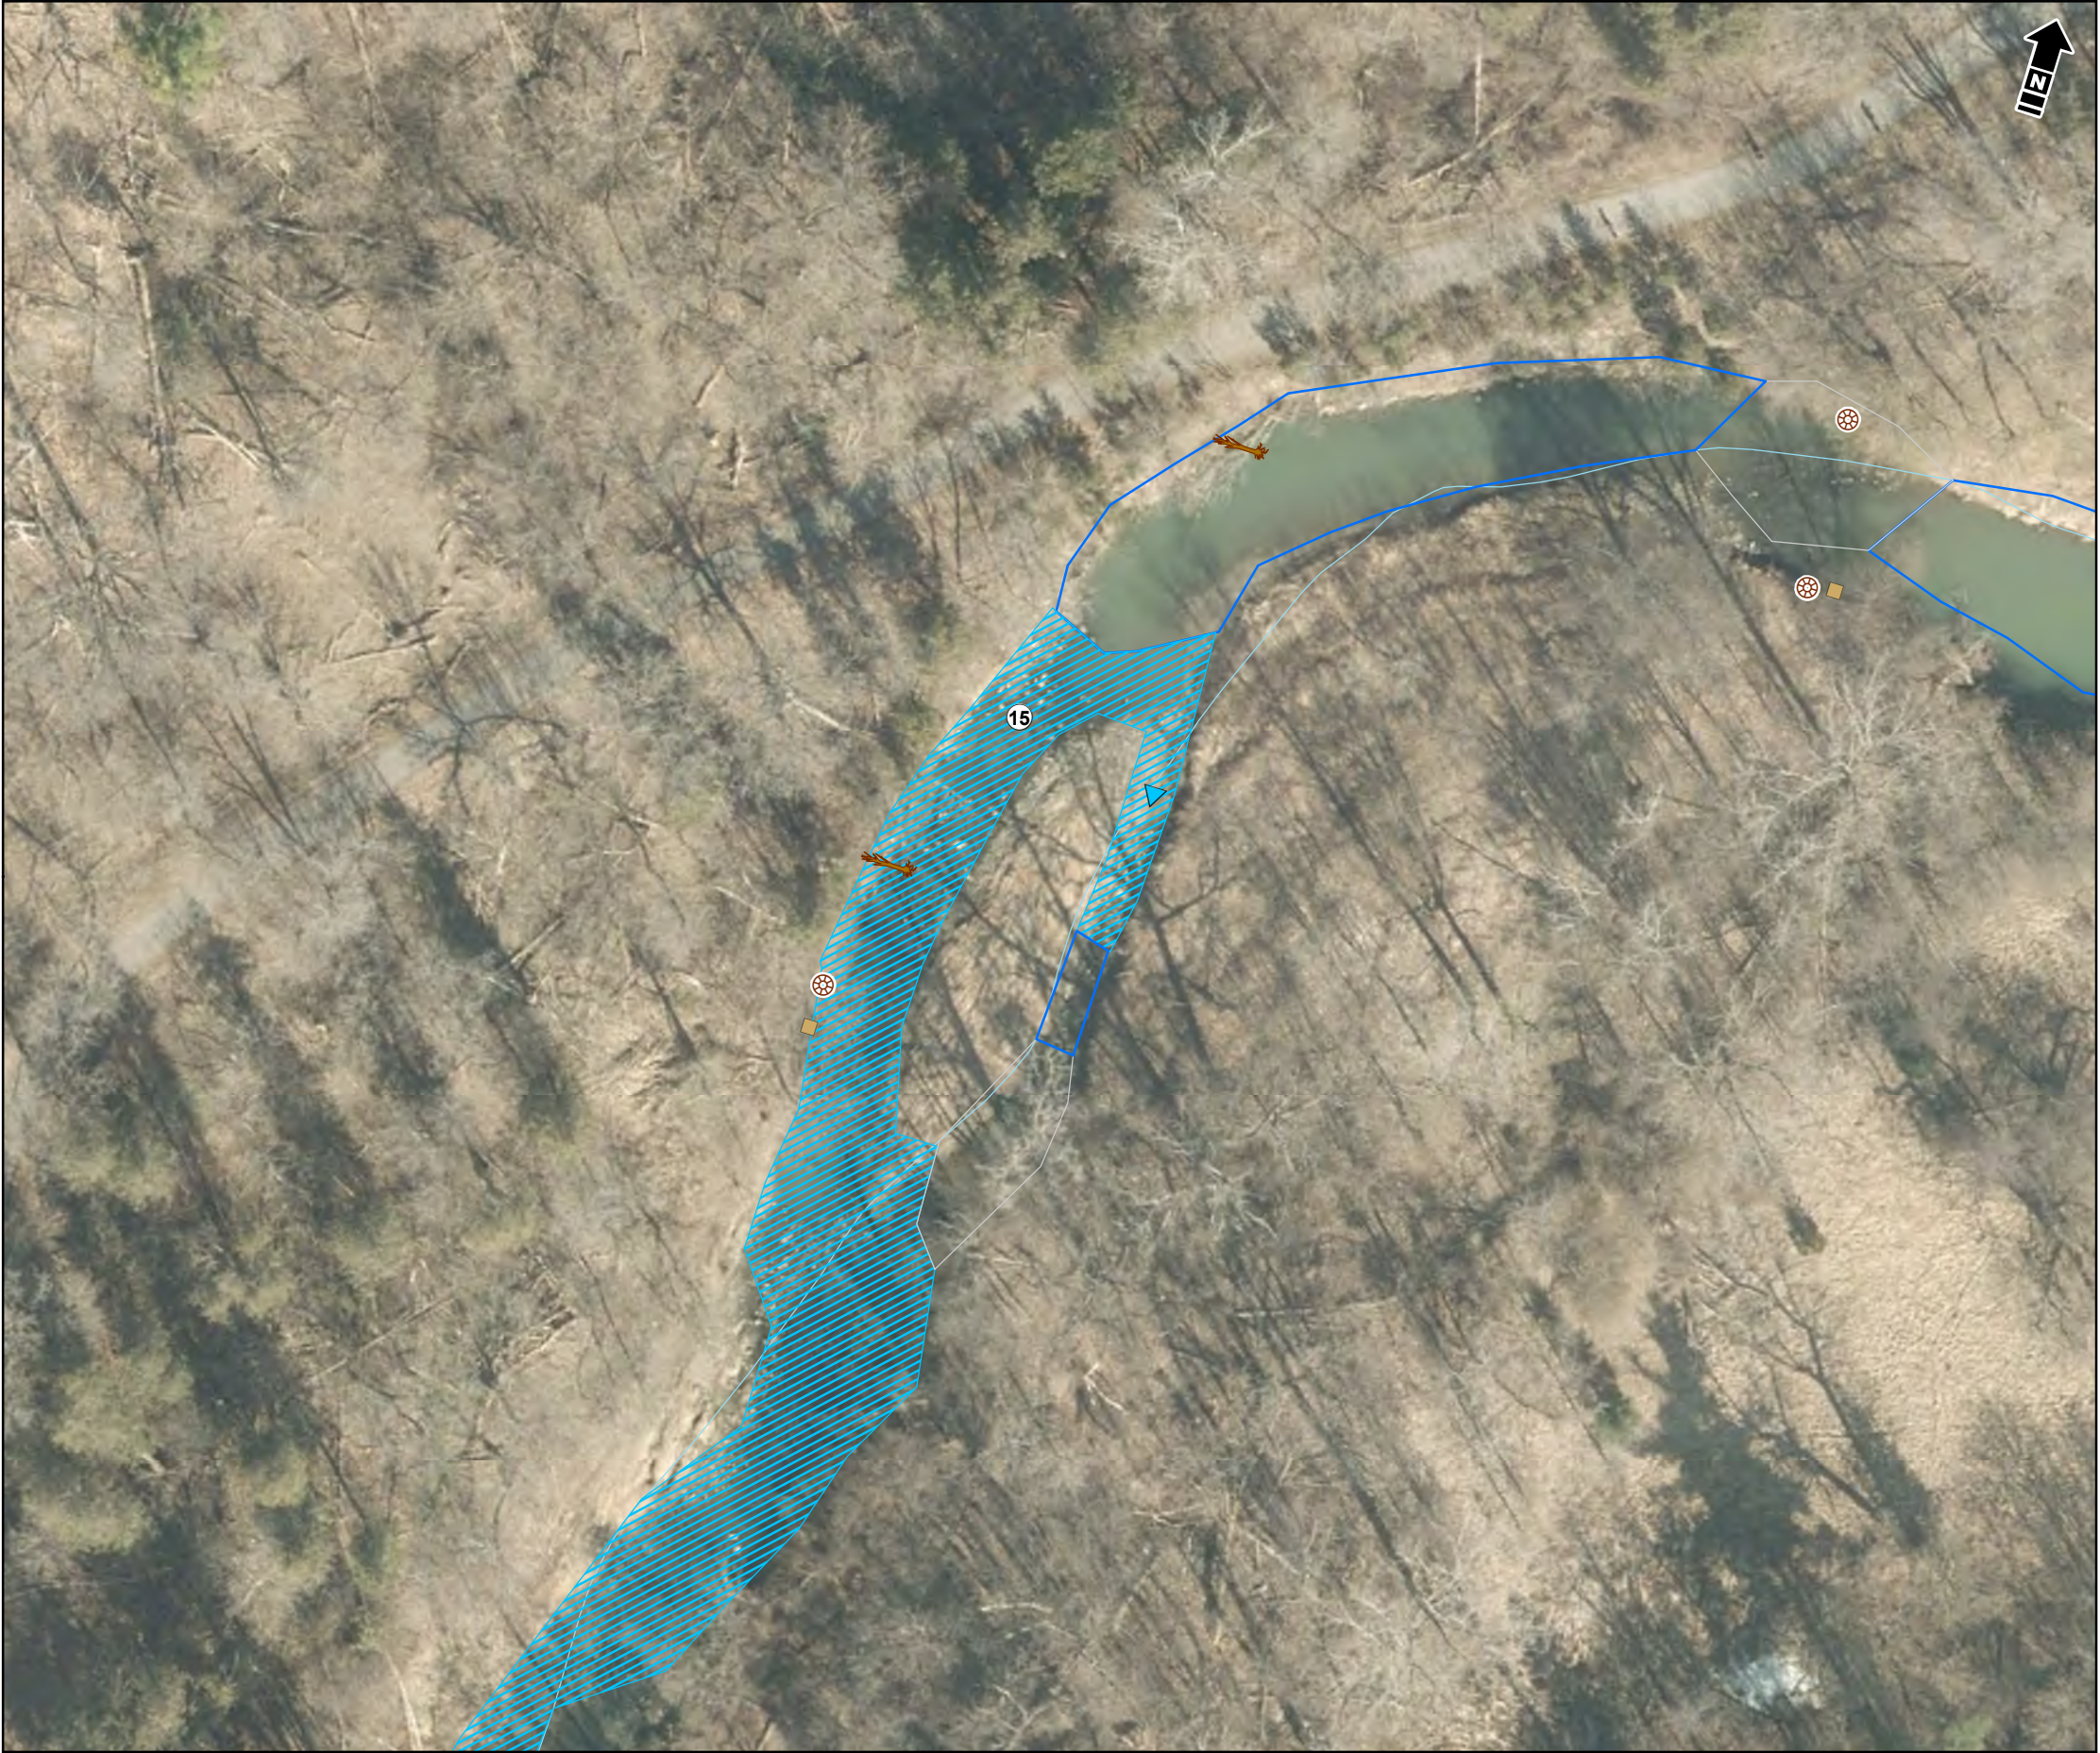
Notes:
15. Riffle with a wetted depth of 32-12cm. Vegetated banks with island near the left bank. Gravel and cobble substrate.

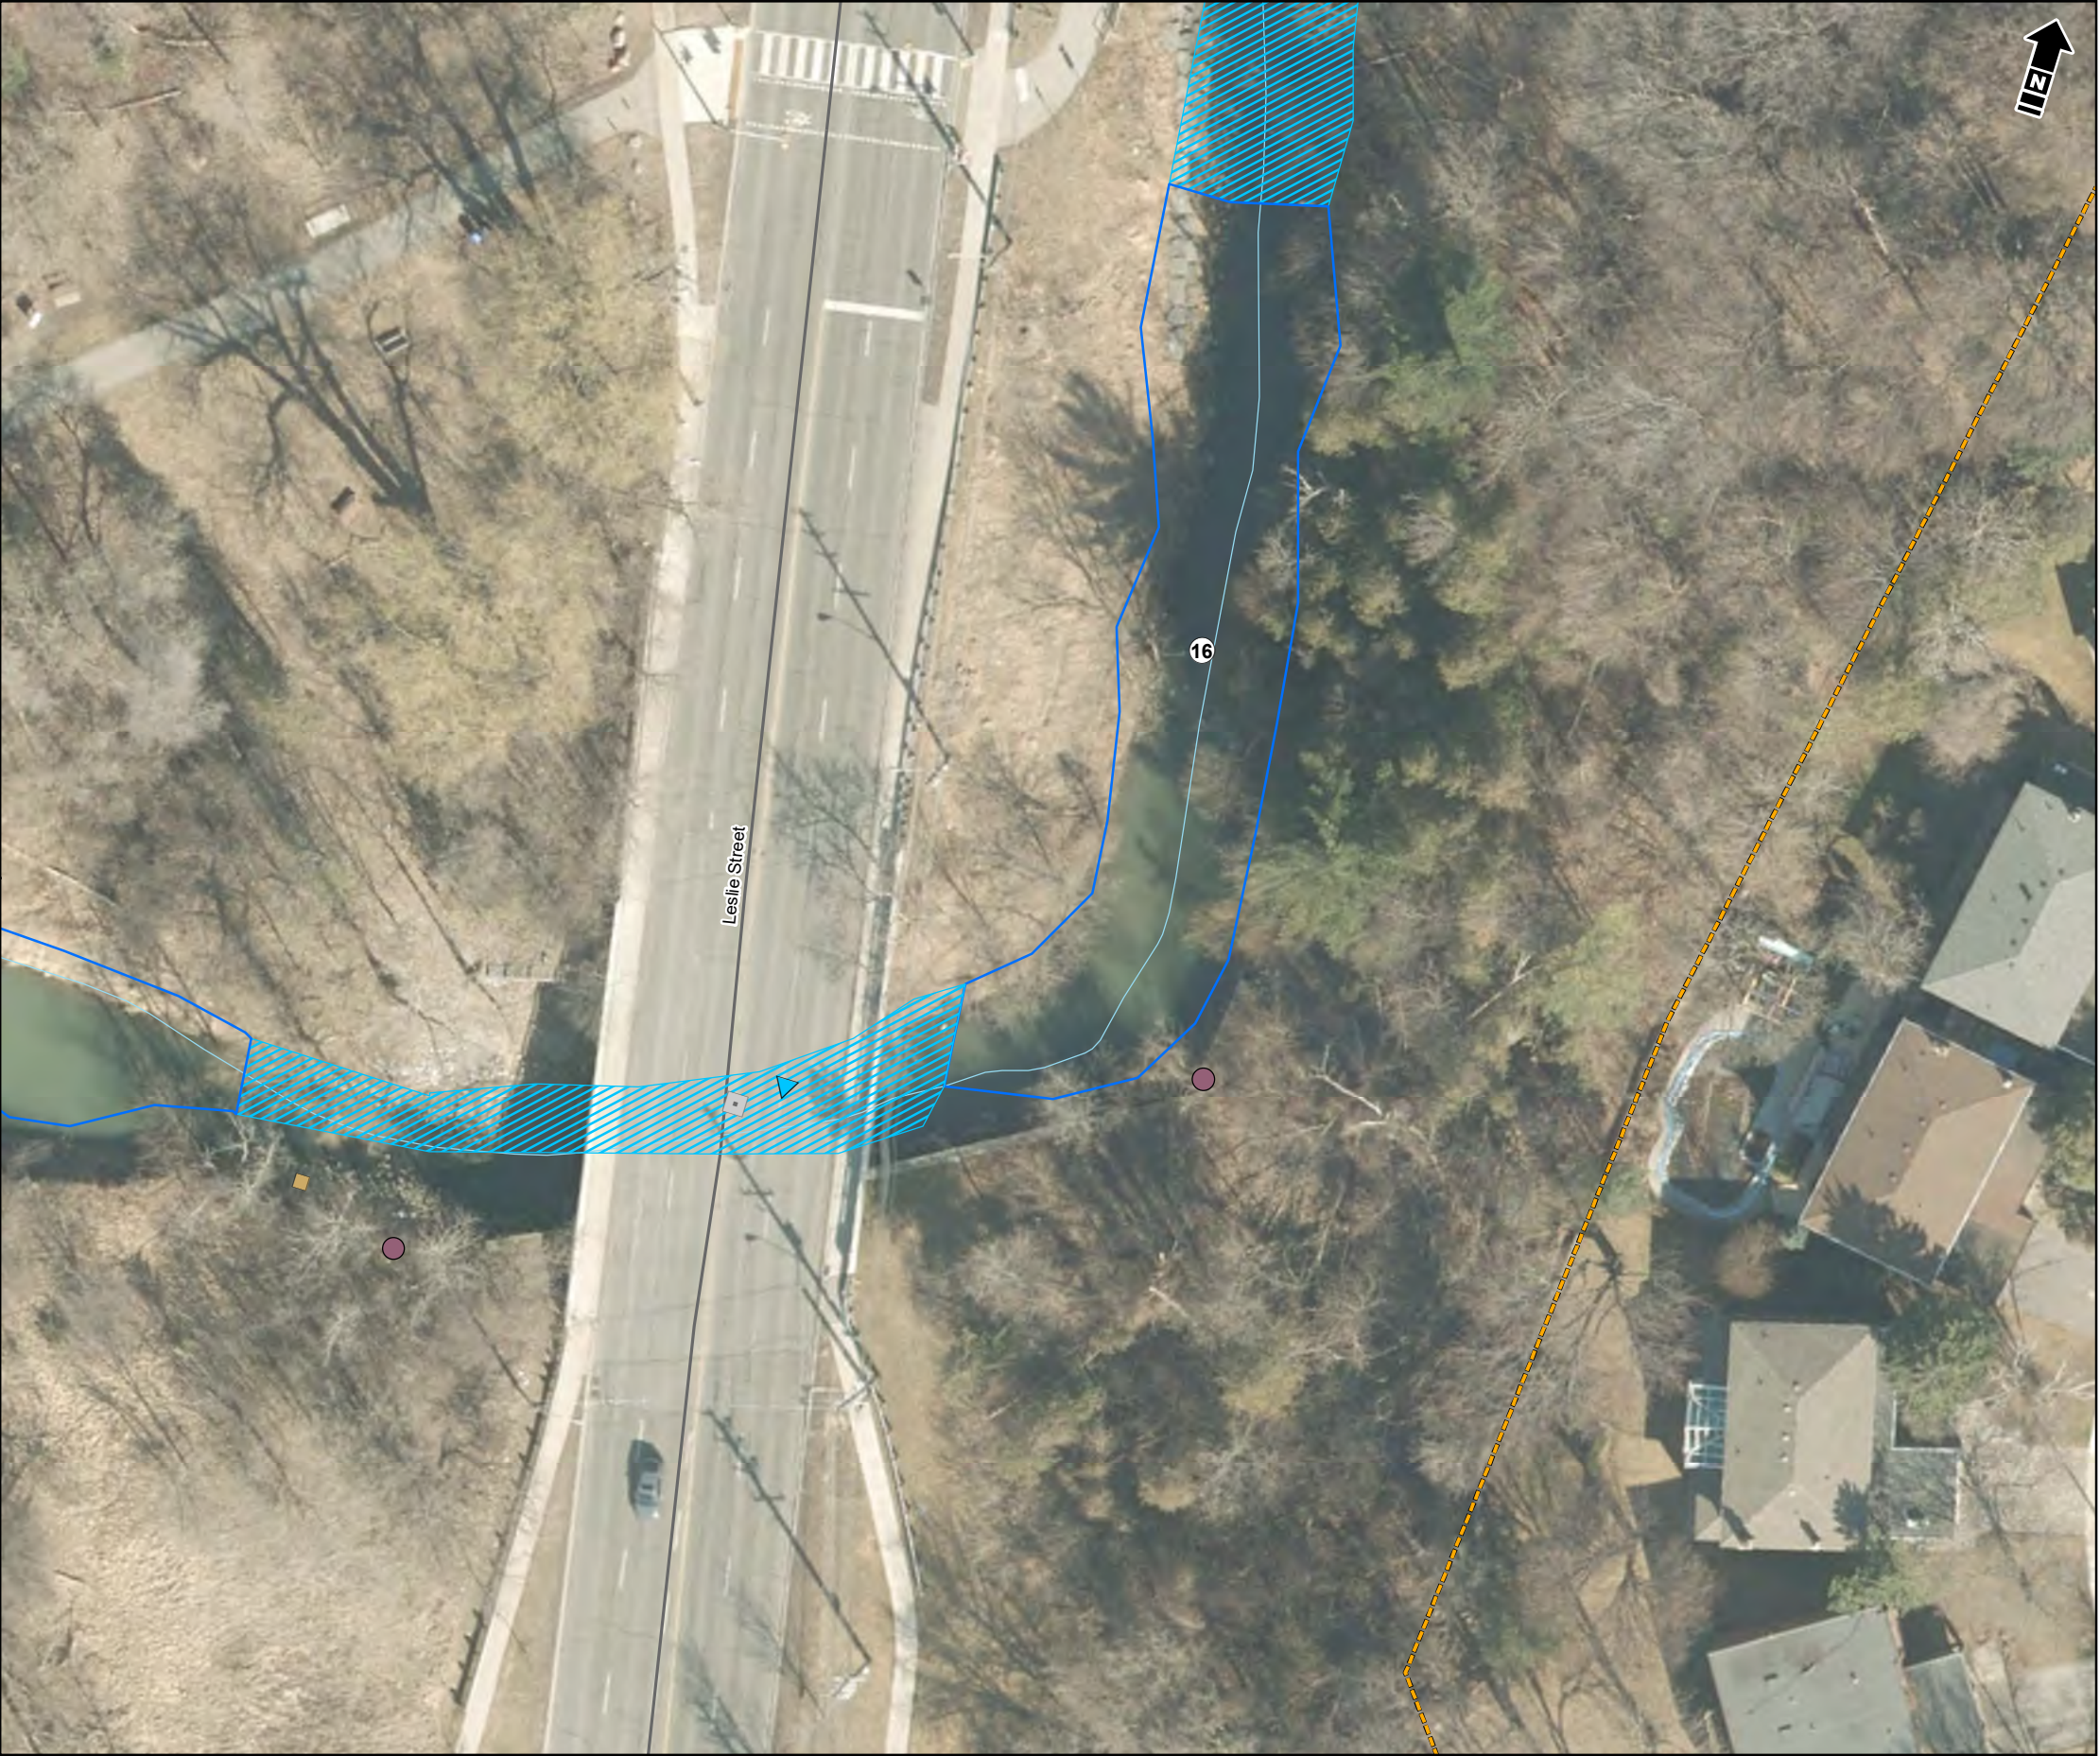
Notes:
16. Pool with a wetted width of 8.80m and wetted depth of 48 cm. Banks with overhanging vegetation and a pedestrian path on the left bank. Sandy gravel substrate.

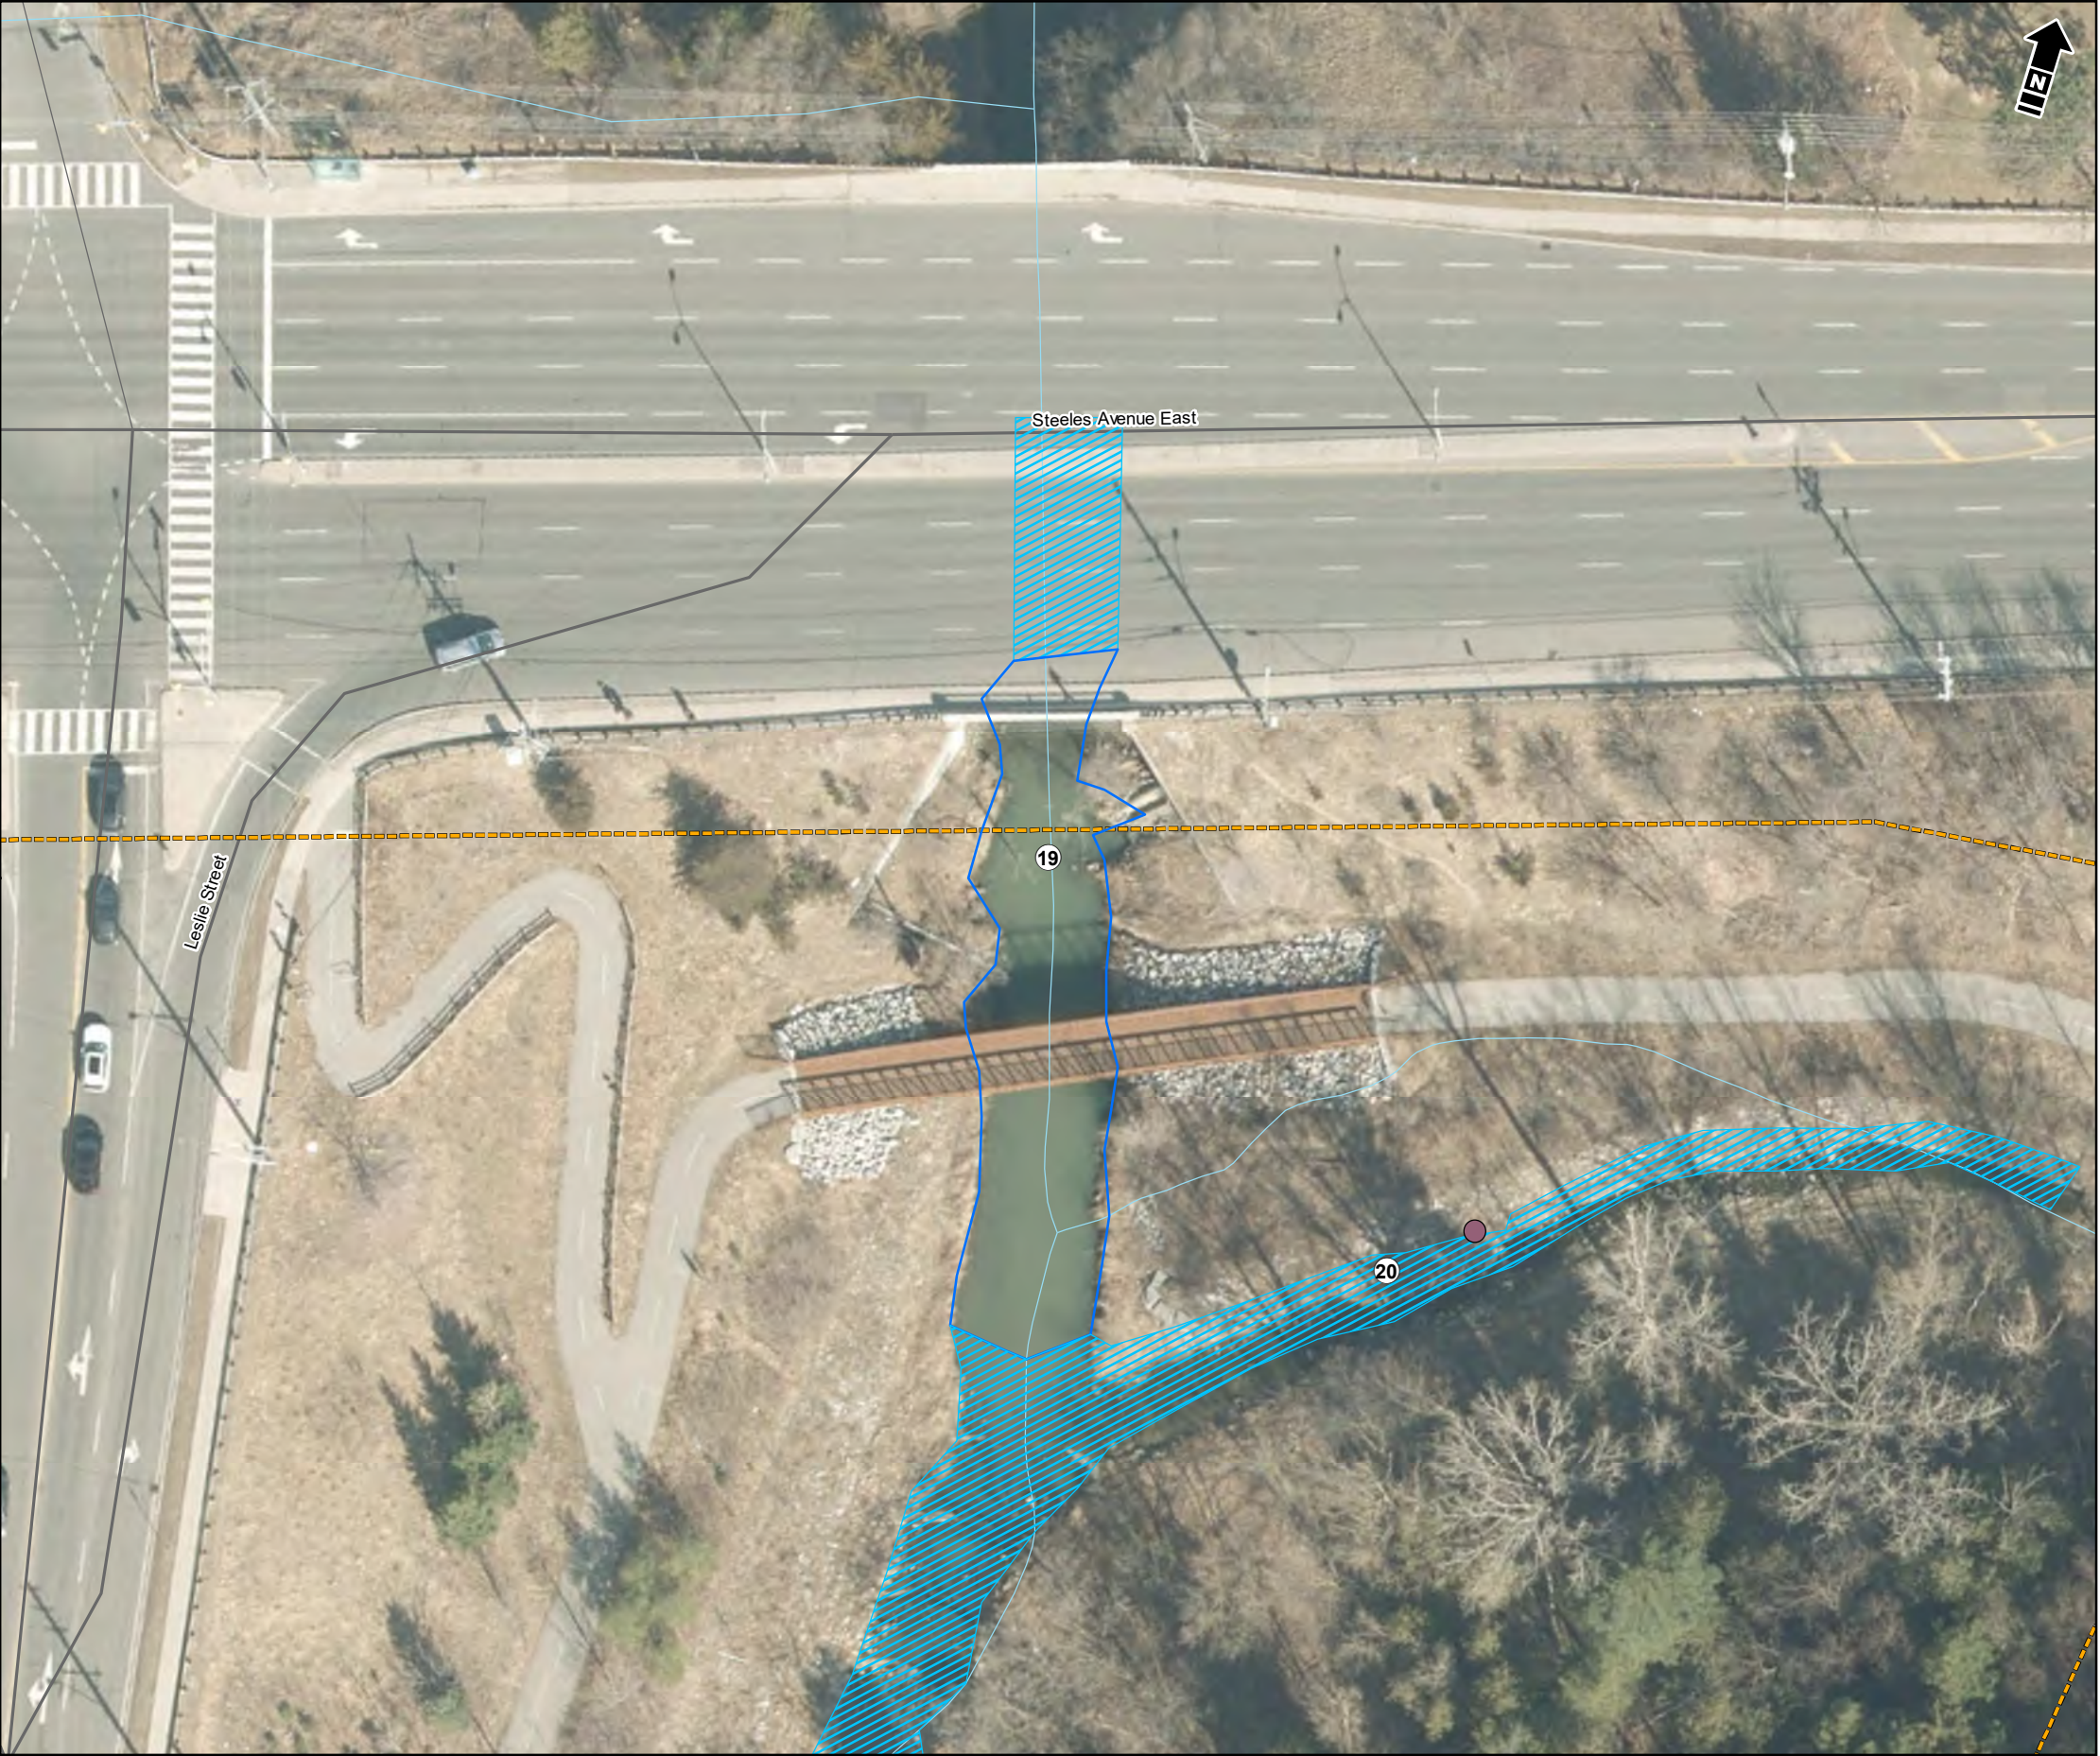
Figure C8n

Notes:
19. Pool with a wetted width of 10.20 m and wetted depth of 1m. Both banks vegetated with tall grasses and shrubs. Sandy substrate.
20. Riffle with a wetted width of 2.3m and wetted depth of 19cm. Armoustone on right and left bank. Boulder and cobble substrate.

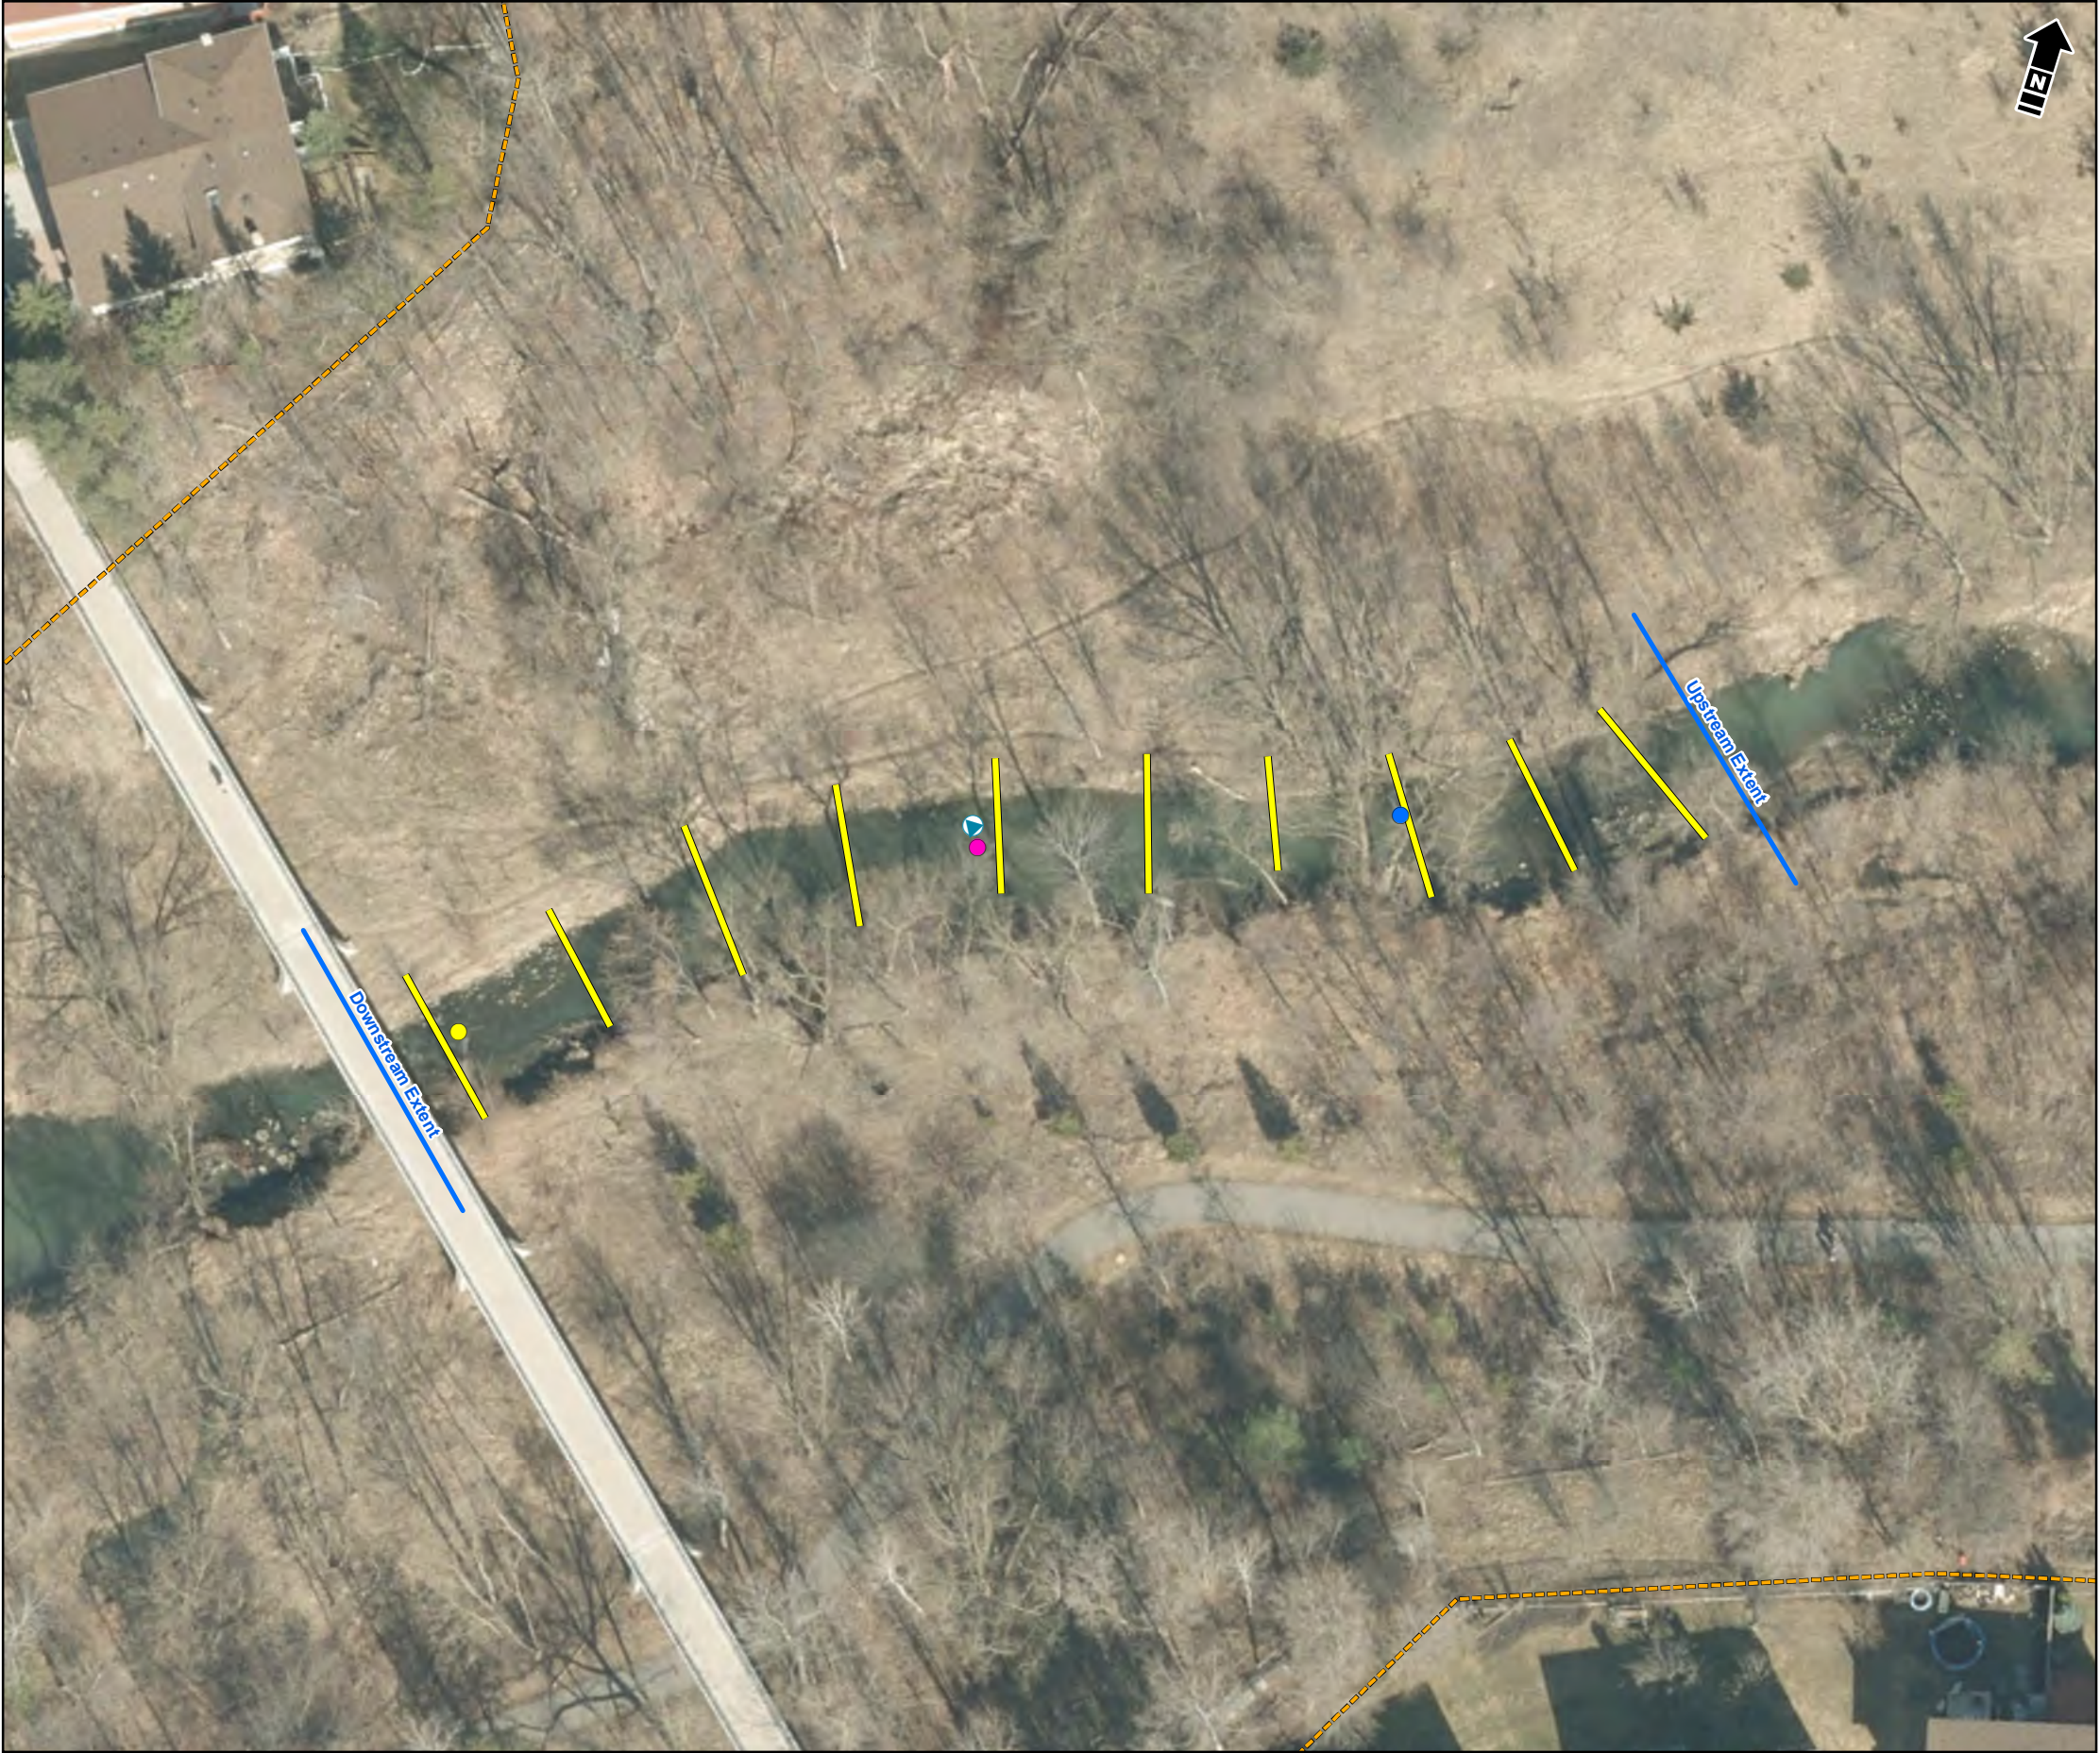
- German Mills Creek GSMP Critical Area
- OSAP Transect
- Upstream/Downstream Extent
- Water Quality Sample
- Benthic Location**
 - Pool
 - Riffle
 - Run

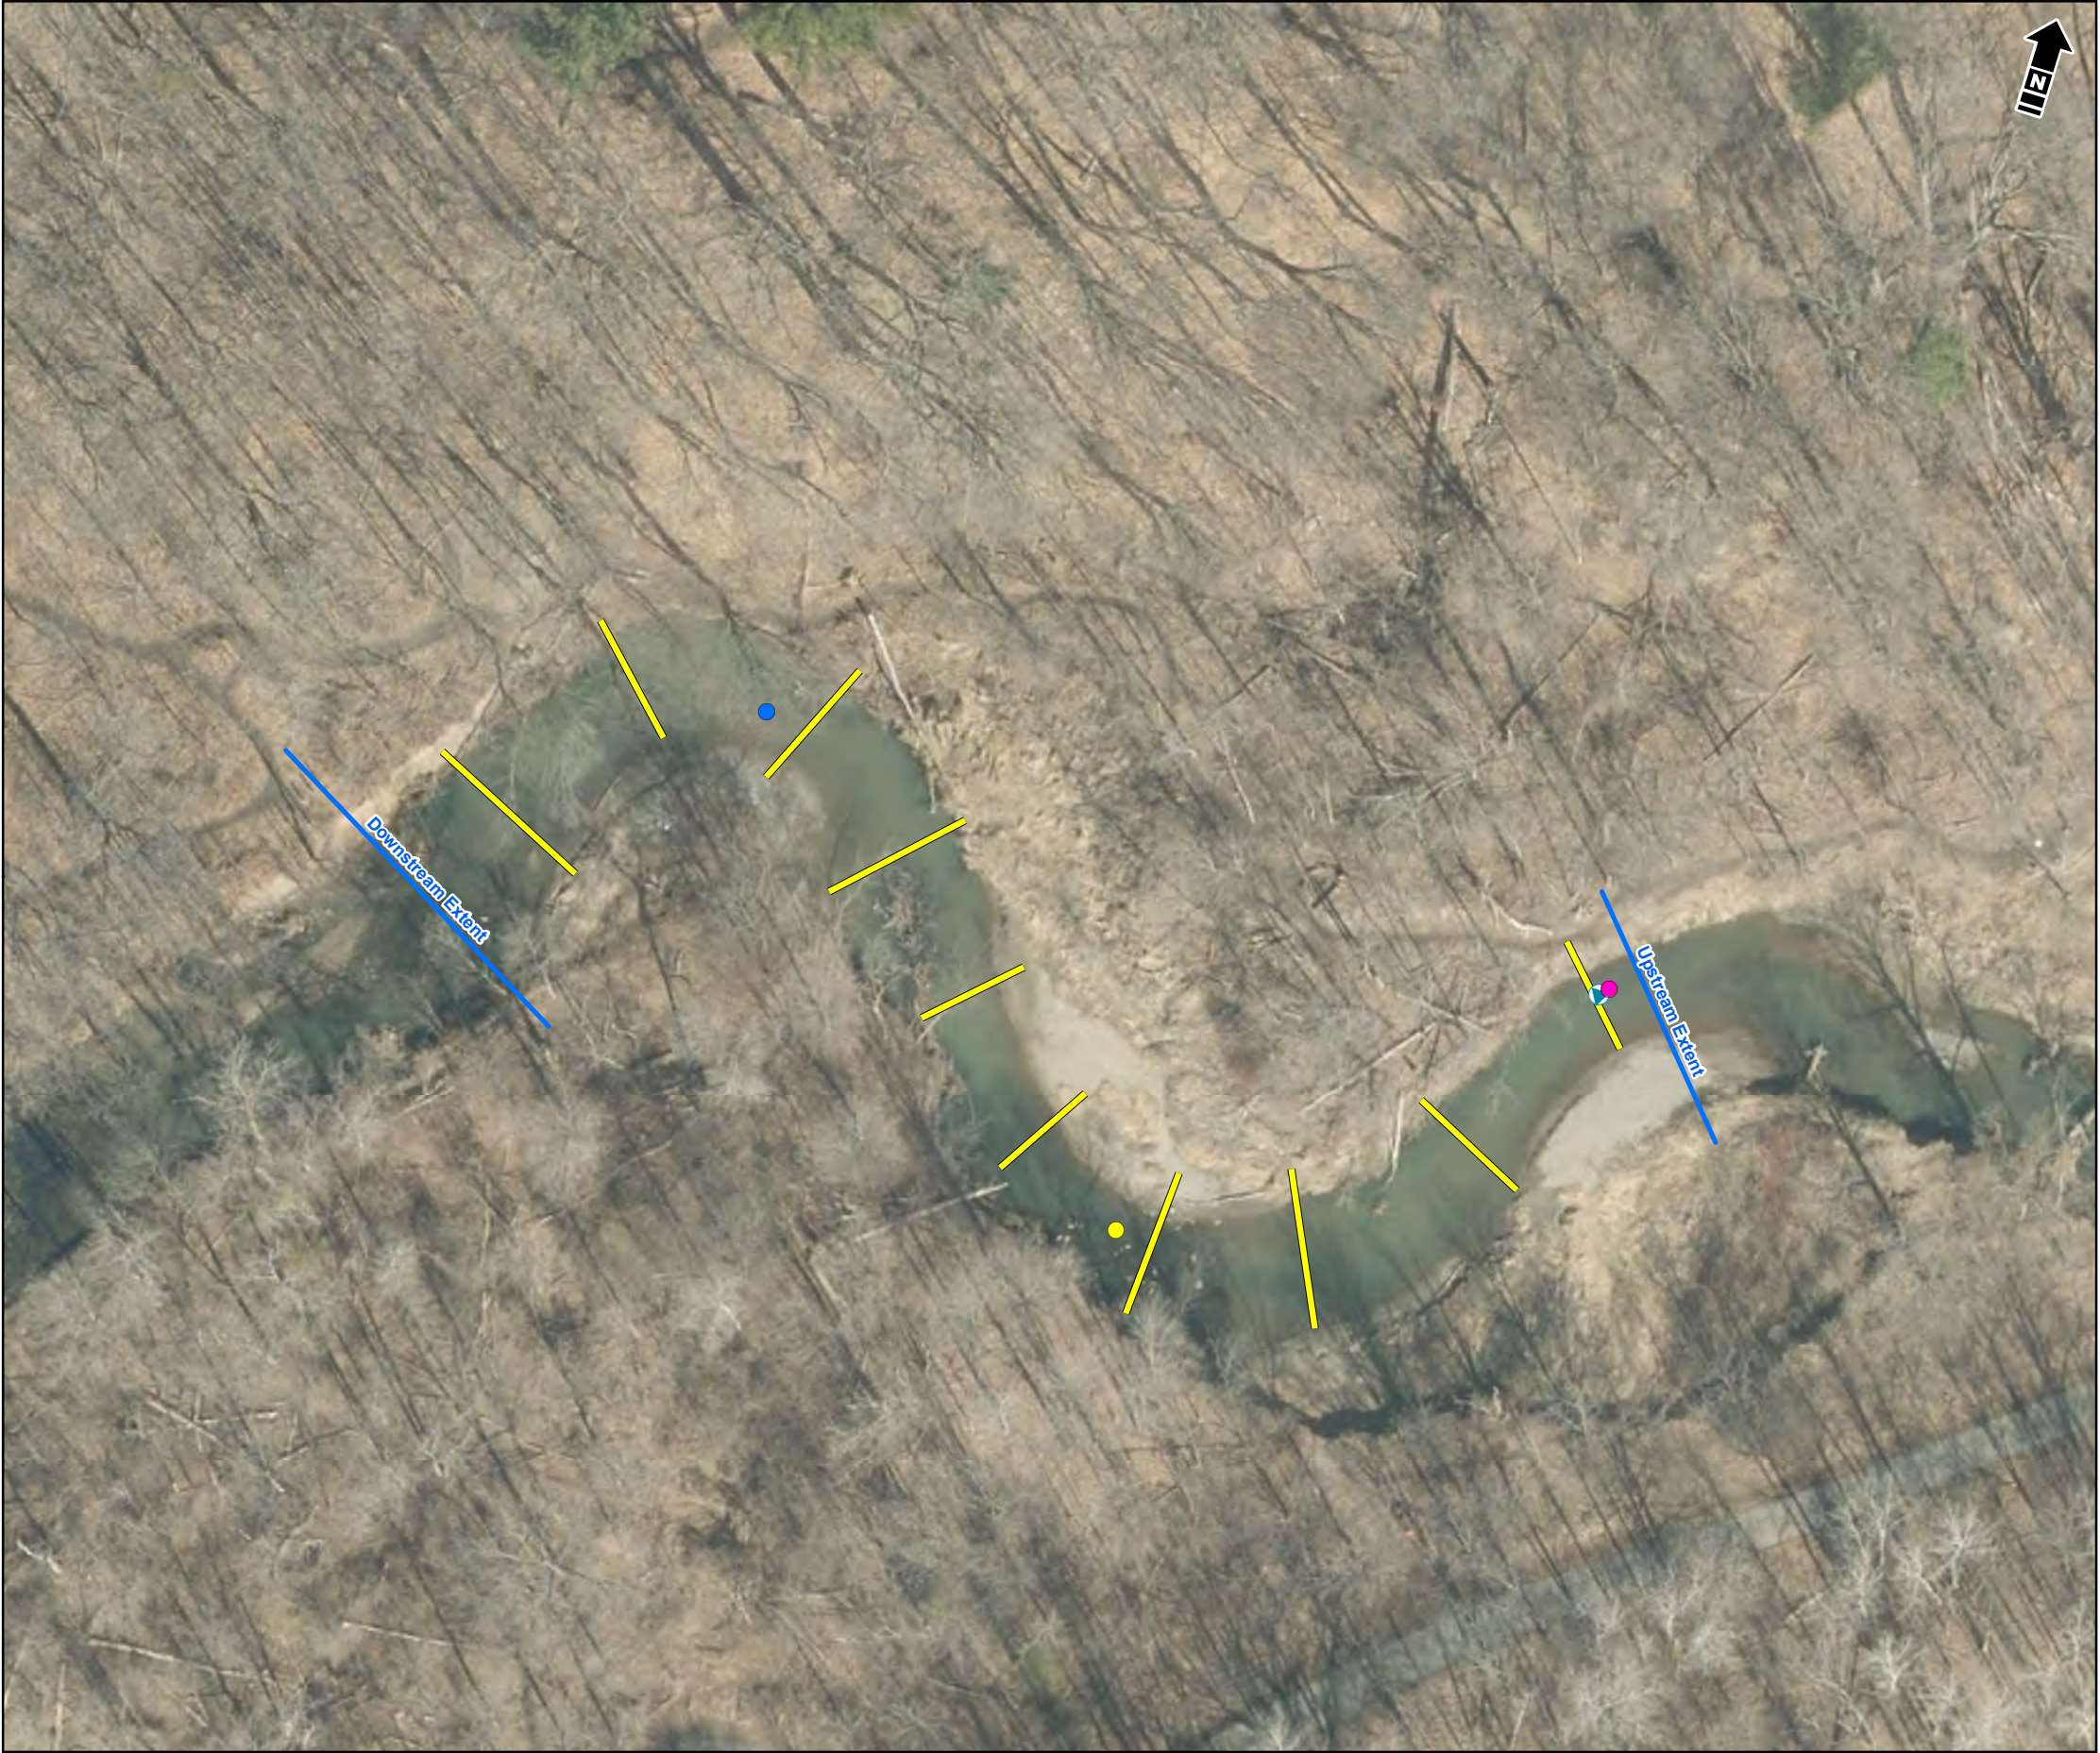
I:\Client\Toronto\32227\FiguresAndTables\ECL\2021\Report\Figure-H4-13-Monitoring_Station_3.mxd - Tab001_L - 14-Jul-22 08:04 PM - mwright - TD005

- German Mills Creek GSMP Critical Area
 - OSAP Transect
 - Upstream/Downstream Extent
 - Water Quality Sample
- Benthic Location**
- Pool
 - Riffle
 - Run
