Construction Update: June 26, 2025

## Gardiner Expressway Strategic Rehabilitation: Dufferin Street to Strachan Avenue | Community Update

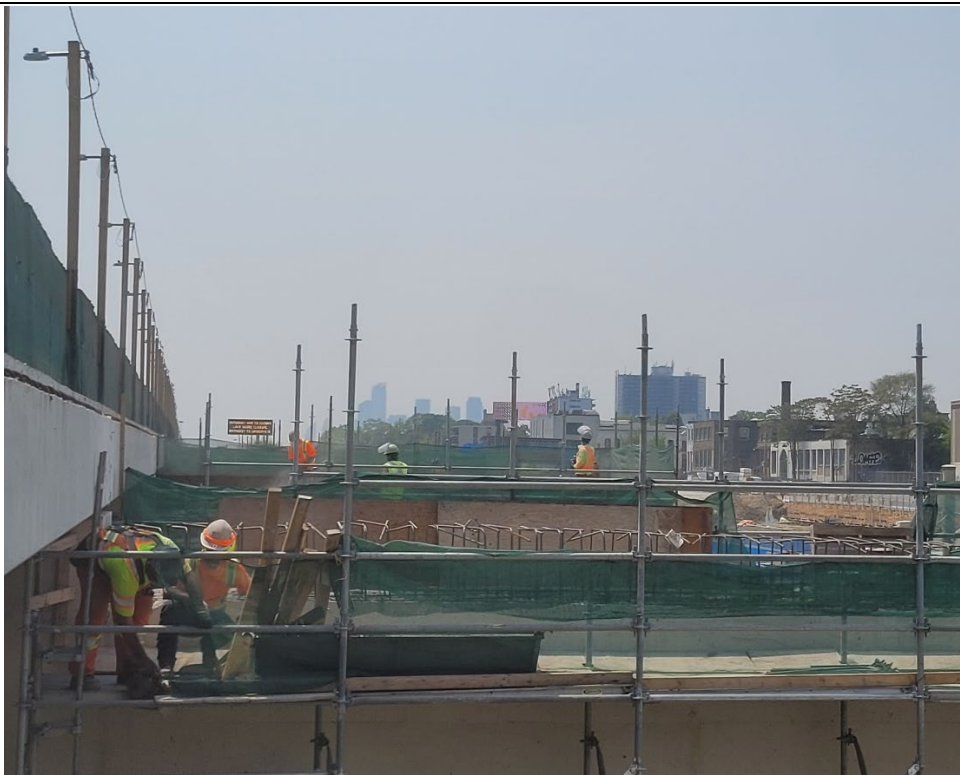
**Stage 3 Workers are installing steel dowels—short reinforcing bars—into the top of a concrete bent. These dowels will help connect the new concrete cap to the existing structure, making it stronger and more stable**

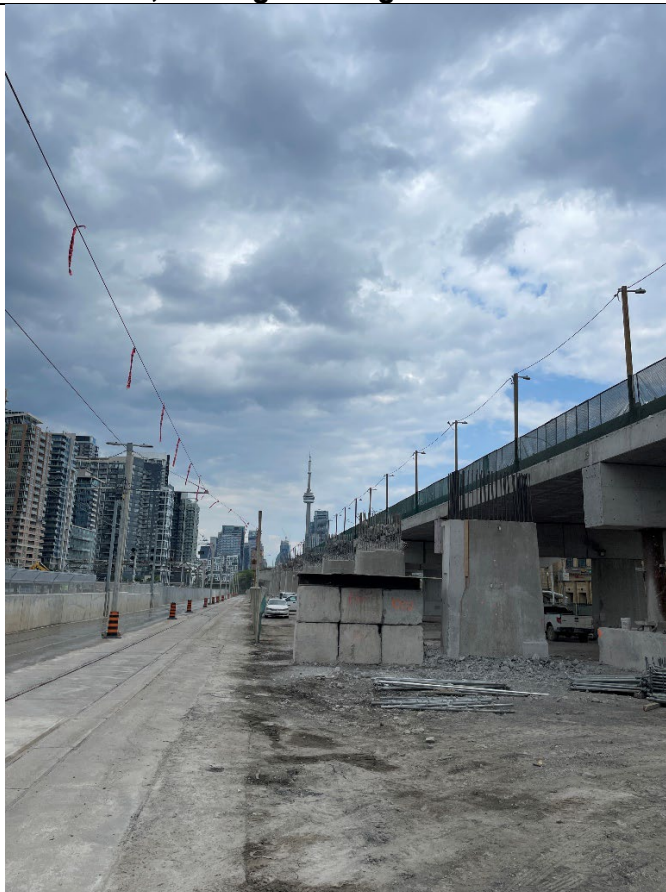
**Stage 3 Workers are removing the top layer of concrete from the bent cap. This process clears the way for new materials to be added and ensures the surface is clean and properly prepared.**

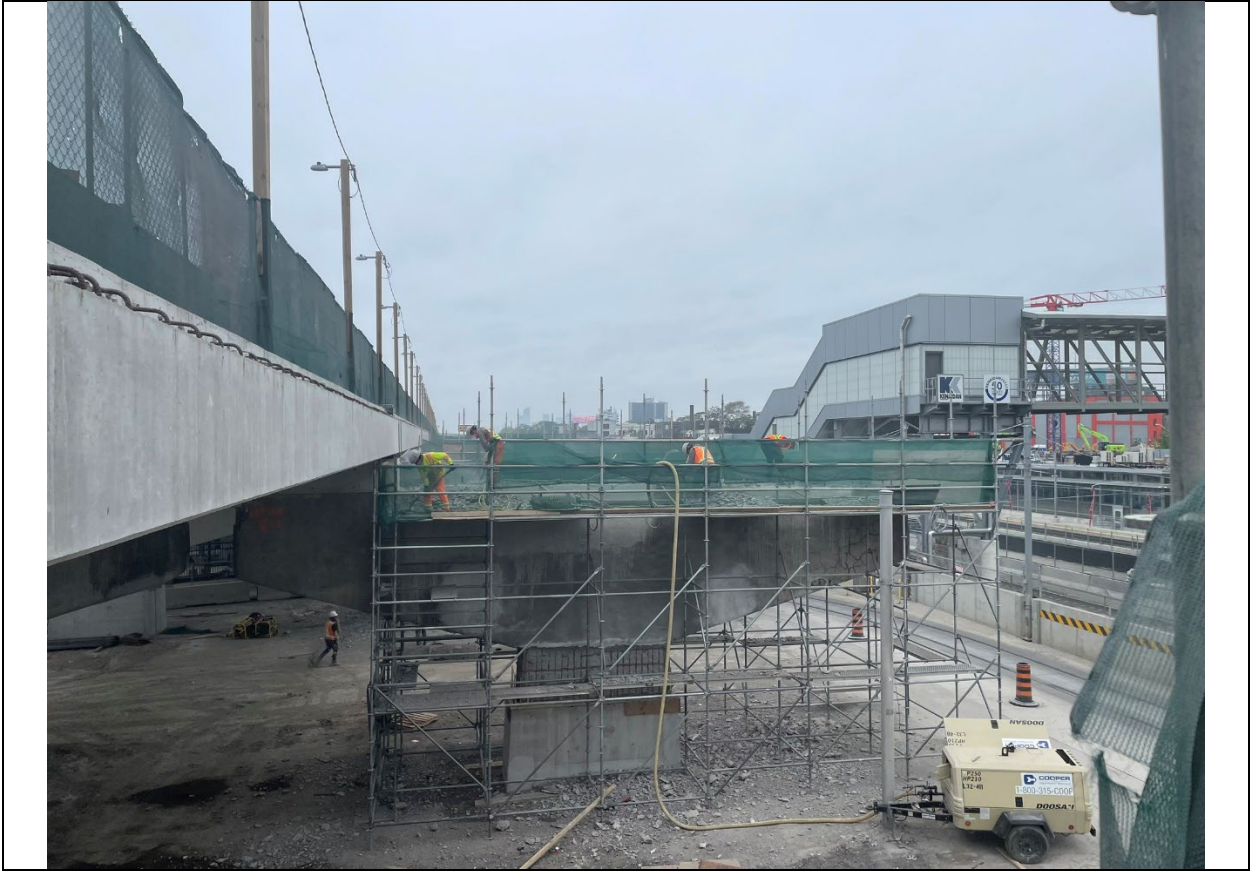
**Stage 3 Bent 16 more top of bent cap concrete removals**

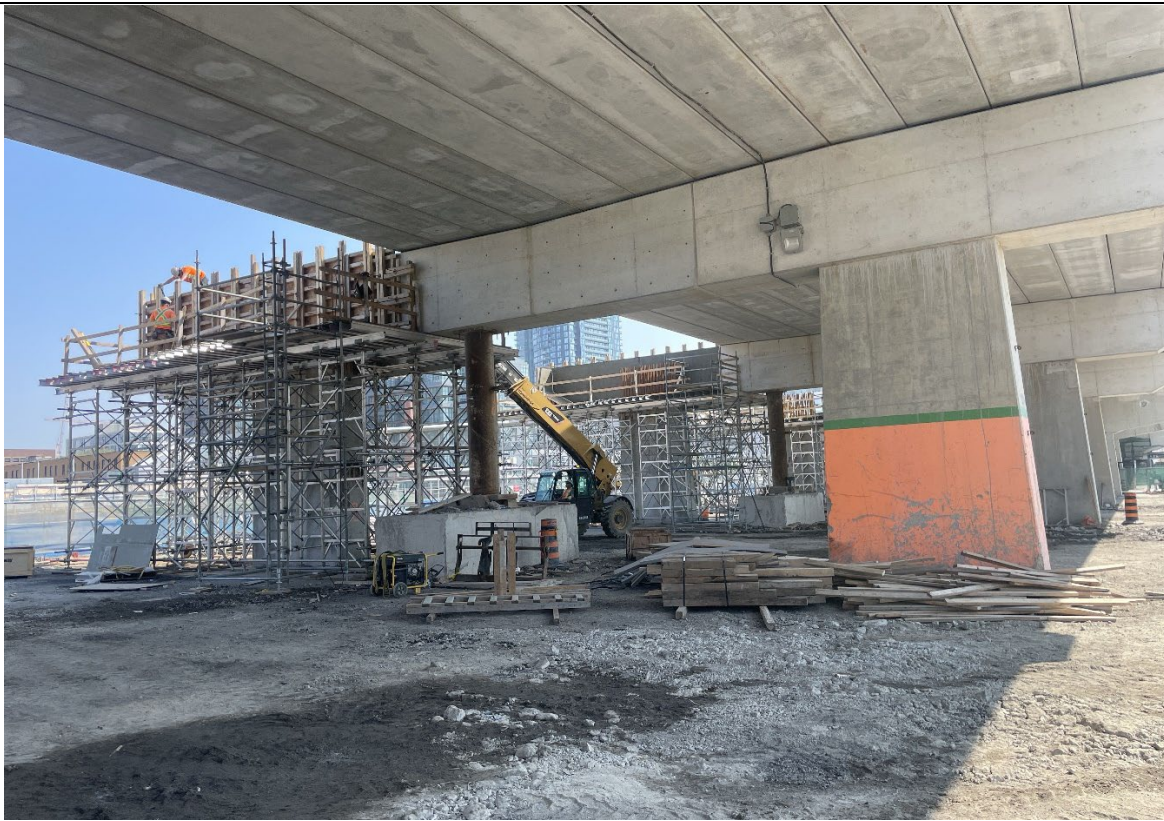
**Stage 3 Wooden panels (formwork) that were used to hold poured concrete in place are now being removed. This happens once the concrete has cured (hardened) and is strong enough to support itself. Removing the forms reveals the newly built concrete structure.**

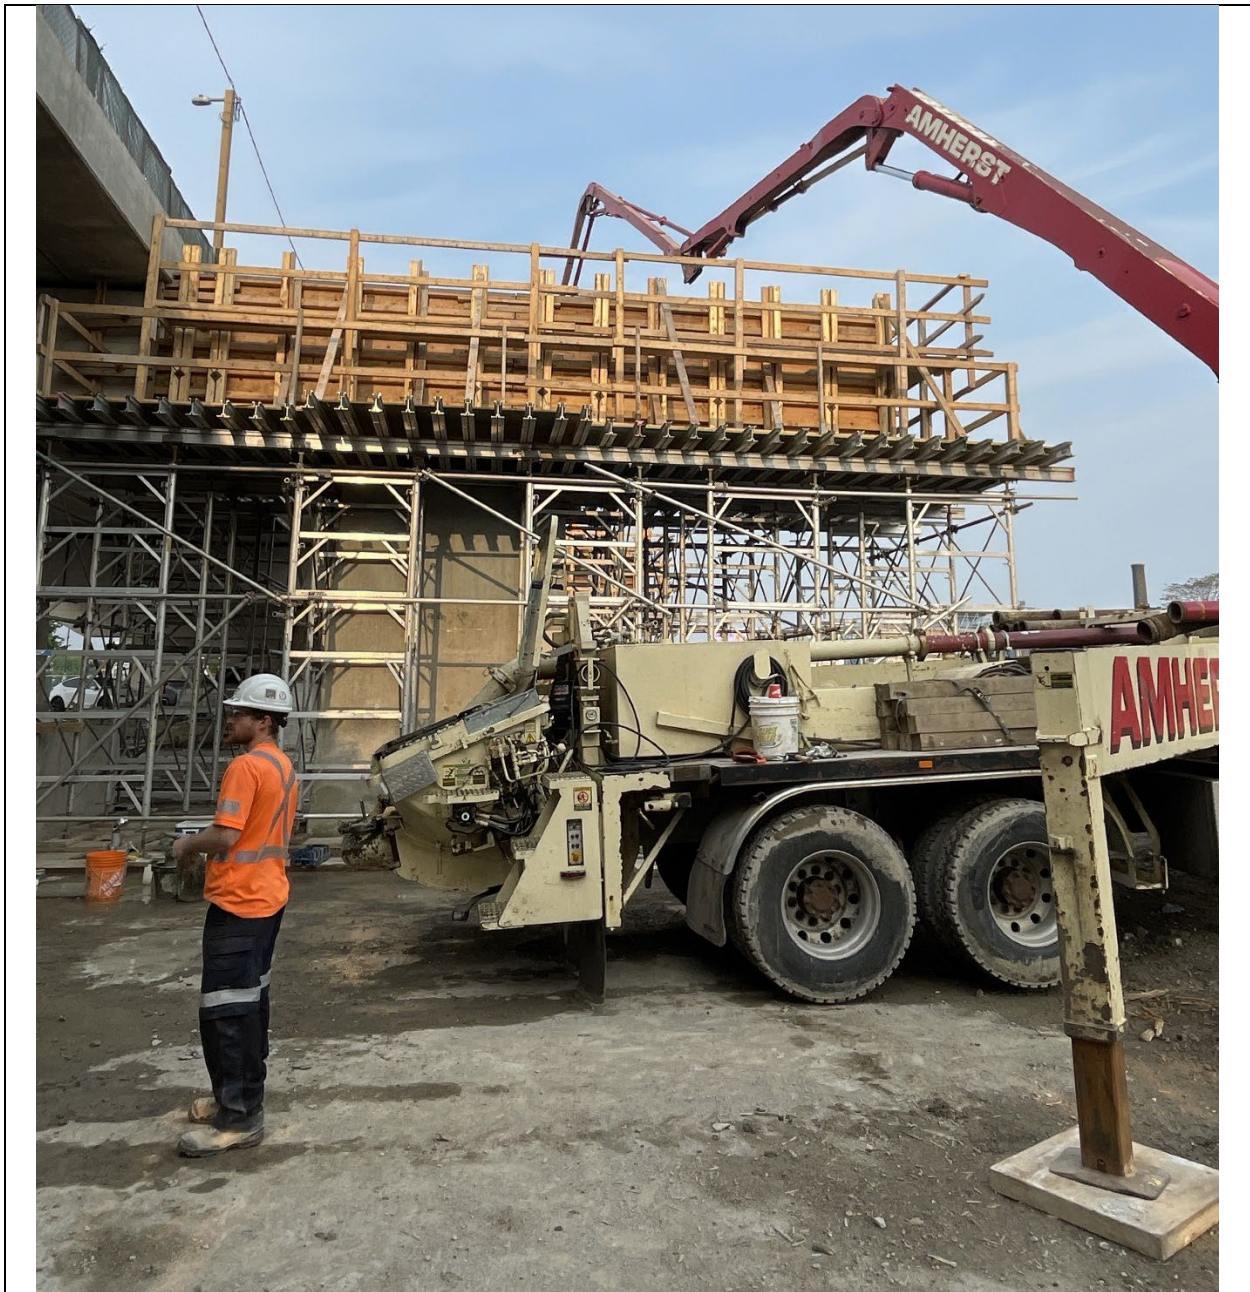
**Stage 3 New concrete is being poured into the prepared area to form a new bent cap**
