### 3 PHASE 2: TECHNICAL ASSESSMENTS AND INFRASTRUCTURE RISK ASSESSMENT

#### 3.1 Technical Assessments

##### 3.1.1 Fluvial Geomorphic Assessments

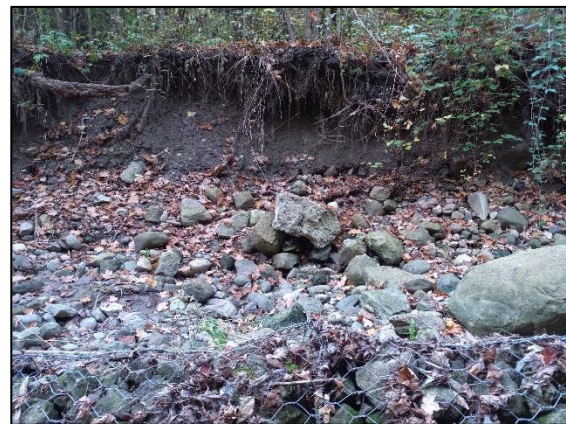
Figure 3-2: Gravel and Cobble Substrate with Sandy Banks in Reach N1

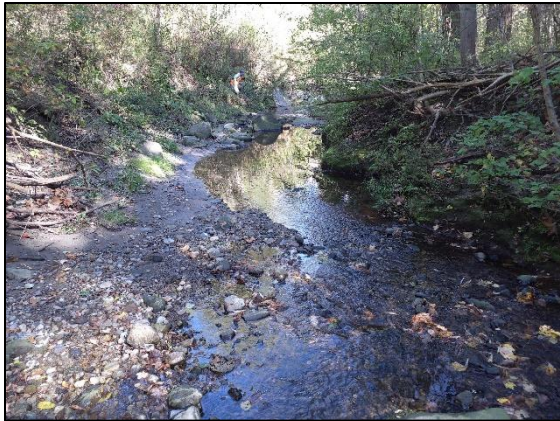
Figure 3-3: Mature Point Bar Development Through Reach N2

This sinuous reach has a sinuosity index of 1.31. The many tight meander bends exhibit the erodible nature of the bank material. Point bar accretion dominates most of this reach as the material is highly mobile in this system (**Figure 3-3**). Armourstone erosion protection is frequently outflanked in this reach due to the limited span of the works, the erodible nature of the banks, and the high rates of erosion. Much of this reach has been previously realigned. This may suggest why the bank material lacks cohesive strength due to a mud deficient matrix in the aggregate used. The more stable boulder toe protection that is present is not embedded into the bank (**Figure 3-4**) and is easily outflanked as the channel meanders into the bank. Key geomorphic parameters for Reach N2 are summarized in **Table 3-3**.

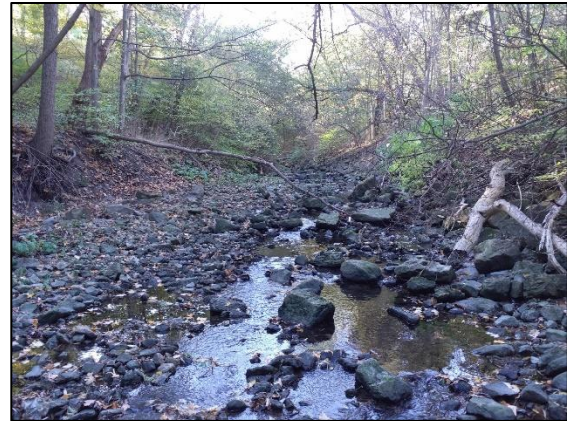
Figure 3-4: Washed-Out Angular Stone and Boulder Treatments in Reach N2

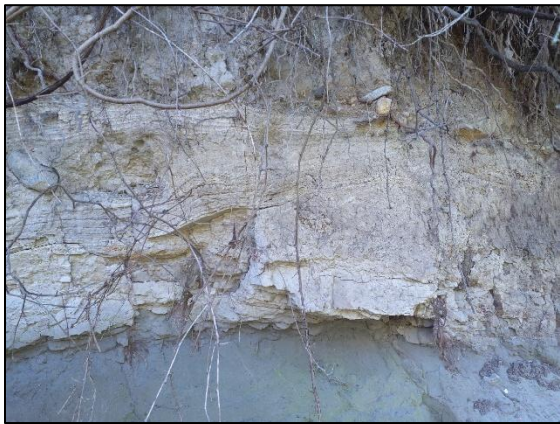
Figure 3-5: Clay and Silt Rich Sand and Gravel in Exposed Banks in Reach N3

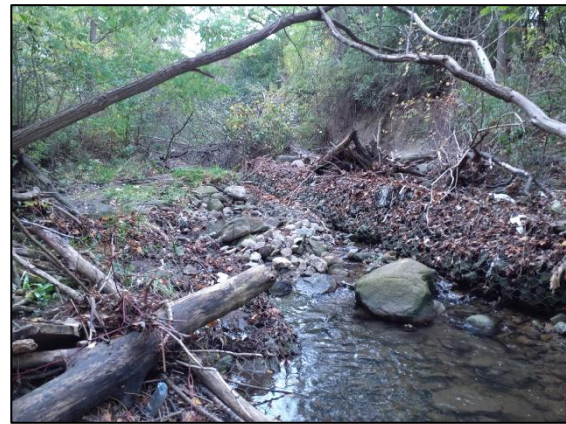
Figure 3-6: Failed Gabion Baskets Through Reach N3

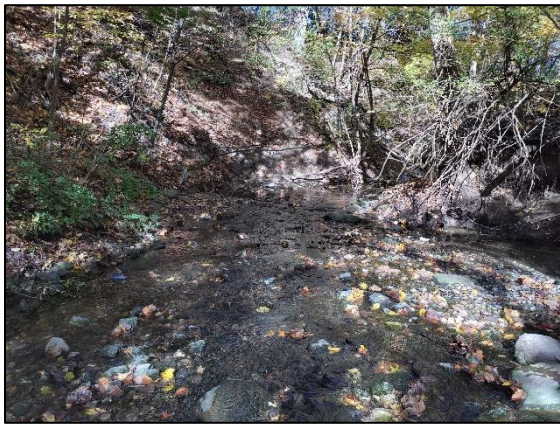
Figure 3-7: Confined Lower Segment Upstream of Maxome Avenue in Reach N4

The lower reach is confined in a narrow valley setting (**Figure 3-7**). The banks and valley slopes are composed of well graded, medium sand material. Angular and cobble material protect the toe of both slope and banks, while the substrate material is mainly coarse gravel with some smaller cobble material, likely sourced from upstream gabion baskets. The gabion baskets in the upstream part of this reach include grouted baskets used as drop structures, emptied gabion baskets used to protect maintenance holes, and partially emptied baskets lining both sides of the channel through Newtonbrook Park (**Figure 3-8**). While Reach N4 maintains the same bankfull width as other downstream reaches, evidence of scour and overall channel depth is far less. This is likely due to the floodplain access provided by Newtonbrook Park during high discharge events. As a result, outflanked structures are not observed in this reach, a significant distinction from the rest of the creek. Key geomorphic parameters for Reach N4 are summarized in **Table 3-5**.

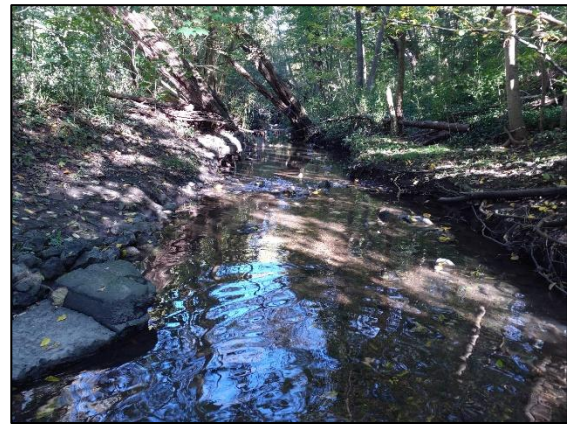
Figure 3-8: Partially Emptied Gabion Baskets Line the Upper Portion of Reach N4

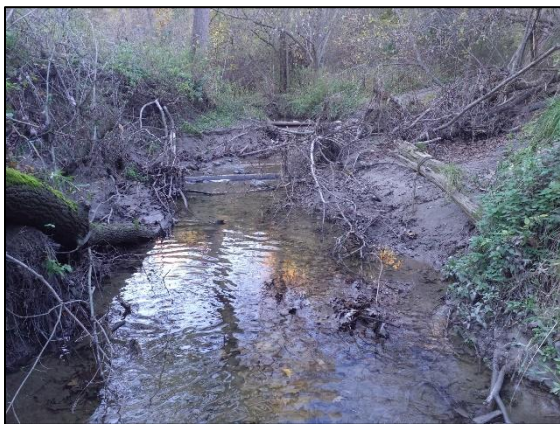
Figure 3-9: Incised Channel Near the Don Confluence Exposing Buried Pipes and Bank Erosion.

Bankfull width in this reach is 2.74 metres, while average bankfull depth is 1.04 metres upstream of the Don River backwater. The channel is actively downcutting, shown from the exposure of buried infrastructure (**Figure 3-9**). The steep gradient and resulting erosion potential causes the valley to both widen and deepen. This presents the added challenge of slope stability as mature trees are undercut in the steep valley setting (**Figure 3-10**). The banks and slope material are silt and sand rich gravel material that erodes easily. The existing armourstone bank protection throughout this reach was designed to protect maintenance hole and sewer infrastructure, however erosion continues in the segments where this armouring is absent. Boulder channel treatments in this reach are still intact, while most angular stone channel treatments are washed out, exposing the glacial clay channel base. This clay layer contacts the sandy gravel material at the slope toe and acts as a flow horizon for groundwater, increasing its susceptibility to erosion. Key geomorphic parameters for Reach Br1 are summarized in **Table 3-6**.

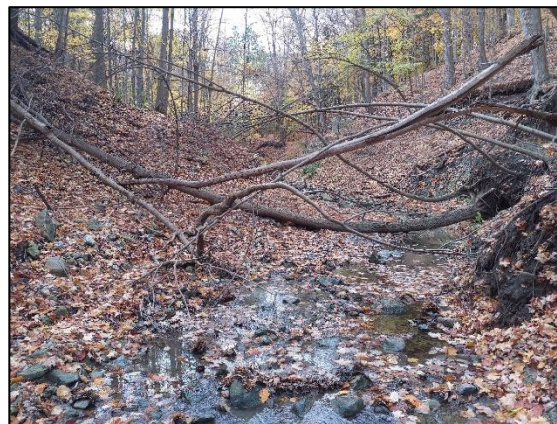
Figure 3-10: Steep Valley Confined Upstream Segment in Reach Br1

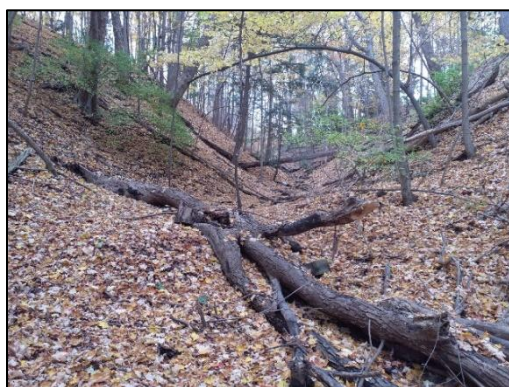
Figure 3-11: Steep Valley Confined Tributary Channel in Reach Br2

Reach Br2 is a tributary of Blue Ridge Creek that extends from Citation Drive and Reach Br1 341 metres up-slope to Burbank Drive. This high gradient reach has a slope of 5.79% and is an essentially straight channel with a sinuosity index of 1.04. At the time of field investigation, the channel was dry and likely remains so until a rain event. Very little erosion was observed as the dense leaf litter and tree debris had obscured any potential observations (**Figure 3-11**).

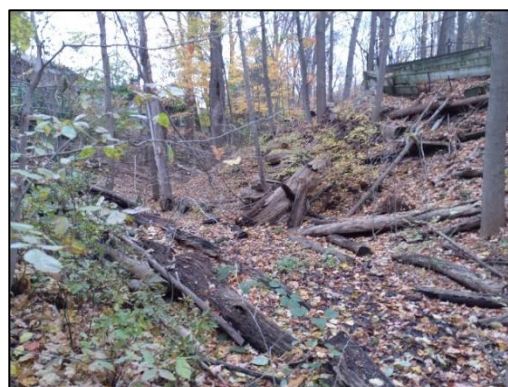
Figure 3-12: Debris from Fallen and Cut Trees in Reach Br2

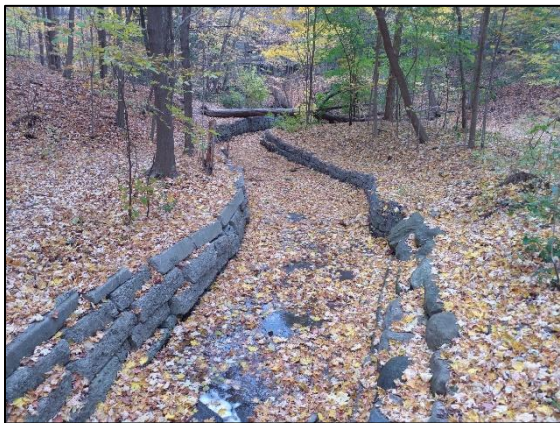
**Figure 3-13: Armourstone and Concrete Lined Channel Upstream of the Confluence with Br1**

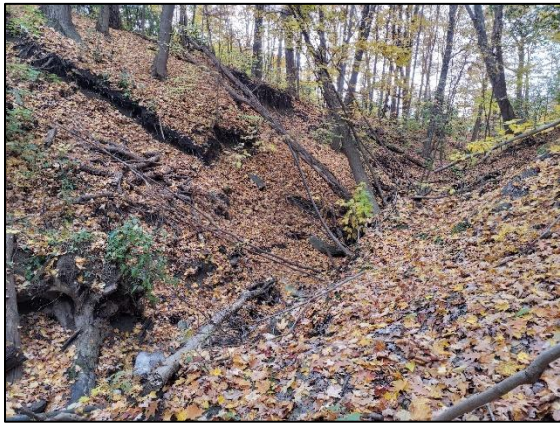
**Figure 3-15 Steep Valley Confined Tributary Channel in Reach Br4**

Slope material is composed of sandy gravel material and is actively eroding, undermining mature trees, and causing slope hazards to adjacent private property (**Figure 3-15**). Erosion control measures in the reach include gabion basket slope stability works and angular stone bed treatments. Gabion baskets have slumped to the point of failure in some sections and angular stone has washed downstream or had been displaced completely in some sections (**Figure 3-16**). The dominant erosion hazard in this reach is the oversteepened valley slope stability driven by channel scour. Key geomorphic parameters for Reach Br4 are summarized in **Table 3-9**.

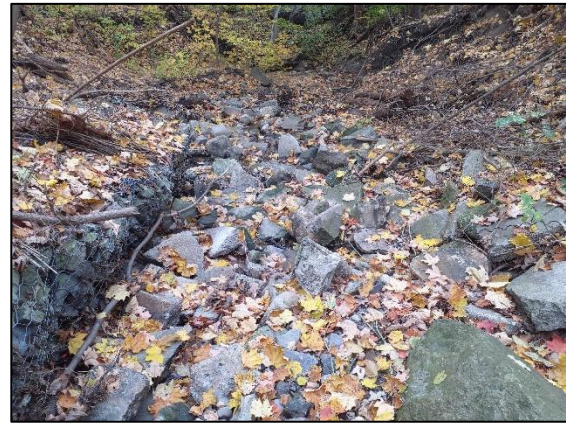
**Figure 3-16: Failed Gabion Baskets and Channel Angular Stone in Reach Br4**

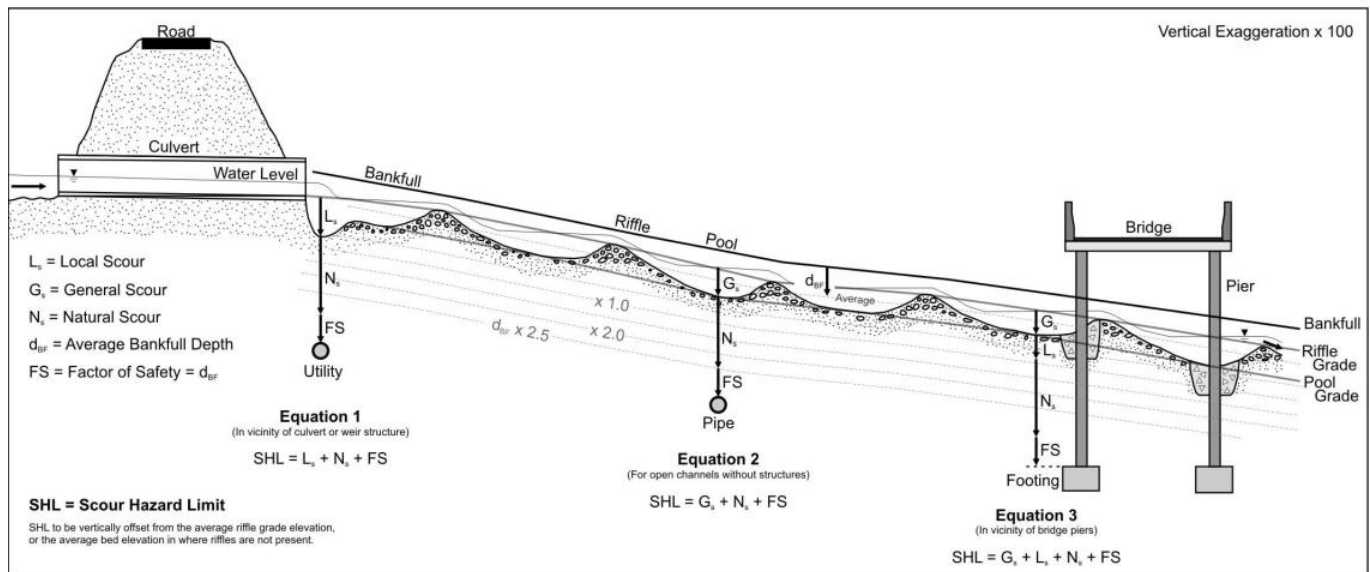
**Figure 3-18: Graphical Definition of the Scour Hazard Limit for Three Cases, Including Culverts, Buried Pipes, and Bridges (CVC, 2019)**

erode the bed vertically. Evidence of the vertical scour processes described above have been observed throughout the Newtonbrook and Blue Ridge Creek system in order to determine the scour hazard limit on a reach-by-reach basis. The Scour Hazard Limit, as defined within Credit Valley Conservation's Fluvial Geomorphic Guidelines, is visually illustrated in **(Figure 3-18)**.

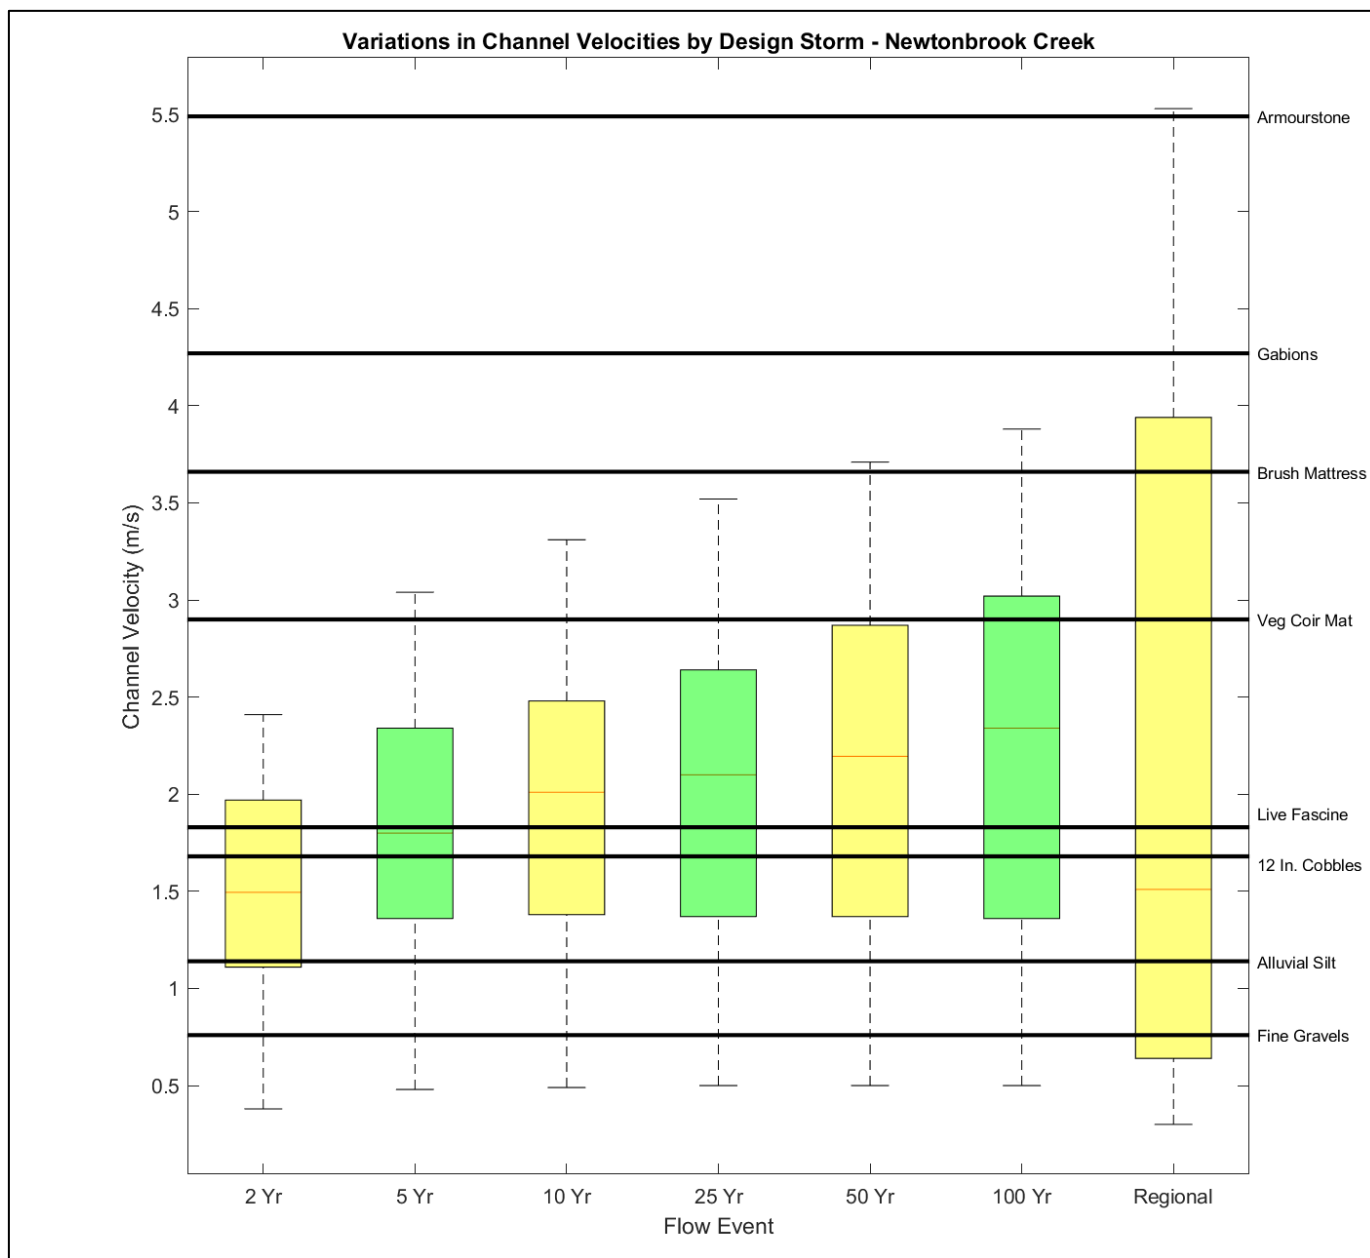
**Figure 3-32: Box and Whisker Plot Illustrating Variations in Channel Velocities by Design Storm for Newtonbrook Creek. Permissible Minimum Velocities for Varying Materials as per Fischenich (2001) Shown on the Right.**

In addition to having an understanding of floodline extents, careful consideration must be given to the expected velocities and shear stresses under the full range of modelled flows. In many instances the modelled velocities can be significant and are capable of causing large scale erosion and the failure of erosion control measures. **Figure 3-32** provides a visual summary of the range of velocities modelled along Newtonbrook Creek under the 2-100 year and regional flow events, while **Figure 3-33** does the same for Blue Ridge Creek.

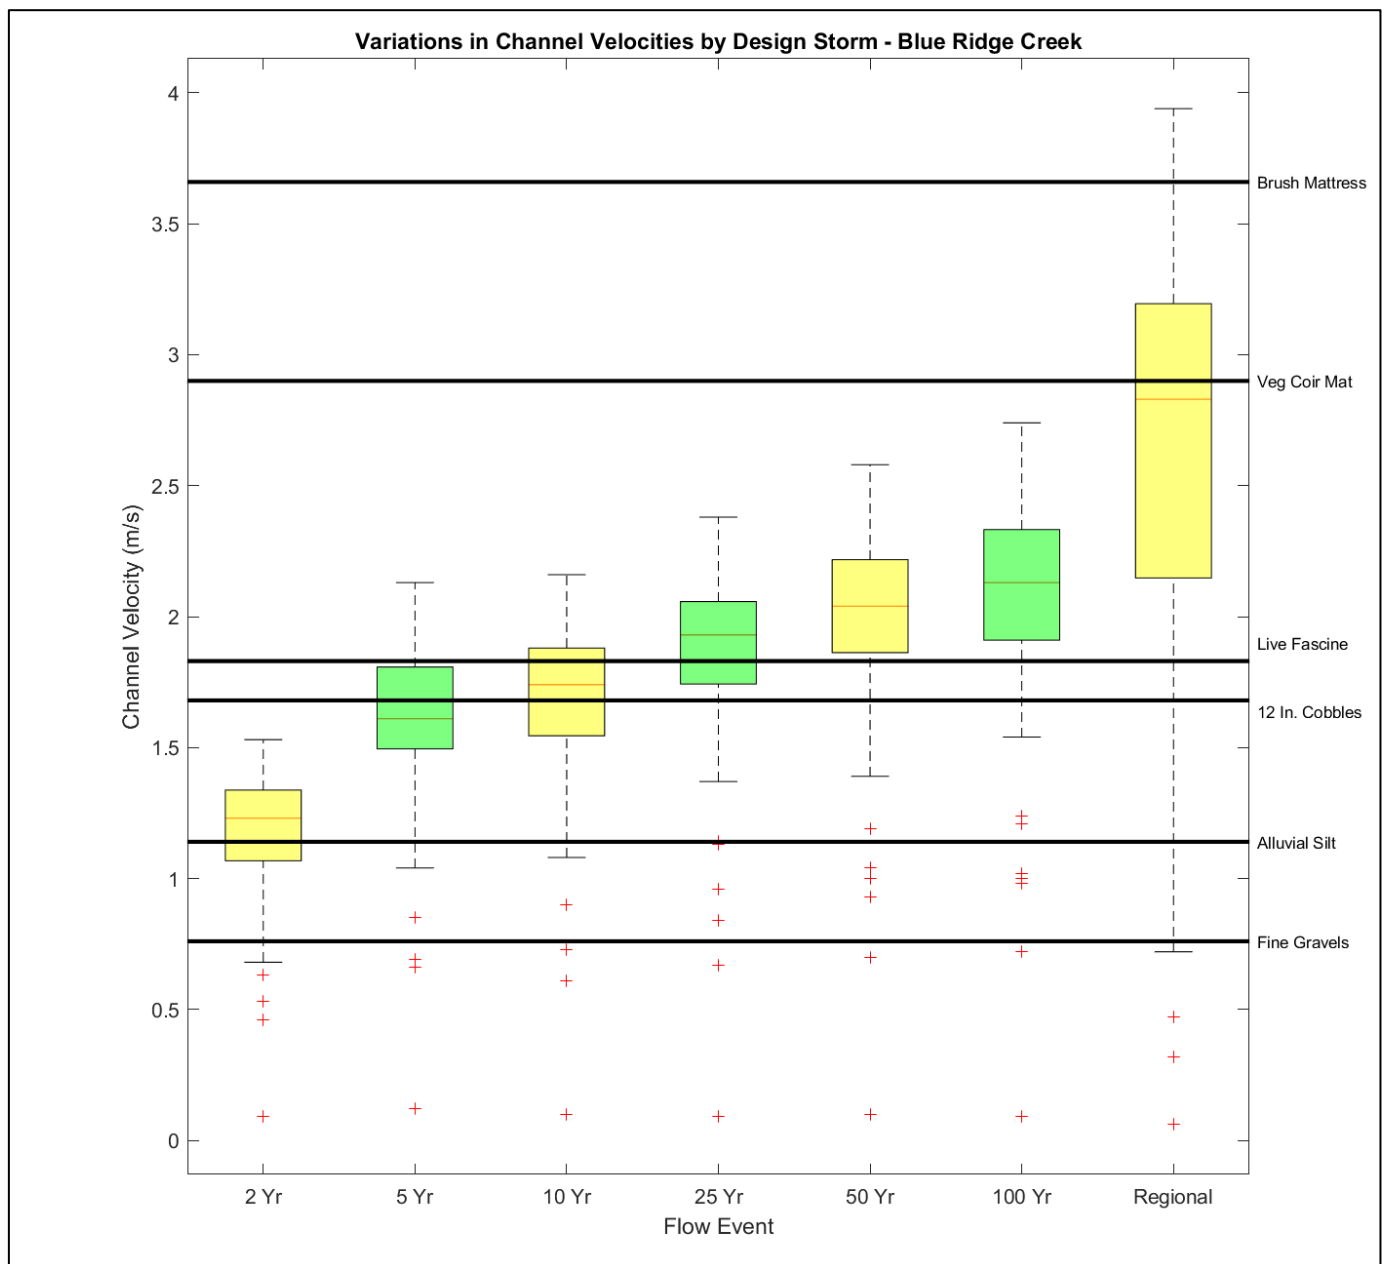
**Figure 3-33: Box and Whisker Plot Illustrating Variations in Channel Velocities by Design Storm for Blue Ridge Creek. Permissible Minimum Velocities for Varying Materials as per Fischenich (2001) Shown on the Right.**
