EXISTING CONDITIONS

EXISTING COASTAL CONDITIONS – PROTECTED SHORELINE

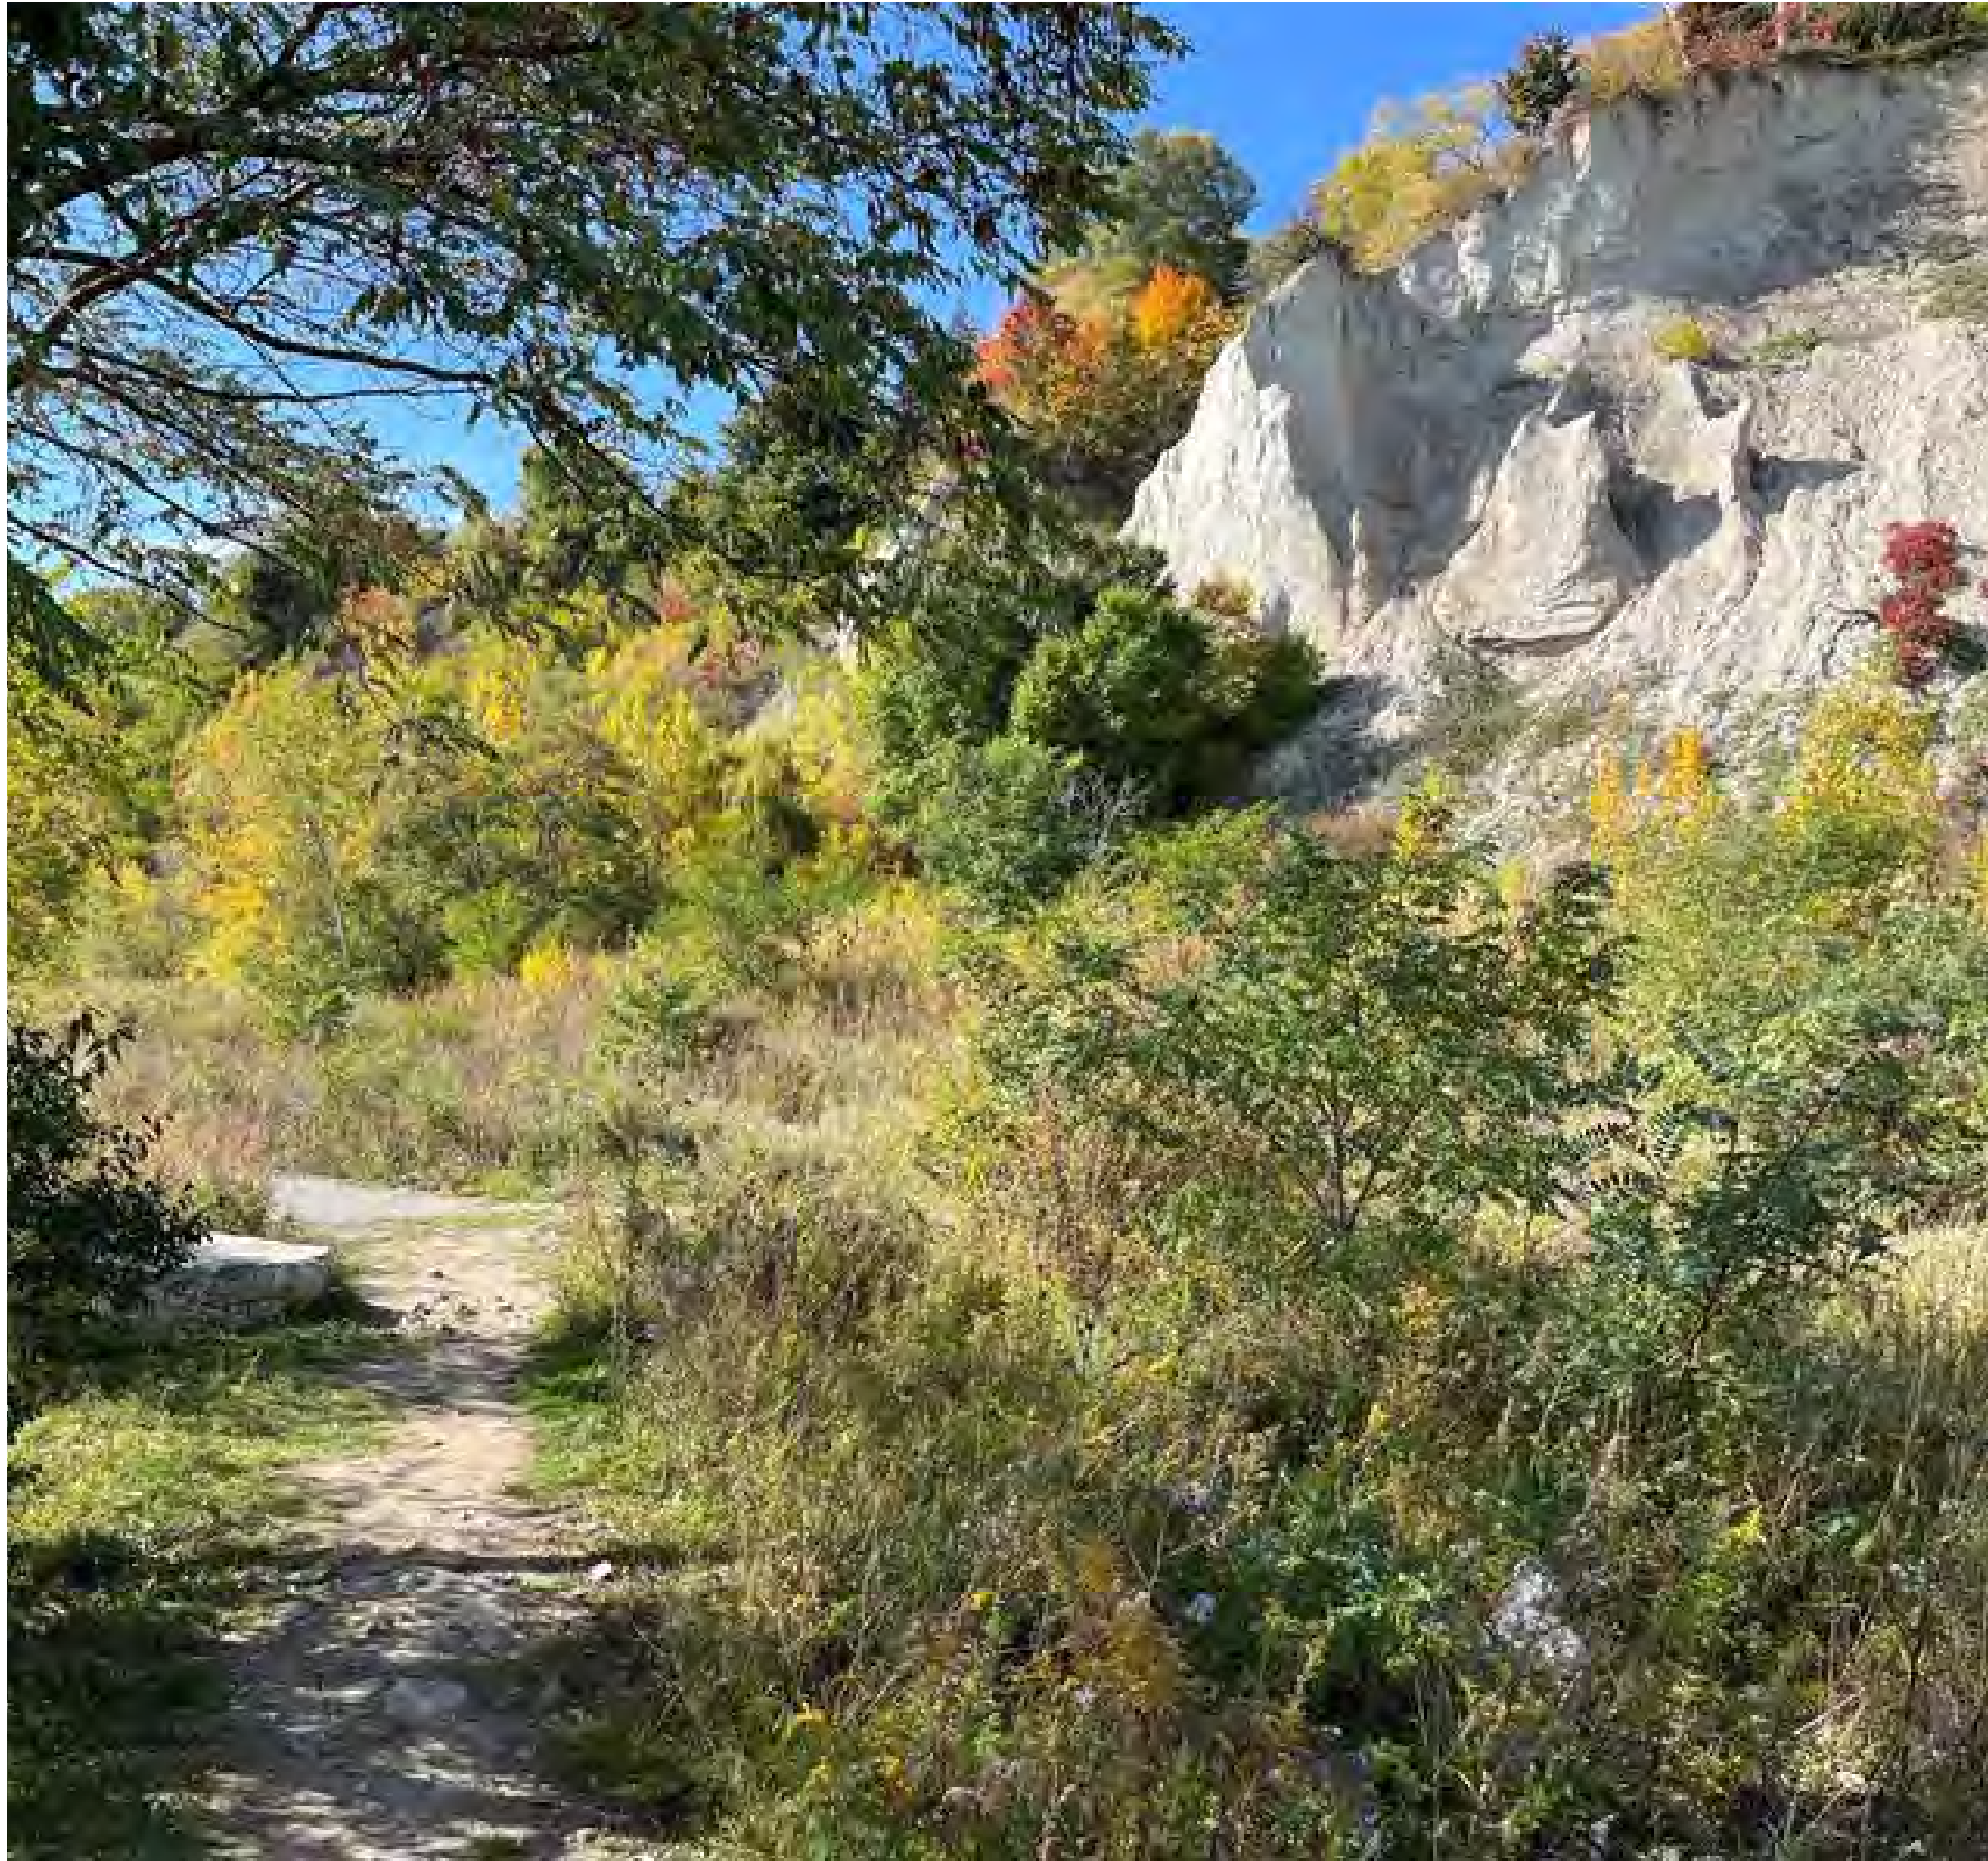
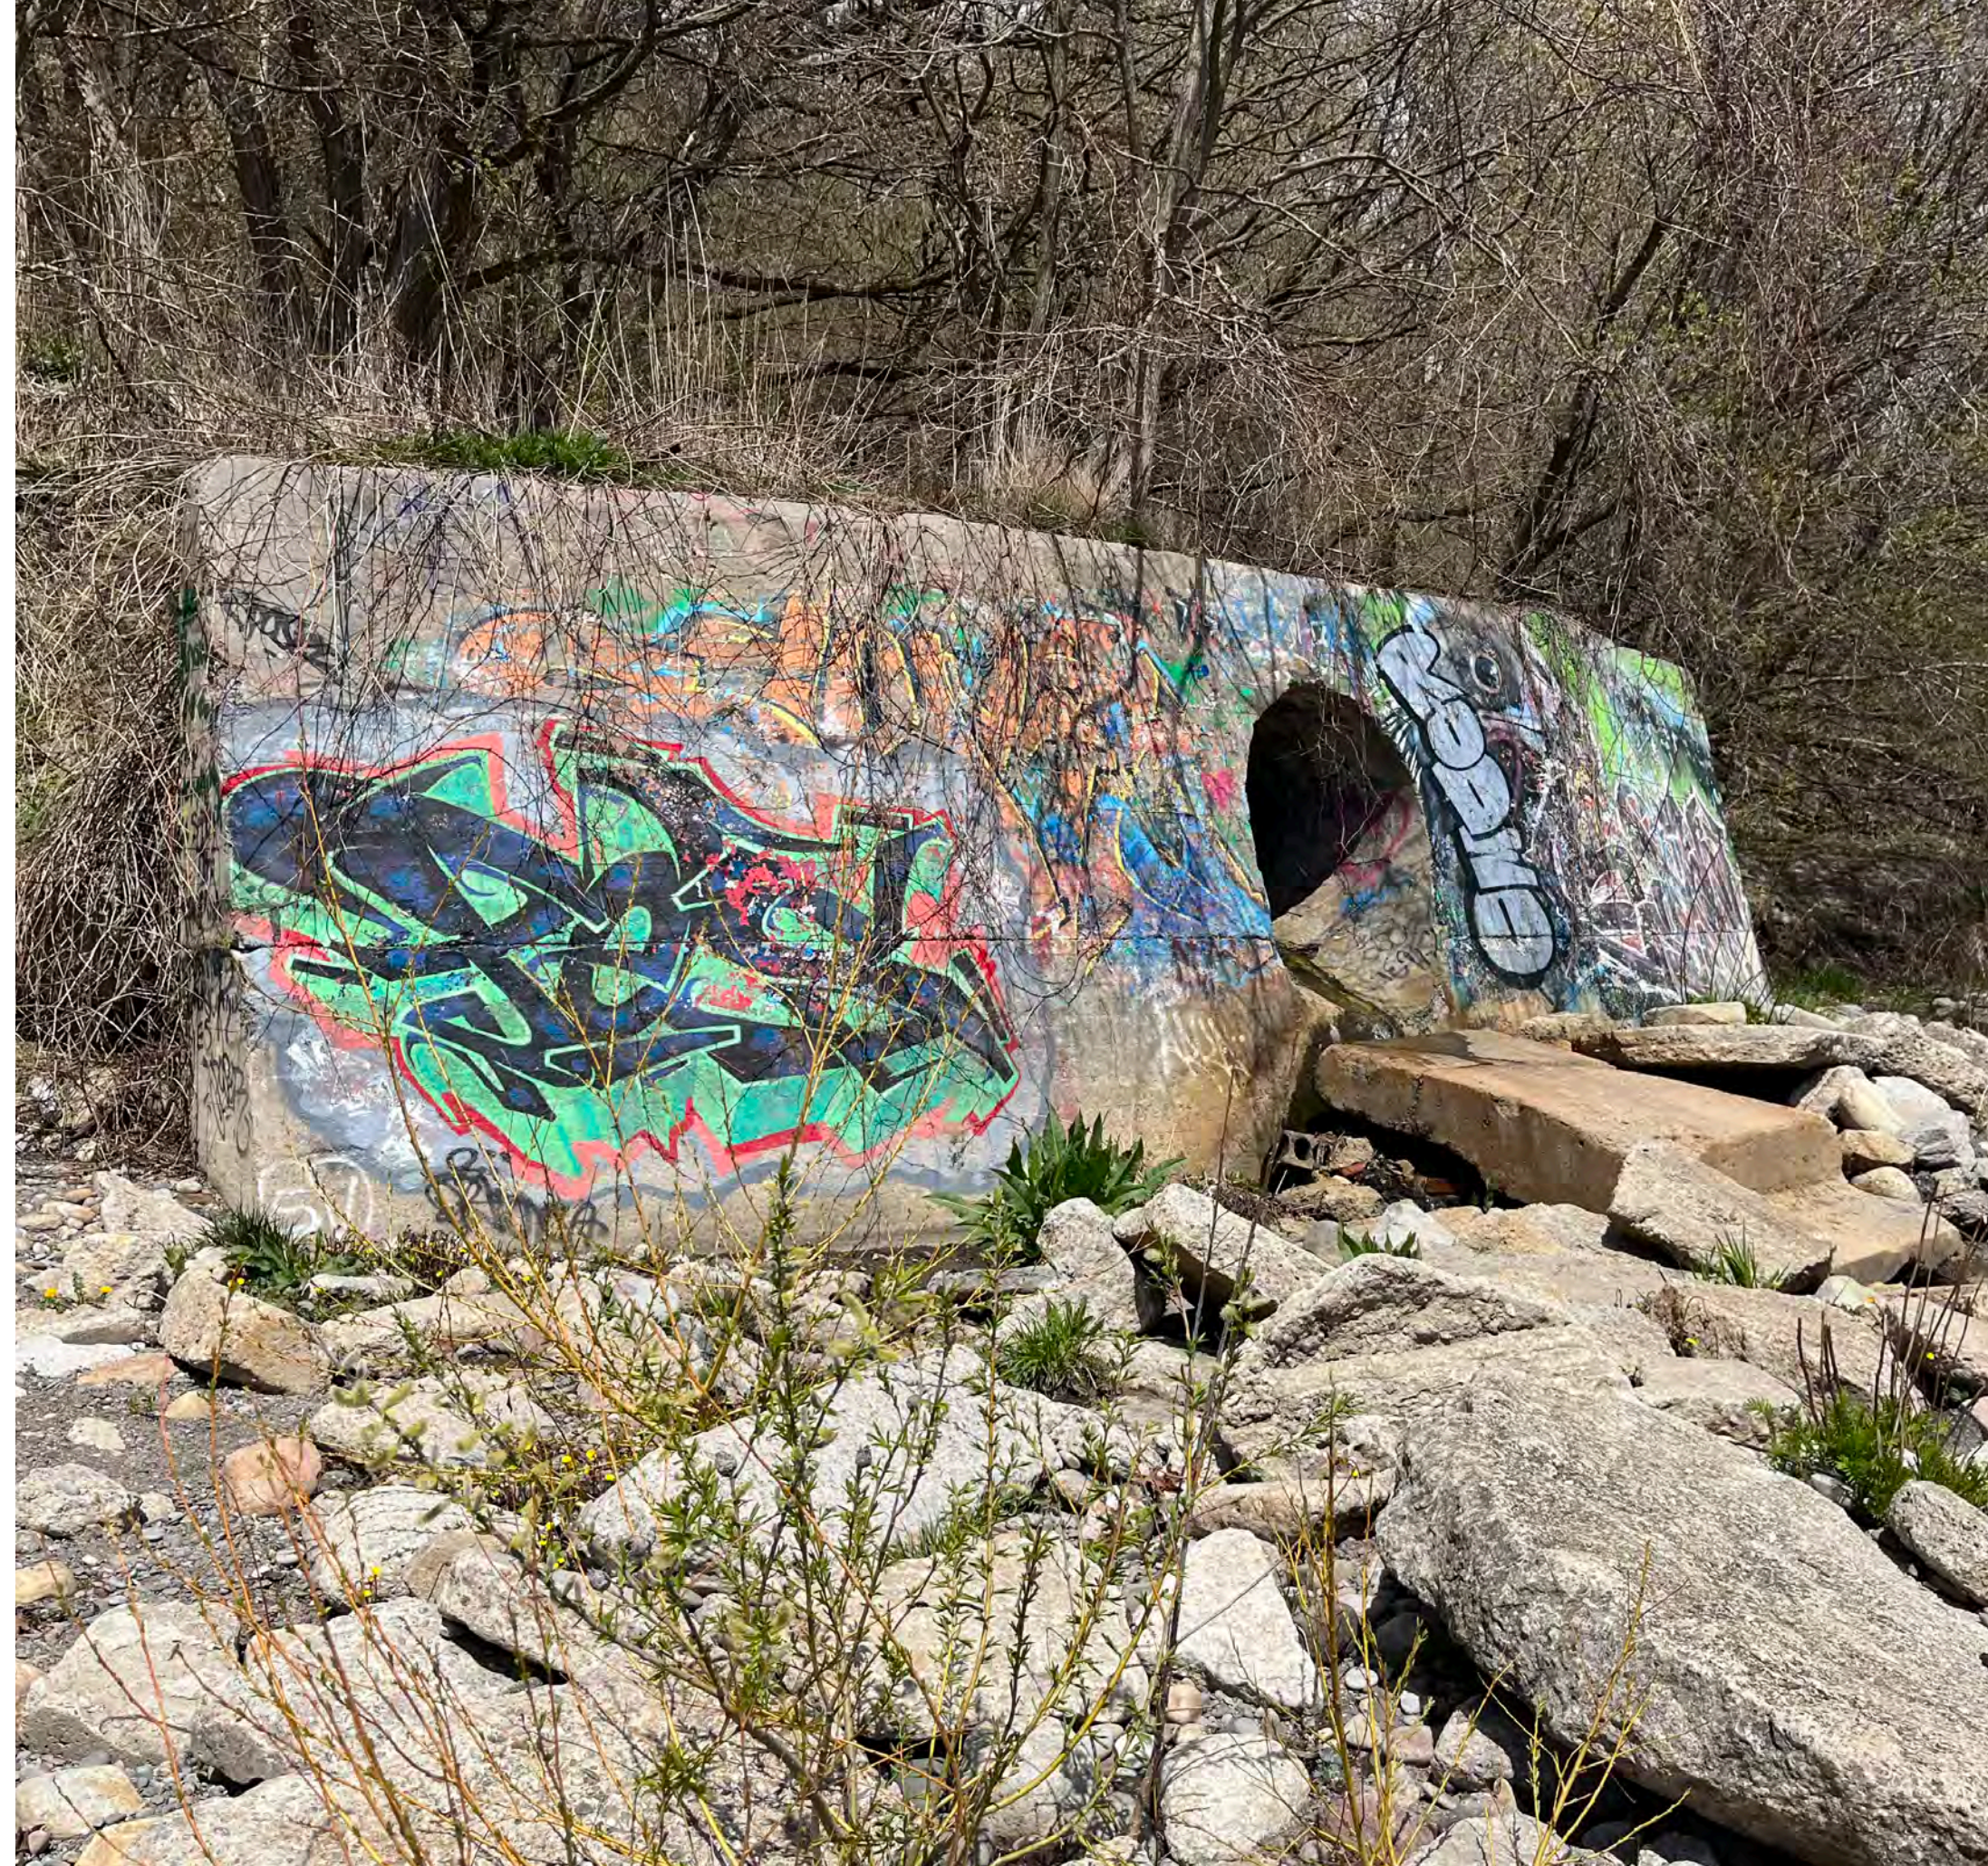
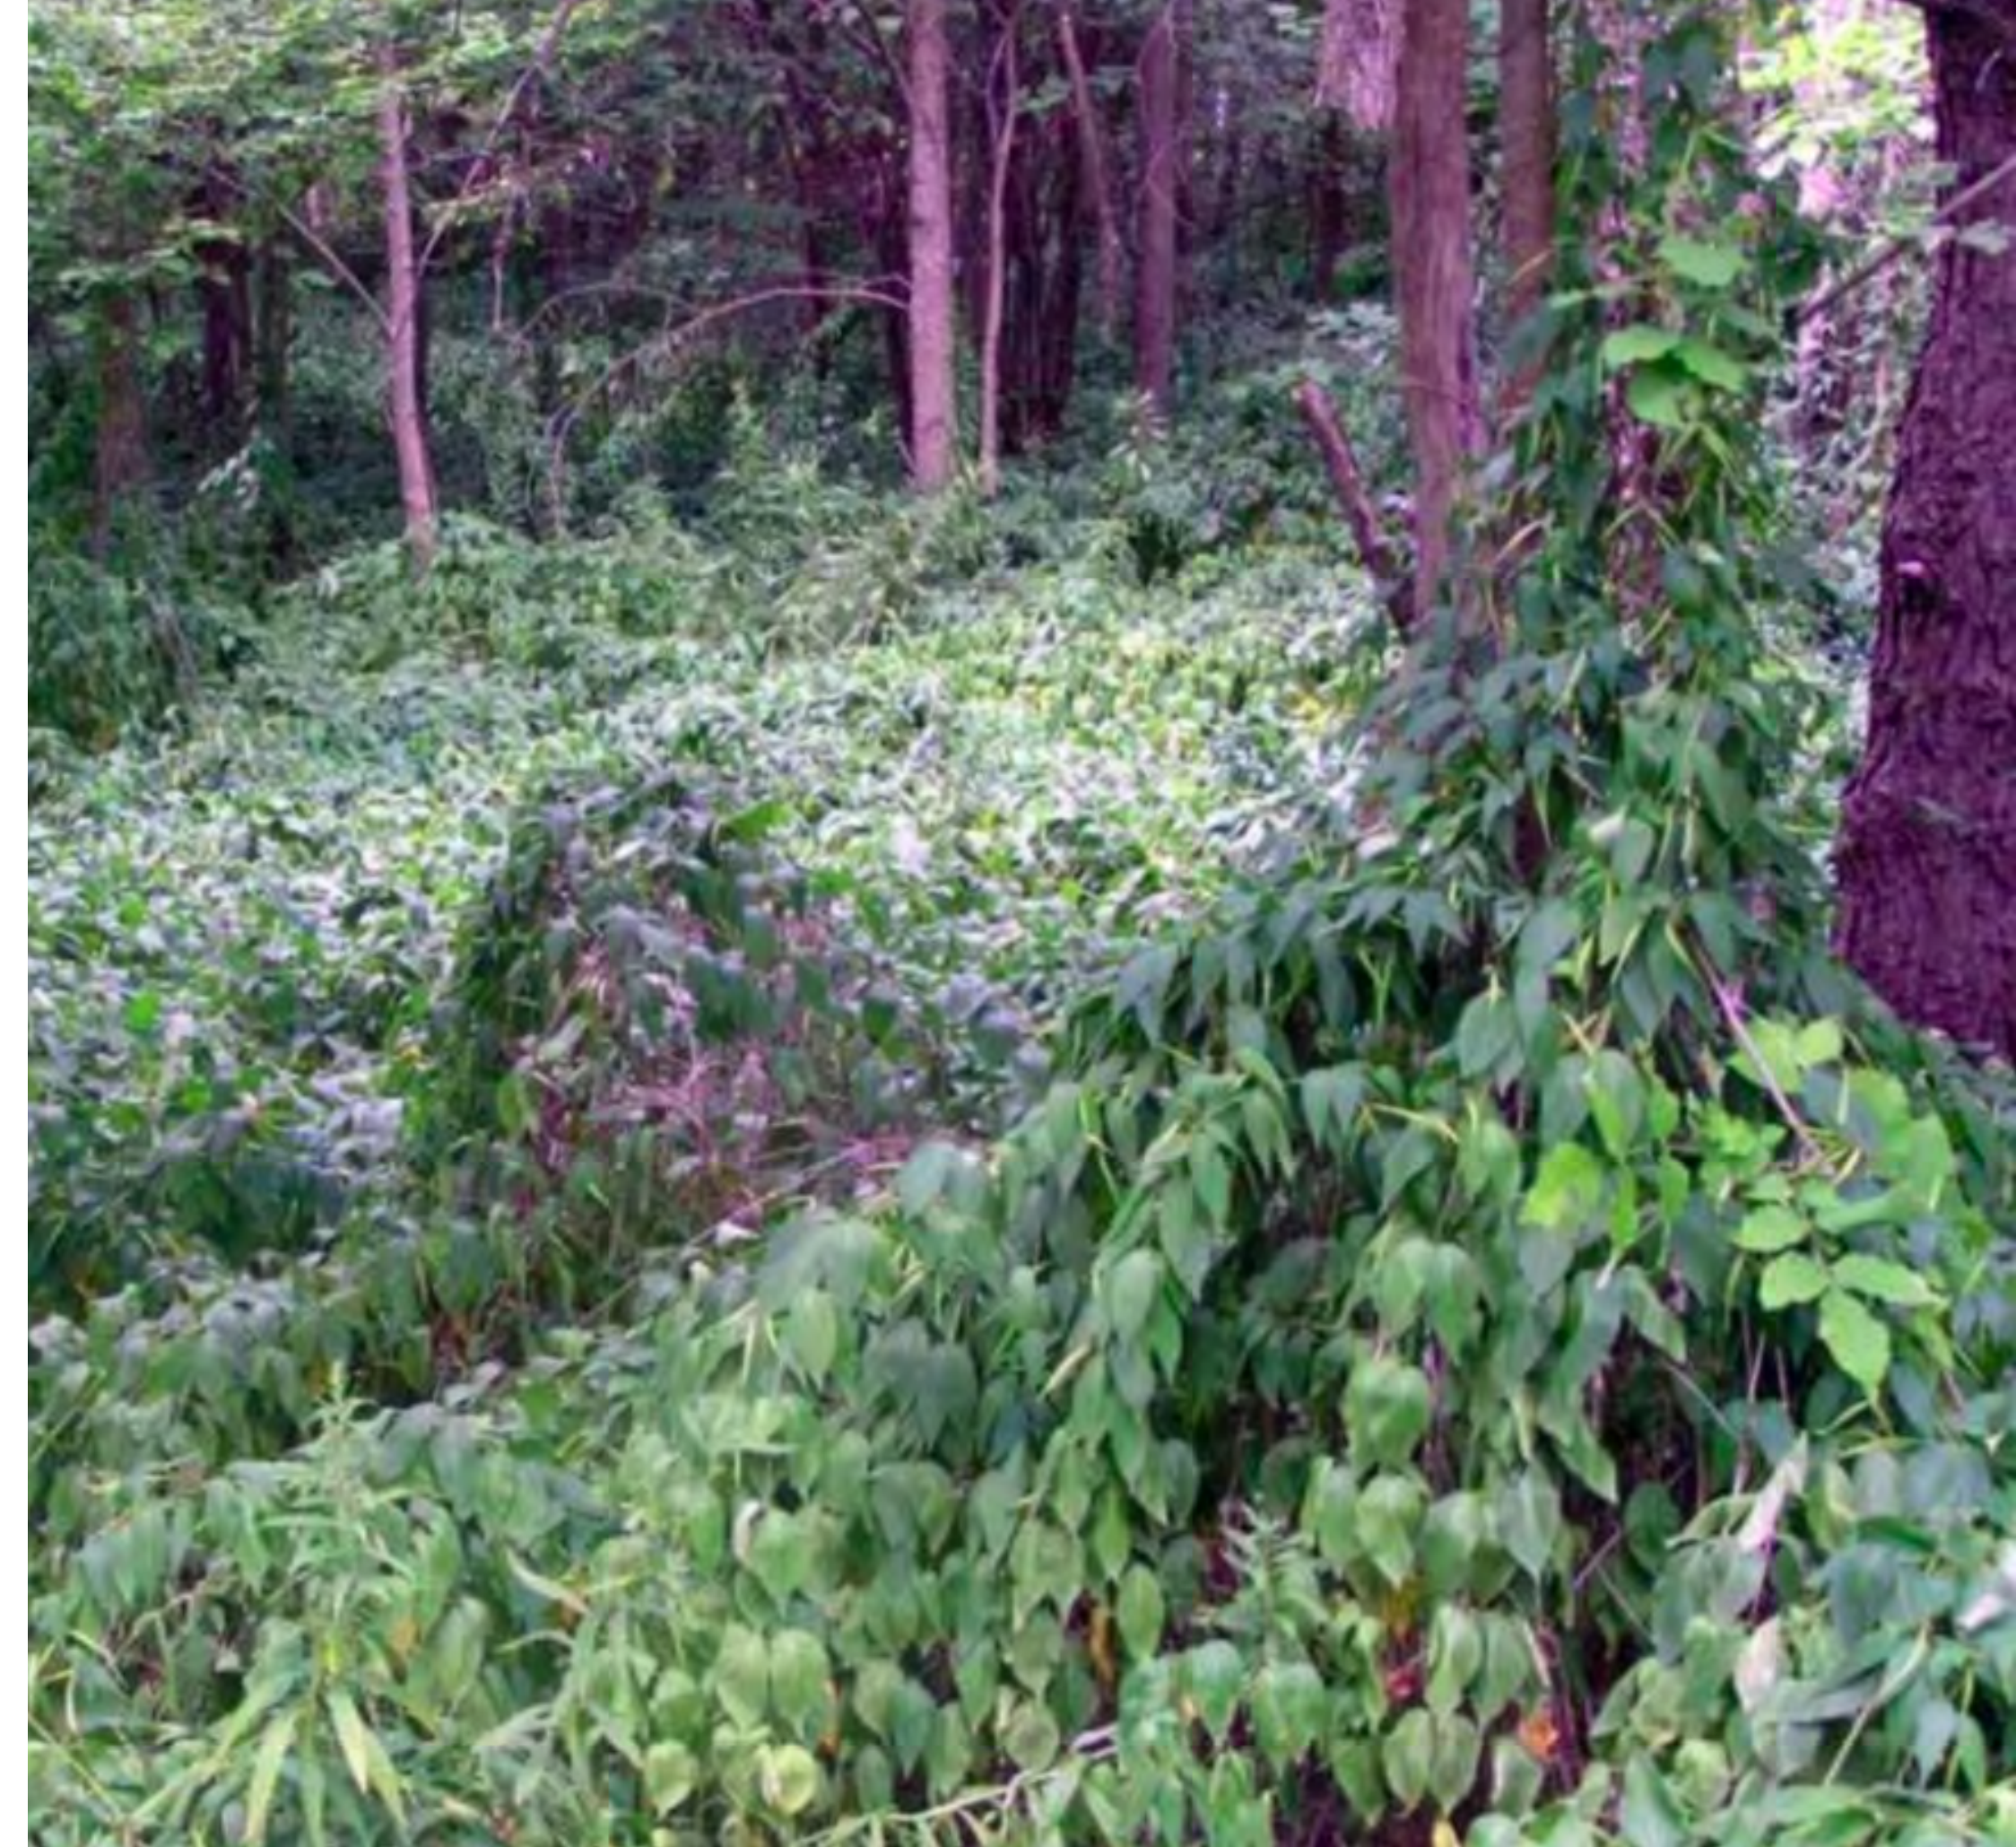
- Unmanaged human access has damaged the landscape:
 - Informal trails cut through sensitive areas
 - Unmanaged entry points disturb soils and plants
 - Garbage and litter degrade both habitat quality and public experience

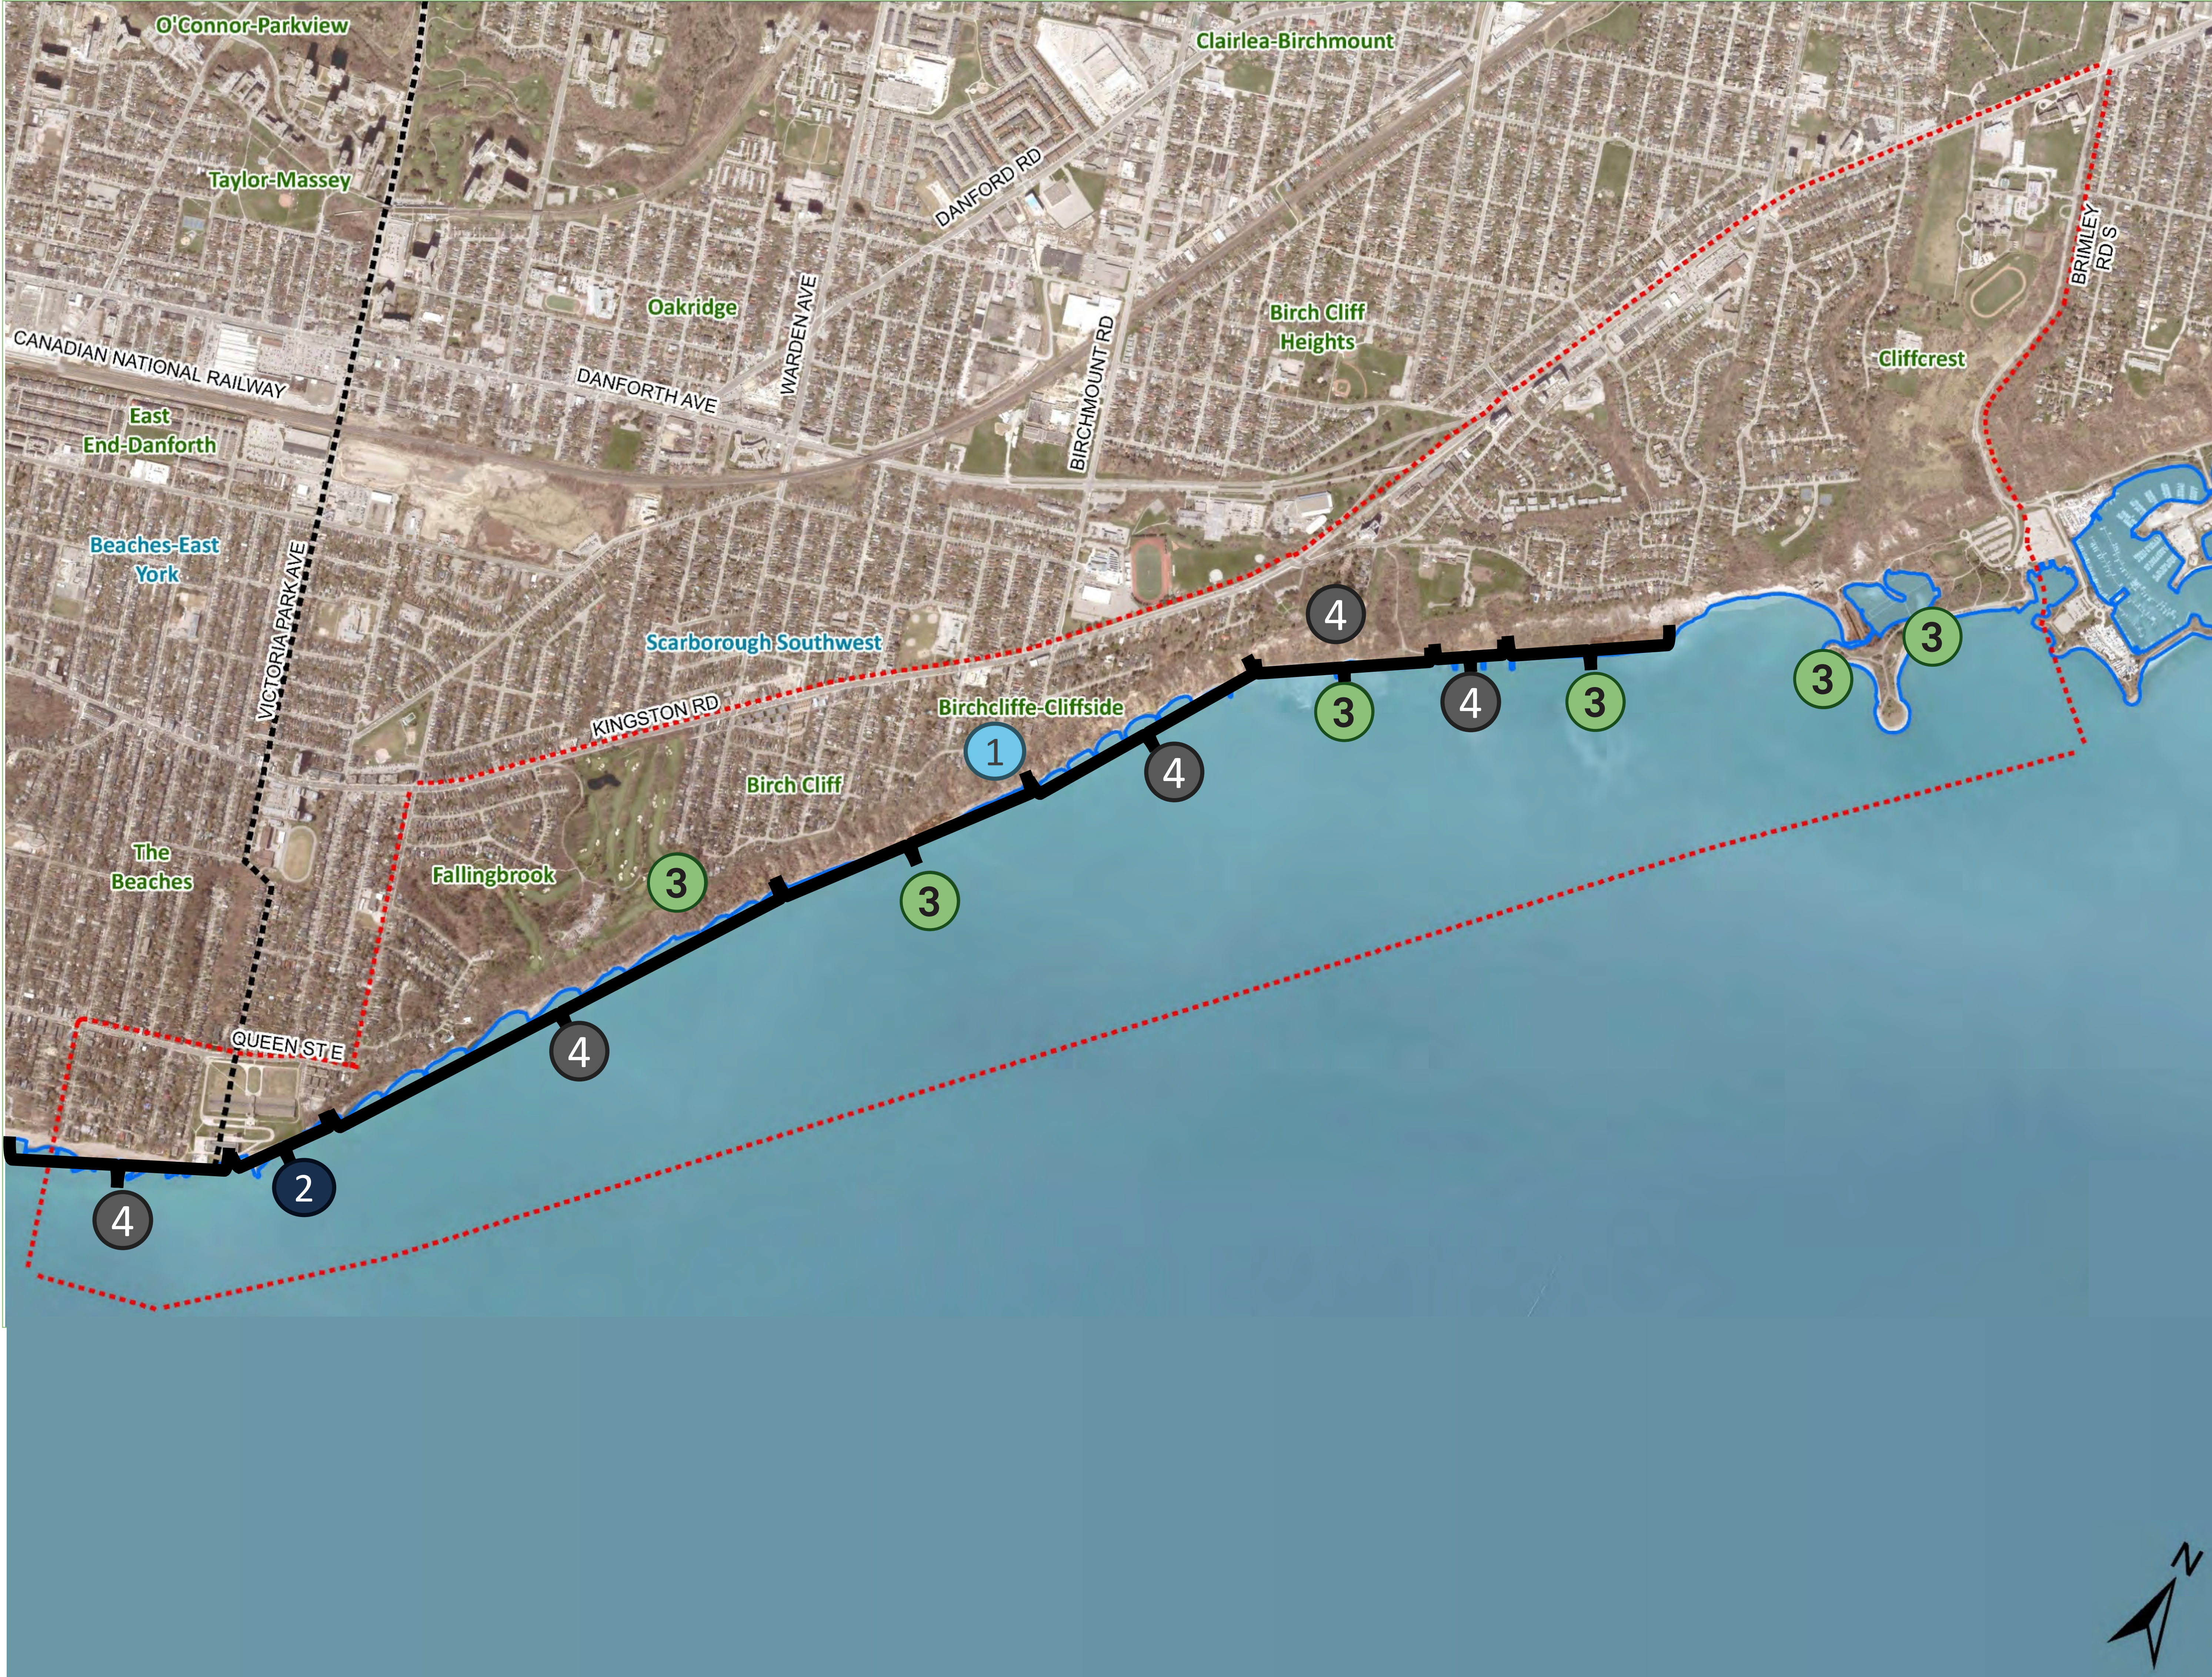
The natural shoreline has been almost entirely eliminated from the study area, only 6% remains. The overwhelming 94% has been fundamentally altered with shoreline erosion protection works.

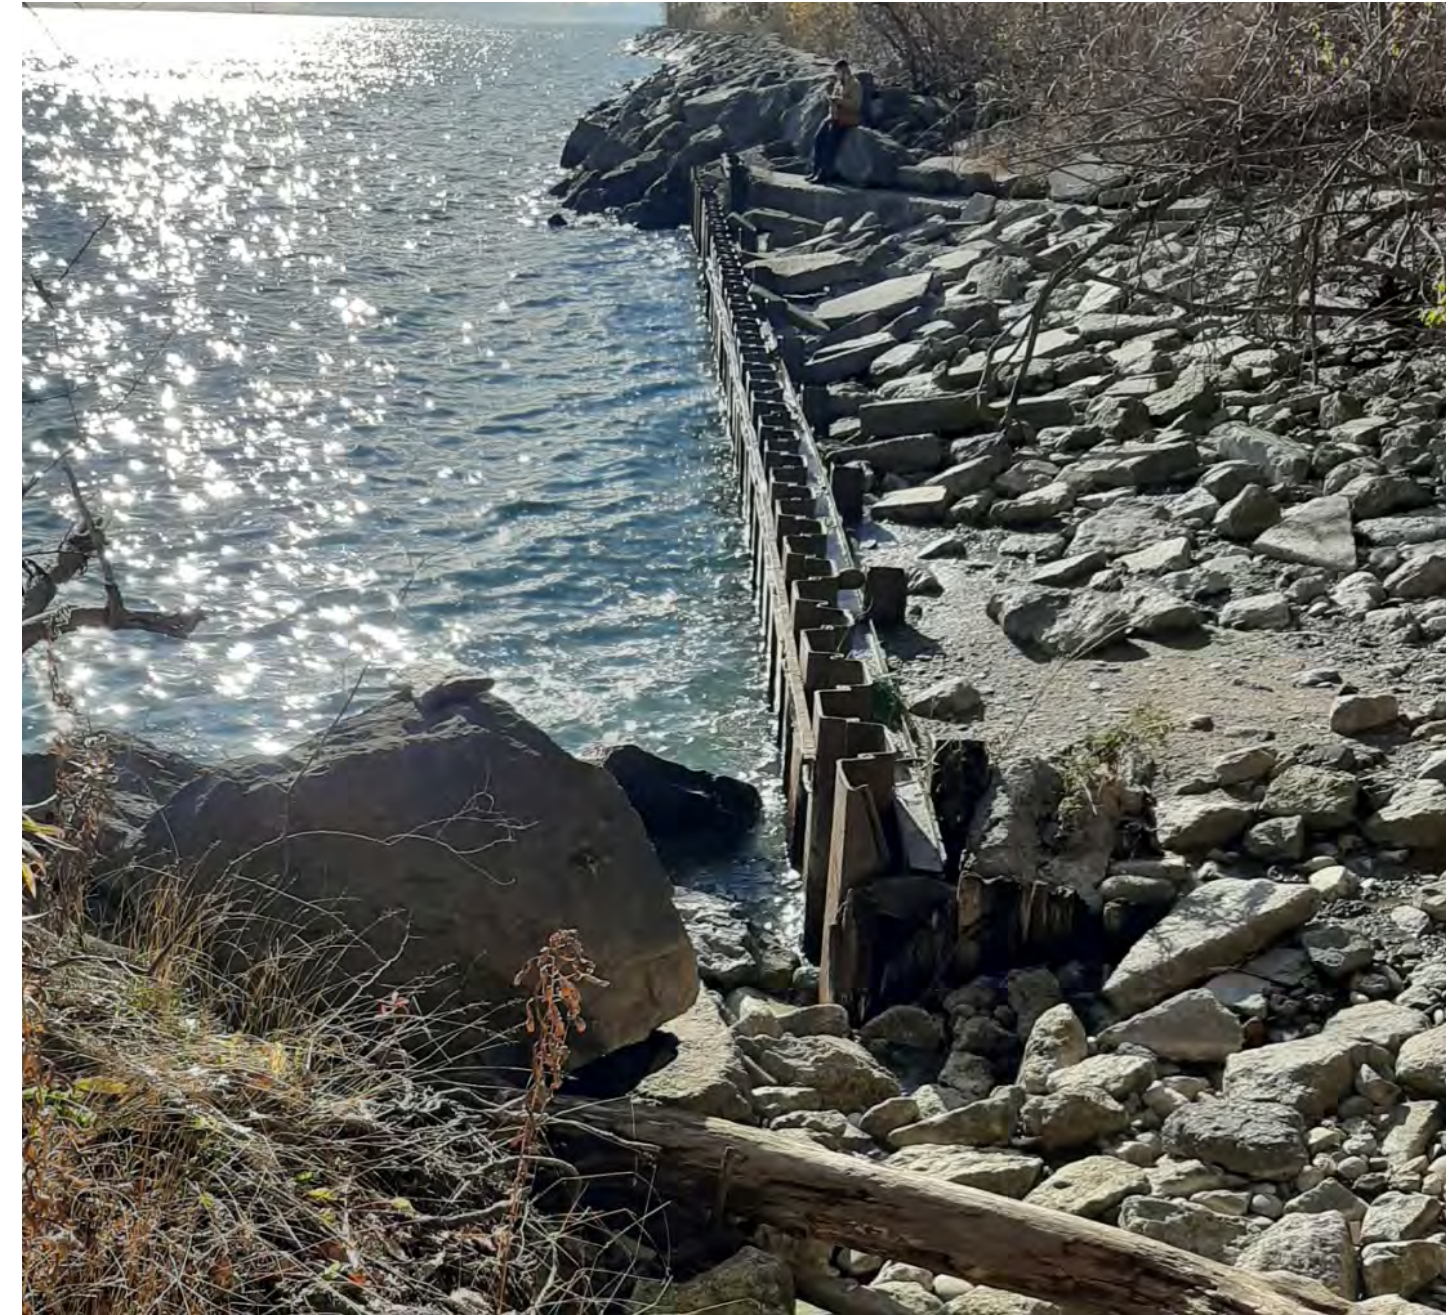
1 Sheet Pile Wall

A metal or vinyl structure that uses interlocking edges to create a continuous wall parallel to the shore.

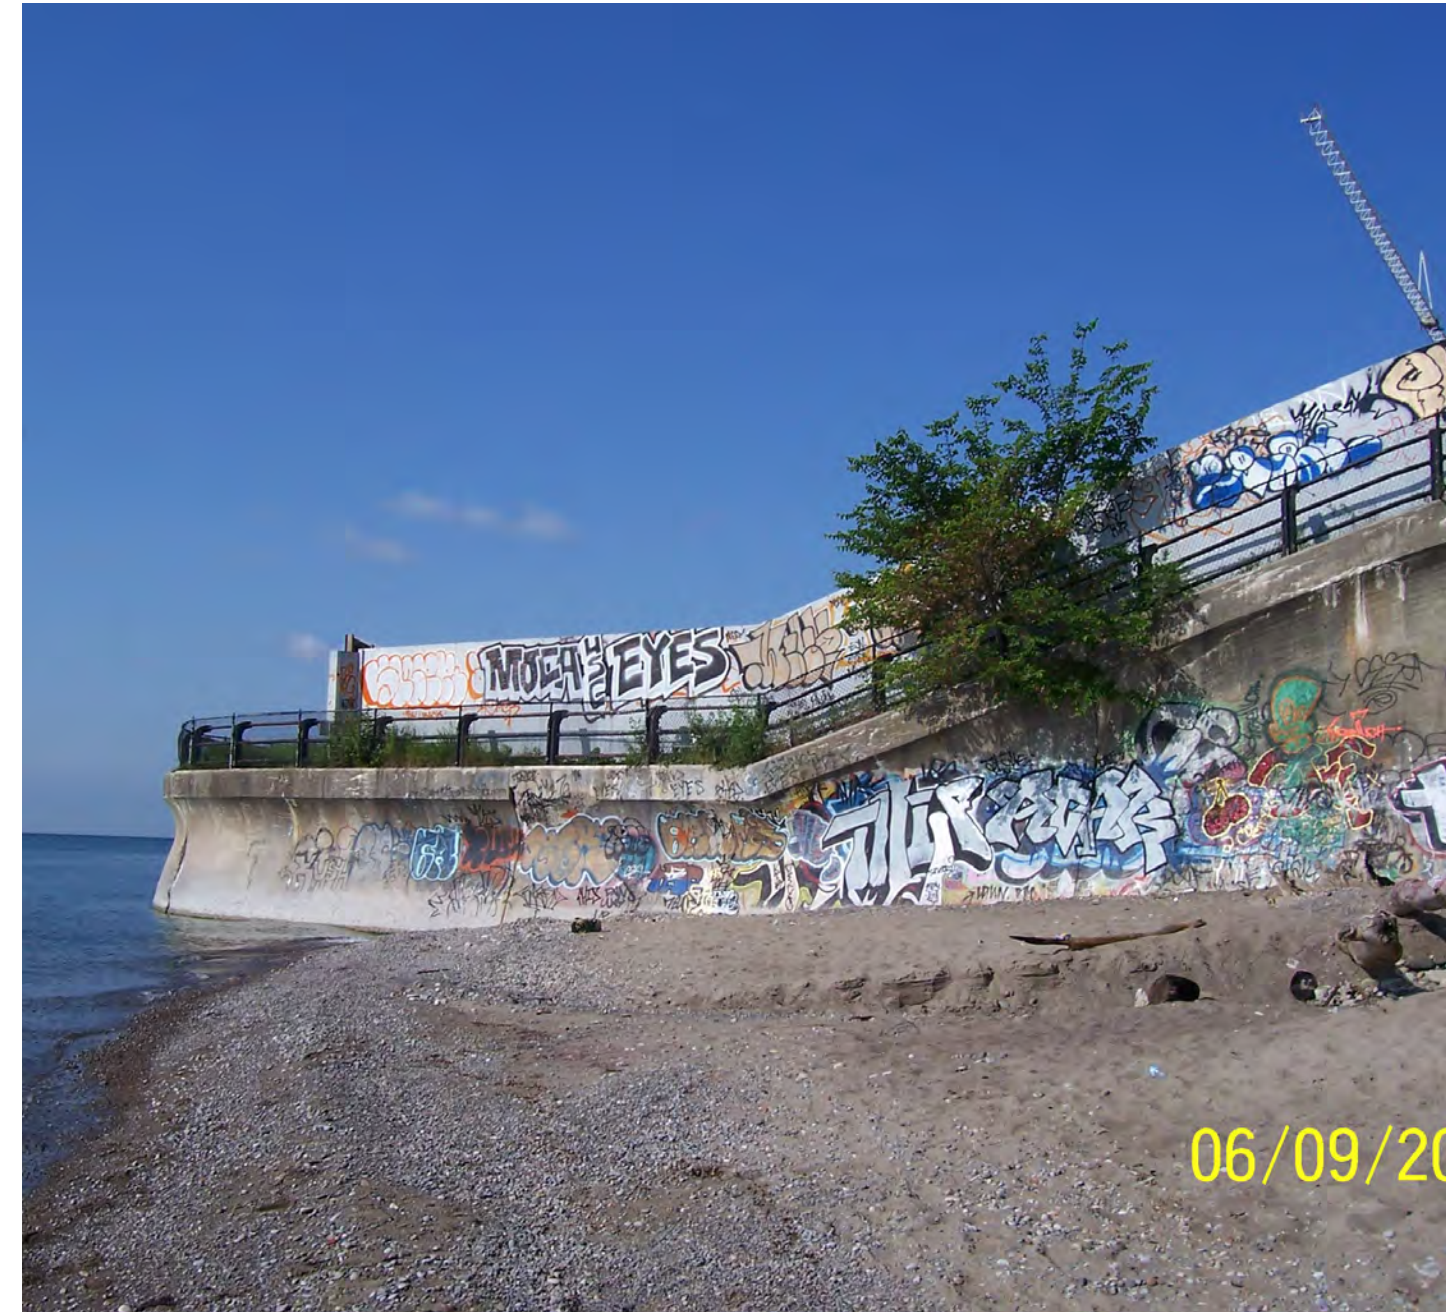
2 Concrete Seawall

A concrete structure used to protect inland areas from wave action and prevent coastal erosion.

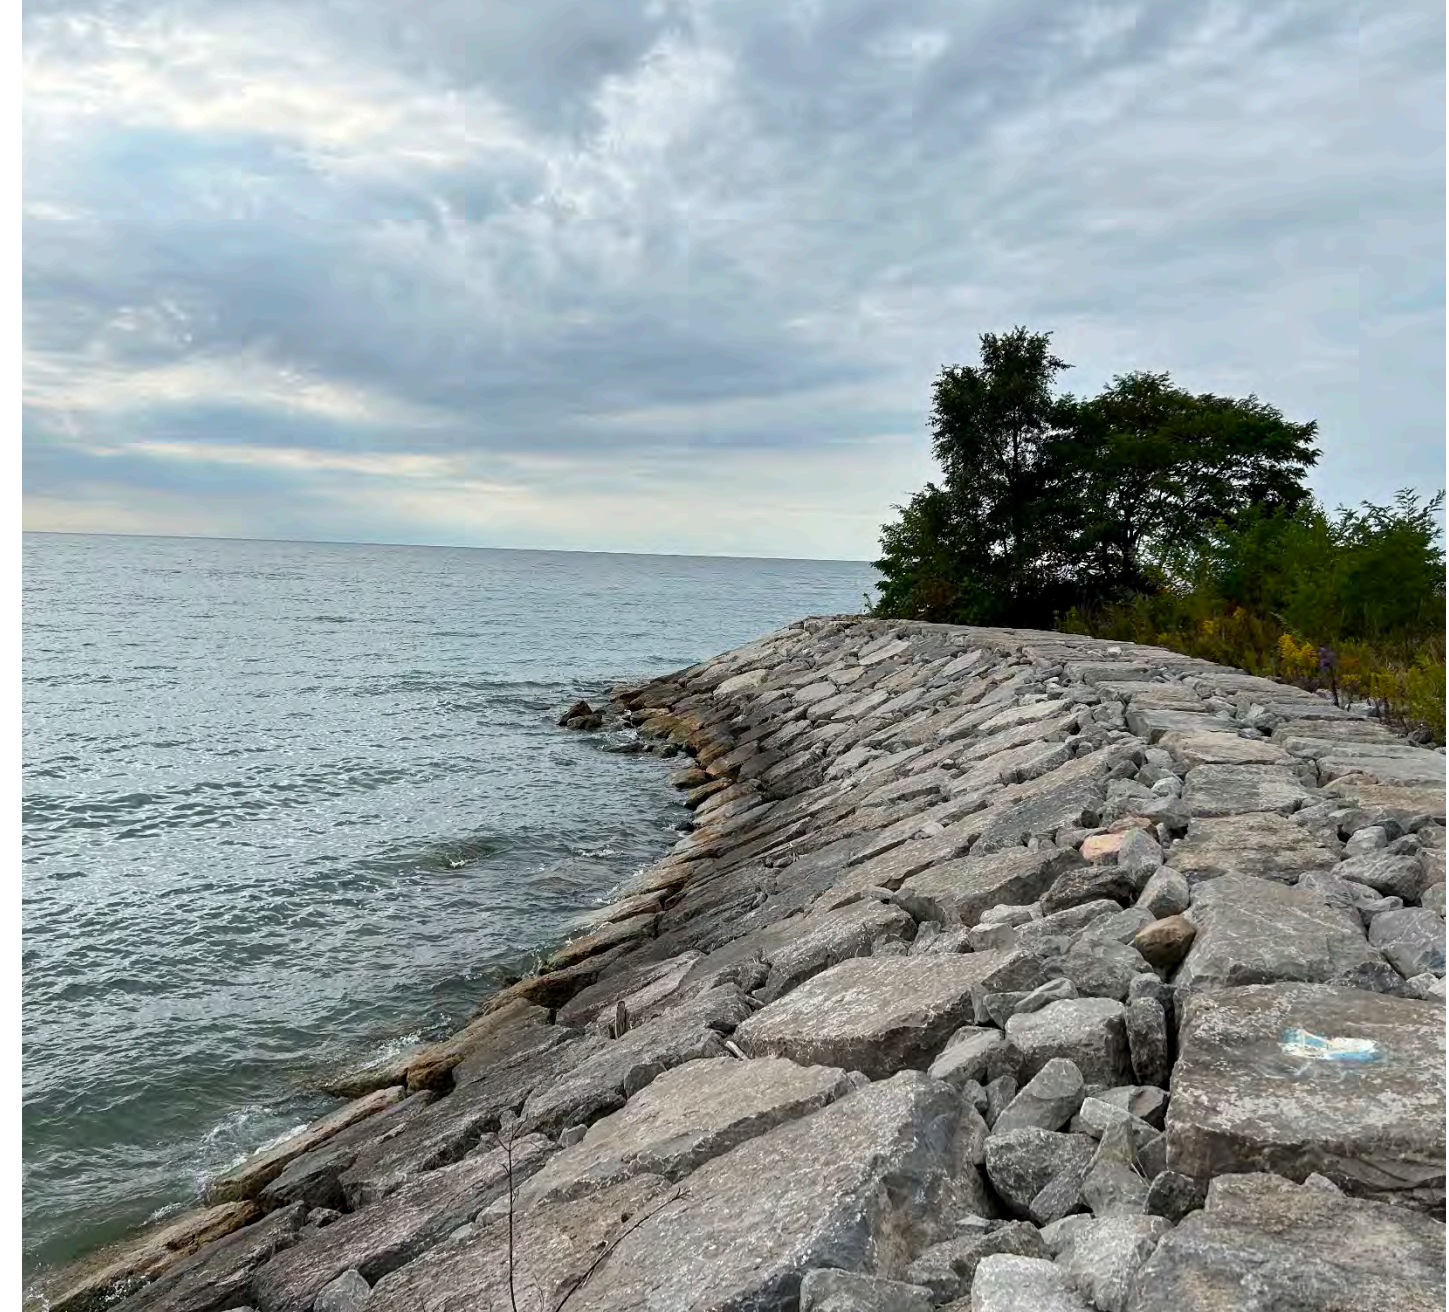
3 Armourstone Revetment

Sloped or unsloped structure built parallel to the shore, made of an impact resistant material. Armourstone is broken quarried rock often used in coastal engineering.

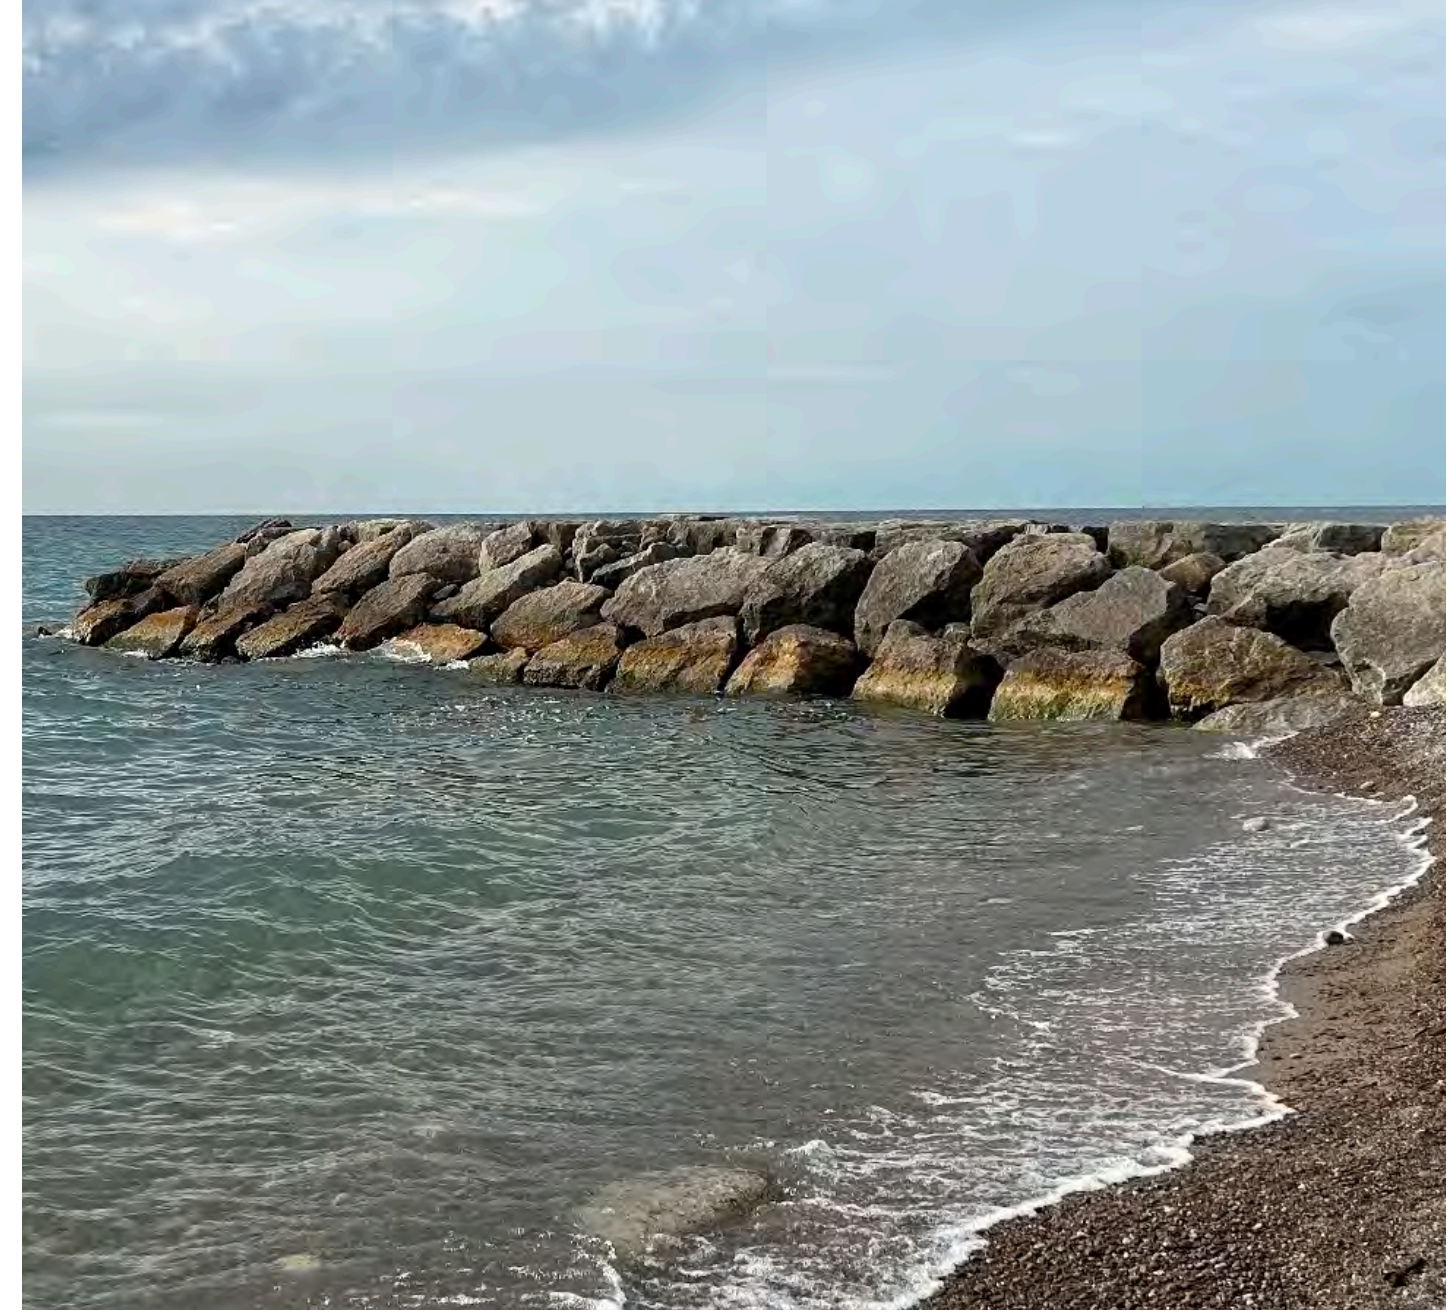
4 Groyne System

A low wall of armourstone or other material extending out into the lake. A series of groynes act together to create and protect shoreline.
