Re: Item 20.25; 150 Hamilton Street – Application to Injure Private Tree

Re: Addendum to Pruning plan for tree #5 at 154/150 Hamilton Street, Toronto, Ontario. Original Report, June 2, 2014, Revised report, May 9, 2016

Re: Pruning plan for tree #5 at 154/150 Hamilton Street, Toronto, Ontario. Original Report, June 2, 2014, Revised report, May 9, 2016

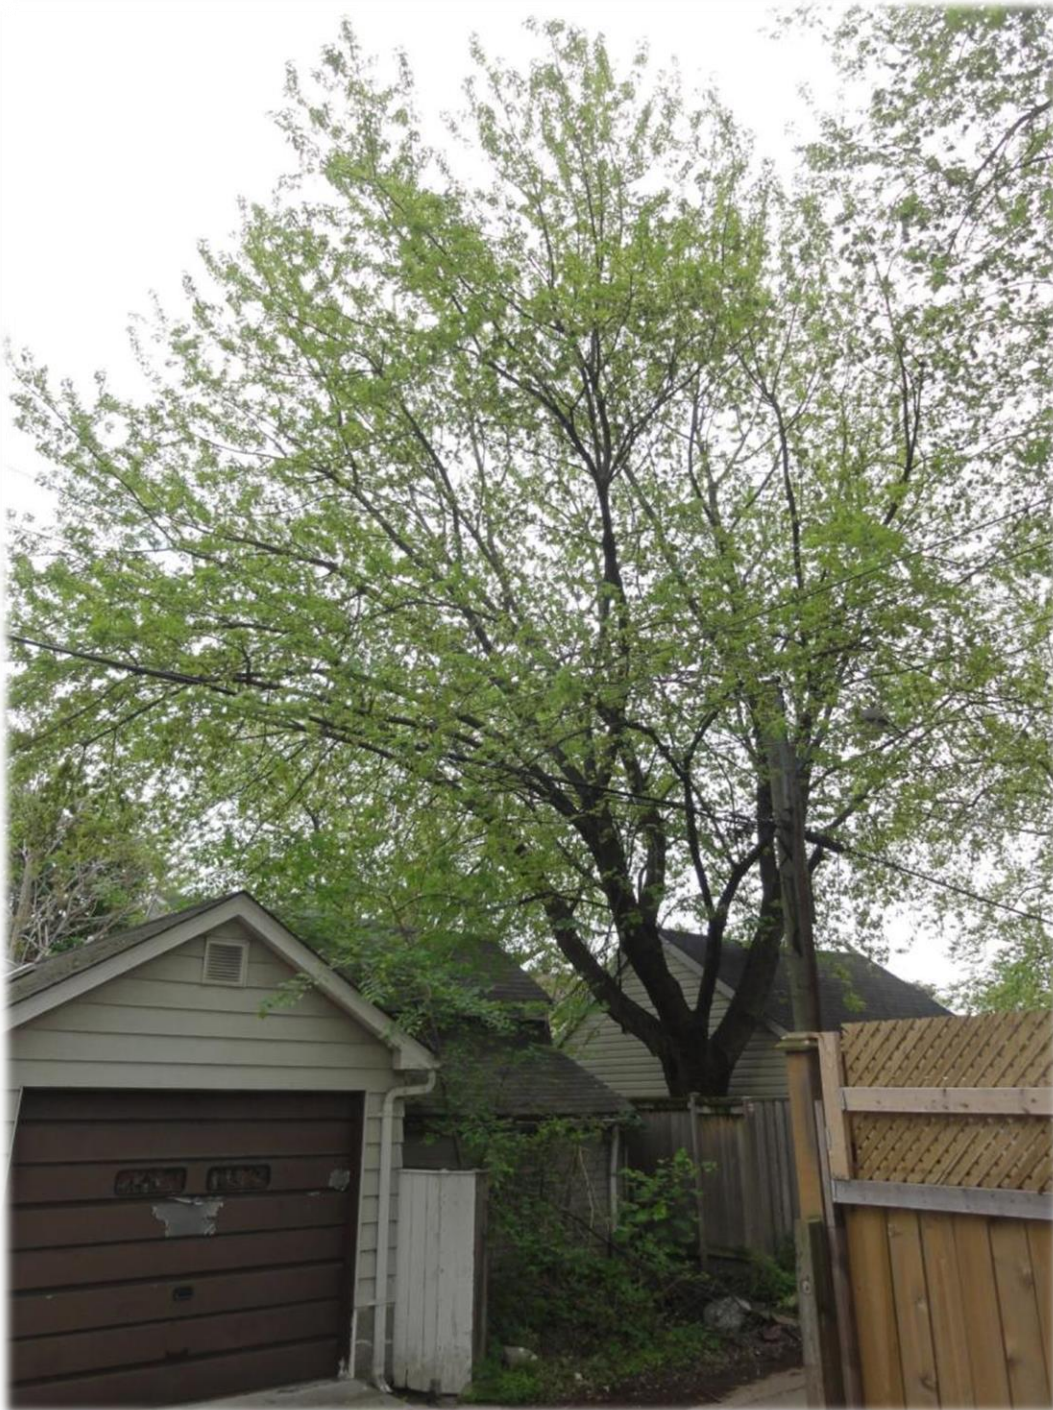
Figure 1: The subject tree, a large silver maple (*Acer saccharinum*) at 150 Hamilton Street, overhanging the subject property at 154 Hamilton Street.

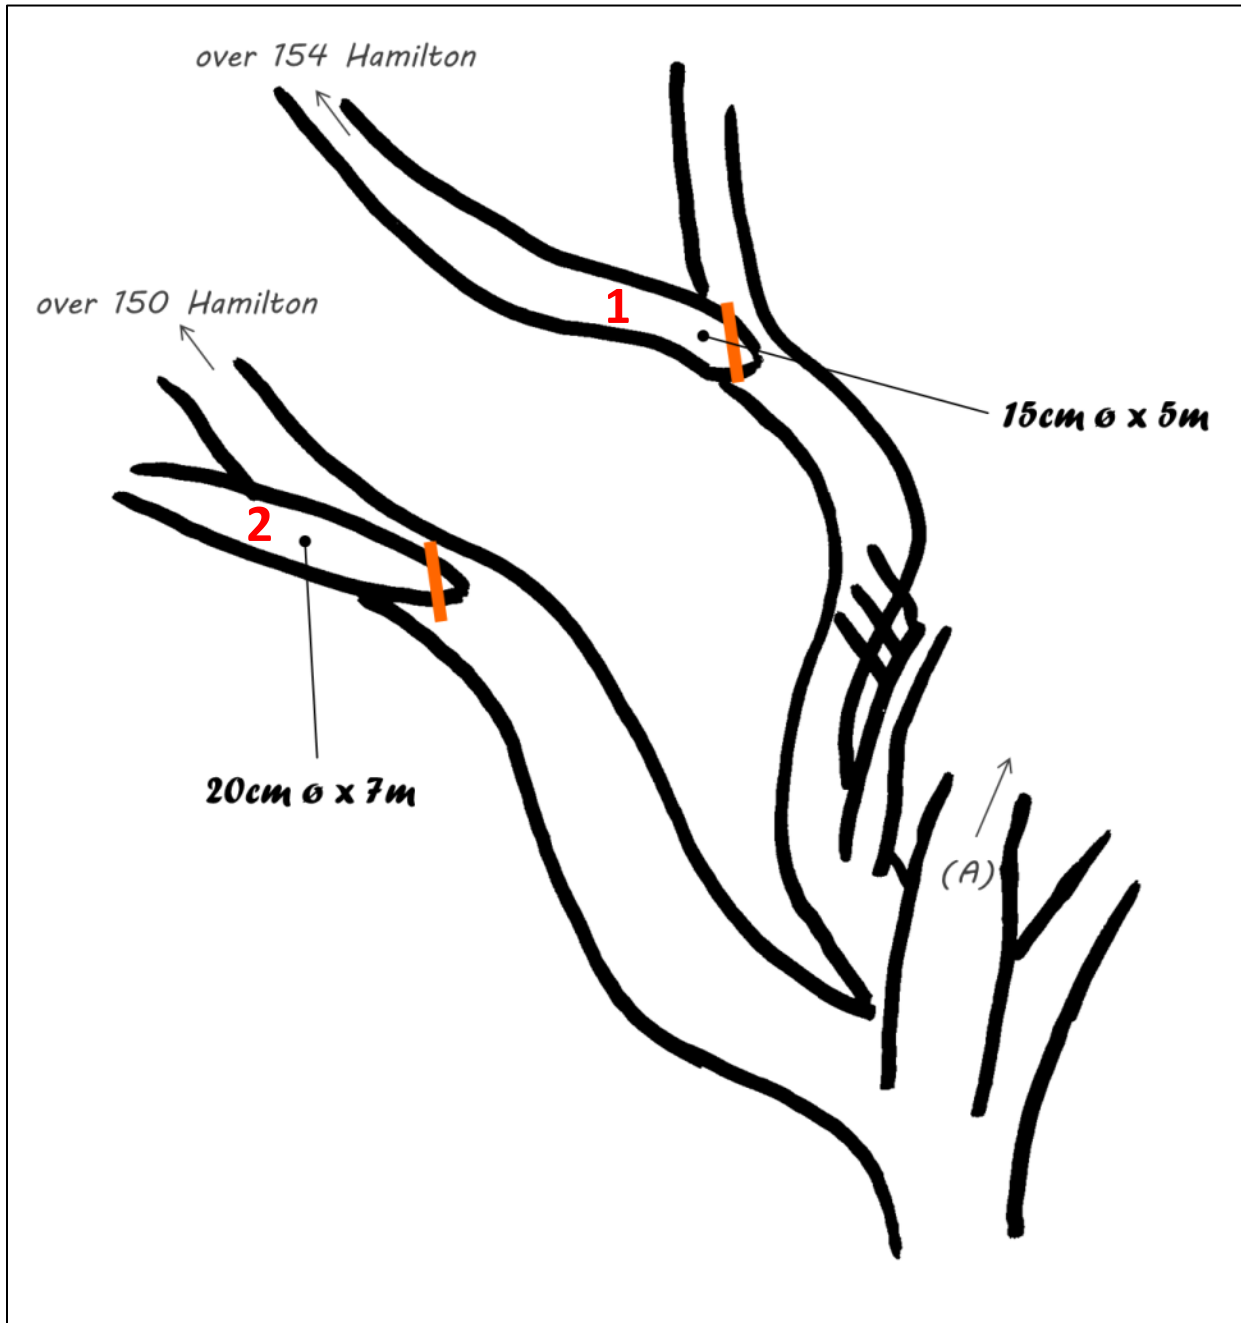
4. Branch 4 - This branch is also growing directly over 154 Hamilton. Removal of the whole branch may be avoidable by removing one side where the branch has its first major fork (Figure 9). This would be determined once the rear outside wall was built on the proposed structure. We recommend removing one side initially and the second branch only if required.
5. Branch 5 - This branch is also growing directly over 154 Hamilton. Removal of the whole branch may be avoidable by removing one side where the branch has its first major fork (Figure 10). This would be determined once the rear outside wall was built on the proposed structure. We recommend removing one side initially and the second branch only if required.

Figure 4: Schematic of proposed removal cuts on other limbs, showing approximate branch sizes.

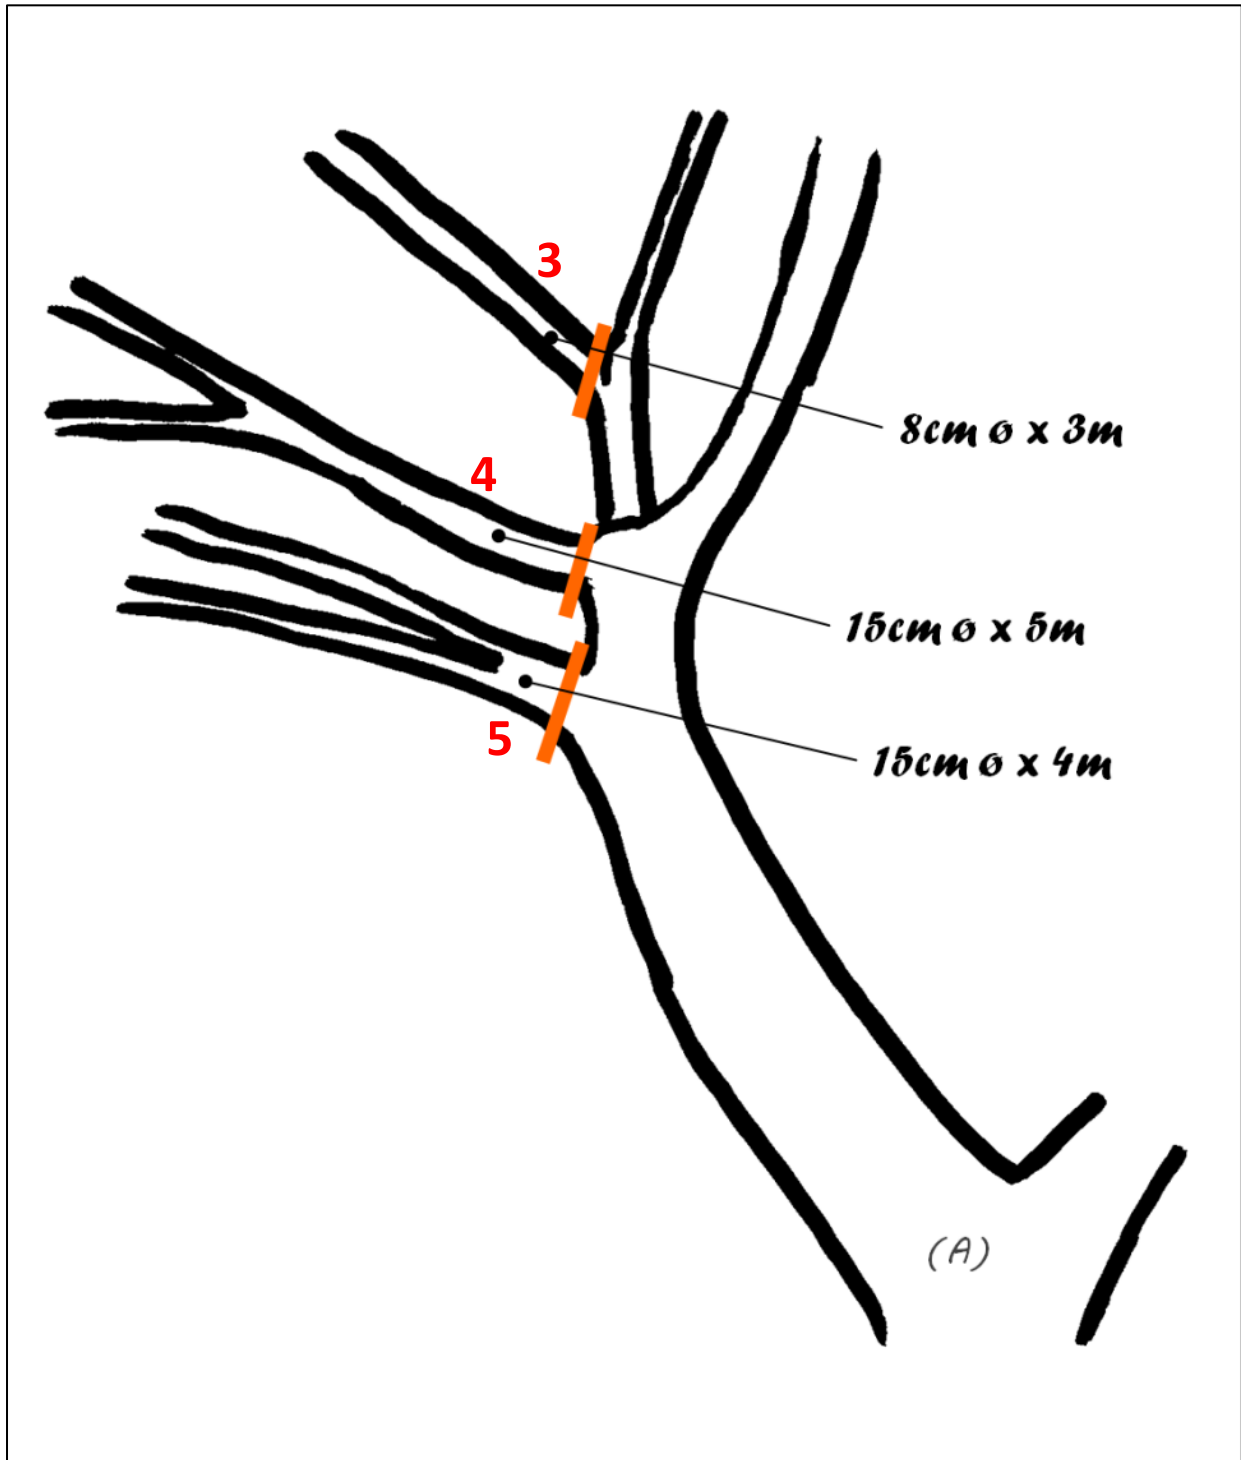
Figure 5: Schematic of proposed removal cuts on limb (A), showing approximate branch sizes.

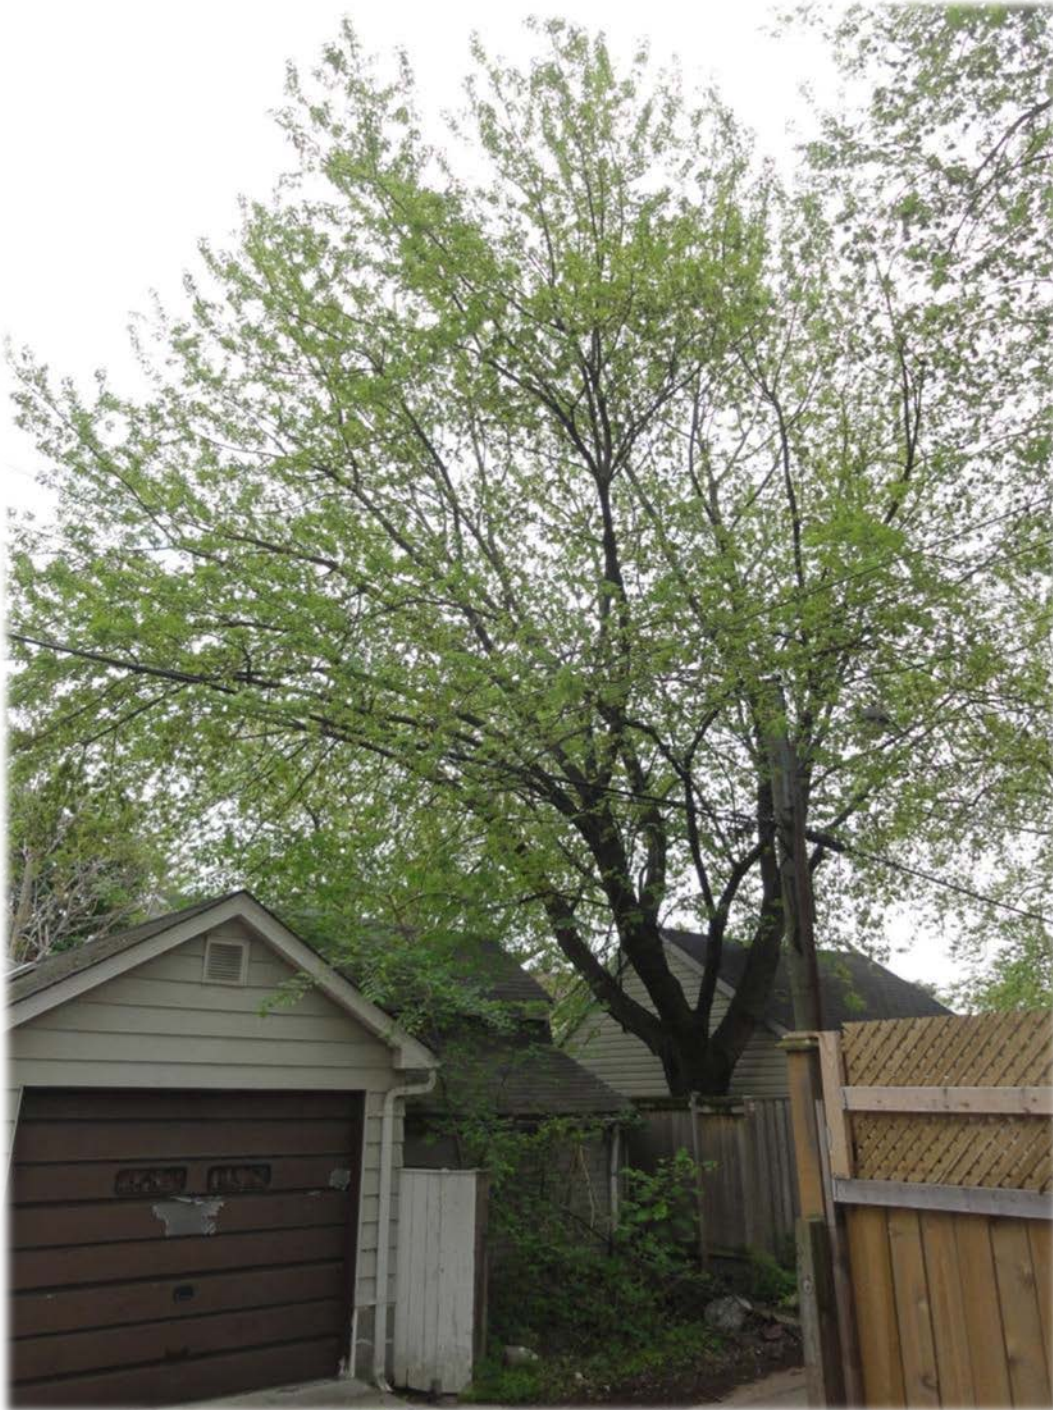
Figure 1: The subject tree, a large silver maple (*Acer saccharinum*) at 150 Hamilton Street, overhanging the subject property at 154 Hamilton Street.

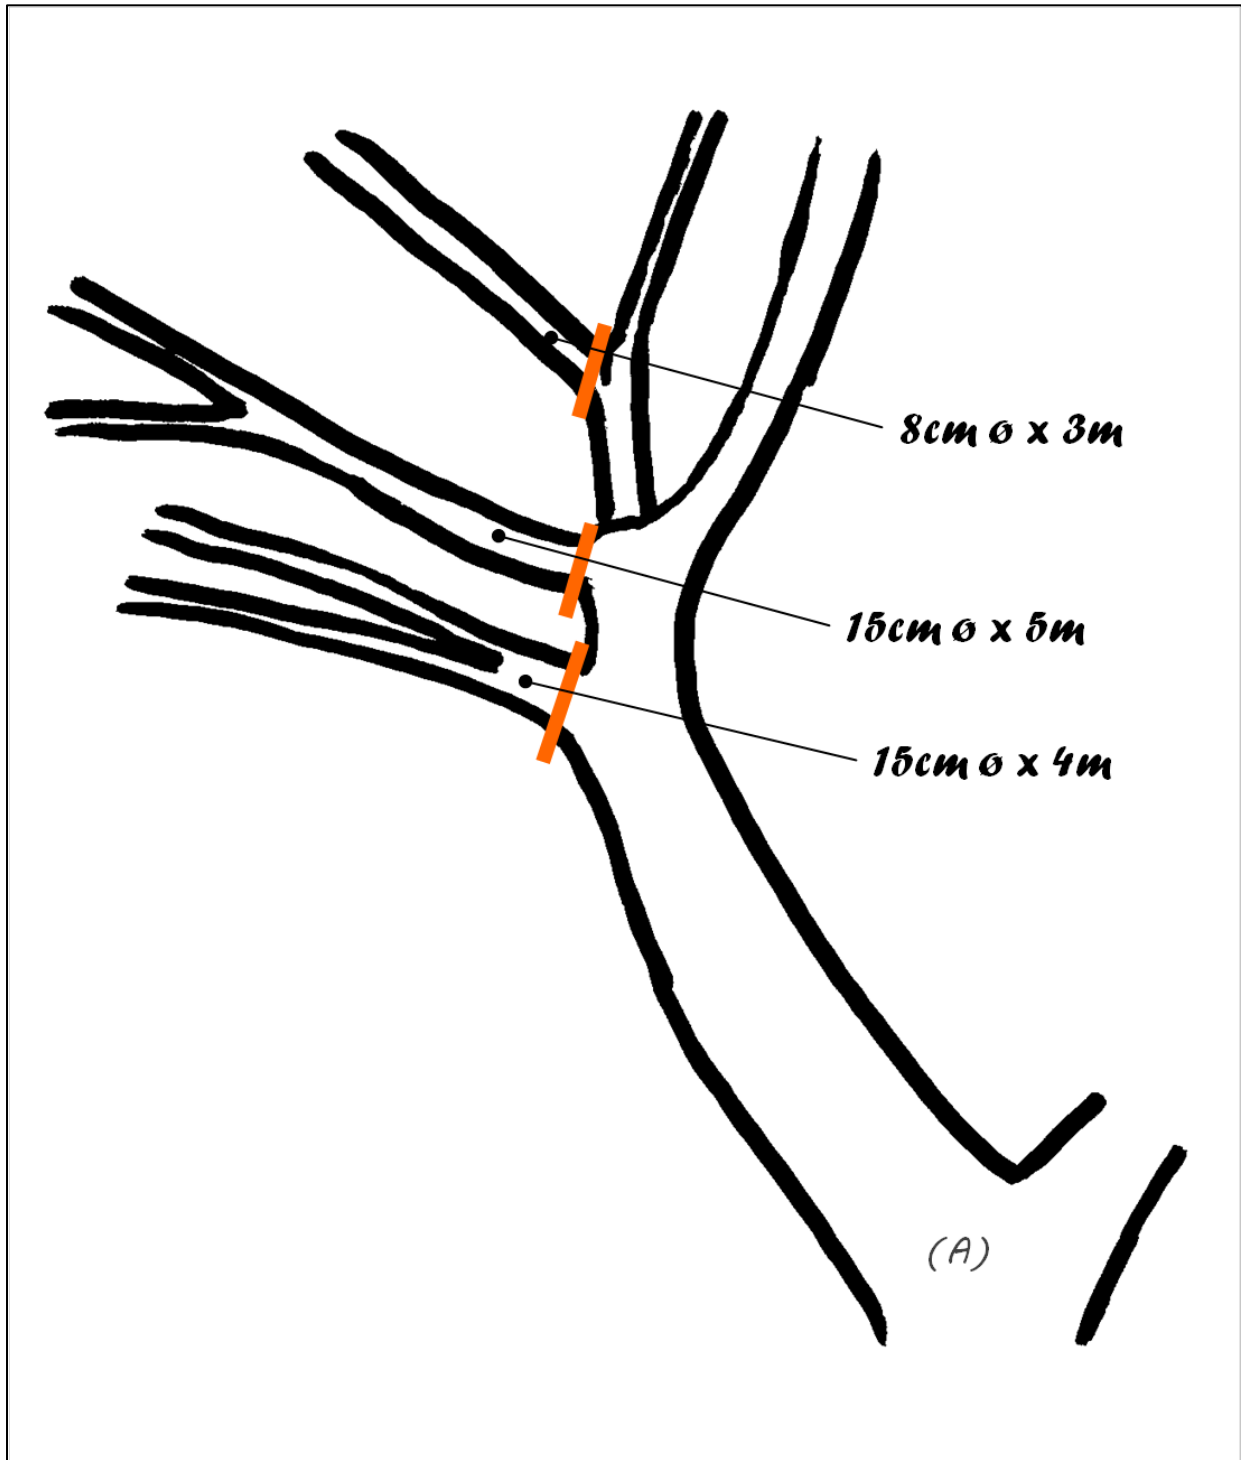
Figure 4: Schematic of proposed removal cuts on limb (A), showing approximate branch sizes.

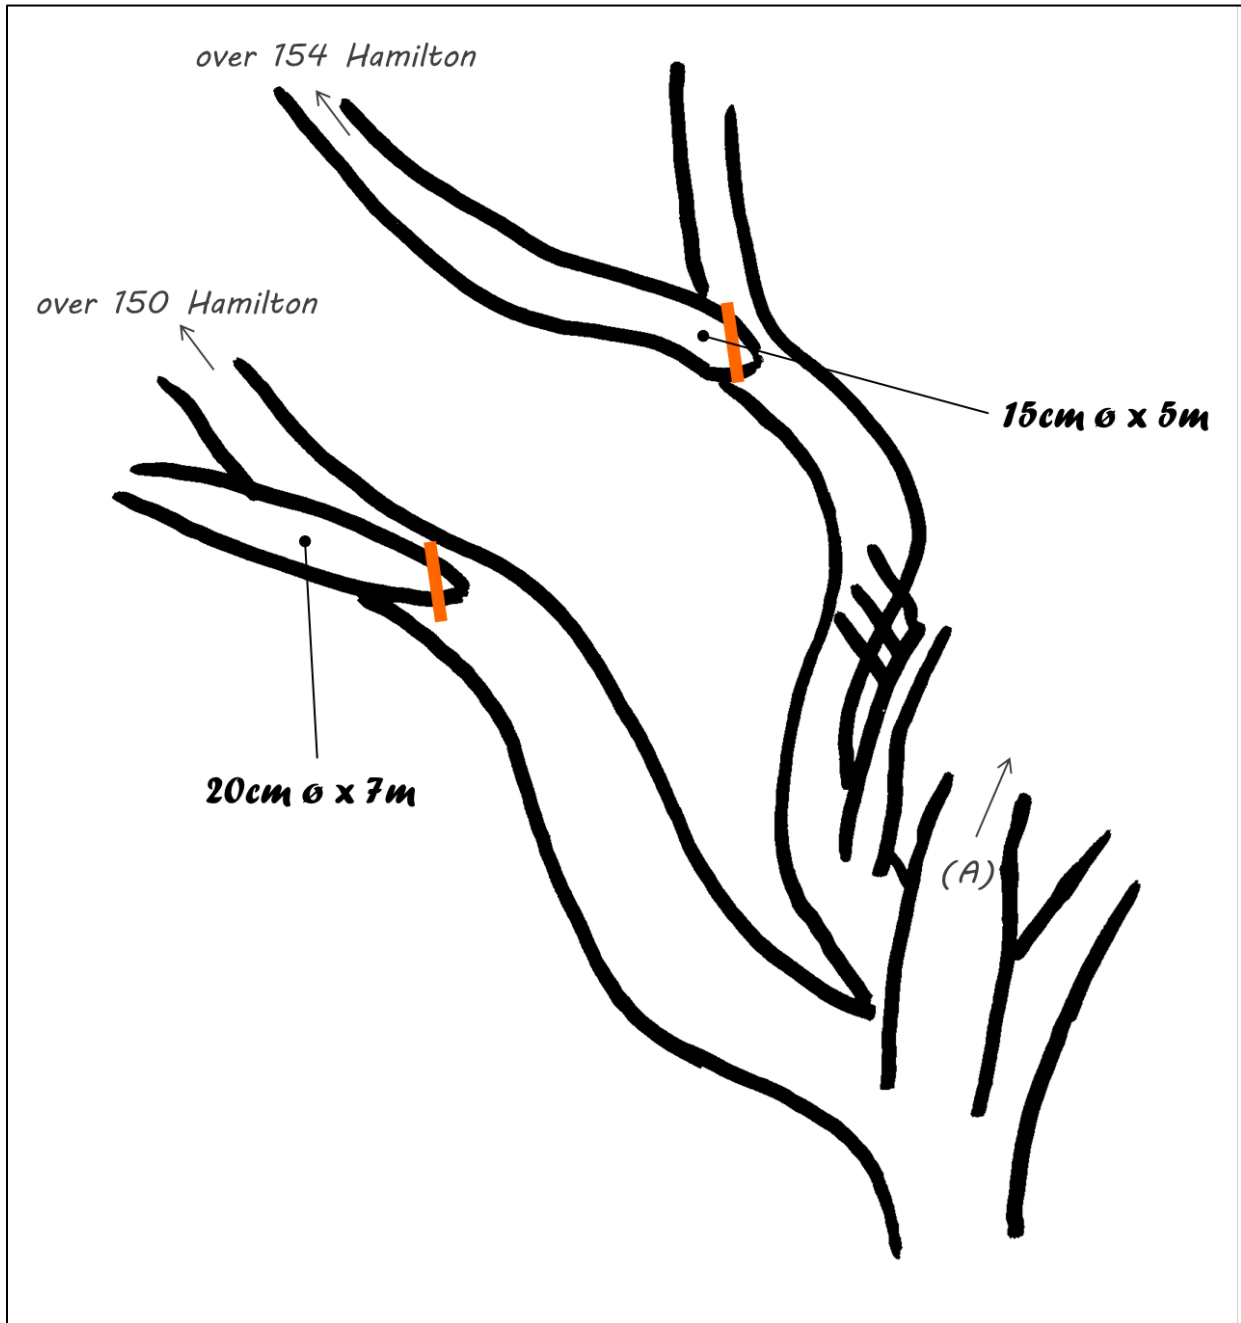
Figure 5: Schematic of proposed removal cuts on other limbs, showing approximate branch sizes.
