South of Bloor Street

North of Bloor Street

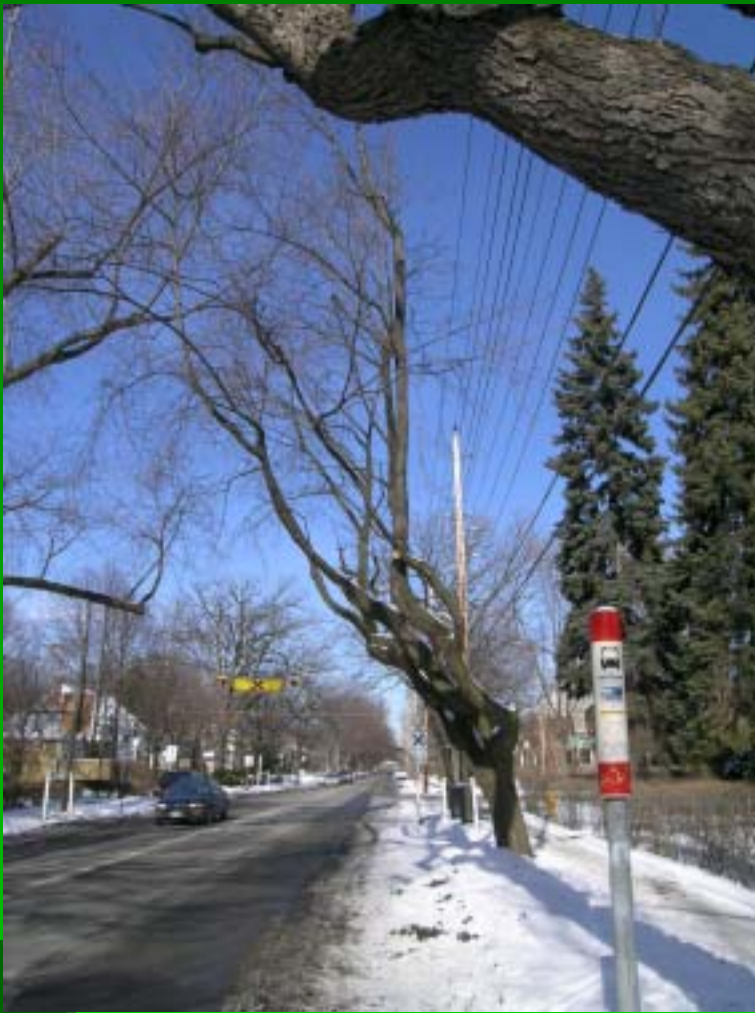
Tree Number 121 at 987 Royal York Road. This tree has been unbalanced by “hydro pruning” and all of its stems over the road have been damaged by vehicles.
