URBANGREEN TREE LTD.

Location: 102 Wimbledon Rd. The 4 Trees are located in the back yard. Tree 1 is near the south fence line, Tree 2 is the center of the yard, Trees 3 and 4 are by the back walkway.

Nature Of Work: Request permission to remove the 4 trees.

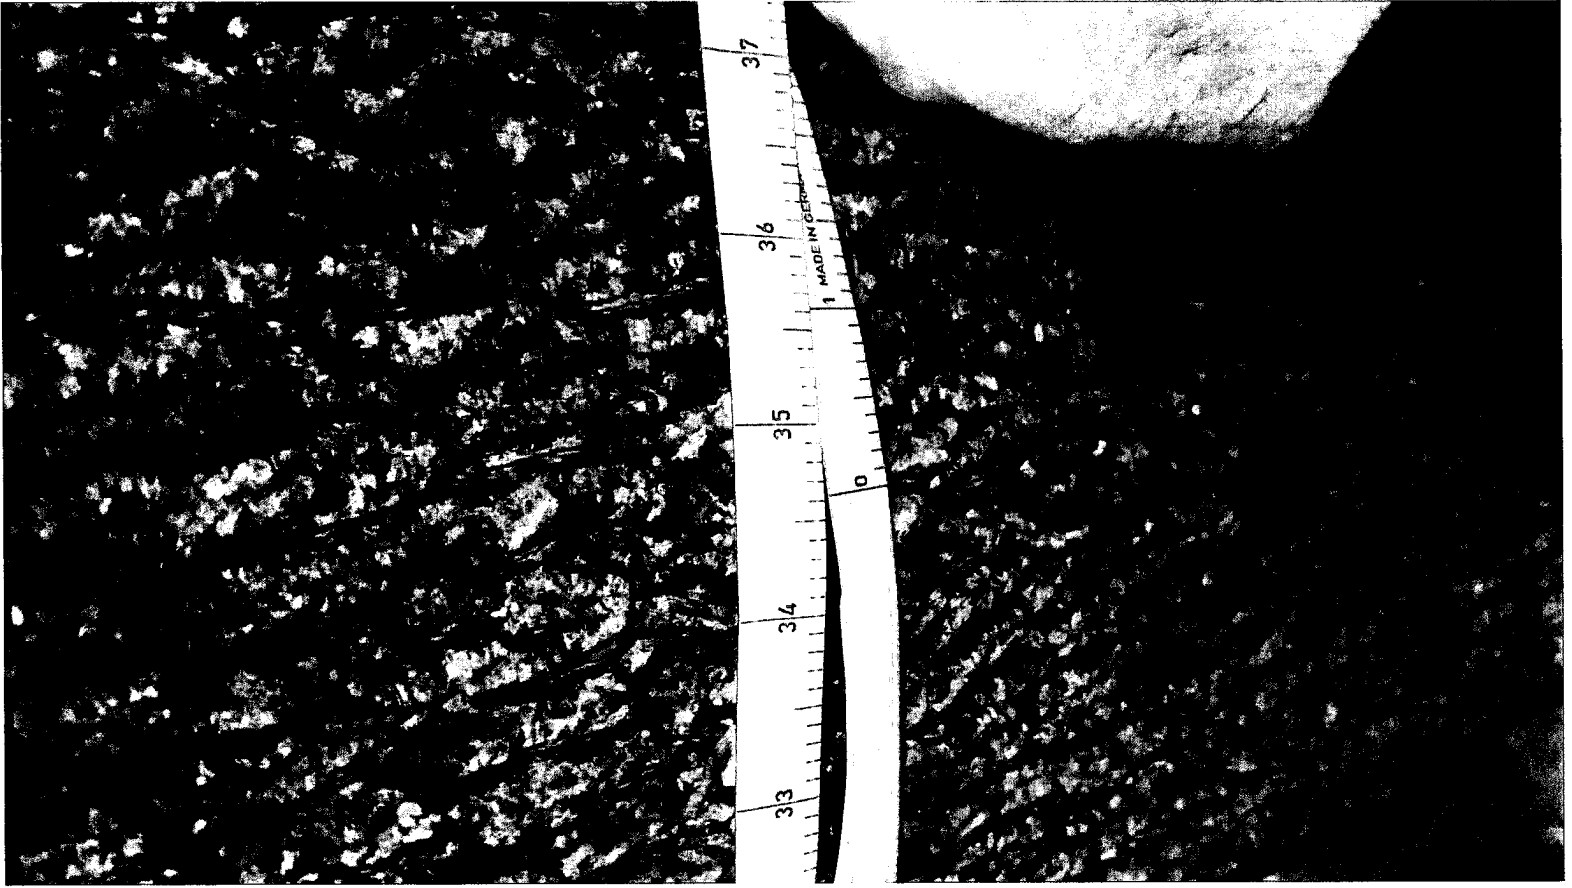
TR 88 1

Condition: Tree 1 - Norway Maple: Large vertical crack in main stem running from base of trunk up 15 feet, causing an increased risk for tree failure.

Tree 1 – Norway Maple: Tree is located next to property line fence on Client's property, the Client and neighbour are worried about future tree failure leading to fence and property damage.

Arborist Recommendation: These trees have poor structure and with the risk to property damage or personal injury due to the locations, are therefore no longer viable to maintain. I recommend removal and replacement.
