TD3.2 - Attachment 3

Attachment 3: MRAB Case Studies, 2015

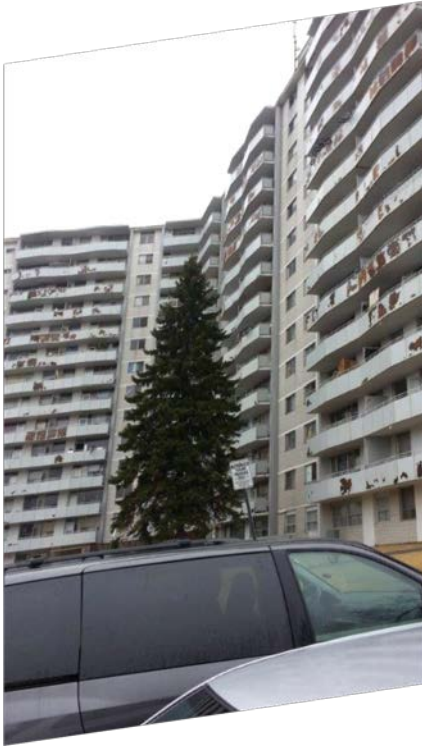
500 Dawes Road

In 2013, the MLS MRAB program audited the Dawes Road property. Although all property standards orders relevant to the audit were complied with, the building owner continued to neglect the building, sustain cleanliness and undertake the needed maintenance repairs.

In 2014, a property standards order was issued pertaining to balcony panel repairs and painting. Due to landlord inaction, MRAB staff were prepared to have contractors repair/paint the balcony panels, but the structural condition of the panels came into question.

MRAB staff issued an order requesting an engineer's report on the integrity of the balcony panels and slabs. The landlord did not comply and staff contacted an engineer to investigate and supply the report. The report was received and staff are currently evaluating the scope of work associated with the identified repairs.

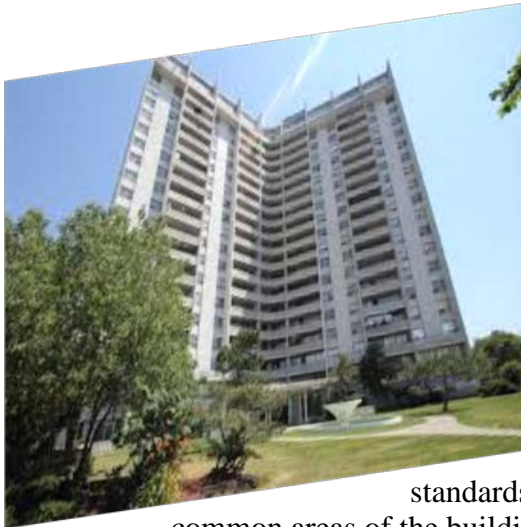
The residential rental apartment building located at 1501 Woodbine Avenue was audited in 2013 by the ML&S MRAB program. The audit resulted in six property standards orders, which identified 122 deficiencies.

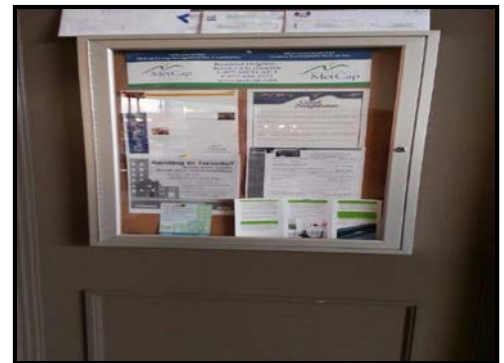
MRAB staff, building management and the building tenant association continue to educate and encourage tenants to submit maintenance requests to building management to expedite resolution and repair response. For example, tenant education pamphlets and window safety brochures are displayed in the building lobby as illustrated in the attached photo.

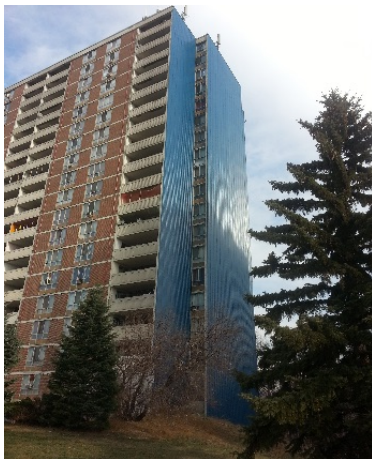
In March 2015, 2777 Kipling Avenue was identified to MRAB officers as a building in need of an audit. A pre-audit assessment was completed and a subsequent audit occurred on April 30, 2015. As a result of this audit, property standards orders were issued relevant to interior common areas, exterior grounds and underground garage.

On May 1, 2015 officers issued a notice of violation pertaining to an excessive accumulation of garbage and waste strewn throughout the exterior of the property. Officers subsequently initiated city action and hired a contractor to clean and remove the garbage and waste.
