CONSERVATION PLAN

8 Elm Street

Toronto, ON
(GBCA Project No: 19002)

8 November 2019

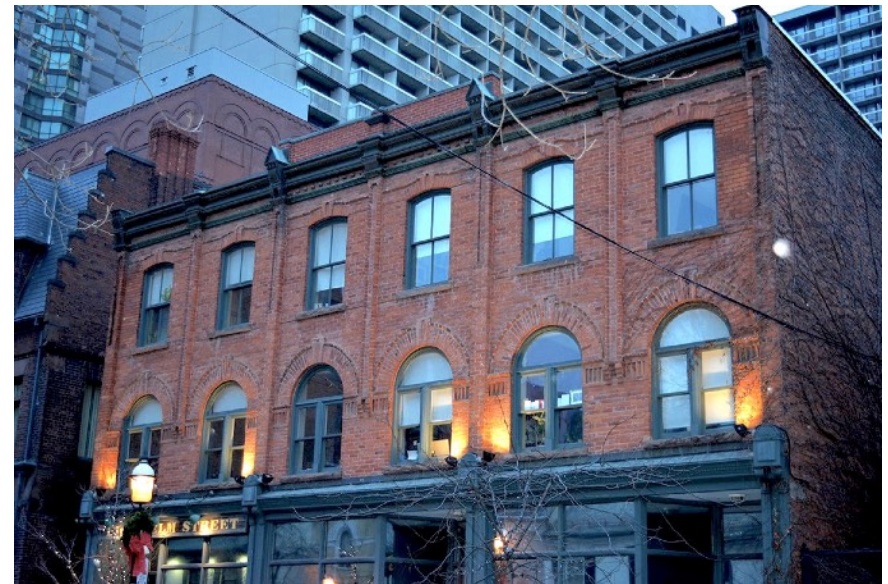
Overall view of the 8 Elm Street facade

- The rebuilt wall will be approximately 2.5 metres long and fully exposed to the exterior, for its entire height.
- Provide mock-ups of selected cleaning techniques for each element for review by the heritage consultant. The approved mock-up will serve as the standard of cleaning for the remainder of the work.

- Remove ivy from masonry, including all left-over tendrils, and clean surface where necessary with low-pressure wash.
- Repair or replace bricks and repoint mortar joints where indicated on the drawings

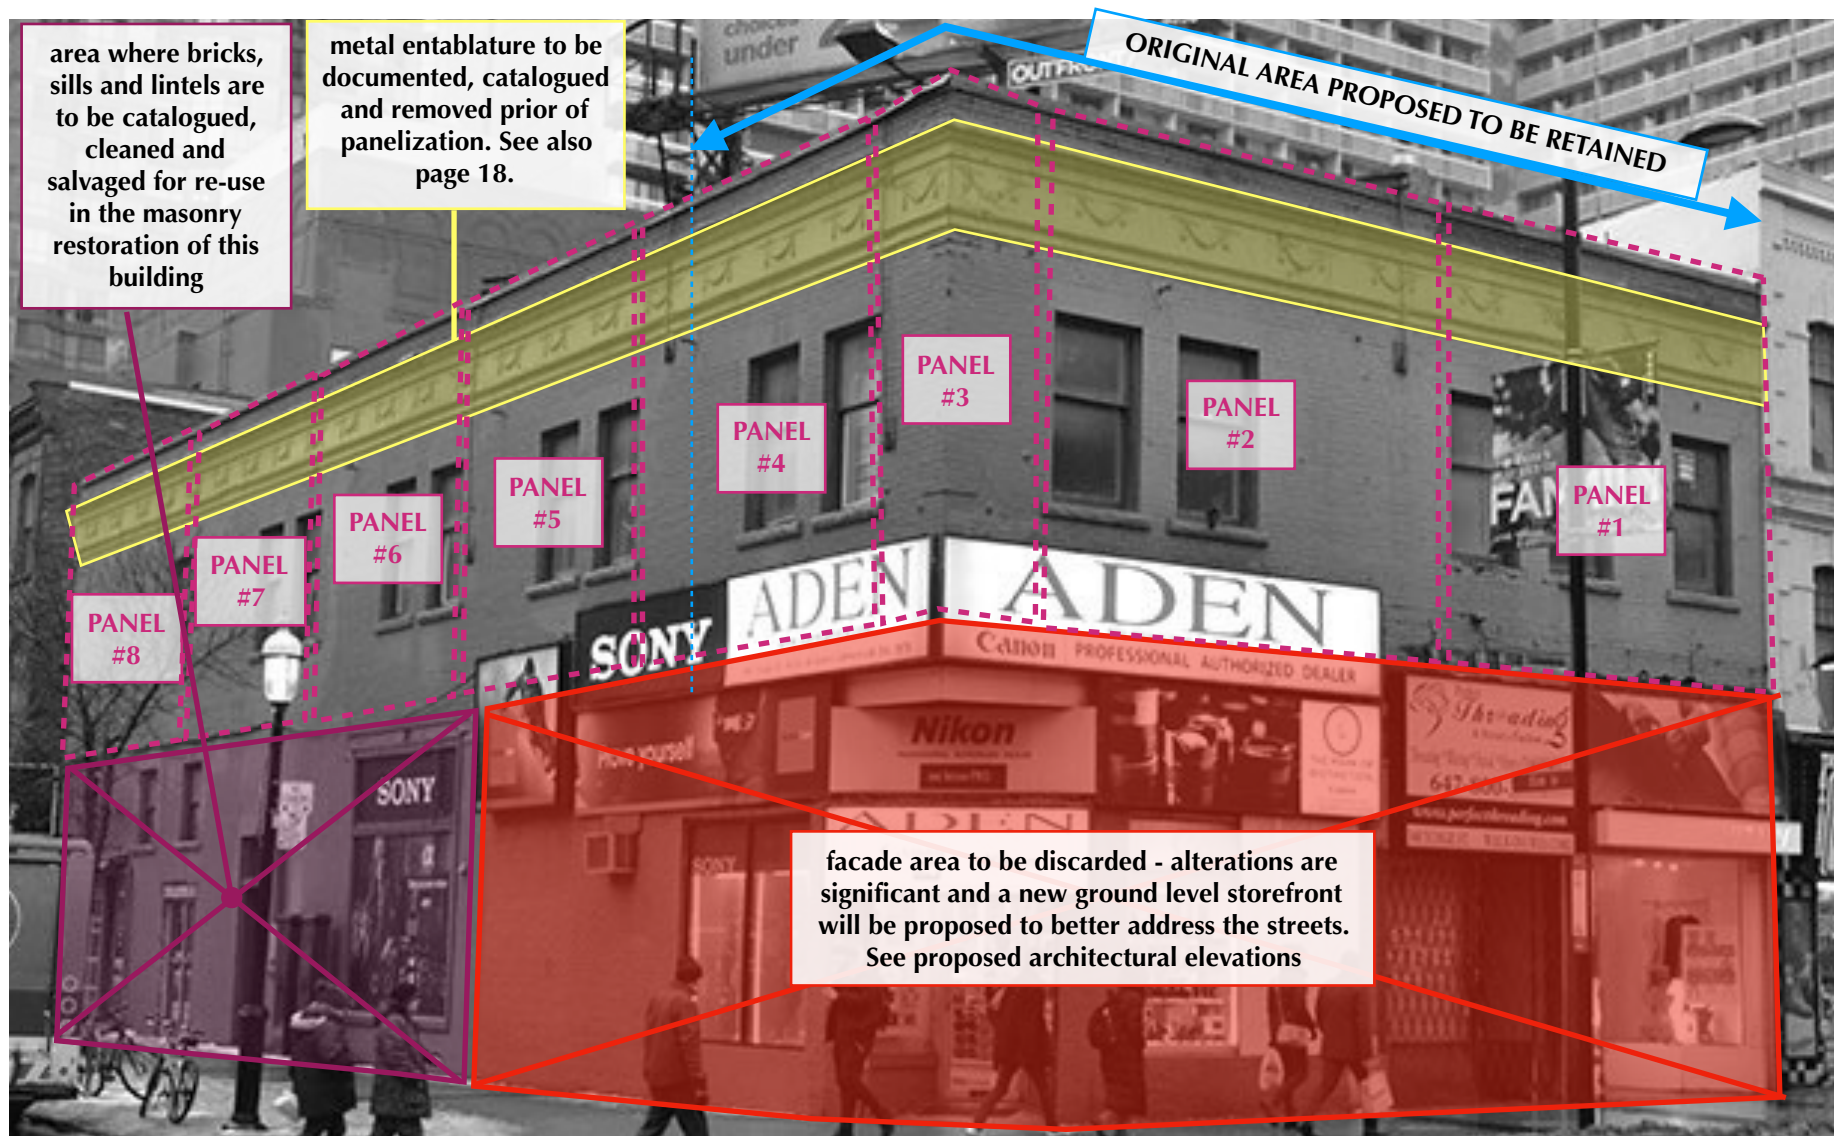
Approximate areas of panelization of 348-350 Yonge Street. For elevation of areas, refer to Appendix IV.

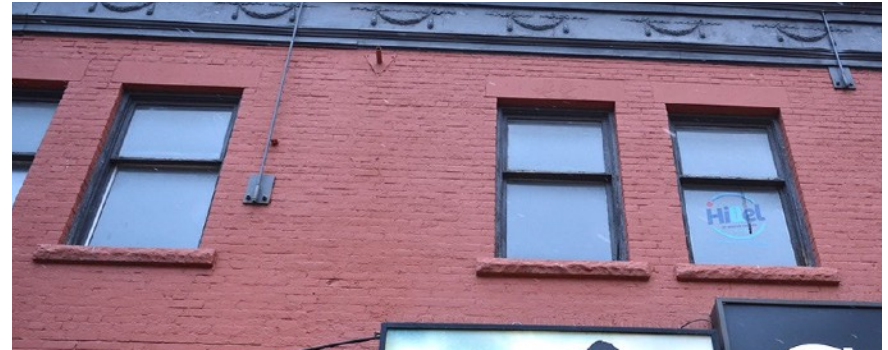
- At ground level: windows and doors are modern aluminum replacements
- At upper storey: windows are wood, double hung, single glazed and appear as original
- Original wood windows are in fair to poor condition.
- Successive layers of paint have been noted on the wood surfaces. Paint is flaking, exposing the wood

Examples of windows on the Elm Street facade. Windows are of wood, double hung, with the lower sash larger than the upper sash.

- Remove all modern aluminum windows and doors.
 - Ground level will be redesigned with new aluminum framed windows and doors.
- Remove all upper storey wood windows and replace with new to match
 - Windows require removal prior of facade panelization strategy
 - New windows will be of wood with an aluminum cladding on the exterior and replicate the existing double-hung style and design shown.

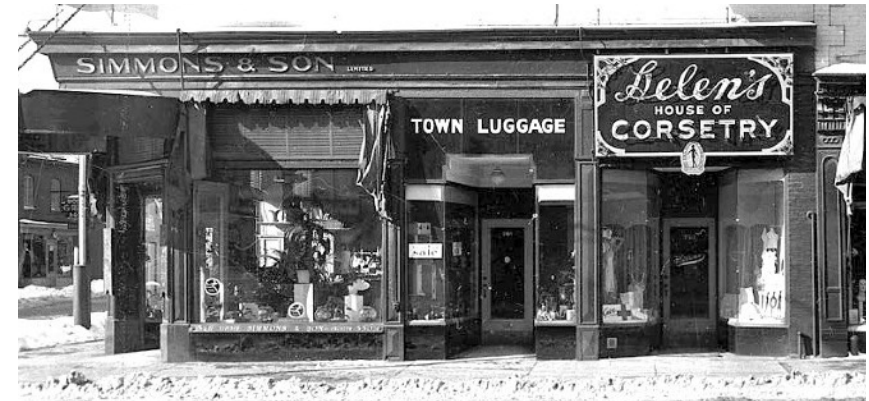
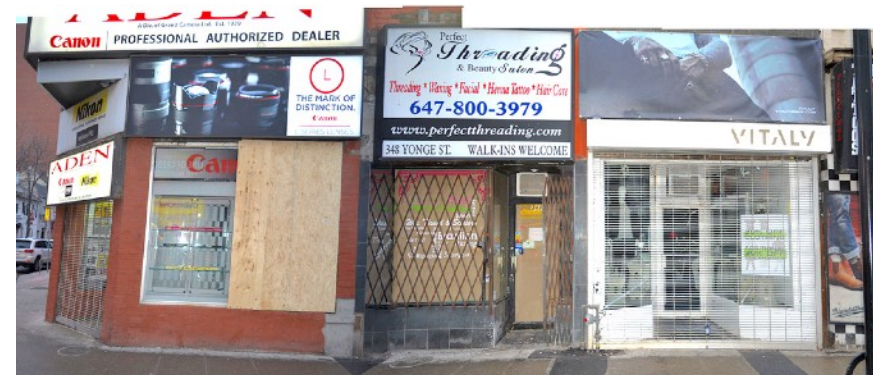
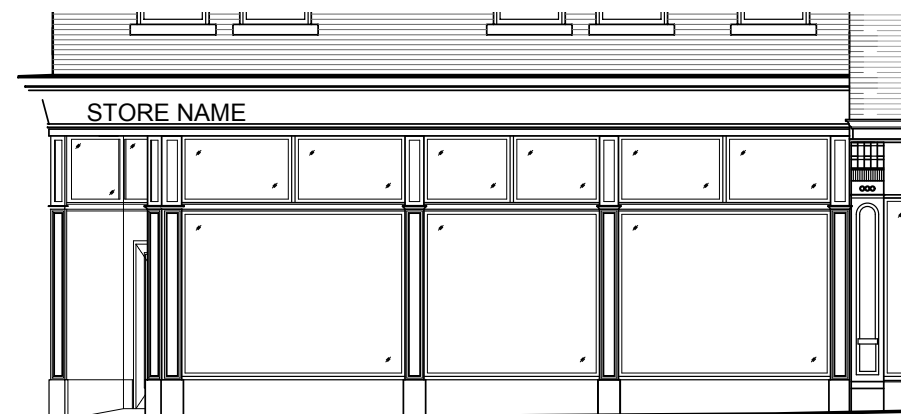
- Storefront structure not properly assessed due to amount of signage which, due to their current occupancy, could not be removed. A wood beam was visible, but its condition was not confirmed. It is expected the beam is in poor condition if it is original.

Top : 1950s photograph of storefronts
 Middle: 2018 Panorama view of storefronts.
 Bottom: Proposed schematic storefront design.

- Remove all obstructions from current storefront and expose the existing structure and, if existing, any original finishes.
 - ▶ Undertake investigation and documentation of the existing condition of the structure

- ▶ Intention is to remove the wood beam (as it is expected to be in poor condition) and replace with a new structural steel beam and columns.
- Rehabilitate storefront with a new design that respects design principles of late 19th century storefronts, using new materials.

- ▶ In the event original heritage fabric is found, it will inform on the design of the new storefronts.
 - ▶ New materials to include wood, metals, glass and granite at the bases.

- ▶ Rehabilitated storefront design must be considered preliminary as it is subject to change if additional information is found following existing storefront dismantling and through coordination with the new retail requirements

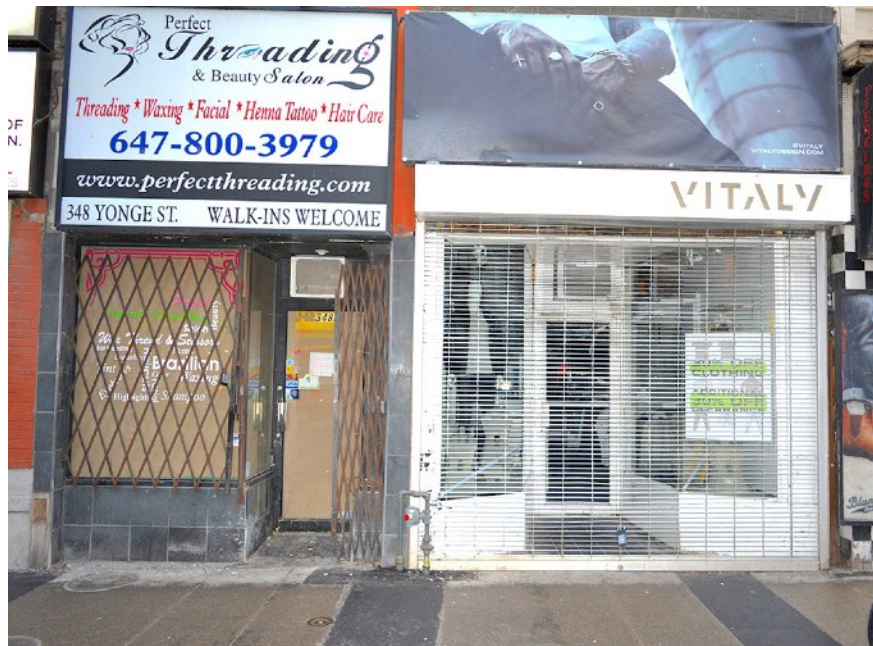
Close-up view of storefronts along Yonge Street

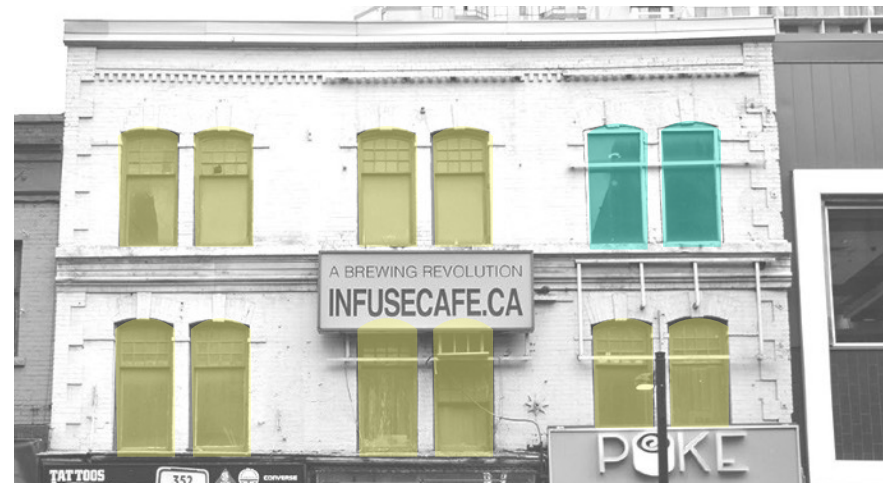
Aluminum frame (non-original).

Wood frame (original)

- Remove all wood windows for restoration to an off-site location
 - Window restoration will consist of:
 - paint removal and repainting
 - repair of damaged wood units and replacement of heavily damaged items
 - Interventions to address glass efficiency may consist of one (or a combination) of the following strategies:
 - removal of all glass panes, retention of sashes and frames and replacement with new insulated glazed units (only possible if sashes can accommodate an increase in glass thickness)
 - retention of existing glass and inclusion of new interior storm sash windows
 - replacement of lower sash with new wood sash and new insulated glazed units
- Replacement of 2 non-original windows with new wood windows to match.

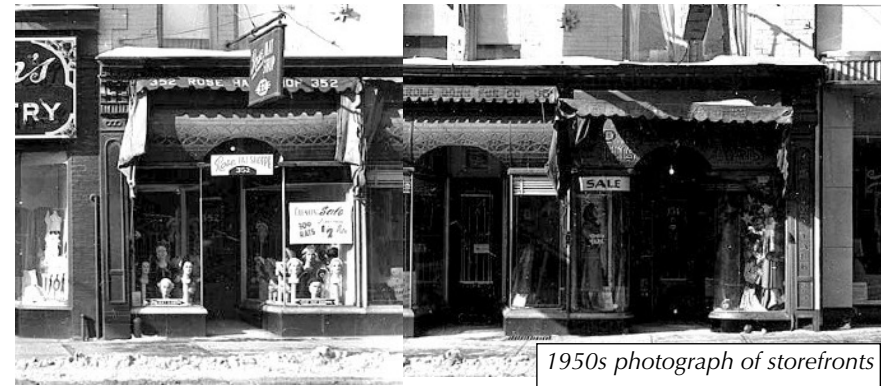
1950s photograph of storefronts

- ▶ New storefront is inspired by the 1950s photograph (see right) and takes design cues through similar proportions and elements.
 - ▶ New design to reference any traces of original finishes found following careful removal of existing non-original storefront finishes.

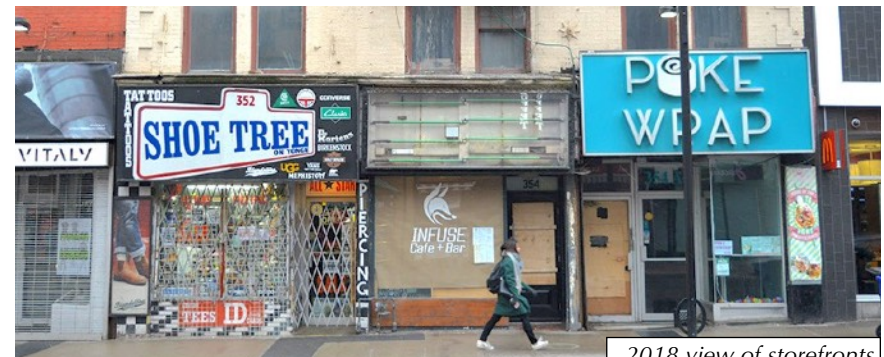
2018 view of storefronts

- ▶ New materials to include wood, metals, glass and granite at the bases.
 - ▶ Rehabilitated storefront design must be considered preliminary as it is subject to change if additional information is found following existing storefront dismantling and through coordination with the new retail requirements

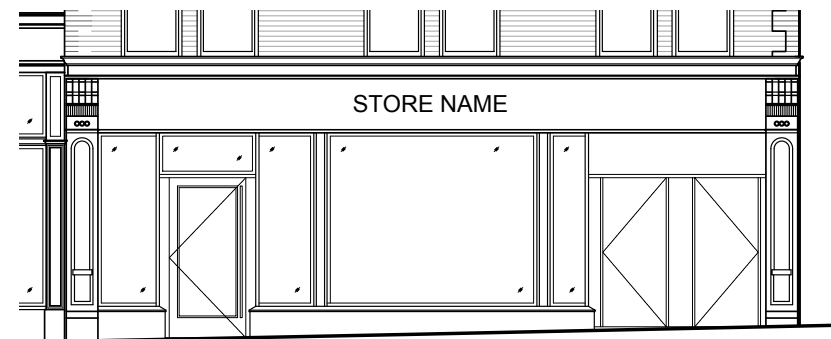
Proposed schematic storefront design.

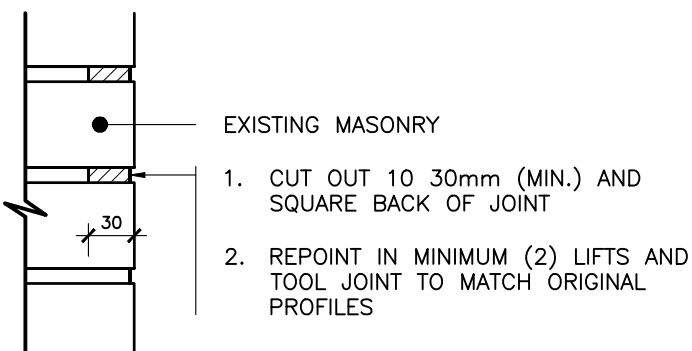
03 RE-POINT JOINTS DETAIL (TYP.)
SCALE: 1:5

NOTE:
CUT OUT DEFECTIVE JOINTS BY HAND WHERE POSSIBLE. WHERE JOINTS ARE THIN, USE SAW BLADE ON HORIZONTAL JOINTS ONLY. ENSURE THAT EDGES (ARRISES) OF BRICKS ARE NOT DAMAGED IN CUT OUT OPERATION.
MORTAR JOINTS ARE DEFECTIVE WHERE THEY ARE SPALLED, MISSING, CRACKED, OR HAVE PREVIOUSLY BEEN POINTED IN CEMENT-BASED MASONRY MORTARS.
