## **Emergency Non-competitive Contract with OJCR Construction Ltd., to Repair a section of the East Don Sanitary Trunk Sewer**

**Date:** March 12, 2021

**To:** General Government & Licensing Committee

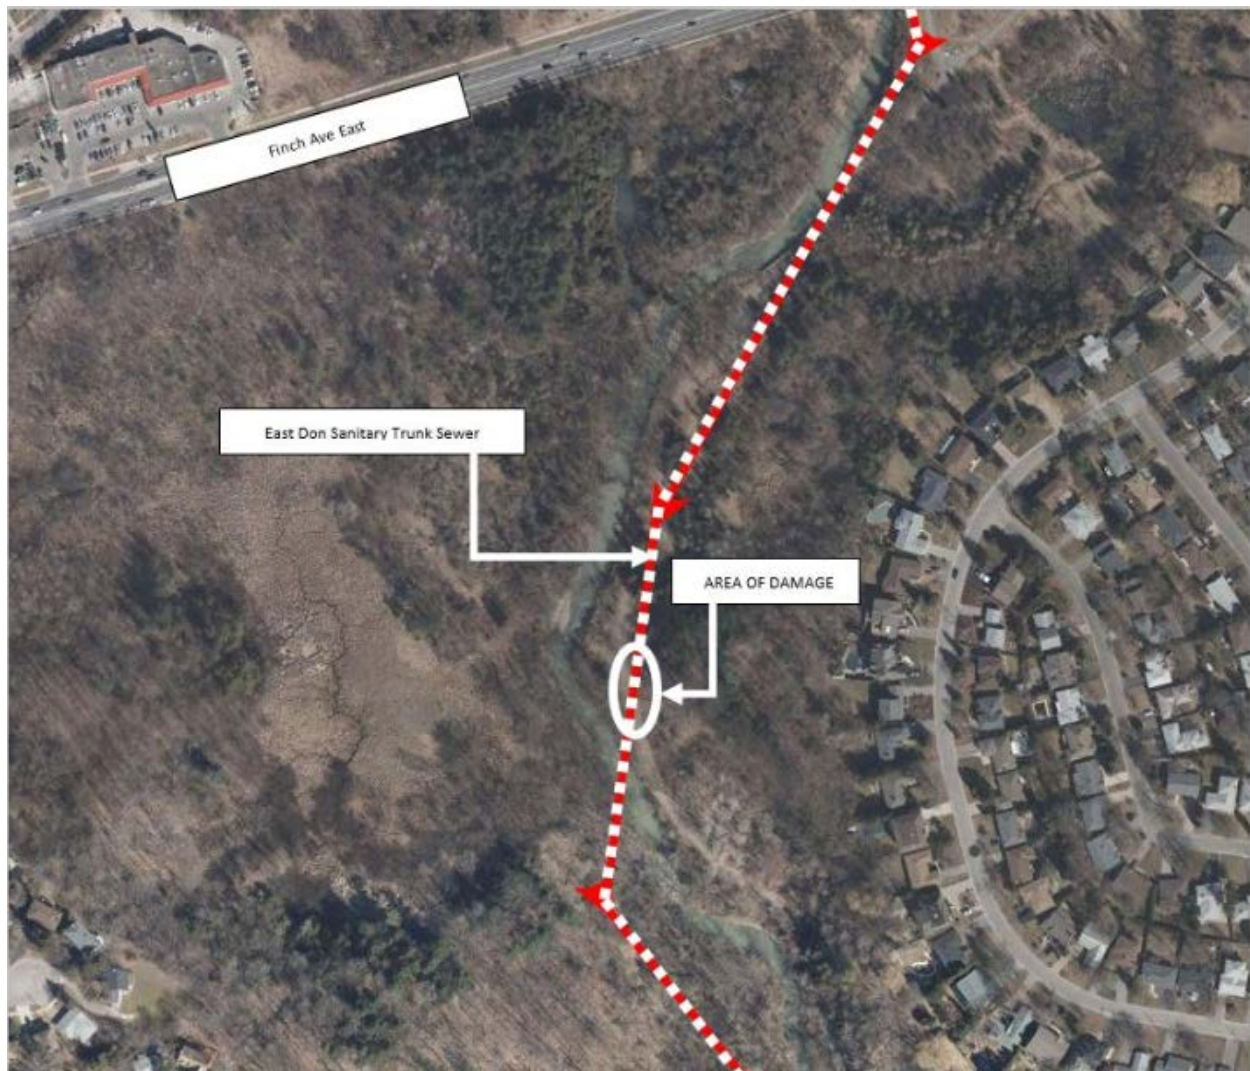
In October 2019, City of Toronto Parks, Forestry & Recreation Services alerted Toronto Water (TW) to deterioration along the East Don Trail, approximately 500 metres south of Finch Avenue East (see Figure 1), with major settlements (sinkholes) up to one metre in depth located directly over top of the 1200 millimetre East Don Sanitary Trunk Sewer (STS). The damaged trunk sewer was deemed an emergency by the General Manager of Toronto Water, under Chapter 195-7.1(G) of the Municipal Code,

TW immediately arranged for closed-circuit television (CCTV) investigation of the STS and initially determined that a 15 metre (nearly 50 feet) section had structurally failed directly below the sinkhole. Trunk sewer standard service level of inspection for preventative maintenance is once every 10 years. A CCTV inspection was completed on this section of the STS in 2016 and at that time no major defects were observed.

**Figure 1: Location of damaged East Don Sanitary Trunk Sewer (STS)**
