8.2 Impact Mitigation Strategy

APPENDICES

A Condition Assessment

11.2.1 West Elevation

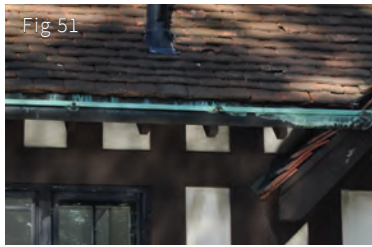
Fig 51

- Copper-clad sconces on either side of carriage-way are in good condition (Fig 50).
- Copper eaves troughs and downspouts are in fair condition; rusting has occurred in several localized areas (Fig 51-54).

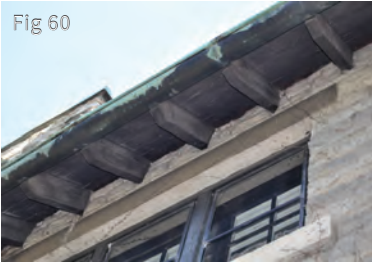
Fig 61

- Wood overhang, fascia, and brackets are in fair condition (Fig 60, 61).

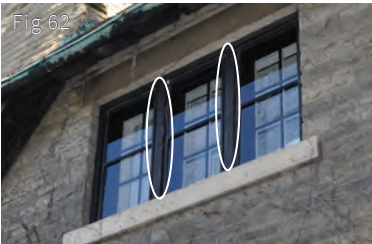
Fig 63

- Original wood windows on ground floor and upper storey are in fair condition (Fig 62, 63).
- Wood window units have been retrofitted with exterior storms (Fig 62, 63).
- Wood window surrounds are in poor condition; paint is flaking in localized areas (Fig 62).

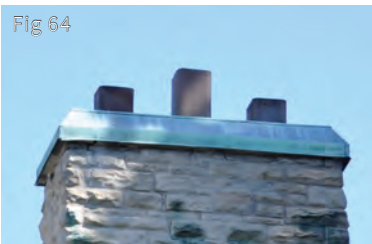
Fig 65

- Copper flashings at top of chimney and copper roof on tower are in good condition (as observed from the ground) (Fig 64, 65).
- Copper flashings around bottom of chimney are in fair condition (Fig 66).
- Copper flashings under terra-cotta tiles at top of roof are exposed from previous repairs (Fig 67).
- Copper eavestrough and downspouts are in fair condition.

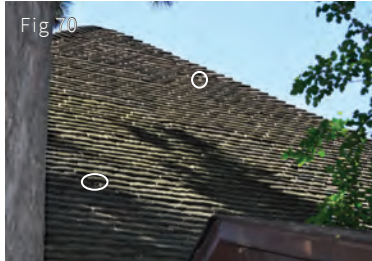
Fig 70

- High grade Credit Valley stone wall in fair condition (Fig 69-72).
- Localized mortar loss, receding mortar joints, and efflorescence near grade (Fig 71, 72).
- Masonry lintel and sill at opening in good condition (69, 72).
- Terracotta roof in fair condition. Localized spalling, missing tiles, and discolouration on select areas (Fig 70).

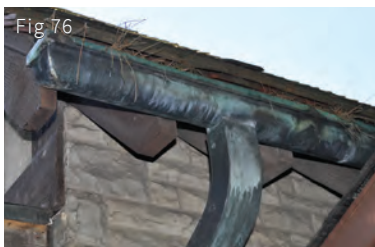
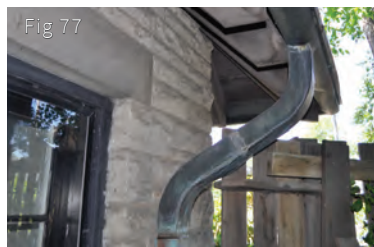
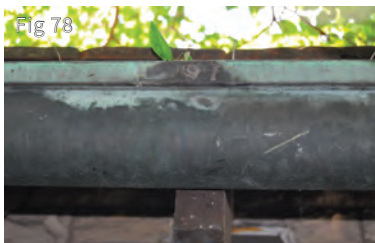
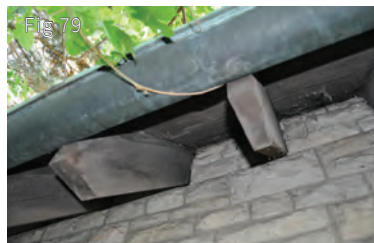
- Copper eavestroughs and downspouts are in fair condition (Fig 76-79).

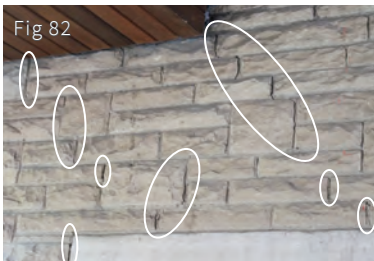
Fig 83

- Credit Valley stone walls in poor condition (Fig 80-83).
- Localized step cracking along mortar joints above both door lintels, suggesting movement in the foundation (Fig 82, 83).

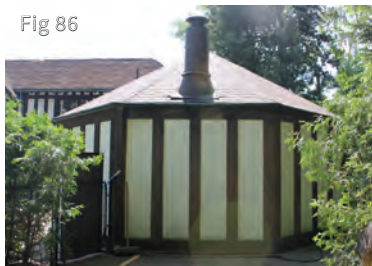
Fig 87

- Octagonal modern extension in good condition overall (Fig 84-88).
- Stucco and wood in fair condition. Minor staining of stucco near grade (Fig 87, 88). Localized flaking of paint on wood (Fig 87, 88).
- Asphalt roof in good condition.
- Copper flashings and eaves troughs in good condition.
- Openings in good condition.
