## 8.2 Impact Mitigation Strategy

### A Condition Assessment

## 11.2.1 West Elevation

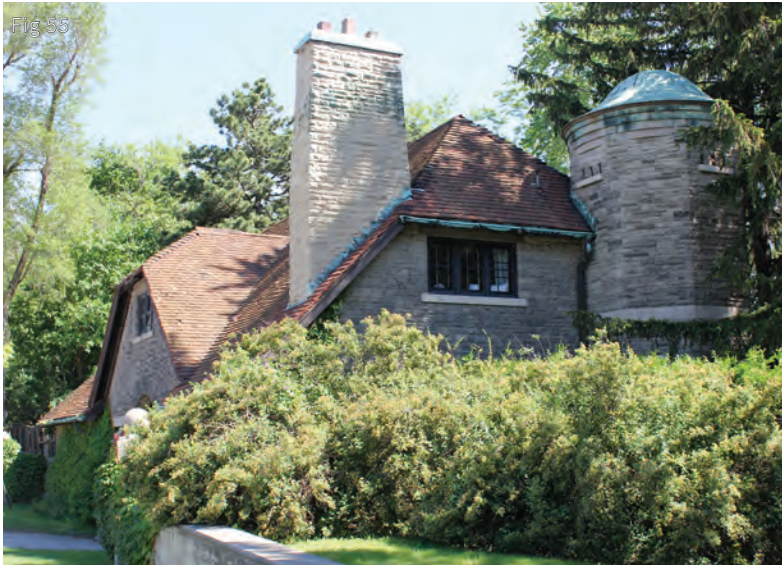
- Vines covering lower half of south elevation exterior masonry walls made assessment difficult; however, exposed high grade Credit Valley stone wall in overall good condition (Fig 55, 57-59).
- Masonry lintels and sills at openings in good condition (Fig 55, 58).
- Terracotta roof in fair condition. Localized spalling, and discoloration on select areas (Fig 56).
- Credit Valley chimney in fair condition, with some staining/discolouration from copper flashings (Fig 57).
- Indiana limestone decorative banding at top of tower discoloured from copper roofing above (Fig 59).

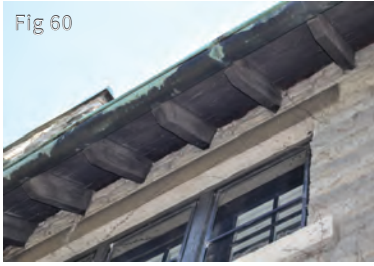
Fig 61

- Wood overhang, fascia, and brackets are in fair condition (Fig 60, 61).

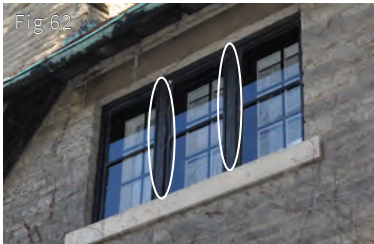
Fig 63

- Original wood windows on ground floor and upper storey are in fair condition (Fig 62, 63).
- Wood window units have been retrofitted with exterior storms (Fig 62, 63).
- Wood window surrounds are in poor condition; paint is flaking in localized areas (Fig 62).

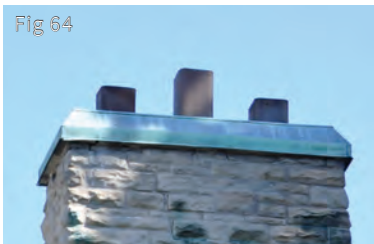
Fig 65

- Copper flashings at top of chimney and copper roof on tower are in good condition (as observed from the ground) (Fig 64, 65).
- Copper flashings around bottom of chimney are in fair condition (Fig 66).
- Copper flashings under terra-cotta tiles at top of roof are exposed from previous repairs (Fig 67).
- Copper eavestrough and downspouts are in fair condition.
