## Investigation into Allegations of Wrongdoing Regarding Building Inspections of 2 Houses

**June 22, 2023**

Tara Anderson, CPA, CA, CIA, BAcc  
Auditor General

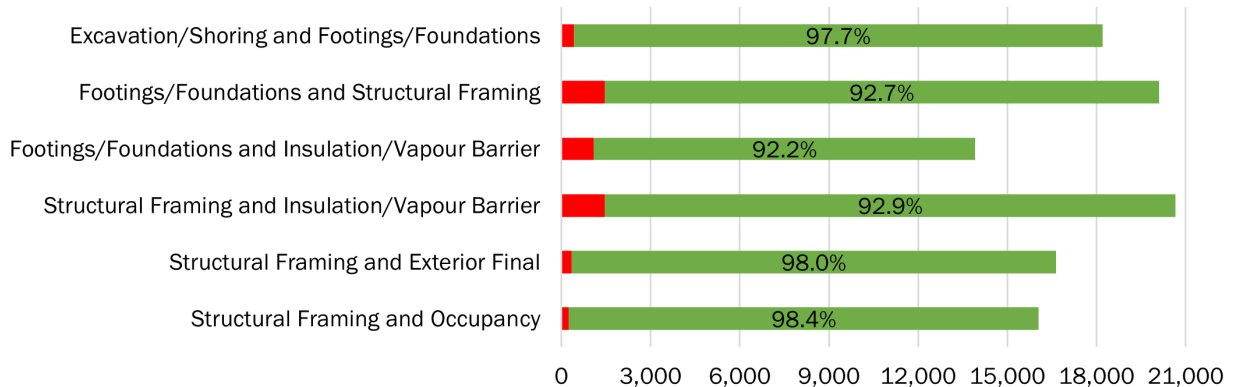
**Chart 1: Data analysis of more inspection stages, permit data from January 1, 2016 to December 9, 2021**

We also wanted to verify whether other inspection stages were being passed out of a logical order. The table below shows that, for the most part, inspections are passed in a logical order.

- Inspections not done in logical order: either both Structural Framing & Insulation/Vapour Barrier Passed but Structural Framing passed after Insulation/Vapour Barrier passed, or Insulation/Vapour Barrier Passed, but Structural Framing stage is Not Passed
- No sign of inspection stages being passed "out of order"

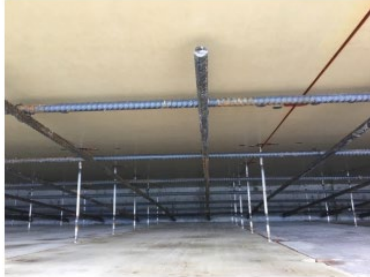
Picture 1:

- *Floor joists were in compliance with framing layout provided by framing company and acceptable.*
- *Top chord of floor joist over breakfast area is cut to install plumbing pipe. Plumbing pipe must be relocated and top chord of joists must be repaired by attaching 18”-2x4 lumber beside it glued and nailed see pictures 1 and 2.*
