HERITAGE IMPACT ASSESSMENT

505 University Avenue

Toronto, ON

Date of Issue: 22 August 2025

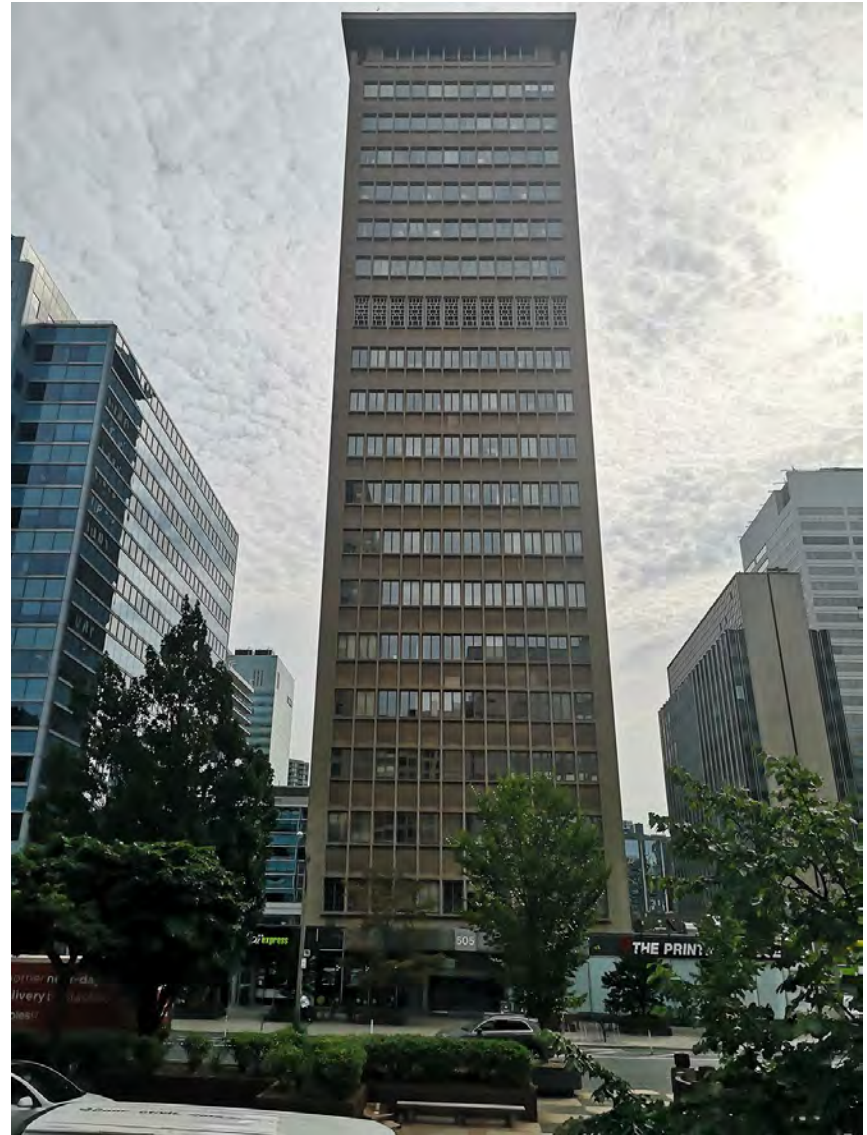
Main west elevation of 505 University Avenue

- Localised areas of eroded or porous stone. It is not fully known how this condition has occurred, although it is possible the stone panel's surface was of inferior quality. These areas include delaminated stone, particularly at the lower floors of the west elevation.

- Significant repairs and replacement of original Queenston Limestone (now unavailable) with Indiana Limestone patches. These patches do not match the Queenston in colour and soiling and thus, over time, a patchwork appearance has developed on the exterior. In addition, a significant number of replacement stones have been inserted into the southeast and northeast corners due to on-going cracking and damage.

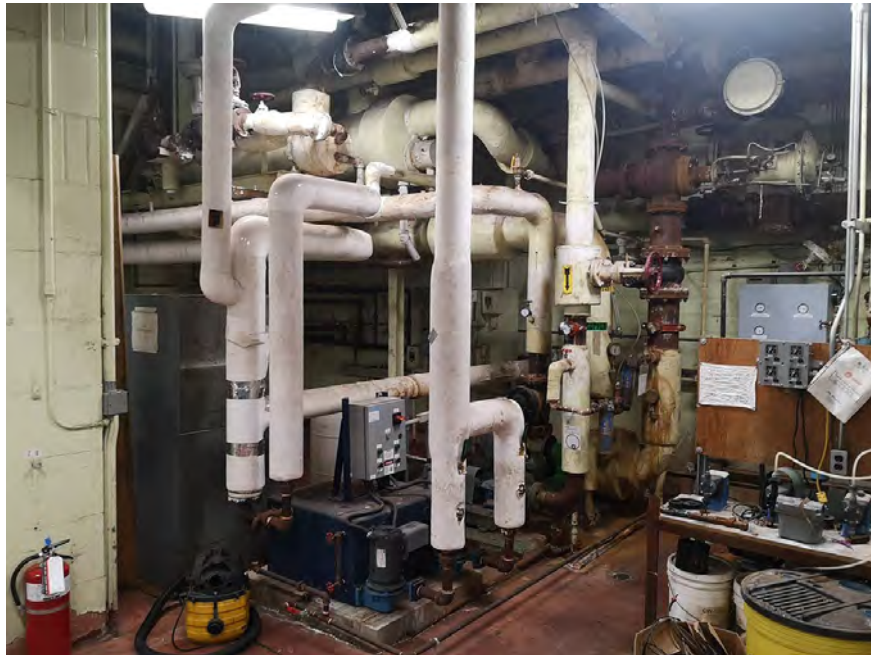
Overall view of original mechanical equipment (heat pumps). The partition walls on the left of the photo are painted hollow terra cotta tiles.

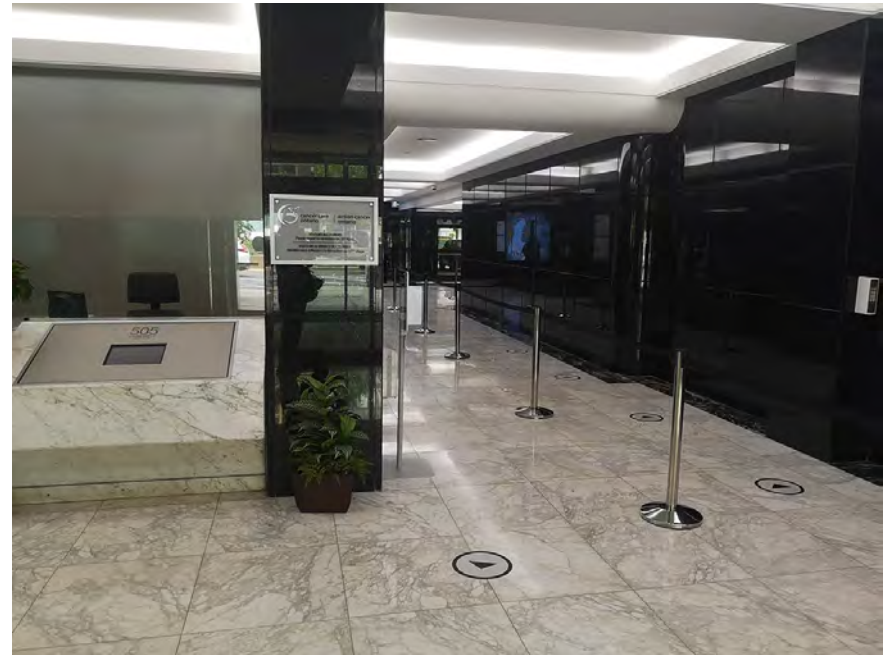
Overall view of the ground level lobby. Finishes inside include some modern interventions

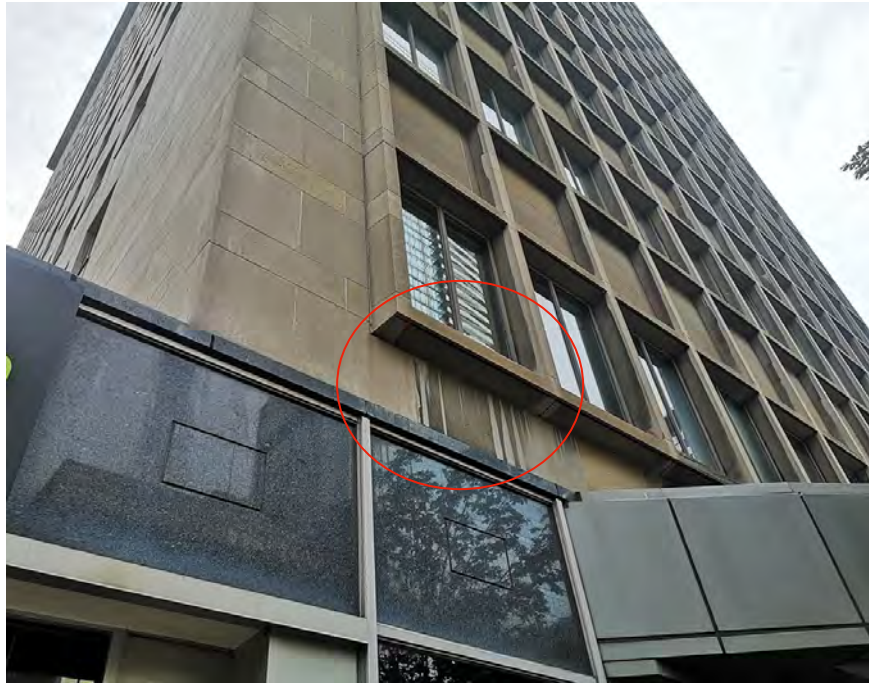
Close-up view of the west elevation, looking up towards fenestration pattern. Drip edges carved into the underside of the stone sills are visible and were added to deflect water away from the walls. These appear to have worked on all areas below window sills. Below the window sill of the bottom left window (red circle), some water run-off is visible, suggesting a potential issue in this area. This is associated with the wall section from the previous page where the stone cladding meets the granite cladding below. However, in the current condition, the granite is not in the same plane as the stone (it is in front of the stone) which differs from the 1956 drawing, suggesting a potential difference in the backing of the granite cladding.
