## 505 University Avenue, Toronto- Site investigation report

| Prepared by: | Donovan Pauly, MSc, CAHP, APTi (Architectural Materials Conservator) |
| Location: | 505 University Avenue, Toronto, Ontario |
| Date of site visit: | September 16-25 |

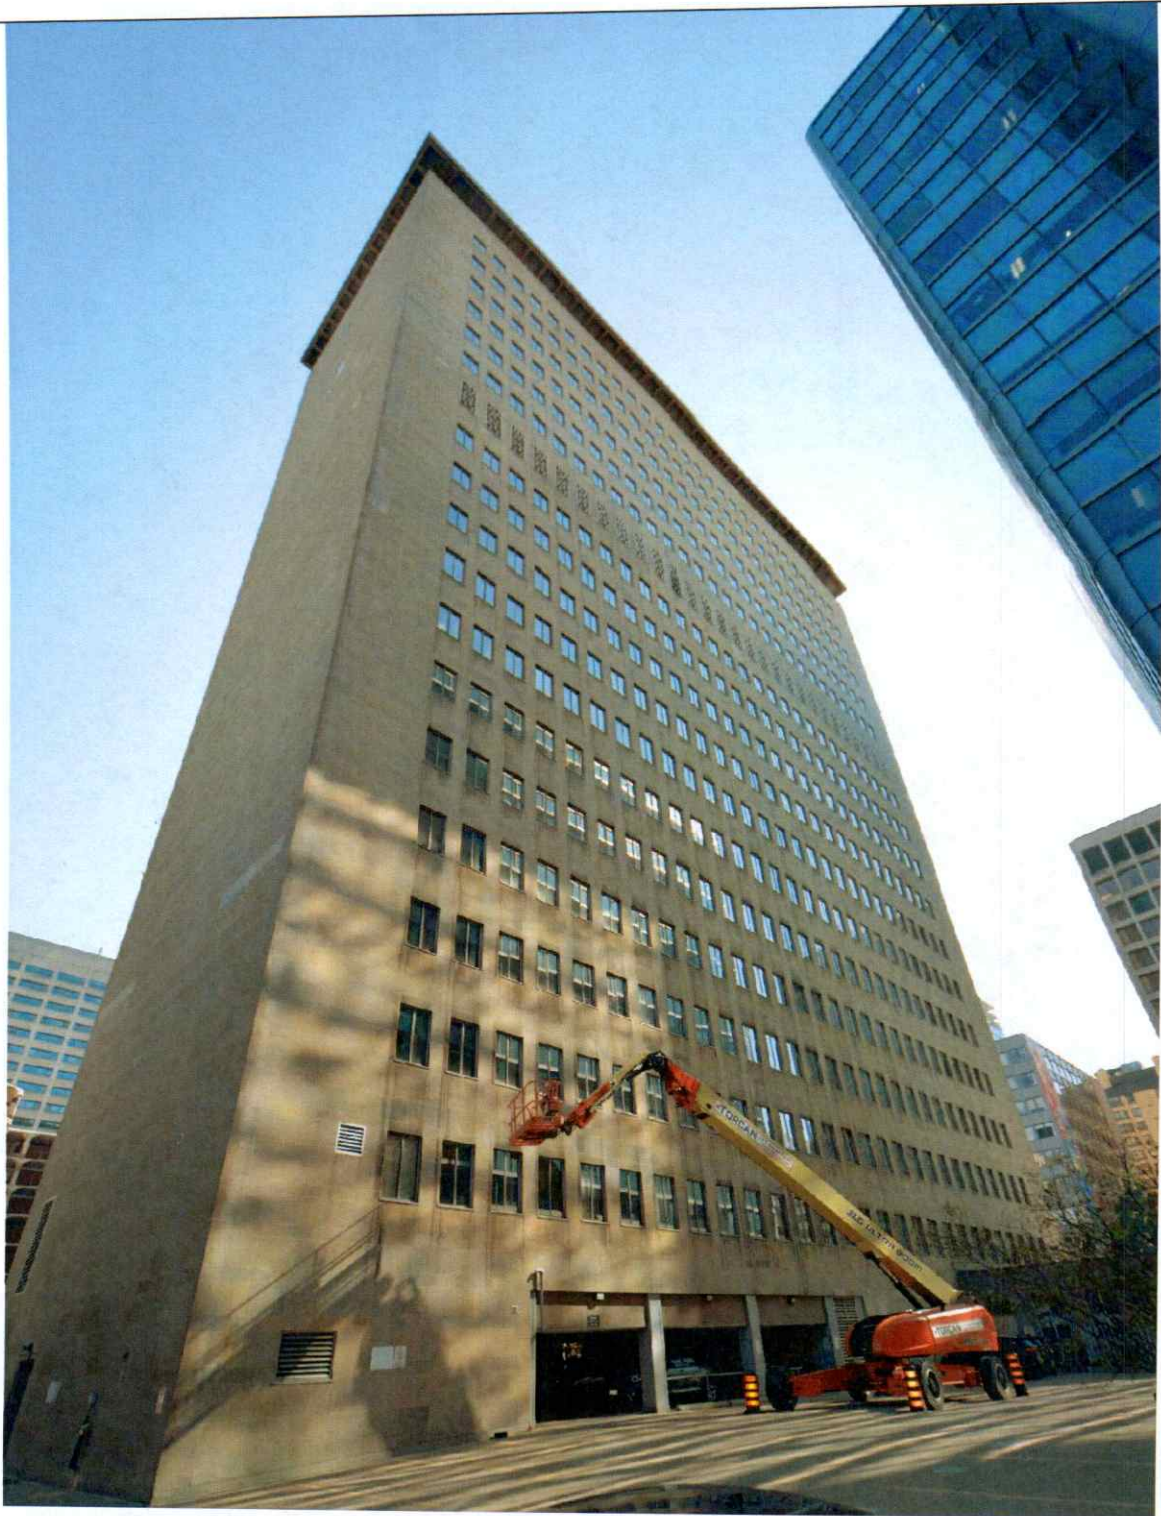
**Figure 8** Overview of the north elevation.

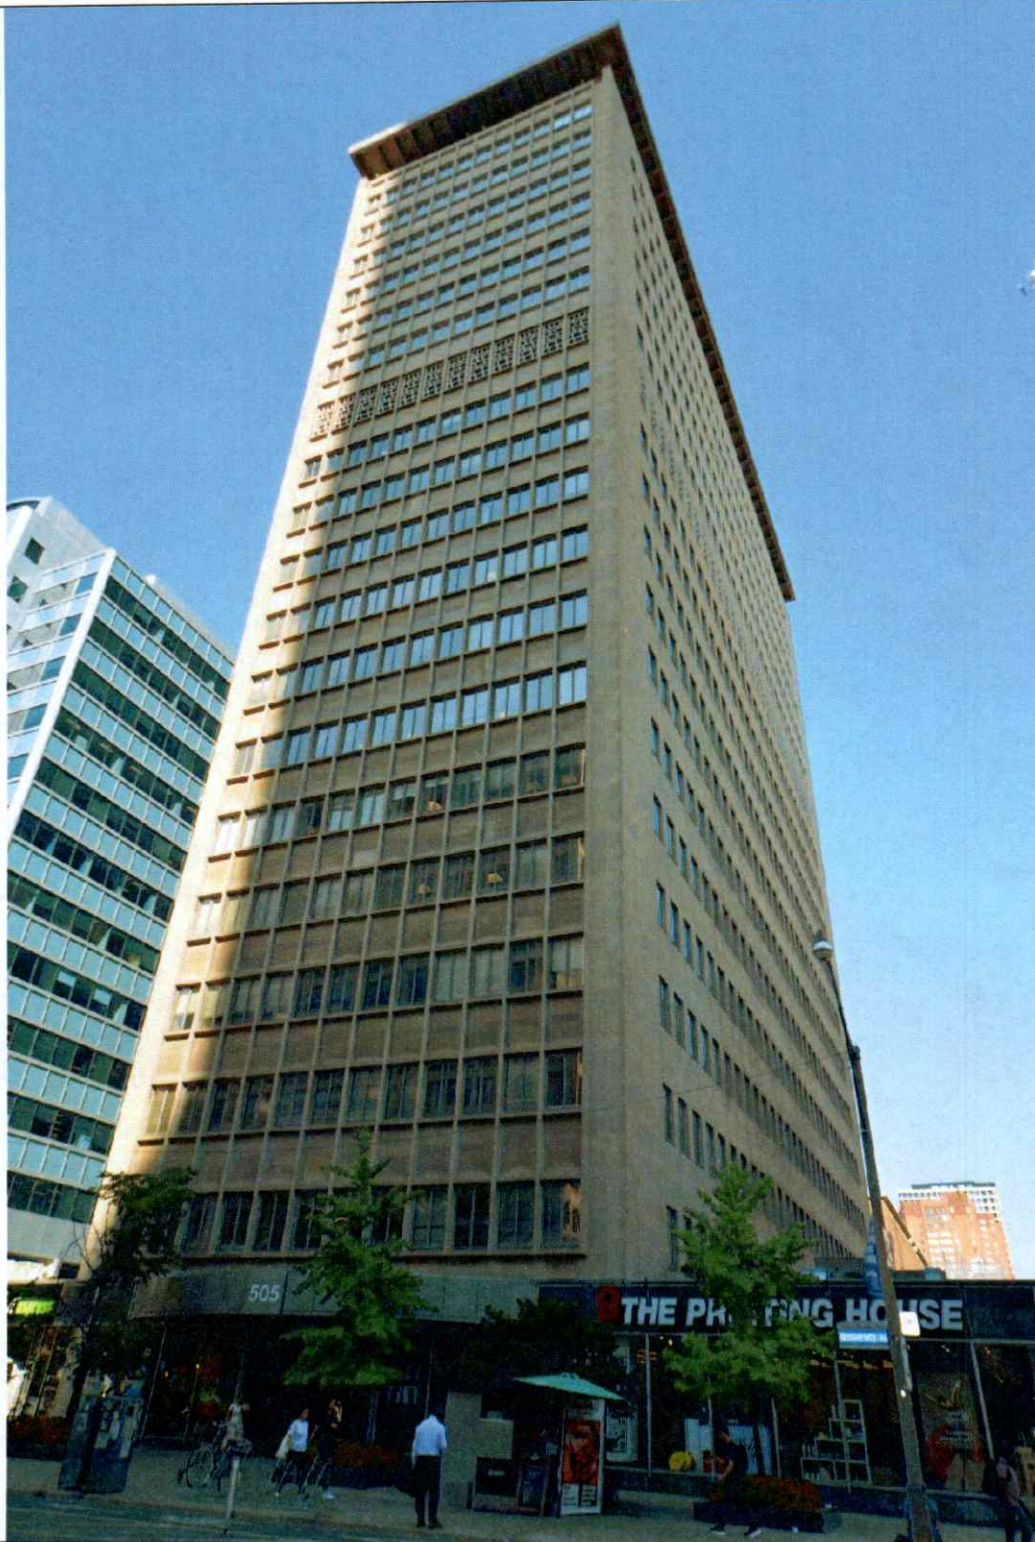
Figure 9 Overview of the west elevation.

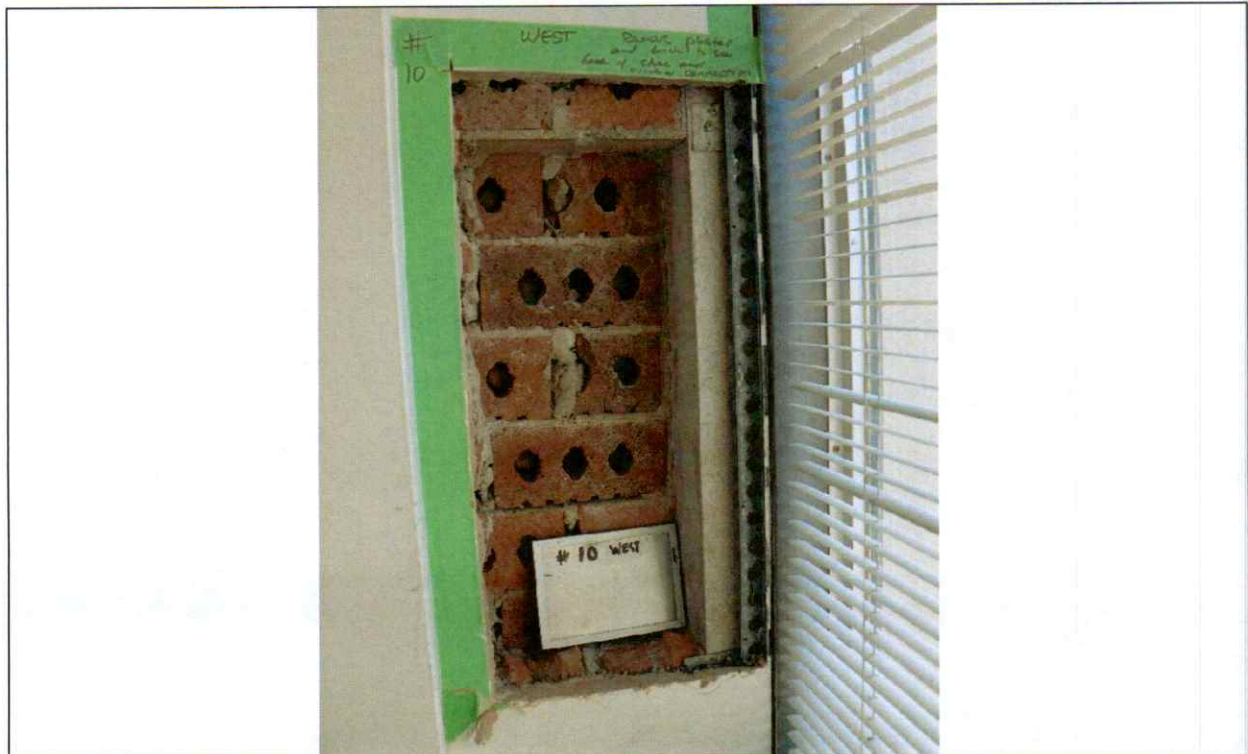
**Figure 28** Investigation opening #10 window mullion.
