# HERITAGE IMPACT ASSESSMENT

## 505 University Avenue

Toronto, ON

Date of Issue: 22 August 2025

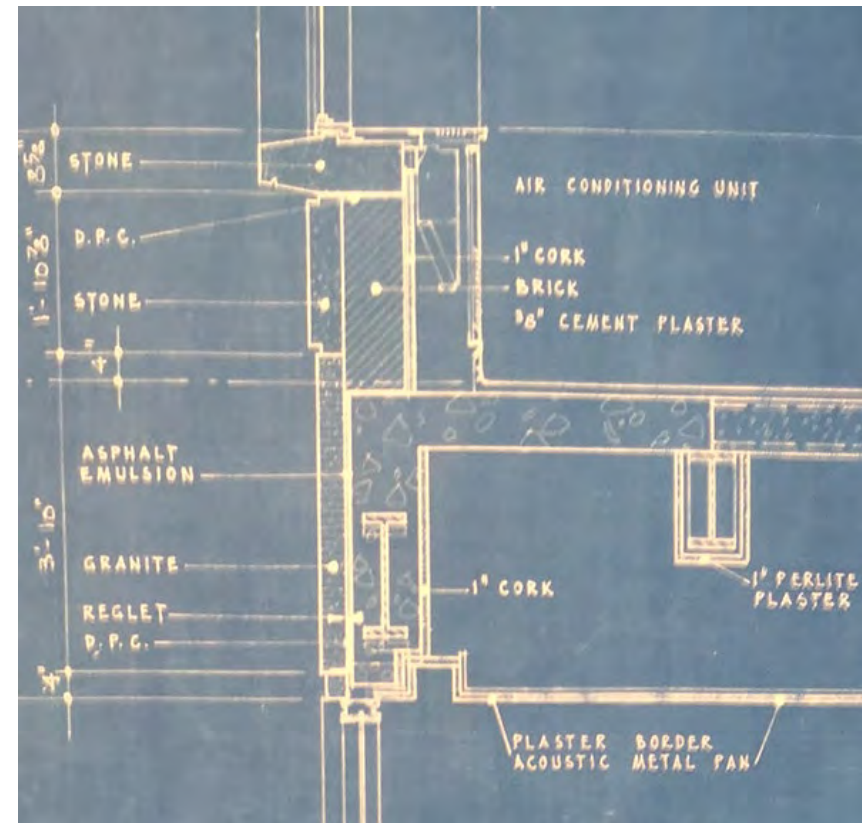
1956 Wall section detail of the main (west) wall where the granite meets the stone, noting materials composing the exterior walls. Behind the granite cladding is reinforced concrete and behind the stone is brick backing (Drawing retrieved at CTA).

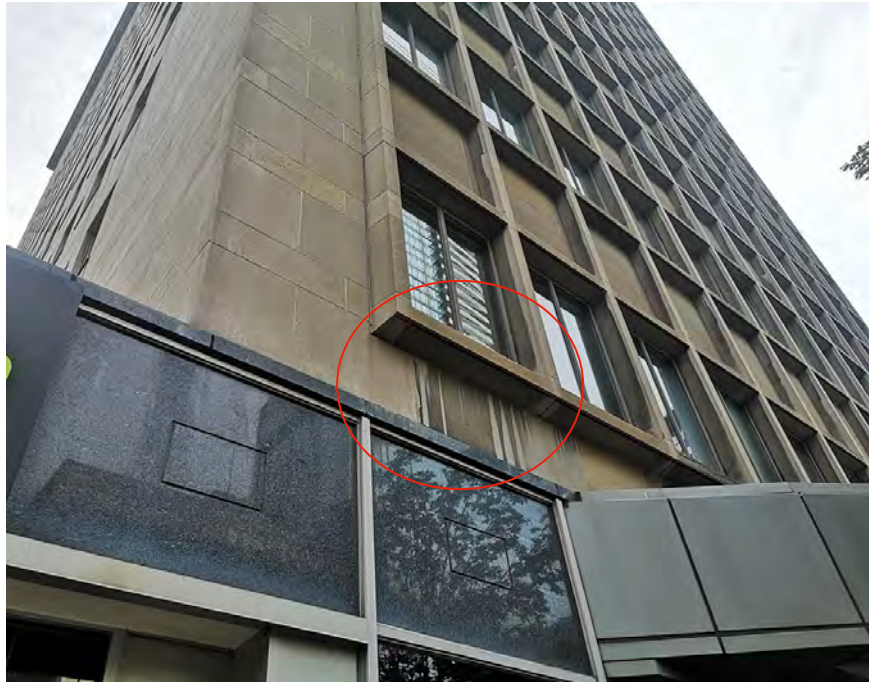
Close-up view of the west elevation, looking up towards fenestration pattern. Drip edges carved into the underside of the stone sills are visible and were added to deflect water away from the walls. These appear to have worked on all areas below window sills. Below the window sill of the bottom left window (red circle), some water run-off is visible, suggesting a potential issue in this area. This is associated with the wall section from the previous page where the stone cladding meets the granite cladding below. However, in the current condition, the granite is not in the same plane as the stone (it is in front of the stone) which differs from the 1956 drawing, suggesting a potential difference in the backing of the granite cladding.
