BCA Report

Sample House High FCI

Portfolio	TCHC - All Op Units
Development	Scattered Units (CHU 20)
Size	1,005 Sq.Ft.
Construction Year	1925
Floor Above Grade	2
Divisional Units	1

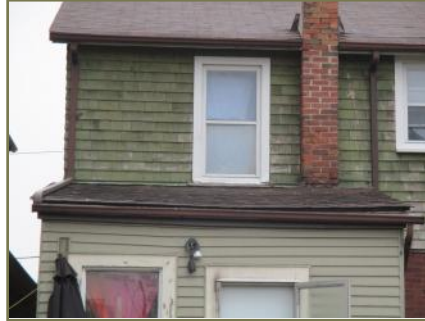
IMG_5971.jpg

Discipline	Shell
Category	B2020 - Exterior Windows
Element Number	1
Replacement Cost	\$7,140
Last Major Action	1985
Location/Name	Entire building
Brief Description	The majority of the windows are metal-framed, single-glazed units. An insulated glass (IGU) window with horizontal sliders is provided for the kitchen. The windows above grade are typically metal-framed, vertical hung, single-glazed units.
Commentary	Damaged window screen were observed. The windows also have aged.
Overall Condition	■ Fair
Validated	Yes

Replace windows

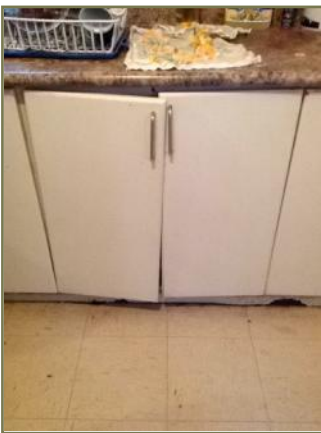
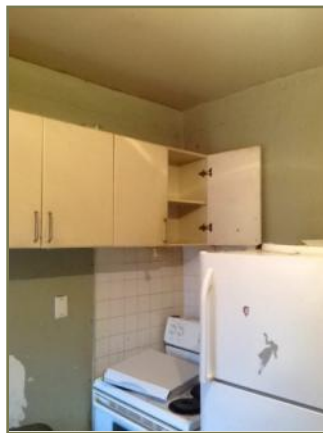
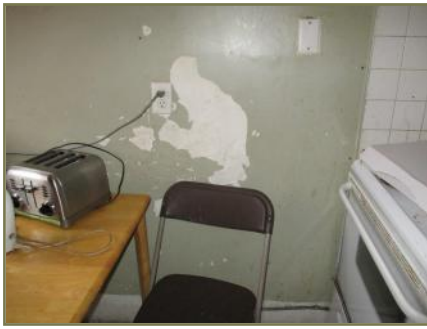
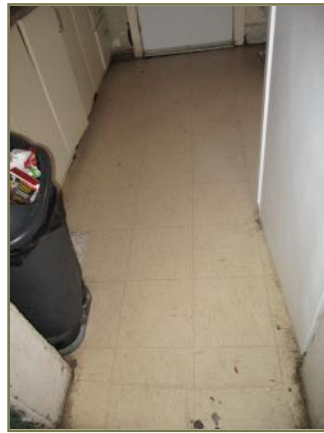
Discipline	Interiors
Category	C1060 - Kitchen Refurbishment
Element Number	1
Replacement Cost	\$9,180
Last Major Action	2016
Location/Name	First floor
Brief Description	The kitchen is finished with vinyl floor tiles, painted walls, and painted ceilings. Wall-mounted cabinets and a laminated countertop that is complete with a sink are provided.
Commentary	Scuffed vinyl floor tiles, peeling paint finish, and cupboards with dislodged doors were observed.
Overall Condition	Good
Validated	Yes

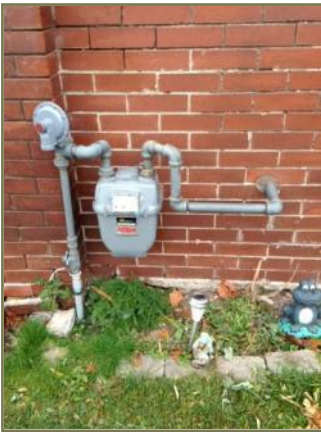
Element.1251.z4j3kvak.vjq.jpg

Discipline	Services
Category	D3012 - Gas Supply System
Element Number	1
Replacement Cost	\$2,550
Last Major Action	1970
Location/Name	Entire building
Brief Description	This site component cannot be accurately assessed using visual means alone and would require invasive or specialized engineering review.
Commentary	Where issues/problems become apparent, further review and action should be considered. Lifecycle renewal may become necessary in the future, but no specific Action was identified during this review.
Overall Condition	■ Fair
Validated	Yes

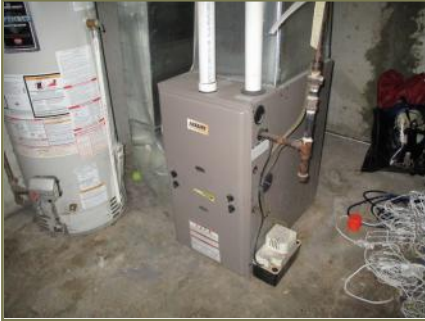
IMG_5941.jpg

Discipline	Services
Category	D3023 - Furnaces
Element Number	1
Replacement Cost	\$5,100
Last Major Action	2011
Location/Name	Basement
Brief Description	A gas-fired furnace that was manufactured by Luxaire provides heating. Based on the date of the pressure test tag on the furnace gas piping, the furnace is estimated to have been installed in 2011.
Commentary	The furnace was in operation during the assessment. No major deficiencies were observed or reported.
Overall Condition	Good
Validated	Yes

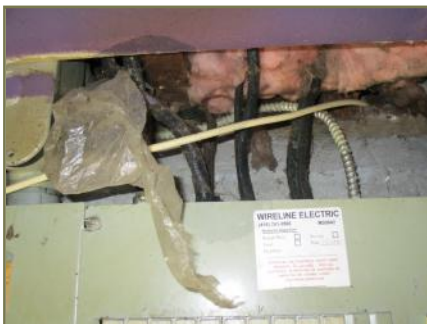
IMG_5927.jpg

Discipline	Services
Category	D5021 - Branch Wiring
Element Number	1
Replacement Cost	\$5,100
Last Major Action	1950
Location/Name	Entire building
Brief Description	This site component cannot be accurately assessed using visual means alone and would require invasive or specialized engineering review.
Commentary	Where issues/problems become apparent, further review and action should be considered. Lifecycle renewal may become necessary in the future, but no specific Action was identified during this review.
Overall Condition	<input type="checkbox"/> Fair
Validated	Yes

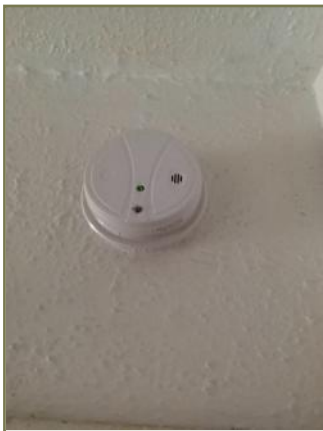
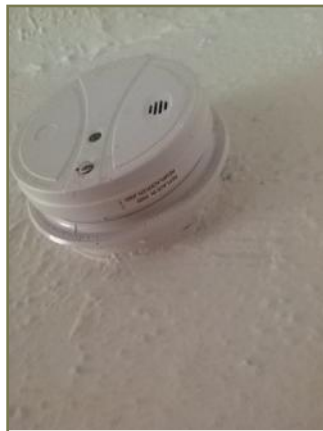
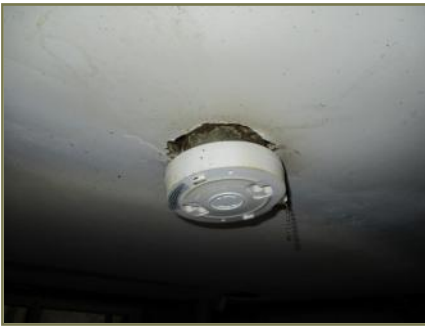
Discipline	Services
Category	D5037 - Fire Alarm System
Element Number	1
Replacement Cost	\$510
Last Major Action	2000
Location/Name	Entire building
Brief Description	Smoke alarms are placed at strategic locations.
Commentary	No major deficiencies were observed or reported.
Overall Condition	■ Fair
Validated	Yes

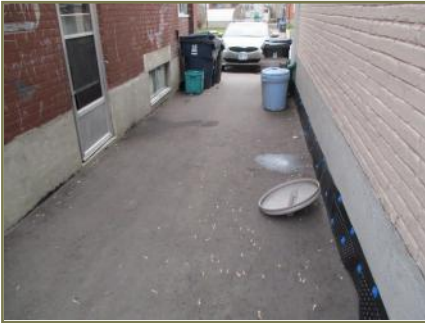
IMG_6085.jpg

Discipline	Building Sitework
Category	G2020 - Parking Lots
Element Number	1
Replacement Cost	\$6,120
Last Major Action	2015
Location/Name	Adjacent to the north elevation
Brief Description	Vehicle parking is provided by an asphalt-paved driveway that is constructed between the dwelling unit and the property at 231 King Edward Avenue.
Commentary	The driveway is in good condition overall.
Overall Condition	Good
Validated	Yes

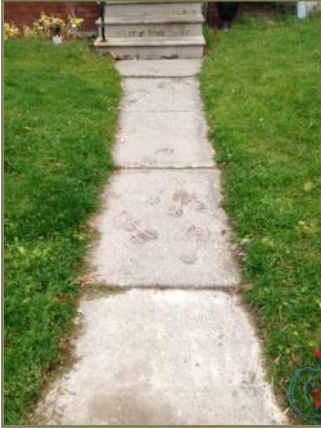
Element.1275.ah29z5md.sjk.jpg

Discipline	Building Sitework
Category	G2030 - Pedestrian Paving
Element Number	1
Replacement Cost	\$2,040
Last Major Action	2010
Location/Name	West of the building
Brief Description	A concrete walkway provides access to the building from the municipal sidewalk on King Edward Avenue.
Commentary	No major deficiencies were observed or reported.
Overall Condition	<div style="display: flex; align-items: center;"> <div style="width: 10px; height: 10px; background-color: yellow; margin-right: 5px;"></div> Fair </div>
Validated	Yes

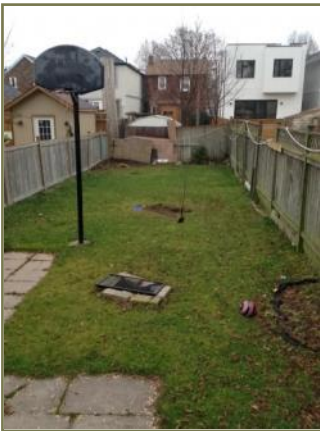
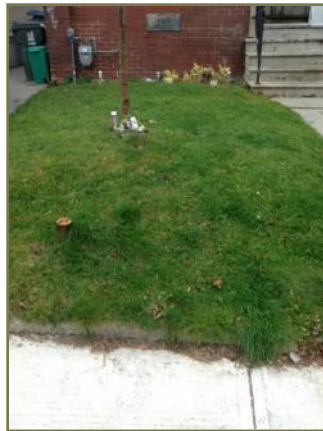
Discipline	Building Sitework
Category	G2050 - Landscaping
Element Number	1
Replacement Cost	\$2,040
Last Major Action	1970
Location/Name	Adjacent to the west & east elevations
Brief Description	Landscaping consists of lawn spaces in the front yard and back yard.
Commentary	No major deficiencies were observed or reported.
Overall Condition	■ Fair
Validated	Yes
