Bank Condition and Flow Capacity Assessment

Flow Capacity and Bank Condition Assessment Memorandum

08 April 2024

To	Daniel McCreery	Contact No.	905-814-4355
Copy to	Bill Snodgrass	Email	Jeff.Doucette@ghd.com
From	Jeff Doucette	Project No.	11209954-MEM-4
Project Name	City of Toronto-Yellow Creek MP		
Subject	Flow Capacity and Bank Condition Assessment

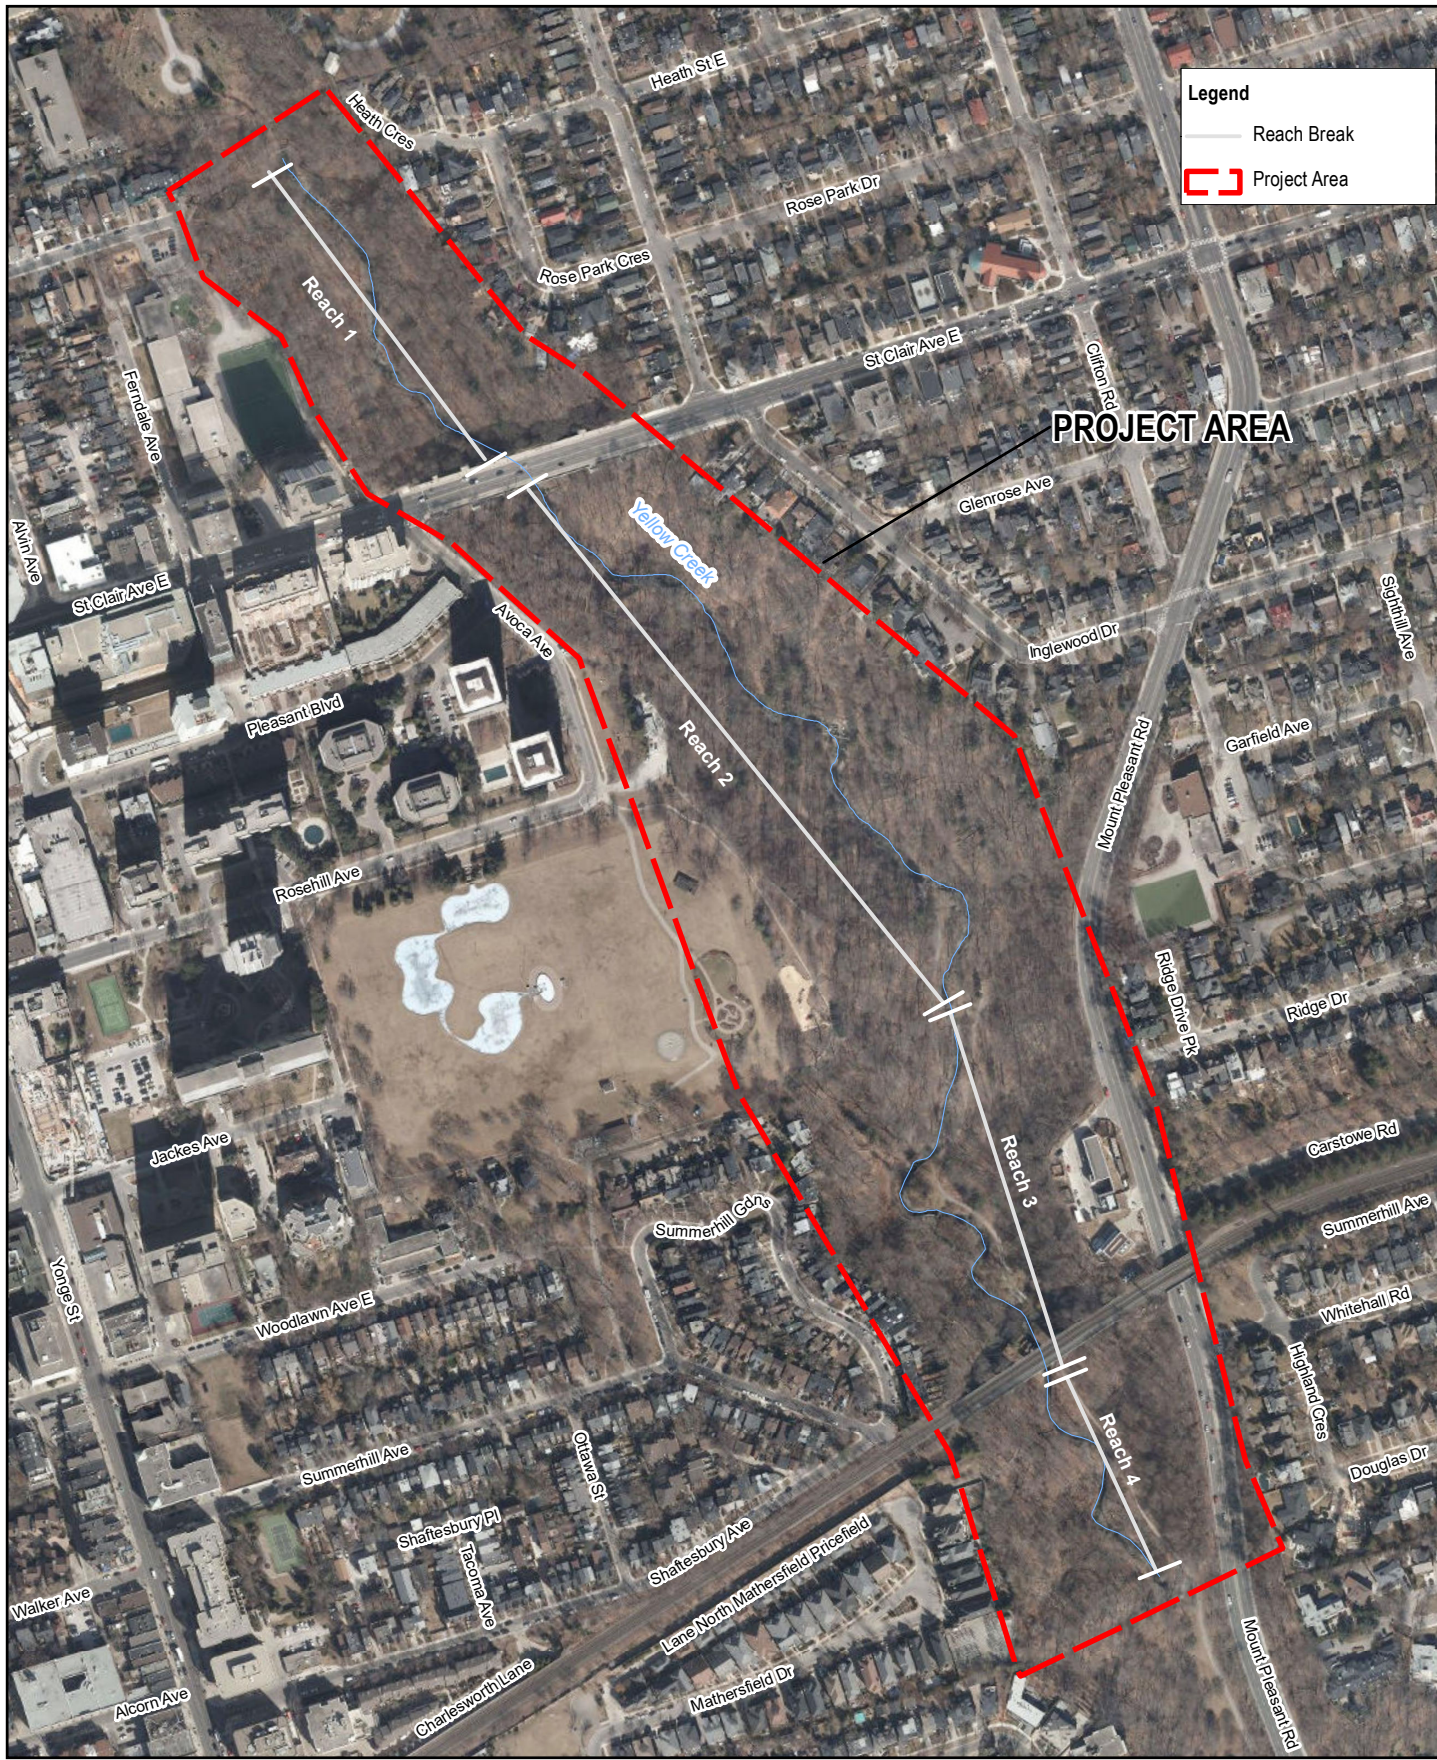
CITY OF TORONTO
YELLOW CREEK GEOMORPHIC SYSTEMS
MASTER PLAN SHORT-TERM EROSION MONITORING
**YELLOW CREEK
REACH 1
BANK CONDITION ASSESSMENT**

The bank condition assessment revealed that most of the gabion basket and many of the quarry block wall bank treatments were failing (4) or have failed (5). Reaches 1 and 2 had the highest percentage of failed and failing banks as 71% and 60% of the banks, respectively, were failing or had failed. This corresponds to approximately 400 m and 600 m of failing or failed banks in reaches 1 and 2, respectively.
