# GERMAN MILLS CREEK GEOMORPHIC SYSTEMS MASTER PLAN PHASE 2 TECHNICAL MEMORANDUM DEVELOPMENT OF ALTERNATIVE SOLUTIONS

Prepared for: CITY OF TORONTO

Prepared by: MATRIX SOLUTIONS INC., A MONTROSE ENVIRONMENTAL COMPANY

Version 1.0 December 2024 Mississauga, Ontario

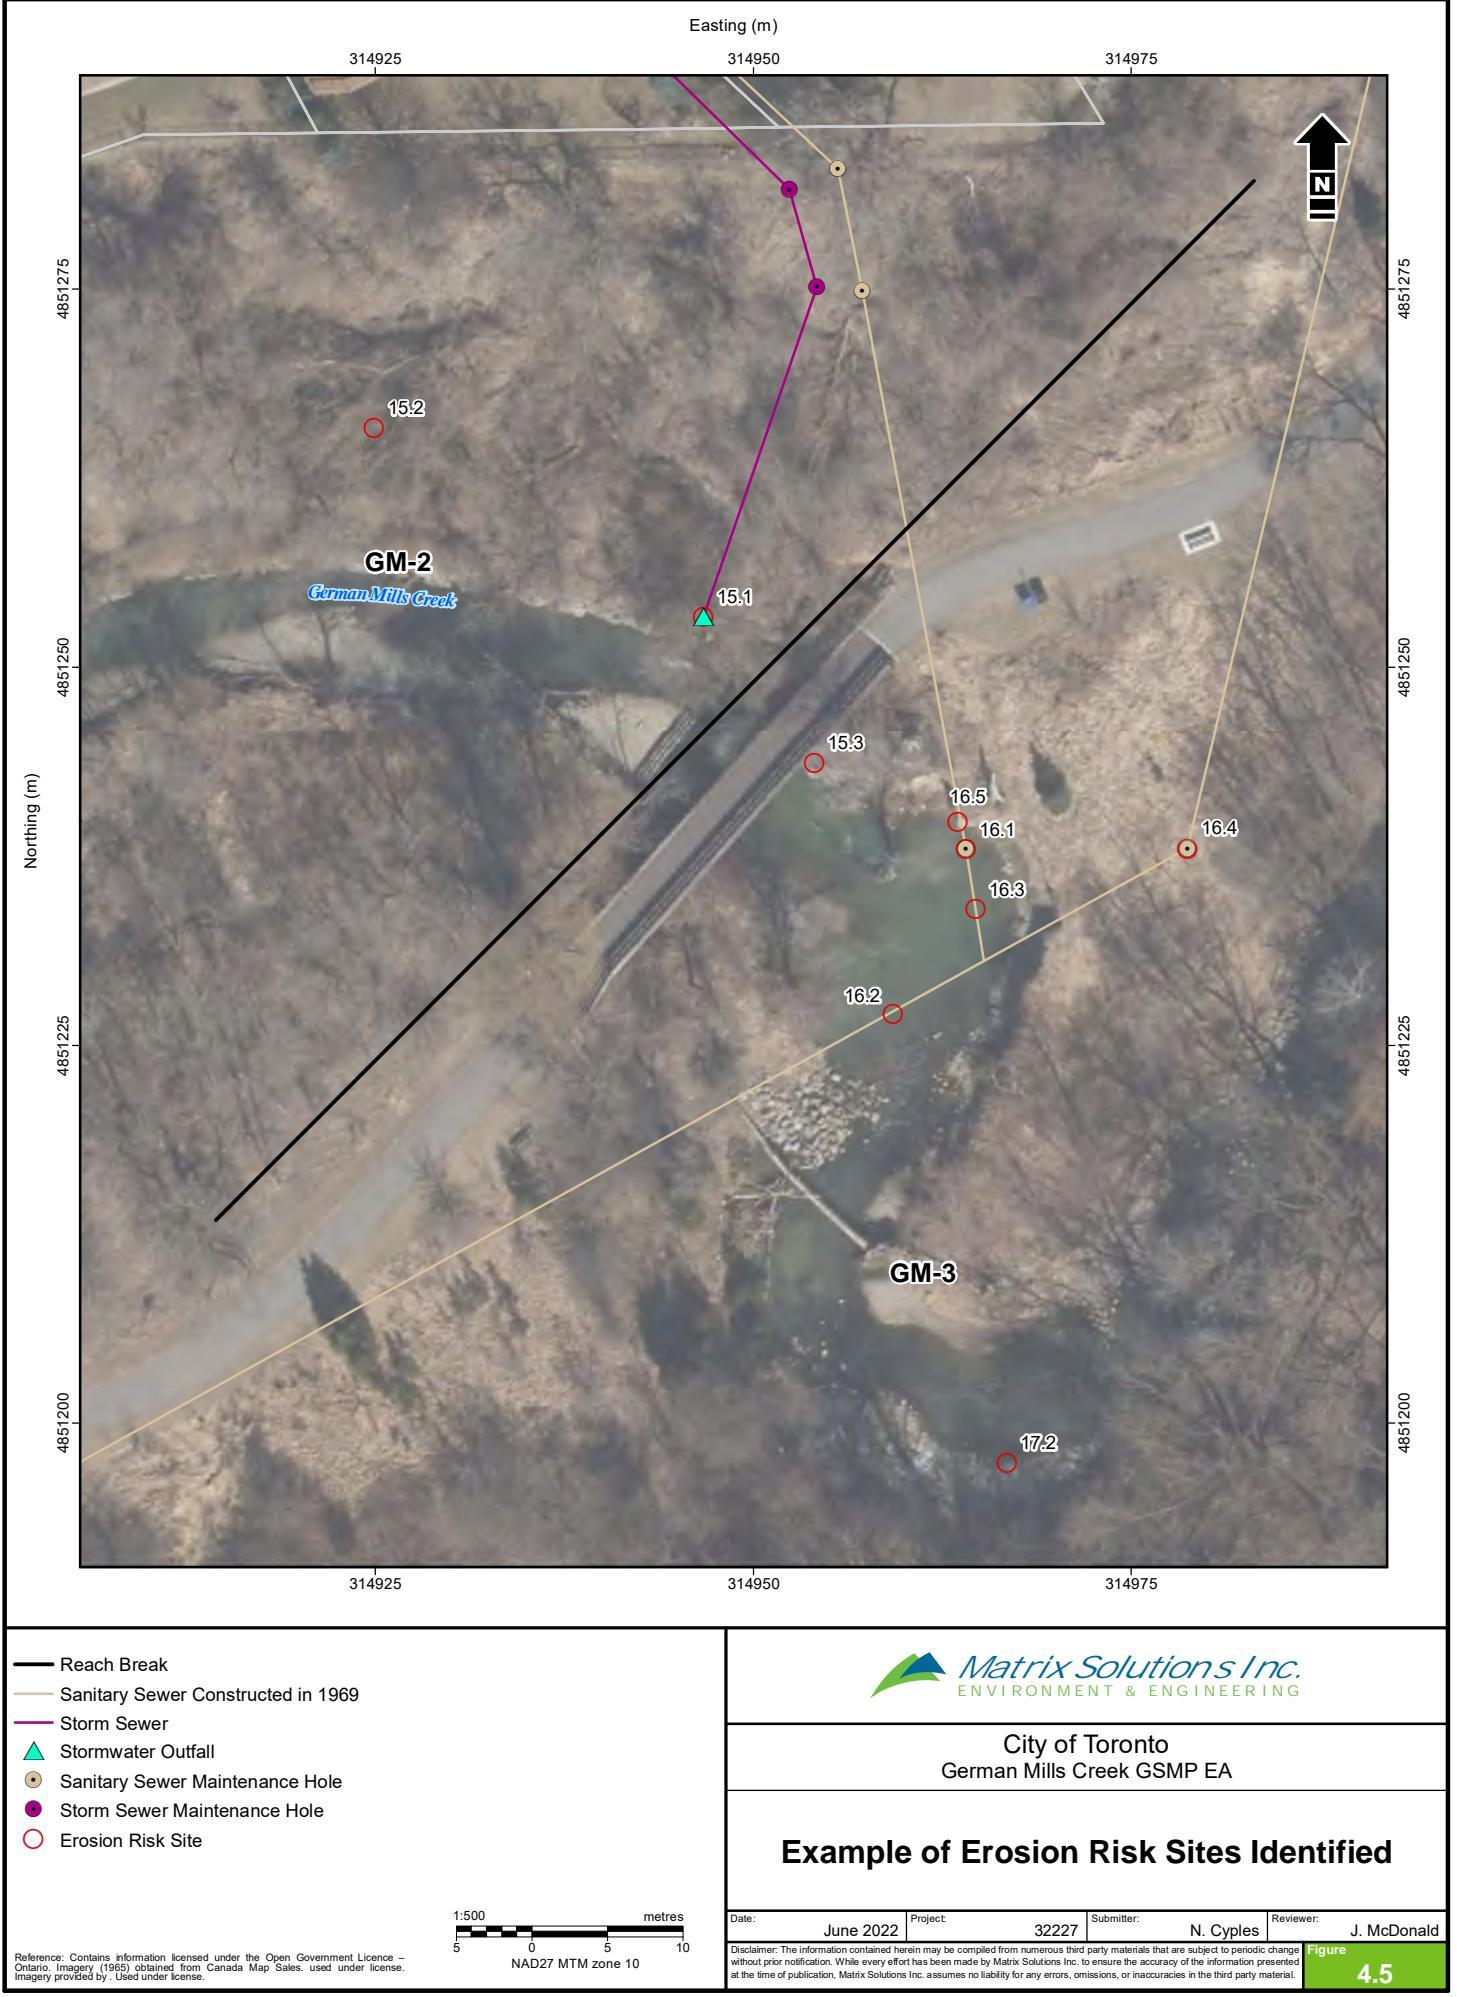
proximal to Toronto Water infrastructure were surveyed and topographic data was used to compare to as-built drawings to determine the vertical and horizontal distance between Toronto Water infrastructure. An example of nine risk sites identified, including vertical and lateral risks, are show below in Figure 4-5. An initial summary of erosion risk sites, risk type, distance to structure, and bank condition classification was presented in Section 3.2.3. and considered in the overall ranking of erosion risk sites.

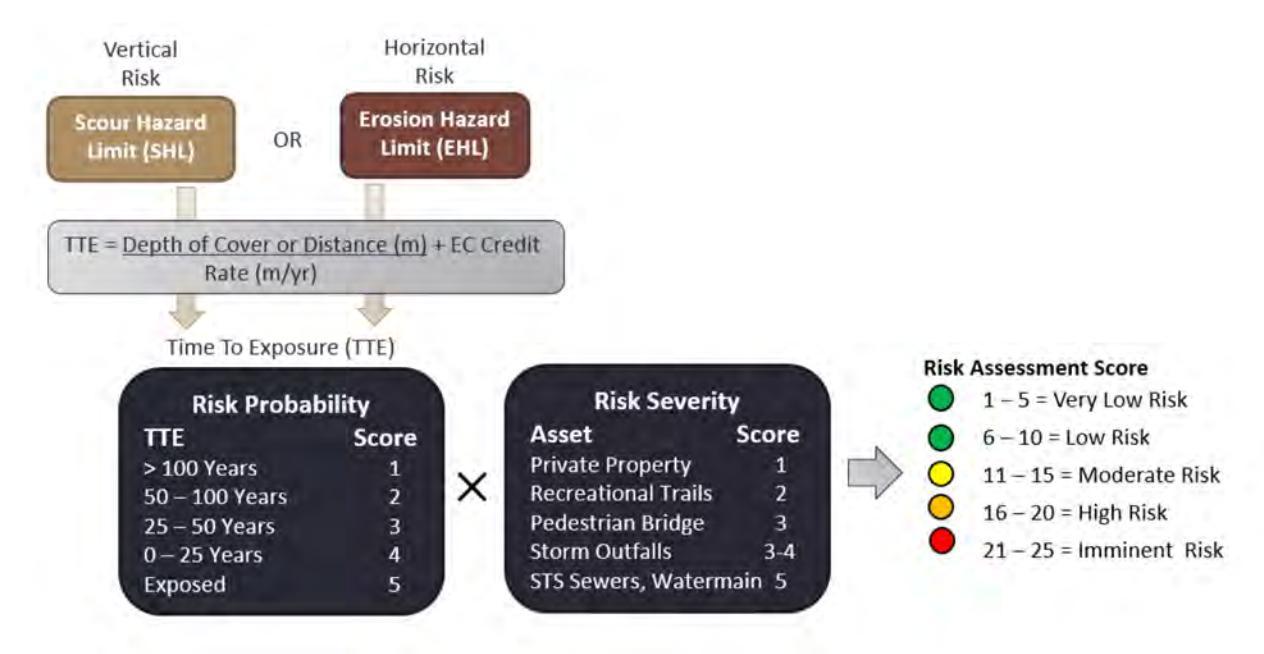
#### FIGURE 4-7 Summary of Total Risk Assessment Score

Erosion risk sites were each assigned an individual site ranking (1 to 56) based on a total risk assessment score (Figures C10a to C10e; Appendix C10). The total risk assessment score is the product of the risk probability (TTE = 1 to 5) and the risk severity (asset ranking 1 to 5, with Toronto Water sewers and watermains scoring 5) with final values ranging from 1 to 25 (Figure 4-7). The full listing of the erosion risk sites is provided in Appendix C12. Based on the top 12 erosion risk sites (primary), the remaining sites

(secondary) were grouped with the primary sites in close proximity to generate local erosion mitigation projects. A twelfth project was identified for the upper reaches of Bestview Tributary and the entire Bestview Tributary has been evaluated as a single site for this study as instability downstream can eventually pose risk to the upper reach. These top 12 local projects will be advanced through development and evaluation of alternative EA process for the German Mills Creek GSMP. An initial development of alternatives is presented in Section 5.
