4.6 Priority Site #4: Exposed Storm Water Outfall at Canary Crescent

4.7 Priority Site #5: Exposed Sanitary Sewer Crossing at Farmingdale Road

4.8 Priority Site #6: Exposed Sanitary Sewer Crossing upstream of Farmingdale Road

4.9 Priority Site #7: Exposed Sanitary Sewer Crossing Downstream of Finch Avenue and Bayview Avenue

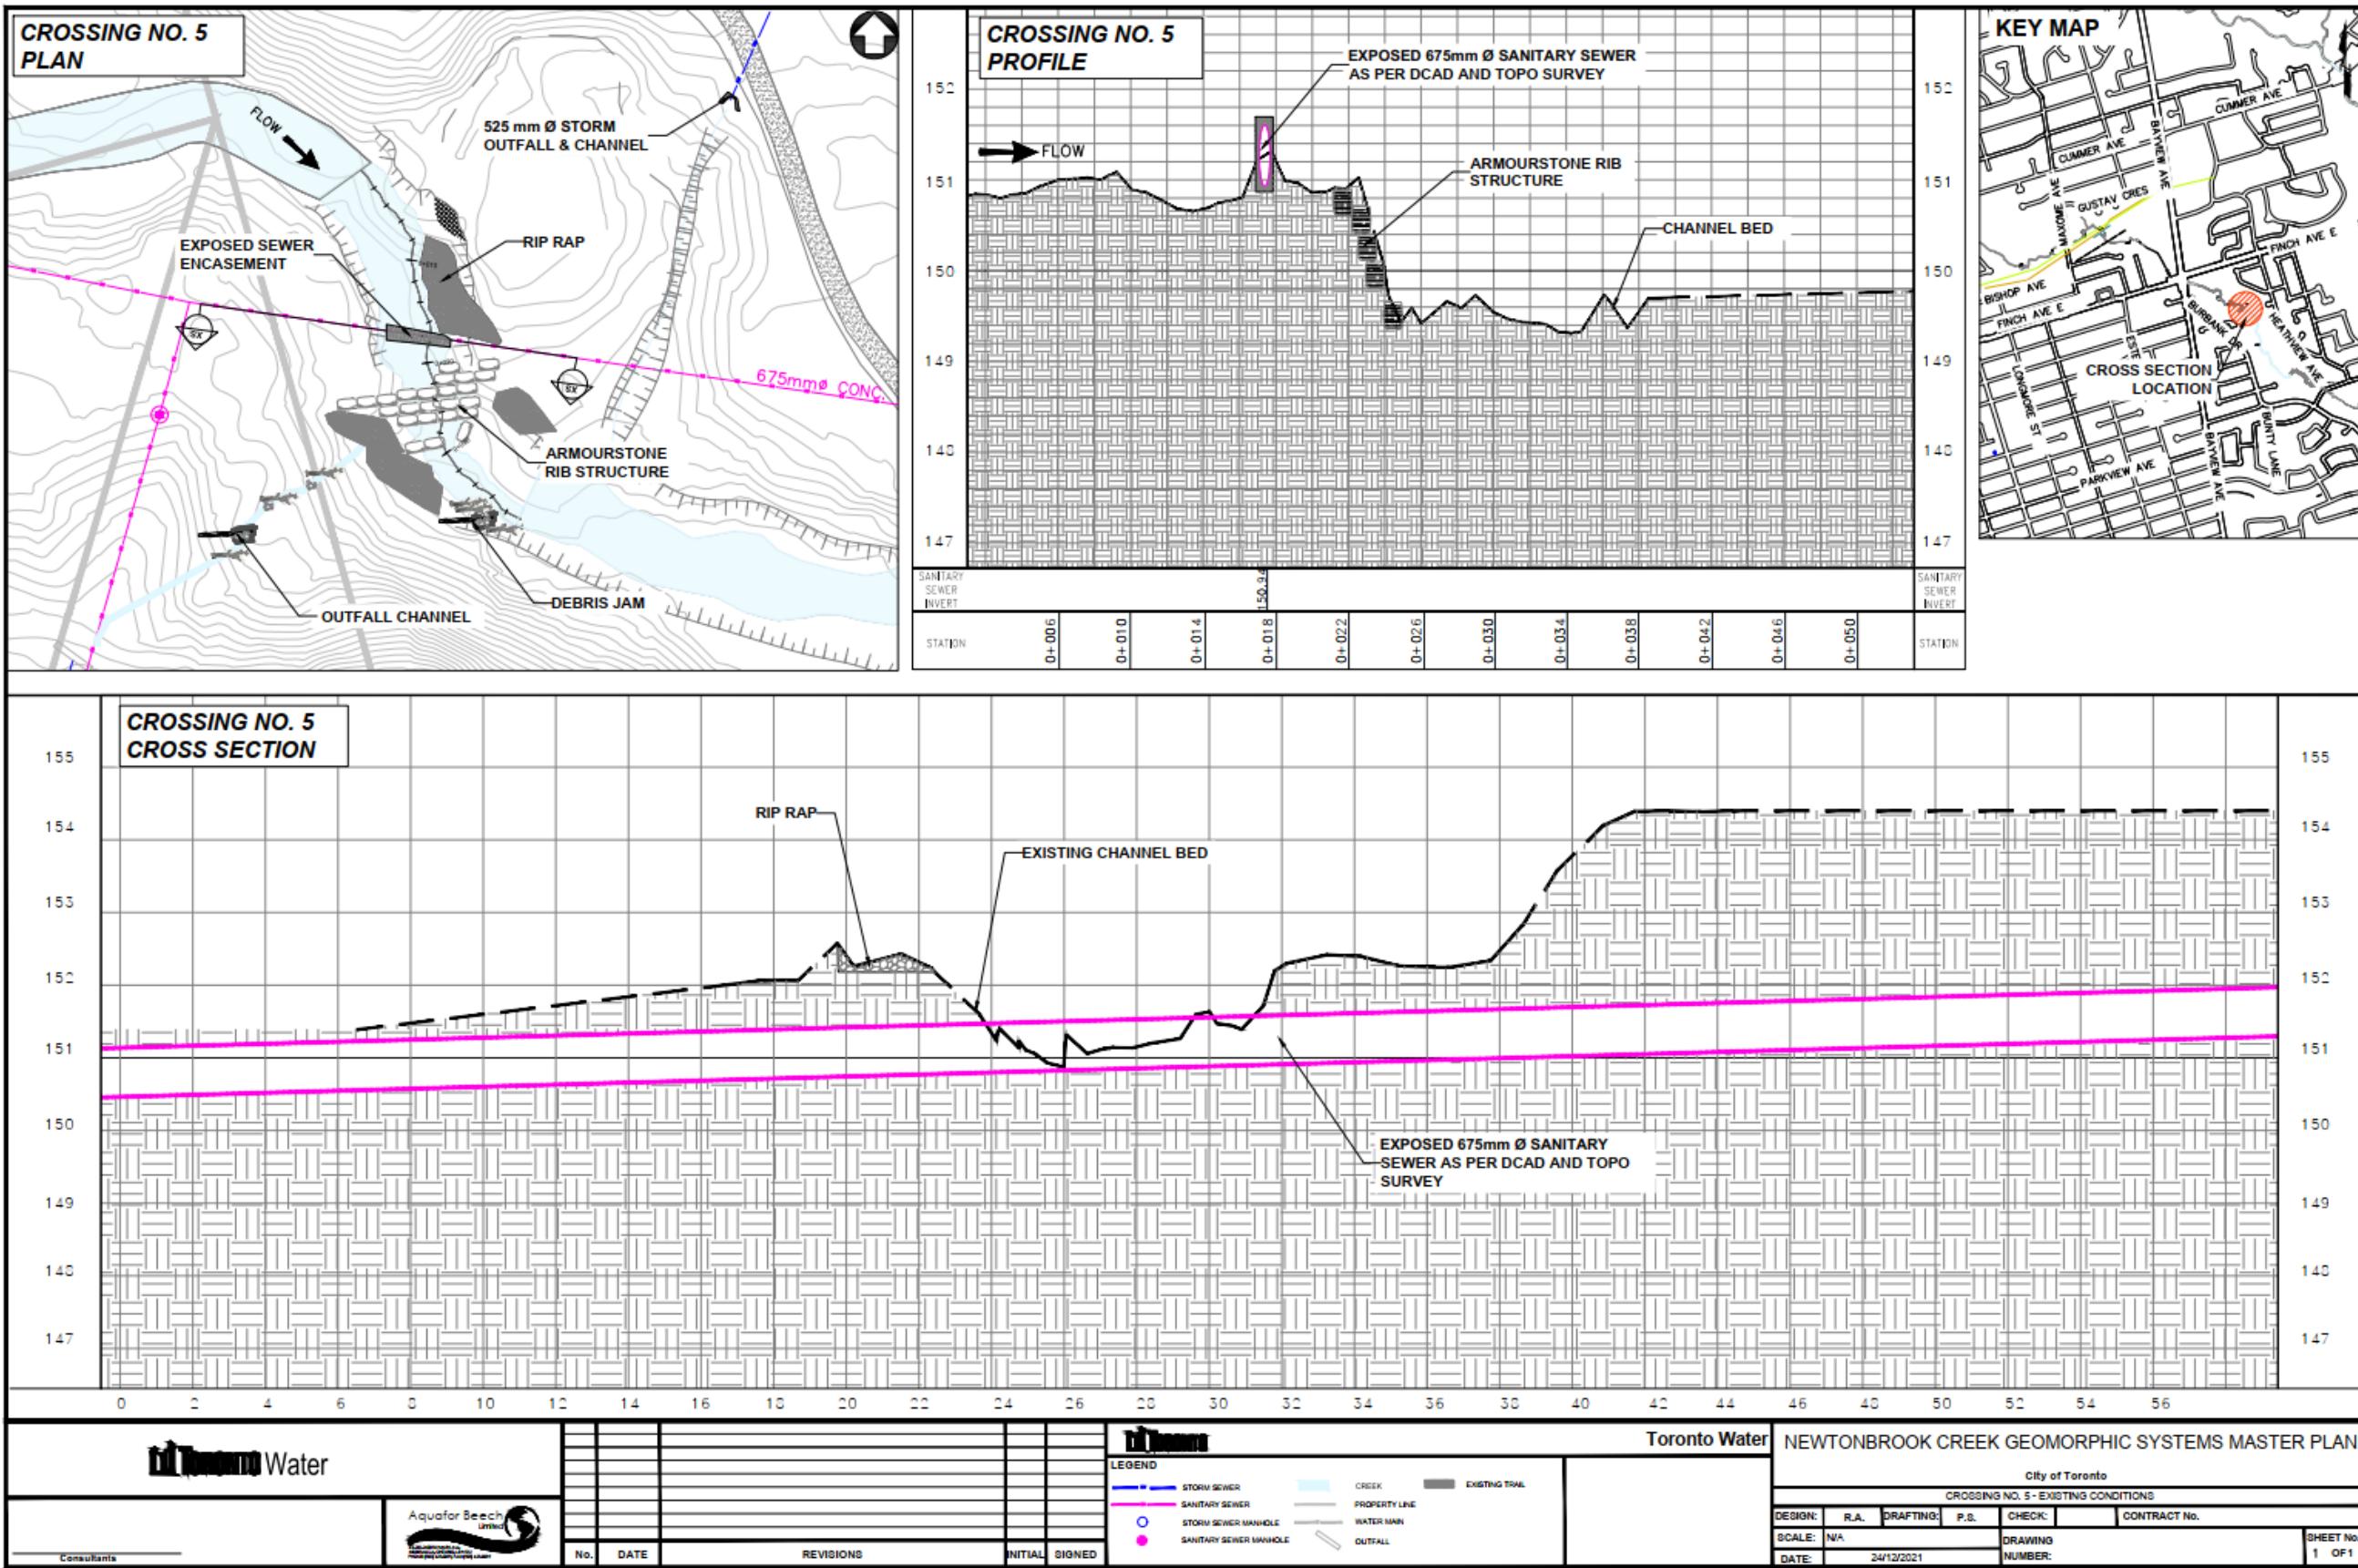
Figure 4-29: Existing Conditions - Priority Site #5

Priority Site #5 is located in Reach N2 of Newtonbrook Creek, approximately 420 metres downstream of the Finch & Bayview crossing. Incision and widening of the channel have exposed the concrete encasement surrounding a 675 mm diameter sanitary Trunk Sewer (Figure 4-25). The concrete encasement, which exhibits signs of degradation due to spalling, is protruding above the bed of the creek creating a slight backwater effect upstream. This exposed sewer crossing is situated just upstream of an armourstone grade control structure that facilitates a near vertical drop of approximately 2.0 metres along the longitudinal profile of the creek. The grade control structure is in a state of poor repair with a number of stones starting to slump and become dislodged (Figure 4-26).

Two (2) storm outfalls outlet to Newtonbrook Creek downstream of the armourstone grade control structure. Both outfalls are setback from the main channel, draining into the creek via steeply sloped outlet channels that are in various states of disarray. One outfall, draining a 525 mm diameter storm sewer, is located on the north side of the channel at the edge of a pedestrian trail (Figure 4-27). The corresponding outfall channel is in fair condition with some minor degradation due to erosion. The second outfall, which drains a 250 mm storm sewer, is situated on the south side of the channel near the top of the valley slope. The outfall protrudes out of an unprotected bank with no visible headwall or wingwall structure. The downstream outfall channel is severely eroded having formed an incised gully full of accumulated debris (Figure 4-28). This southern outfall is located on private property (10 Farmingdale Road), consequently a permission to enter agreement or easement may need to be obtained to facilitate repairs to this structure.

Parameter	Southern Outfall	Northern Outfall
Toronto Water Asset ID	OF4902413782	OF4907413839
Year of Construction	1956	1956
Diameter	Small (< 250 mm)	Medium (250 – 1200 mm)
Shape	Circular	Circular
Material	CMP	Concrete
Headwall	None	Concrete
Outfall Condition	Poor	Fair
Erodibility of Adjacent Substrate	High	High
