Appendix F-1 – Preliminary Pavement Evaluation Report

**PRELIMINARY PAVEMENT EVALUATION REPORT
MUNICIPAL CLASS EA STUDY FOR
LAWRENCE PARK NEIGHBOURHOOD
CITY OF TORONTO, ONTARIO**

File No. 11-12-2126

December 06, 2013

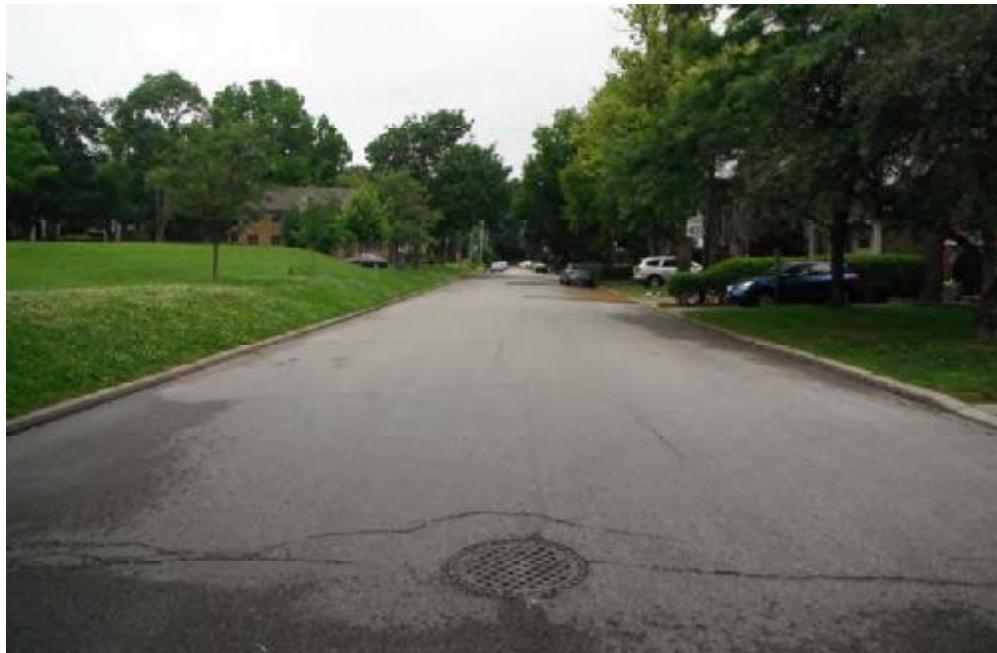
PHOTOGRAPH 1. Braeside Road from Langton Avenue to Rothmere Drive, urban cross section, looking north.

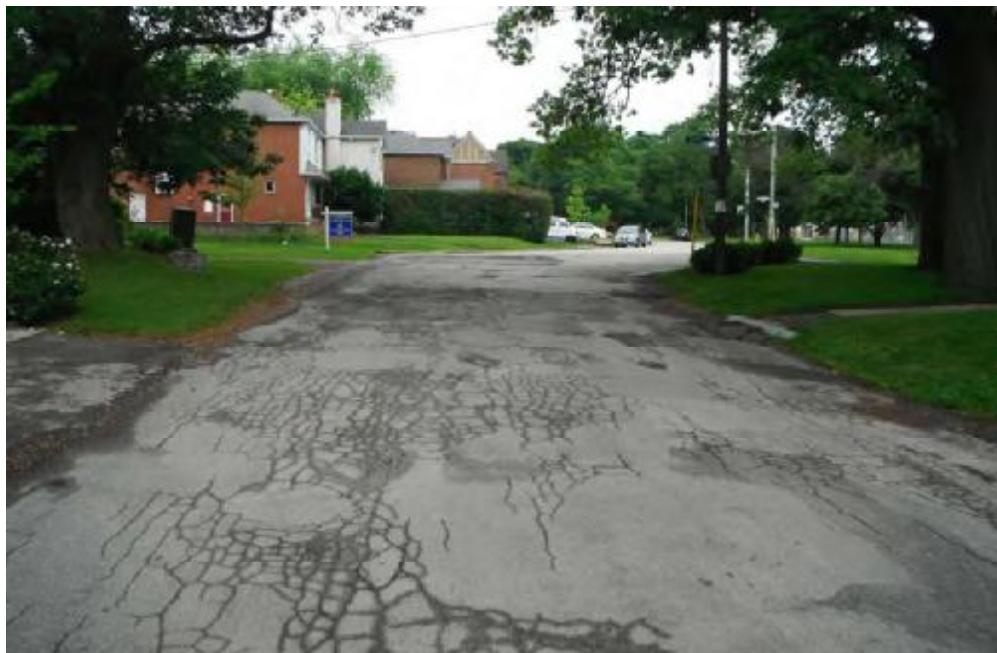
PHOTOGRAPH 2. Rothmere Drive from Braeside Road to Mildenhall Road, rural cross section, looking west.

| Roadway Sections | From | To | Overall Condition | General Distresses |
|---|---|---|---|--|
| Rothmere Drive | Braeside Road | Mildenhall Road | PCR = 29 RCR = 1 Poor | <ul style="list-style-type: none"> • Throughout severe flushing. • Throughout very severe distortion. • Throughout very severe alligator longitudinal wheel track cracking. • Frequent severe single and multiple centreline cracking. • Extensive severe alligator pavement edge cracking. |

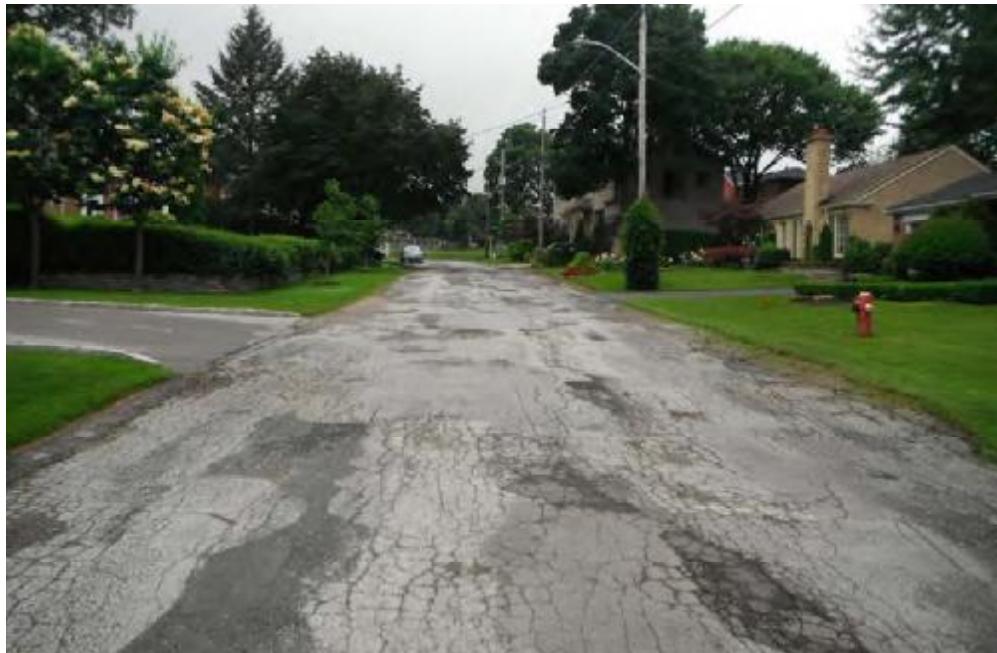
PHOTOGRAPH 3. Braeside Crescent from Braeside Road to Proctor Crescent, rural cross section, looking west.

| Roadway Sections | From | To | Overall Condition | General Distresses |
|---|---|---|---|--|
| Braeside Crescent | Braeside Road | Proctor Crescent | PCR = 27 RCR = 1 Poor | <ul style="list-style-type: none"> • Throughout severe flushing. • Throughout very severe distortion. • Throughout severe alligator longitudinal wheel track cracking. • Throughout severe alligator pavement edge cracking. • Throughout severe alligator transverse cracking. |

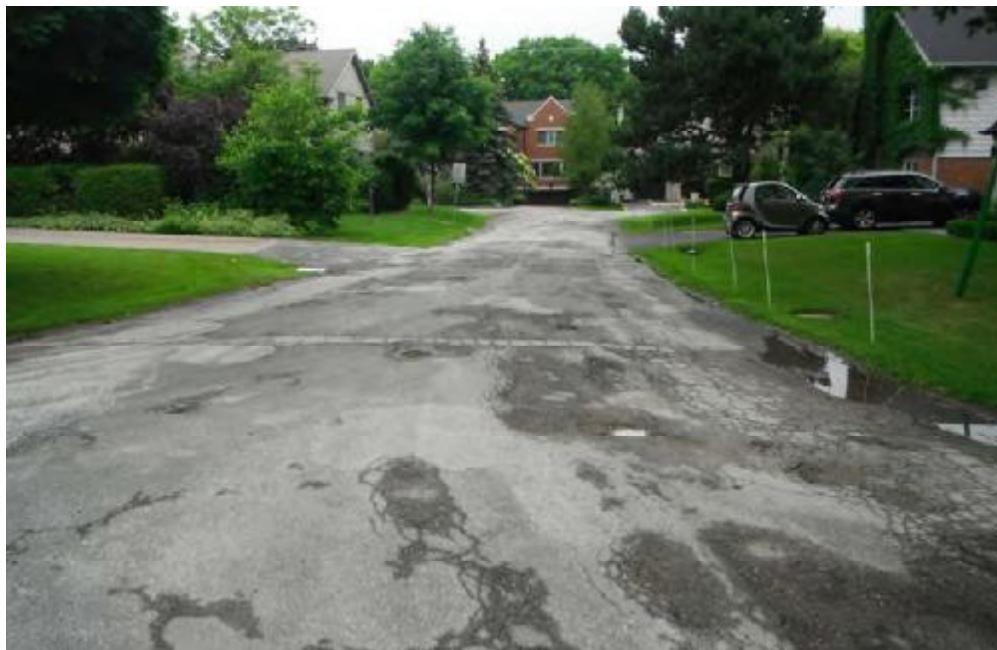
PHOTOGRAPH 4. Proctor Crescent from Mildenhall Road to Rothmere Drive, rural cross section, looking north.

| Roadway Sections | From | To | Overall Condition | General Distresses |
|---|---|---|---|--|
| Proctor Crescent | Mildenhall Road | Rothmere Drive | PCR = 27 RCR = 1 Very Poor | <ul style="list-style-type: none"> • Throughout severe flushing. • Throughout very severe distortion. • Throughout severe alligator longitudinal wheel track cracking. • Throughout severe alligator pavement edge cracking. • Throughout severe alligator transverse cracking. |

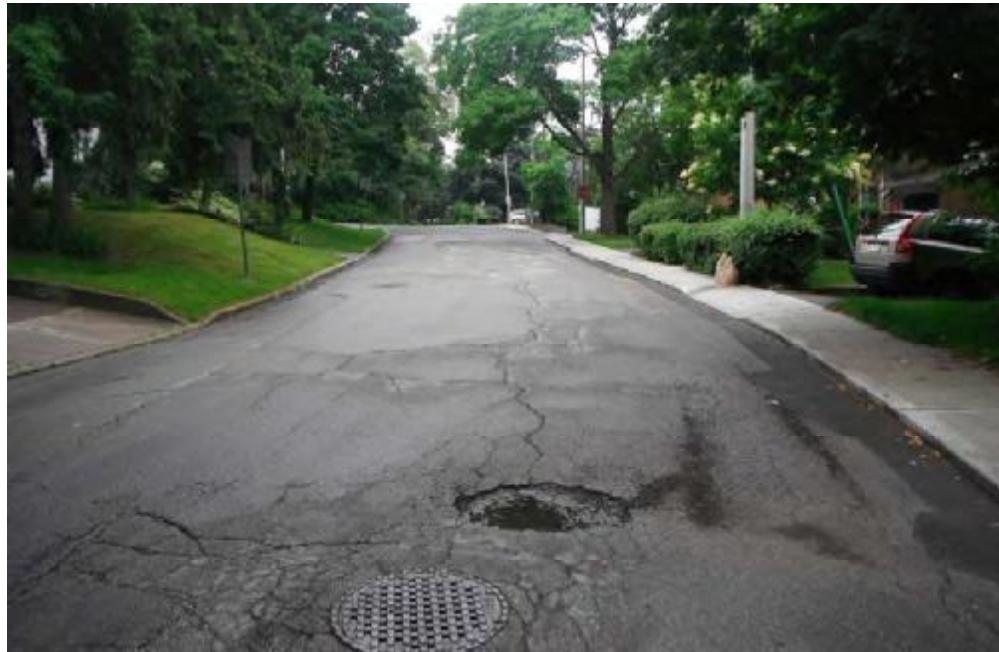
PHOTOGRAPH 5. Lawrence Crescent from Mount Pleasant Road to Mount Pleasant Road, urban cross section, looking north.

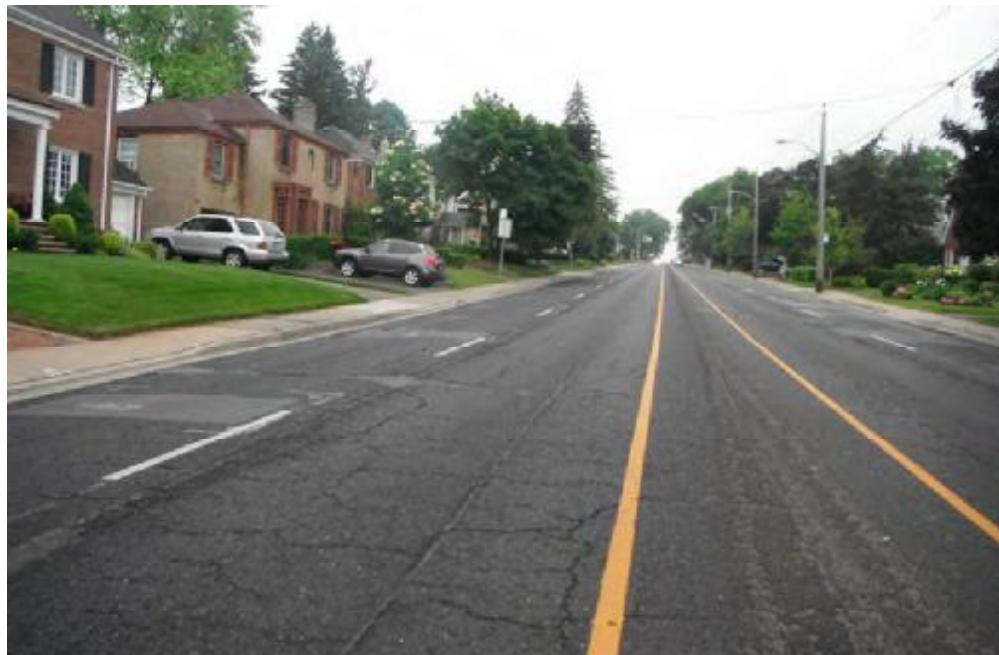
PHOTOGRAPH 6. Lawrence Avenue East, Section 1 from Bayview Avenue to 224 Lawrence Avenue East, urban cross section, looking west.

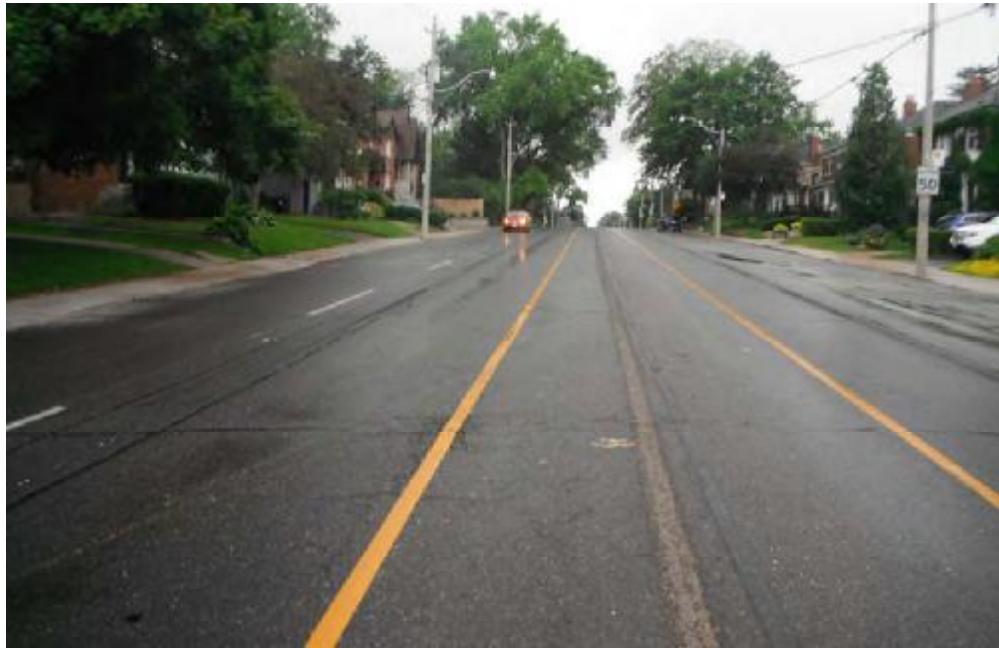
PHOTOGRAPH 7. Lawrence Avenue East, Section 2 from 224 Lawrence Avenue East to Wanless Crescent, urban cross section, looking west.

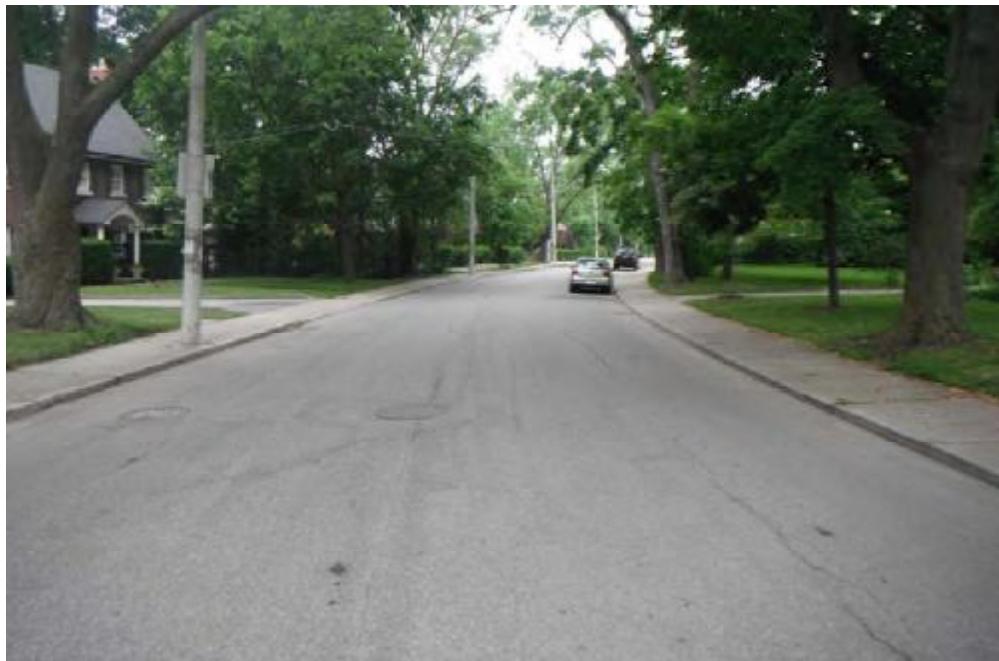
PHOTOGRAPH 8. Dinnick Crescent from Lawrence Avenue East to Mount Pleasant Road, urban cross section, looking north.

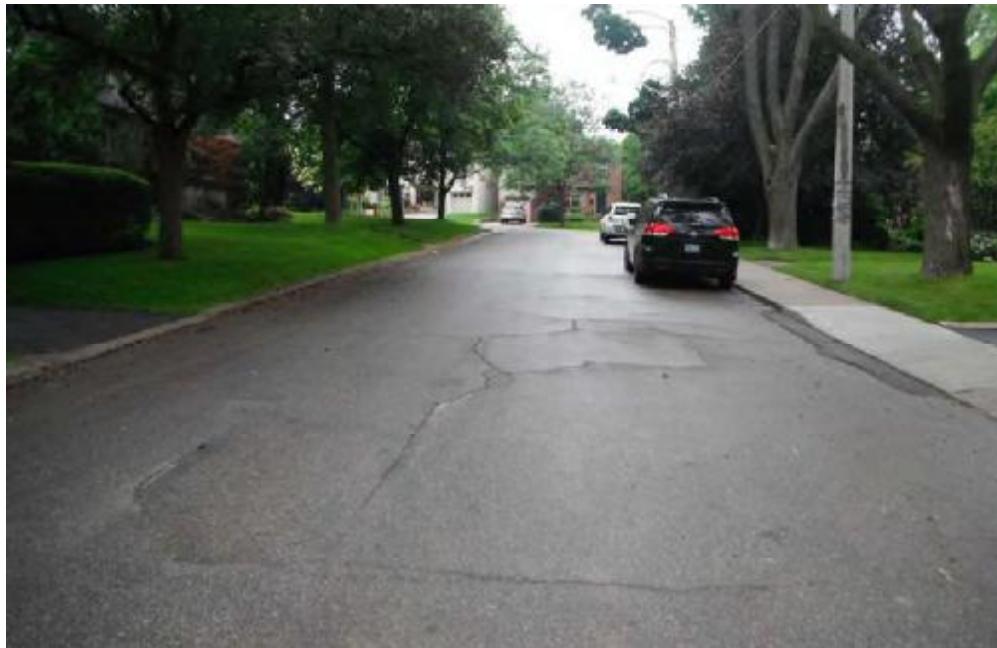
PHOTOGRAPH 9. Lympstone Avenue from Lawrence Crescent to Dinnick Crescent, urban cross section, looking west.

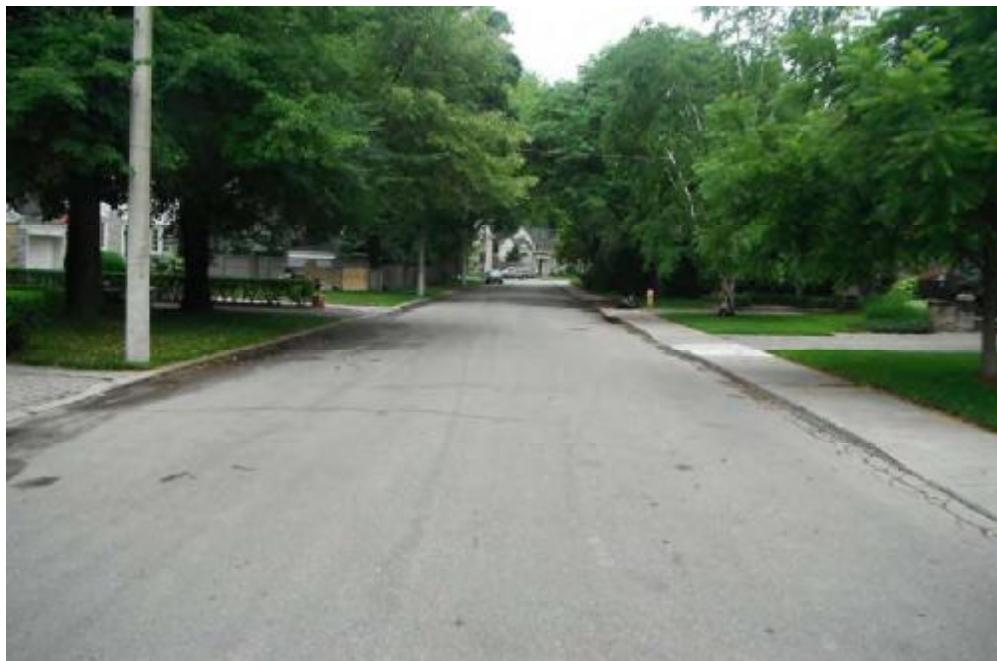
PHOTOGRAPH 10. Buckingham Avenue, Section 1 from Dinnick Crescent to Wanless Crescent (east), urban cross section, looking west.

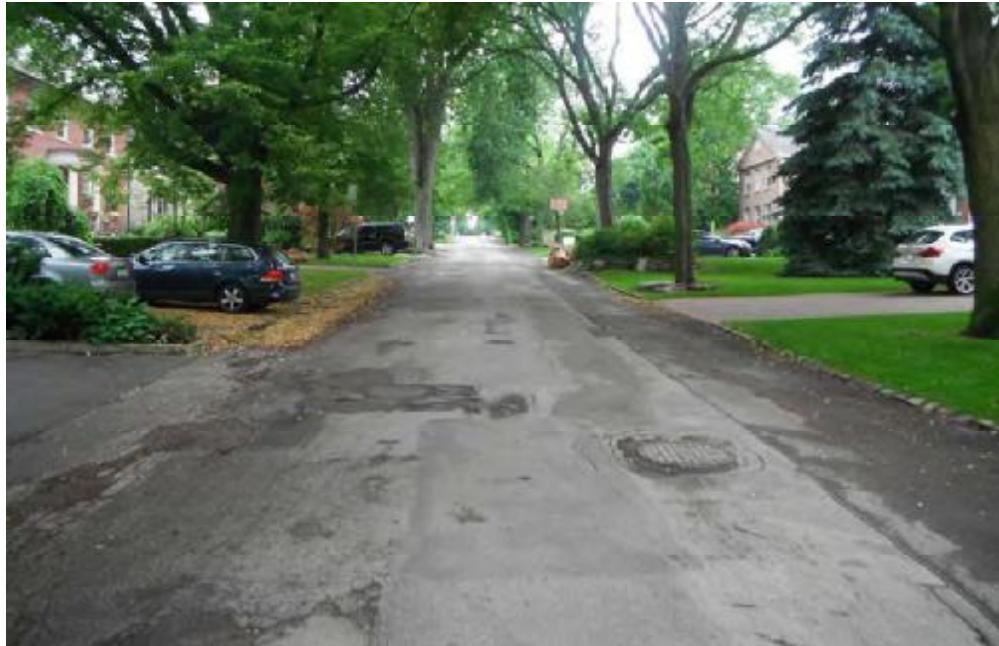
PHOTOGRAPH 11. Buckingham Avenue, Section 2 from Wanless Crescent (east) to Mildenhall Road, rural cross section, looking west.

| Roadway Sections | From | To | Overall Condition | General Distresses |
|---|---|---|---|--|
| Buckingham Avenue, Section 2 | Wanless Crescent (east) | Mildenhall Road | PCR = 28 RCR = 1 Poor | <ul style="list-style-type: none"> • Few moderate raveling and coarse aggregate loss. • Throughout severe flushing. • Throughout moderate distortion. • Extensive severe alligator longitudinal wheel track cracking. • Intermittent severe alligator pavement edge cracking. • Few very severe alligator transverse cracking. |

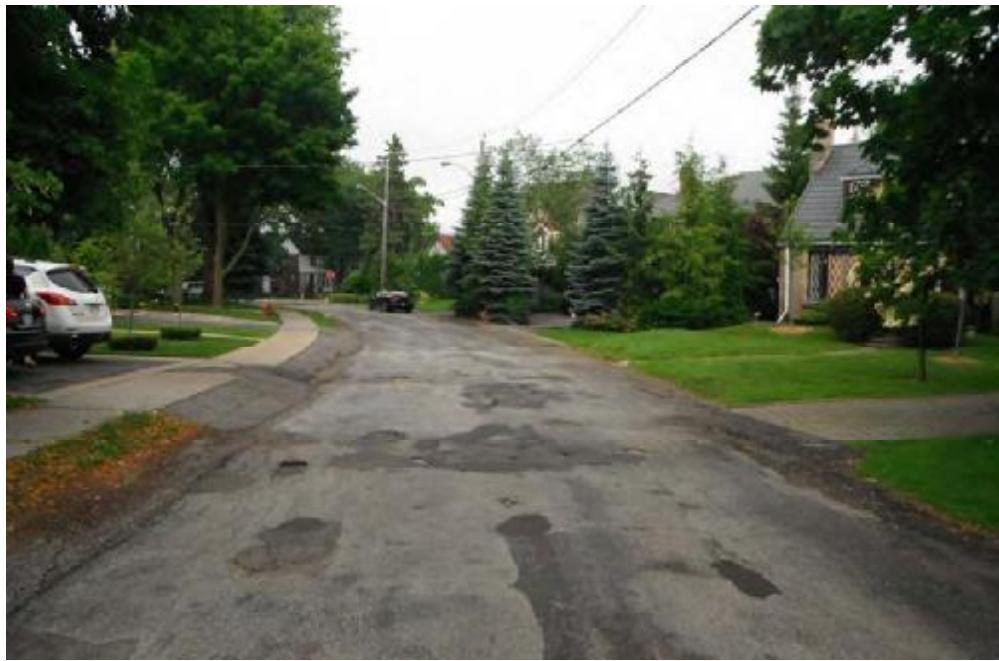
PHOTOGRAPH 12. Wanless Crescent, East Section from Buckingham Avenue to Lawrence Avenue East, rural cross section, looking north.

| Roadway Sections | From | To | Overall Condition | General Distresses |
|---|---|---|---|--|
| Wanless Crescent, East Section | Buckingham Avenue | Lawrence Avenue E | PCR = 29 RCR = 1 Poor | <ul style="list-style-type: none"> • Throughout very severe flushing. • Throughout very severe distortion. • Extensive severe alligator longitudinal wheel track cracking. • Frequent moderate alligator pavement edge cracking. • Frequent moderate alligator transverse cracking. |

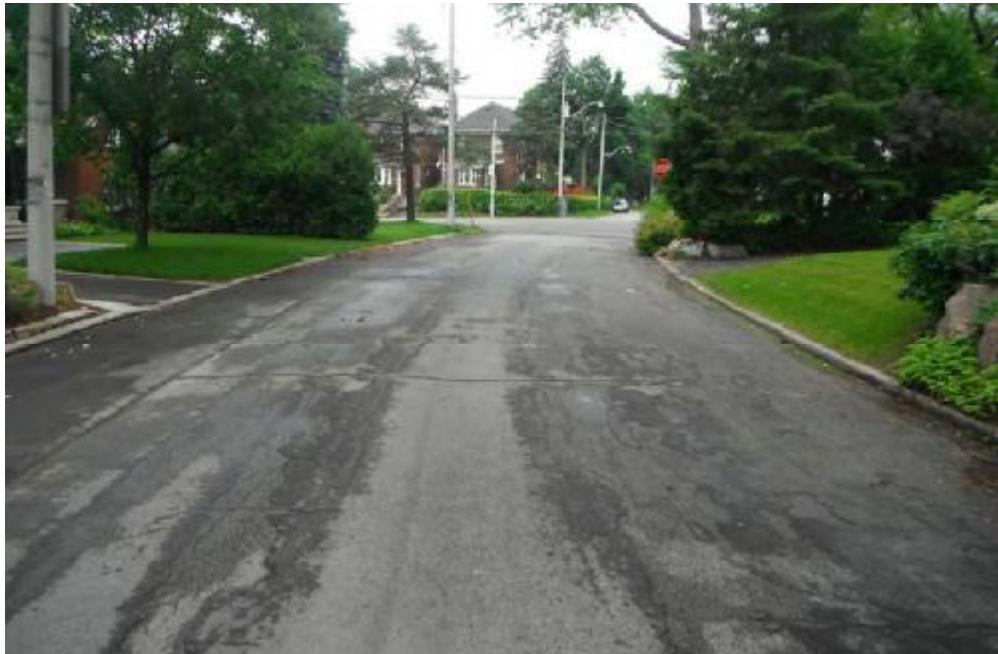
PHOTOGRAPH 13. Wanless Crescent, West Section from Buckingham Avenue to Lawrence Avenue East, urban cross section, looking north.

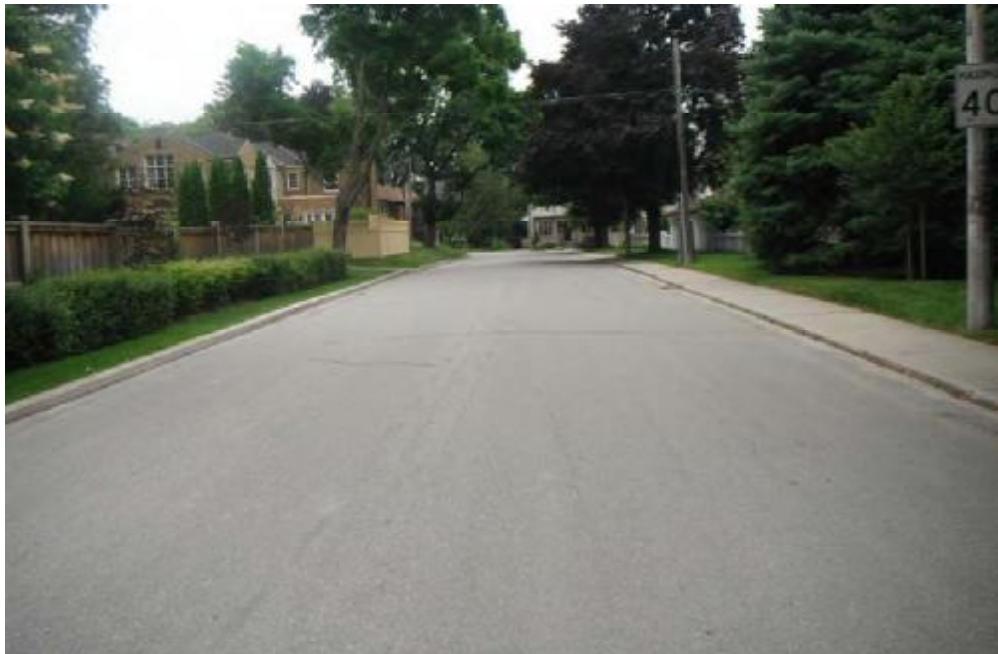
PHOTOGRAPH 14. St. Ives Avenue from Buckingham Avenue to Cheltenham Avenue, urban cross section, looking north.

| Roadway Sections | From | To | Overall Condition | General Distresses |
|---|---|---|---|--|
| St. Ives Avenue | Buckingham Avenue | Cheltenham Avenue | PCR = 89 RCR = 8 Good | <ul style="list-style-type: none"> • Frequent slight single and multiple centreline cracking. • Frequent slight single and multiple pavement edge cracking. • Frequent slight half, full, and multiple transverse cracking. |

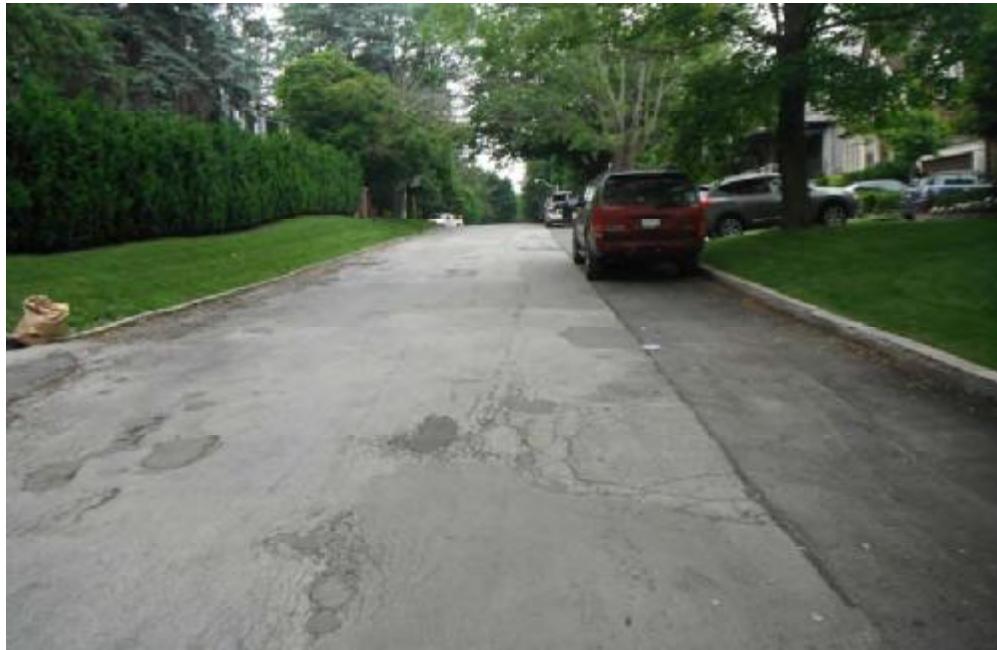
PHOTOGRAPH 15. Cheltenham Avenue, Section 1 from St. Ives Crescent to Mildenhall Avenue, rural cross section, looking west.

| Roadway Sections | From | To | Overall Condition | General Distresses |
|---|---|---|---|---|
| Cheltenham Avenue, Section 1 | St. Ives Crescent | Mildenhall Avenue | PCR = 39 RCR = 2 Poor to fair | <ul style="list-style-type: none"> Extensive moderate flushing. Extensive moderate distortion. Intermittent severe alligator longitudinal wheel track cracking. Intermittent severe alligator pavement edge cracking. Frequent very severe alligator transverse cracking. Few moderate longitudinal meander and midlane cracking. |

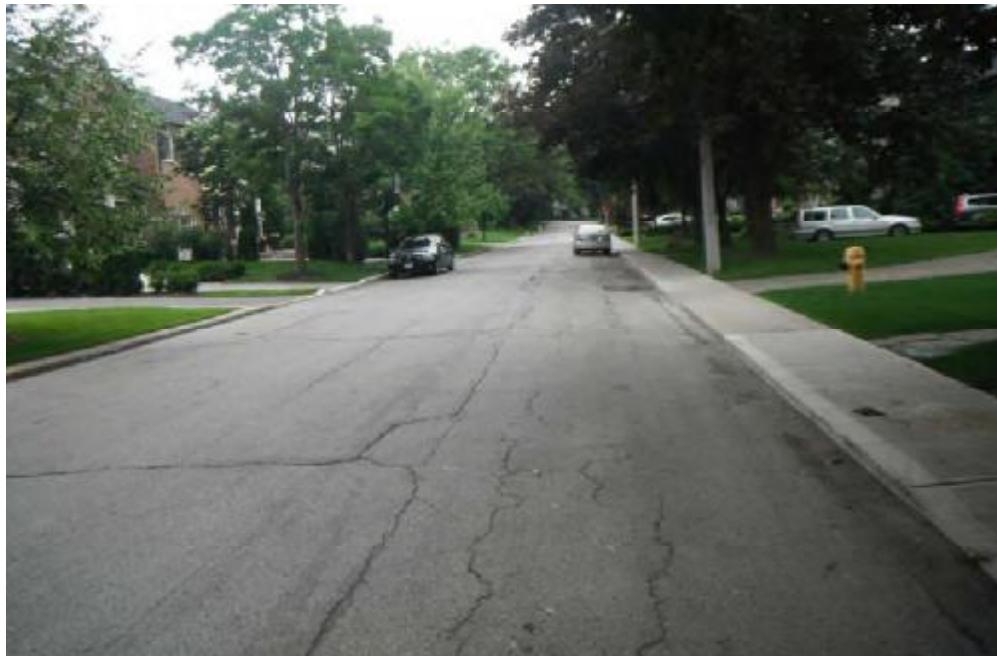
PHOTOGRAPH 16. Cheltenham Avenue, Section 2 from Dinnick Crescent to St. Ives Crescent, urban cross section, looking west.

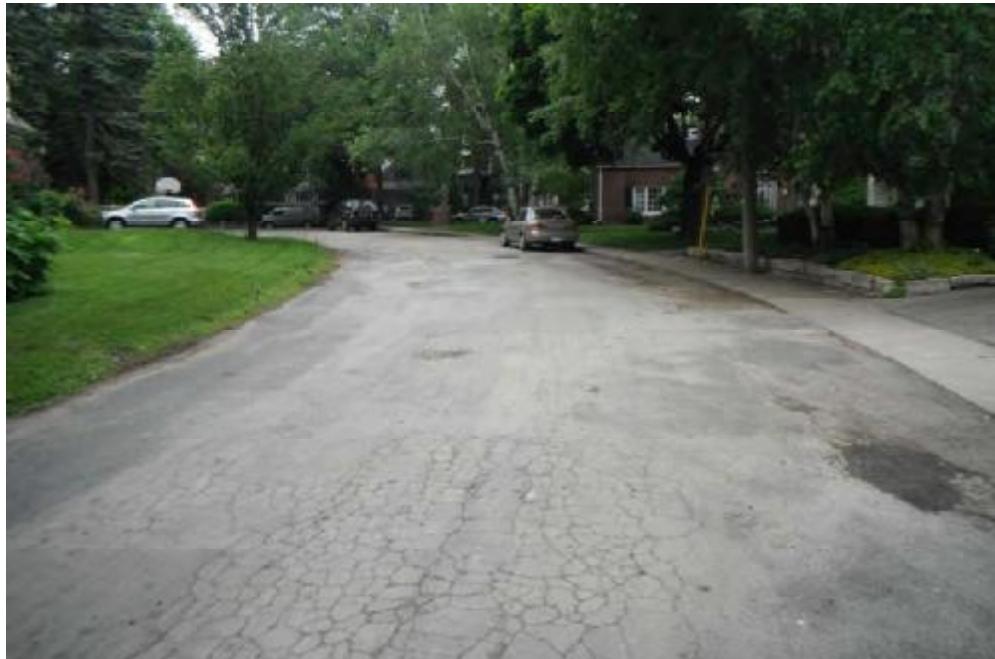
PHOTOGRAPH 17. St. Ives Crescent, East Section from Cheltenham Avenue to Rochester Avenue, semi-urban cross section, looking north.

| Roadway Sections | From | To | Overall Condition | General Distresses |
|---|---|---|---|---|
| St. Ives Crescent, East Section | Cheltenham Avenue | Rochester Avenue | PCR = 39 RCR = 2 Poor to fair | <ul style="list-style-type: none"> Extensive severe flushing. Extensive severe distortion. Frequent severe alligator longitudinal wheel track cracking. Frequent very severe half, full and multiple transverse cracking. Frequent severe alligator transverse cracking. |

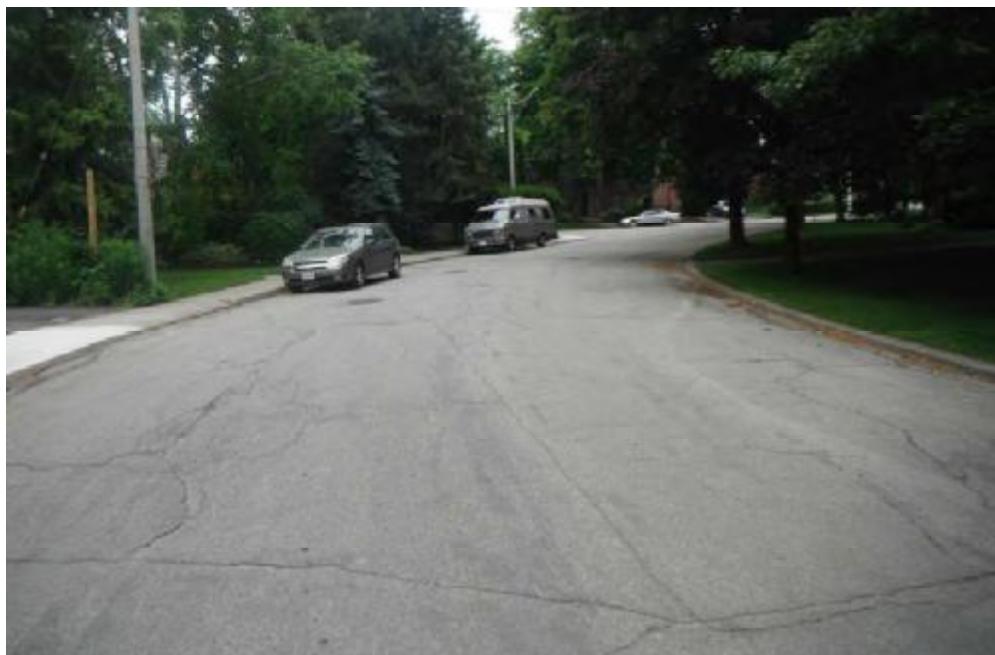
PHOTOGRAPH 18. St. Ives Crescent, West Section from Cheltenham Avenue to Rochester Avenue, urban cross section, looking north.

| Roadway Sections | From | To | Overall Condition | General Distresses |
|---|---|---|---|---|
| St. Ives Crescent, West Section | Cheltenham Avenue | Rochester Avenue | PCR = 48 RCR = 3 Poor to fair | <ul style="list-style-type: none"> Extensive slight ravelling and coarse aggregate loss. Extensive slight distortion. Intermittent moderate single and multiple pavement edge cracking. Intermittent severe alligator pavement edge cracking. Extensive very severe half, full, and multiple transverse cracking. Extensive severe longitudinal meander and midlane cracking. |

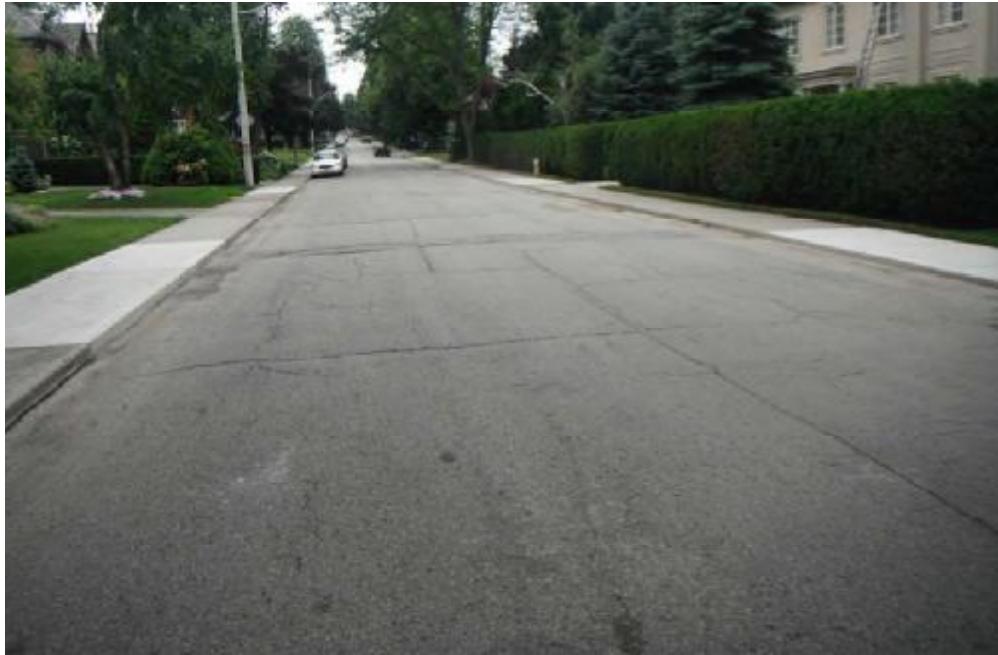
PHOTOGRAPH 19. Rochester Avenue, Section 1 from Dinnick Crescent to St. Ives Avenue, urban cross section, looking west.

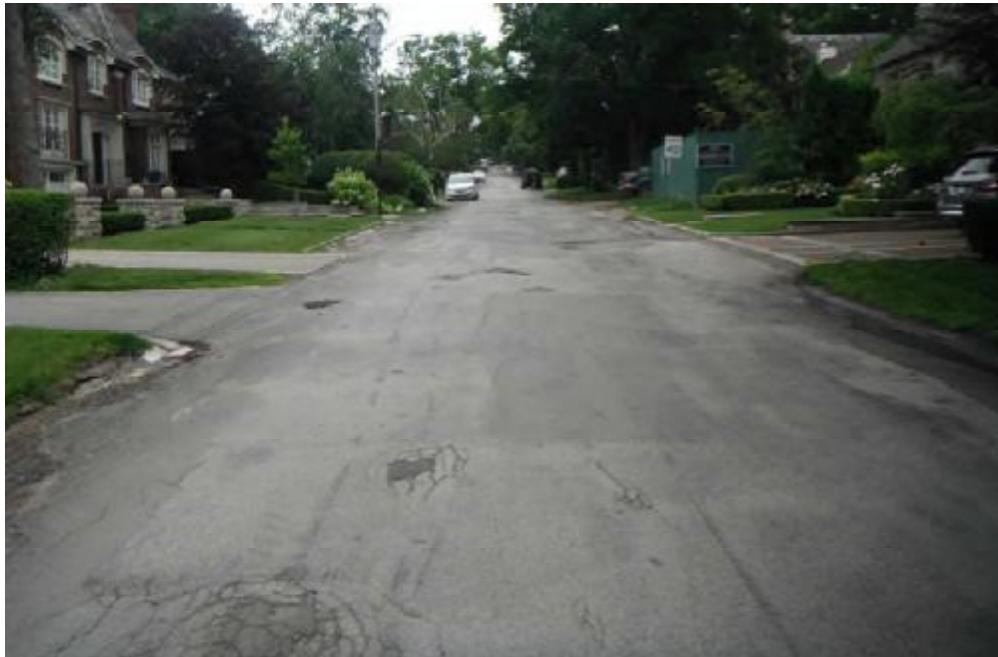
PHOTOGRAPH 20. Rochester Avenue, Section 2 from St. Ives Avenue to Lewes Crescent, rural cross section, looking west.

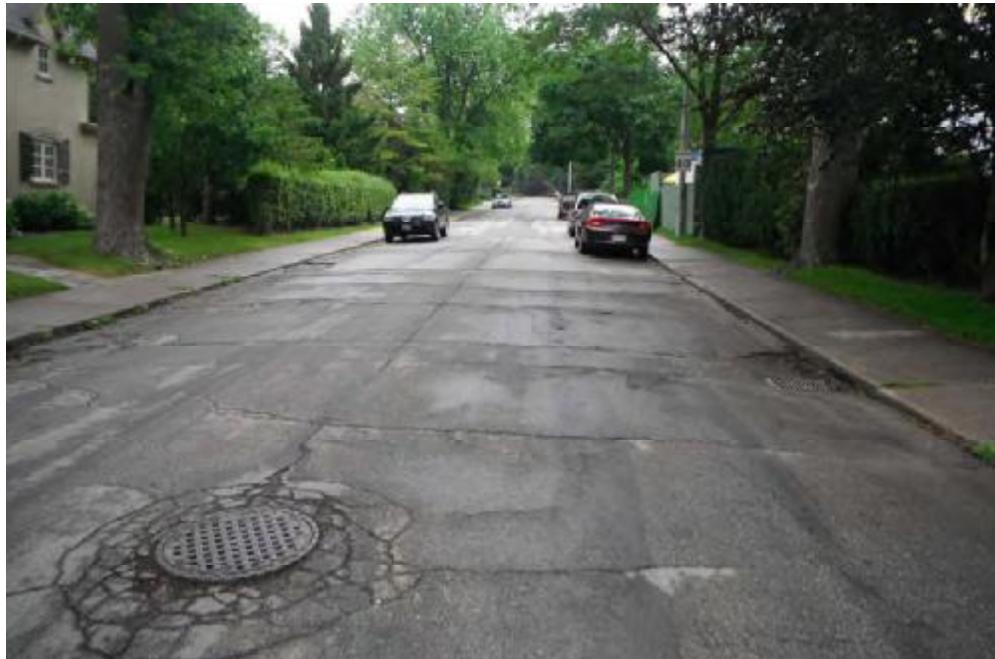
PHOTOGRAPH 21. Dundurn Road, Section 1 from Dinnick Crescent to Dawlish Avenue, urban cross section, looking north.

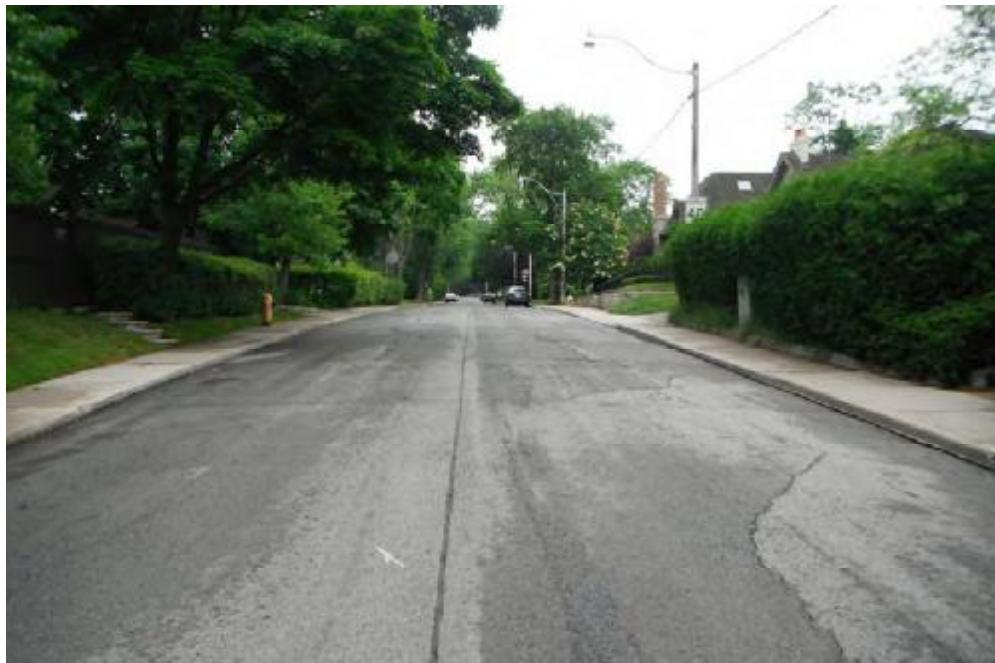
PHOTOGRAPH 22. Dundurn Road, Section 2 from Dawlish Avenue to Glengowan Road, urban cross section, looking north.

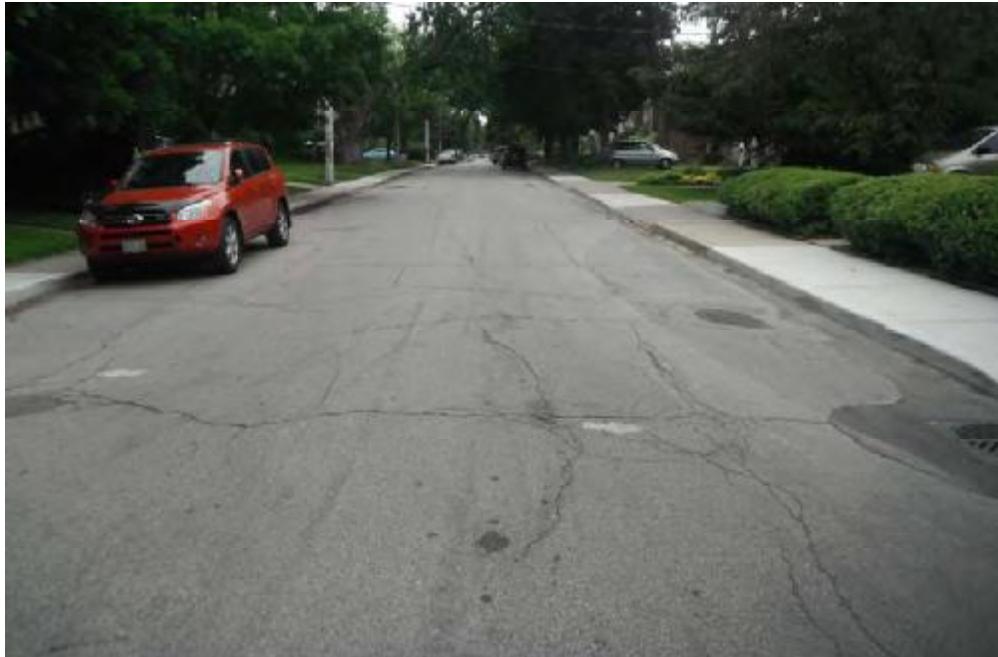
PHOTOGRAPH 23. St. Leonards Avenue, Section 1 from Mount Pleasant Road to St. Leonards Crescent, urban cross section, looking east.

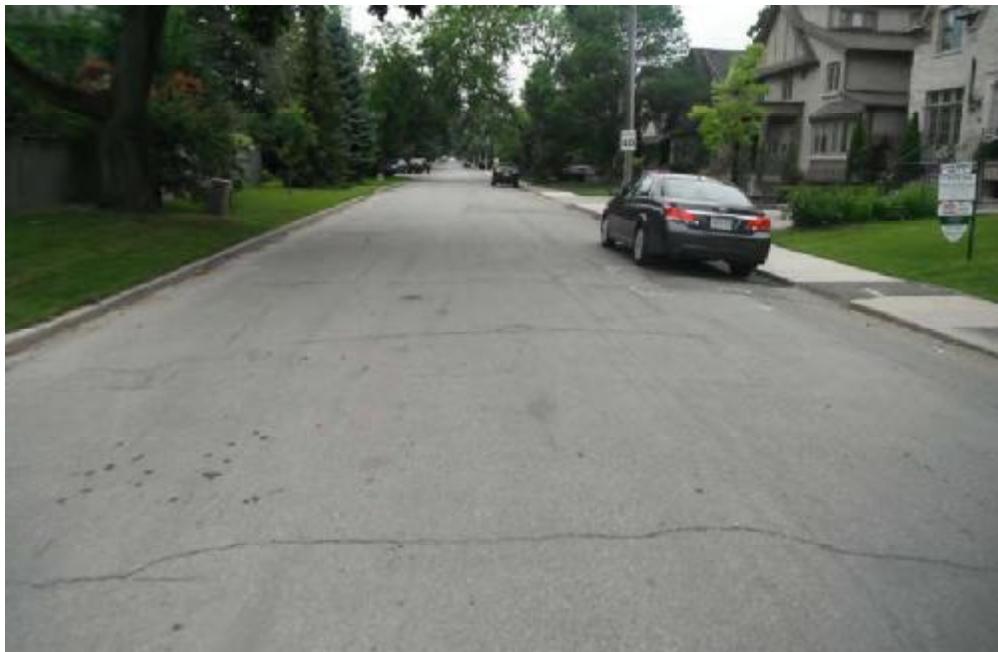
PHOTOGRAPH 24. St. Leonards Avenue, Section 2 from St. Leonards Crescent to 207 St. Leonards Avenue, urban cross section, looking east.

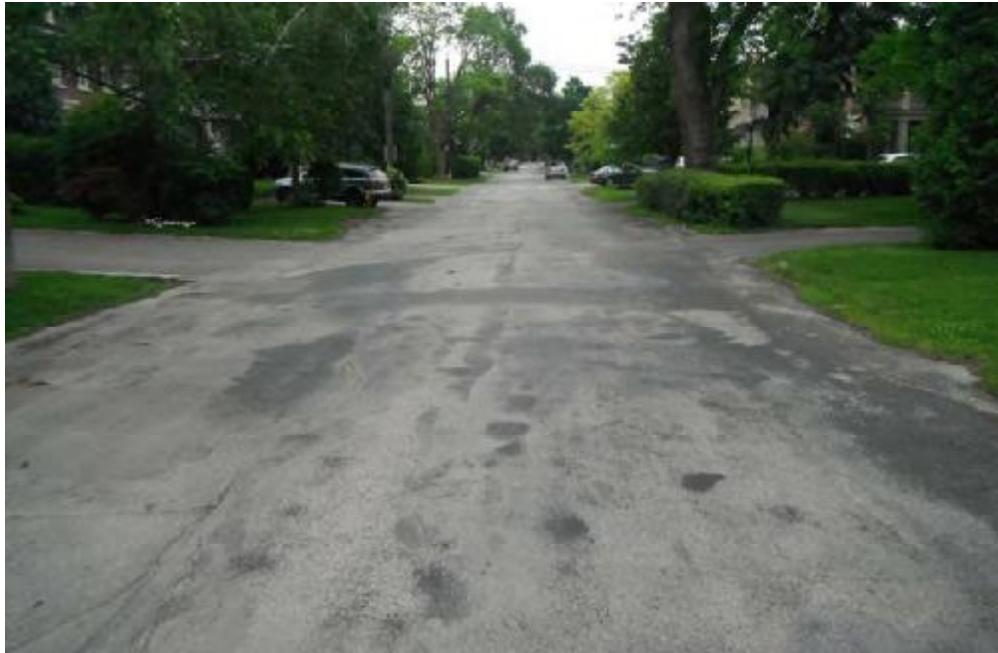
PHOTOGRAPH 25. St. Leonards Avenue, Section 3 from 207 St. Leonards Avenue to Bayview Avenue, rural cross section, looking east.

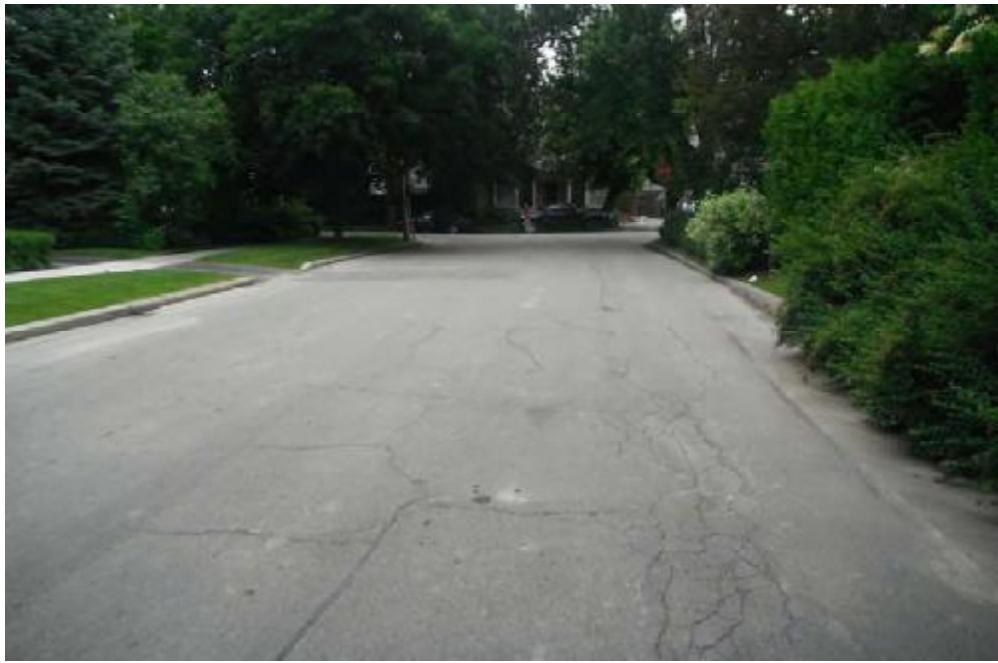
PHOTOGRAPH 26. St. Ives Avenue from Rochester Avenue to St. Leonards Avenue, urban cross section, looking north.

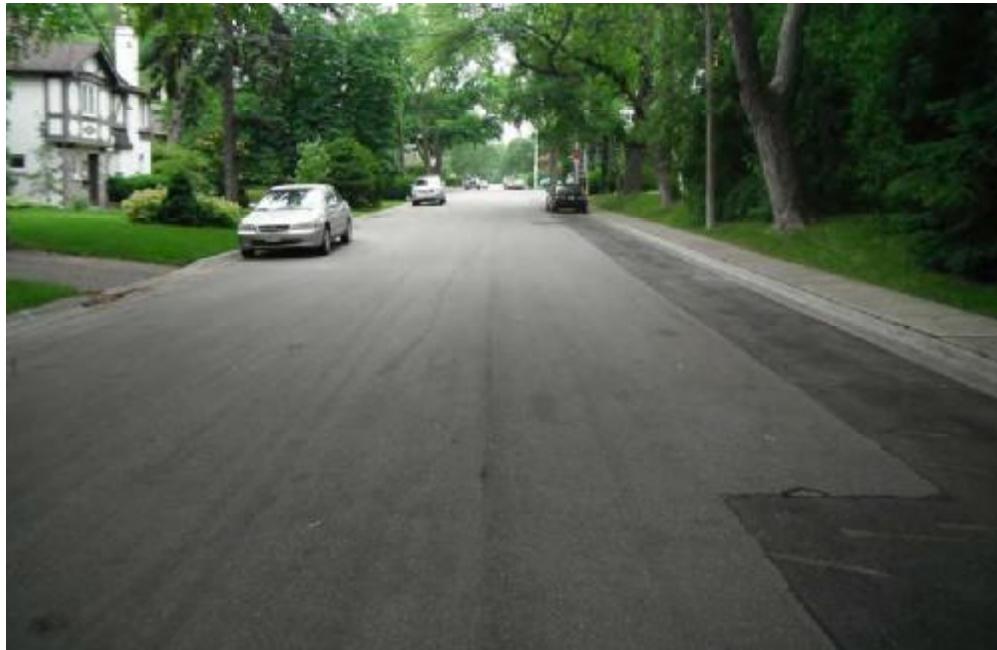
PHOTOGRAPH 27. Dawlish Avenue, Section 1 from St. Leonards Crescent to East End, urban cross section, looking west.

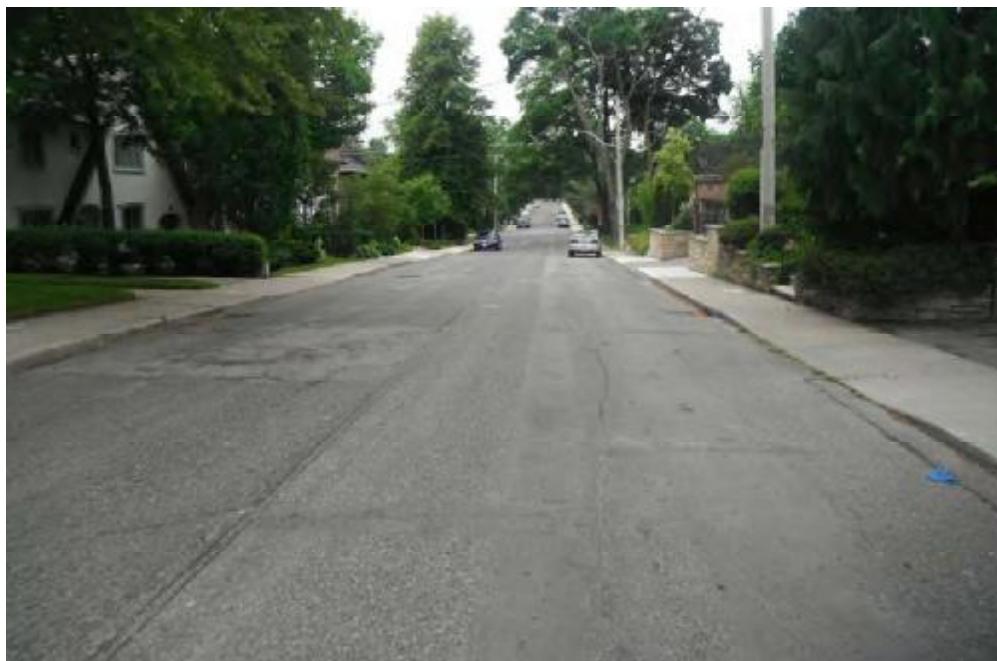
PHOTOGRAPH 28. Dawlish Avenue, Section 2 from Mount Pleasant Road to St. Leonards Crescent, urban cross section, looking west.

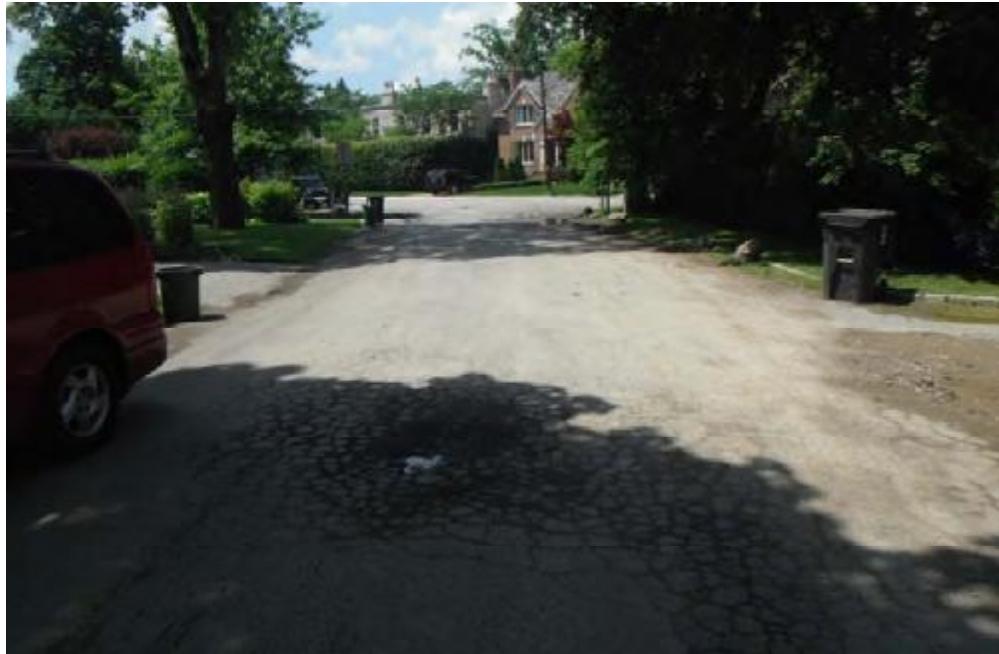
PHOTOGRAPH 29. St. Leonards Crescent, East Section from Dawlish Avenue to St. Leonards Avenue, rural cross section, looking north.

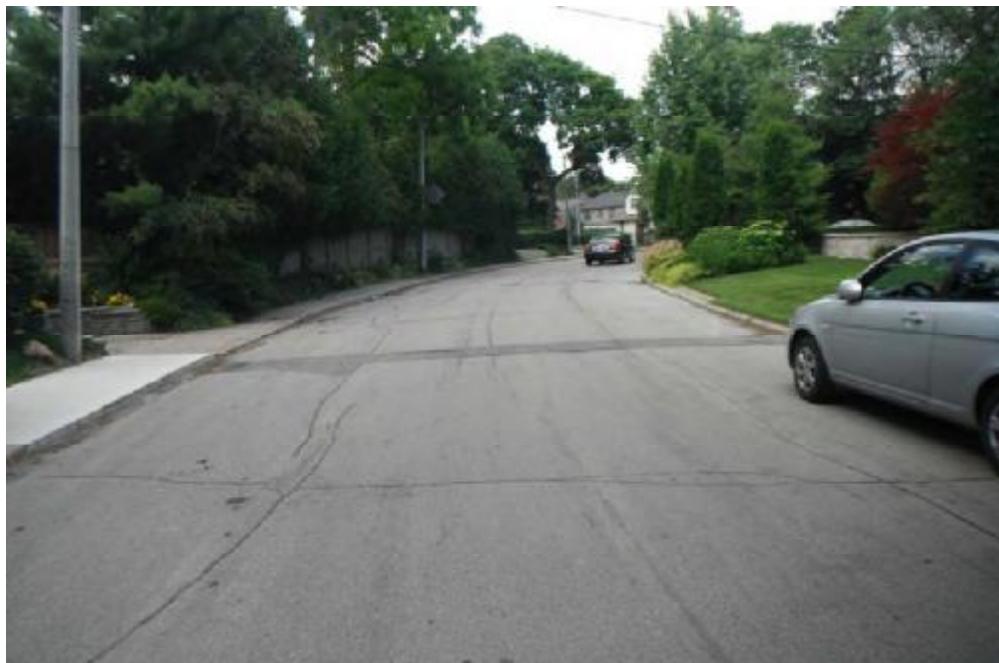
PHOTOGRAPH 30. St. Leonards Crescent, West Section from Dawlish Avenue to St. Leonards Avenue, urban cross section, looking north.

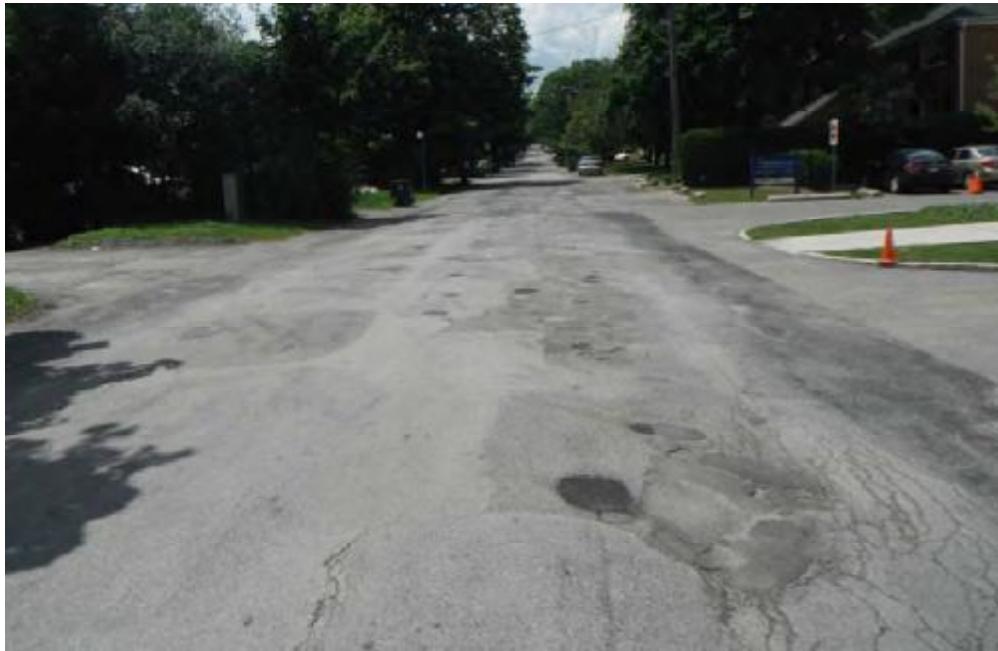
PHOTOGRAPH 31. Dawlish Avenue from St. Leonards Crescent to Bayview Avenue, rural cross section, looking west.
