Appendix F-1 – Preliminary Pavement Evaluation Report

**PRELIMINARY PAVEMENT EVALUATION REPORT
MUNICIPAL CLASS EA STUDY FOR
LAWRENCE PARK NEIGHBOURHOOD
CITY OF TORONTO, ONTARIO**

File No. 11-12-2126

December 06, 2013

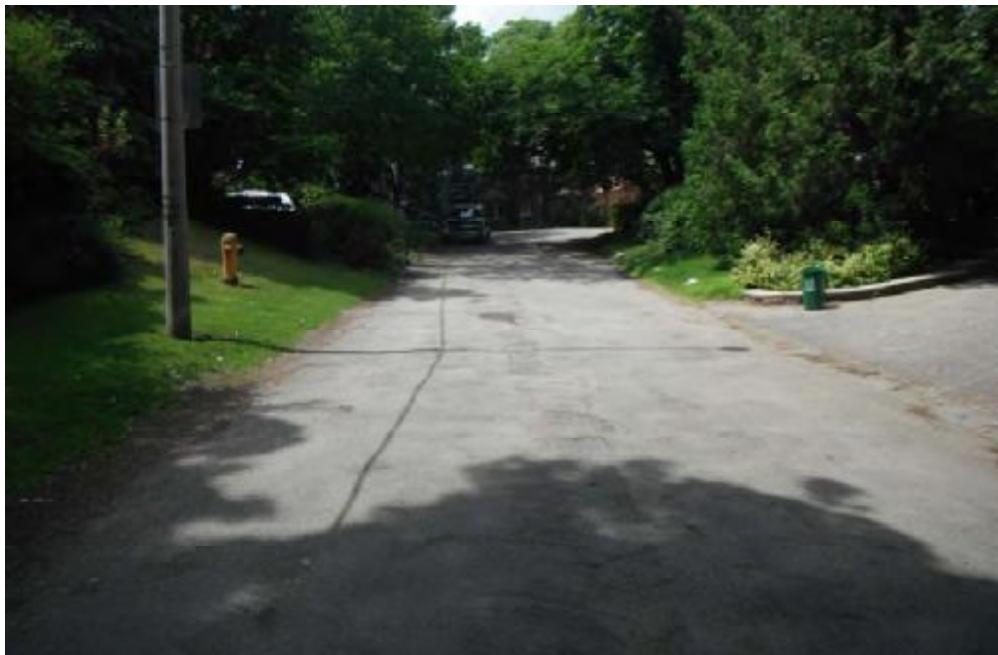
PHOTOGRAPH 32. Pinedale Road from Dawlish Avenue to Strathgowan Crescent, rural cross section, looking north.

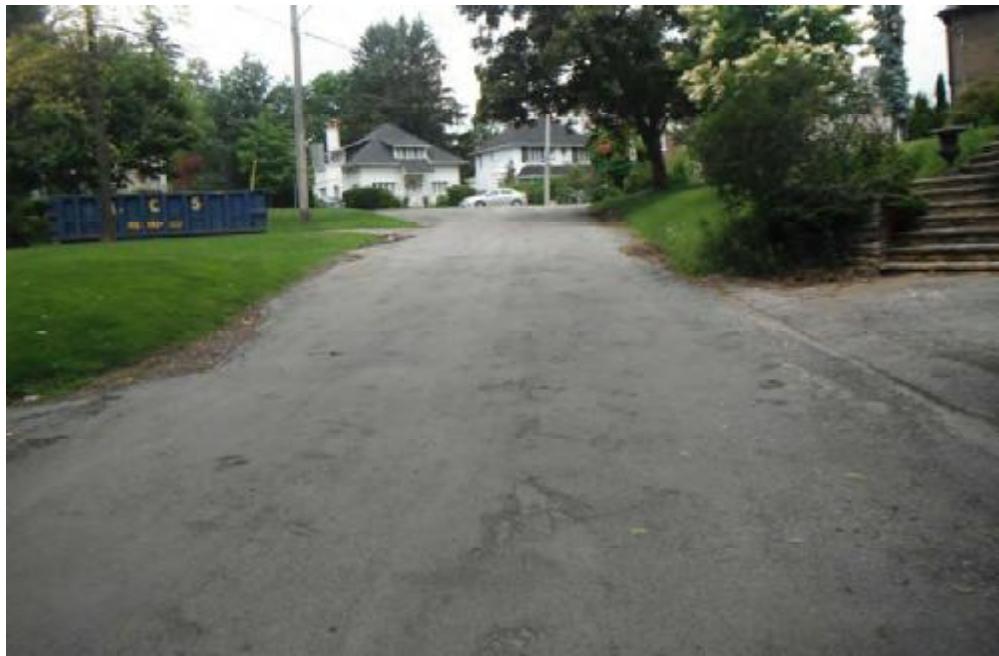
PHOTOGRAPH 33. Fidelia Avenue from Dawlish Avenue to Strathgowan Crescent, rural cross section, looking north.

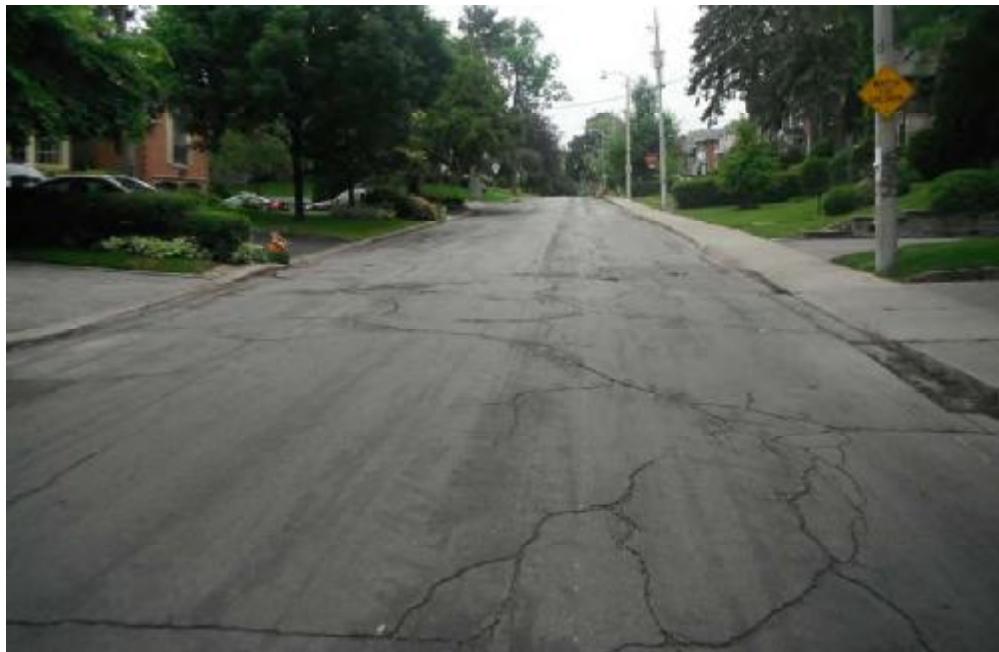
PHOTOGRAPH 34. Glengowan Road from Mount Pleasant Road to Strathgowan Crescent, urban cross section, looking west.

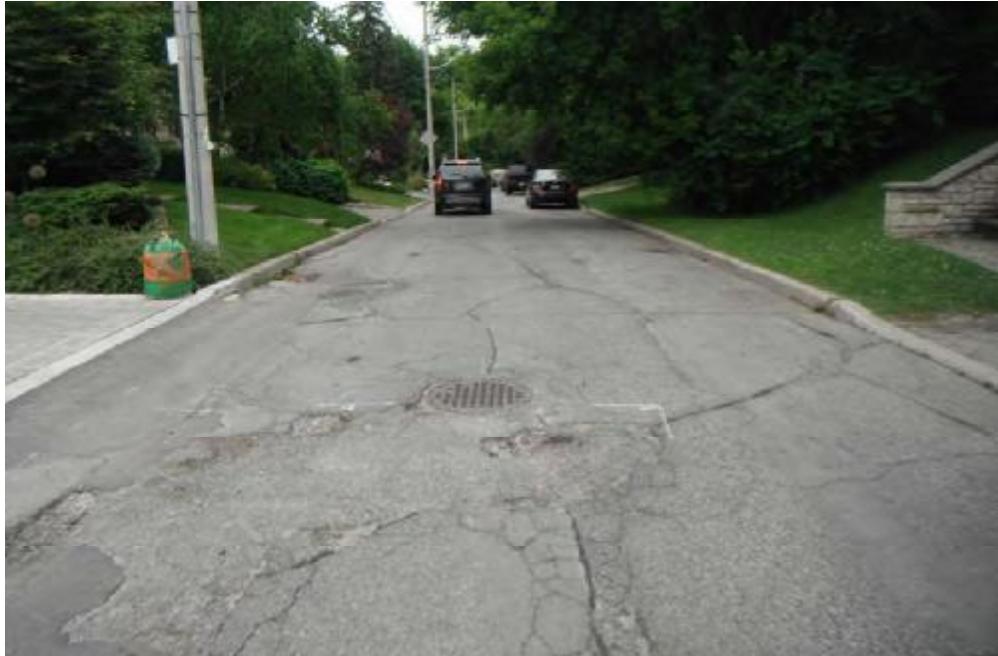
PHOTOGRAPH 35. Strathgowan Avenue from 280 m West of Strathgowan Crescent to Strathgowan Crescent, urban cross section, looking west.

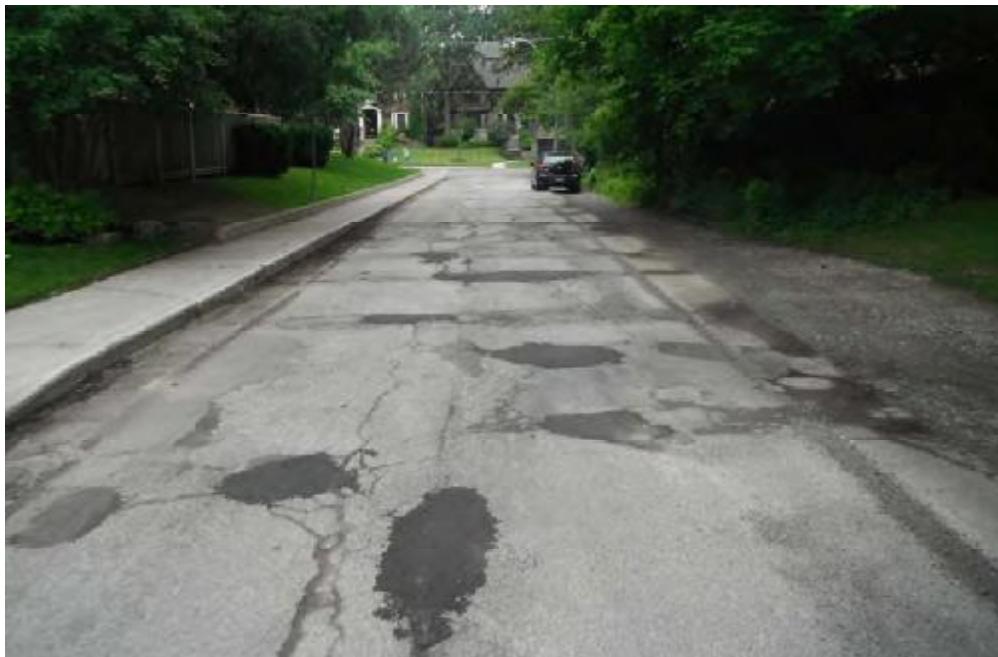
PHOTOGRAPH 36. Garland Avenue from Glengowan Road to Strathgowan Crescent, semi-urban cross section, looking north.

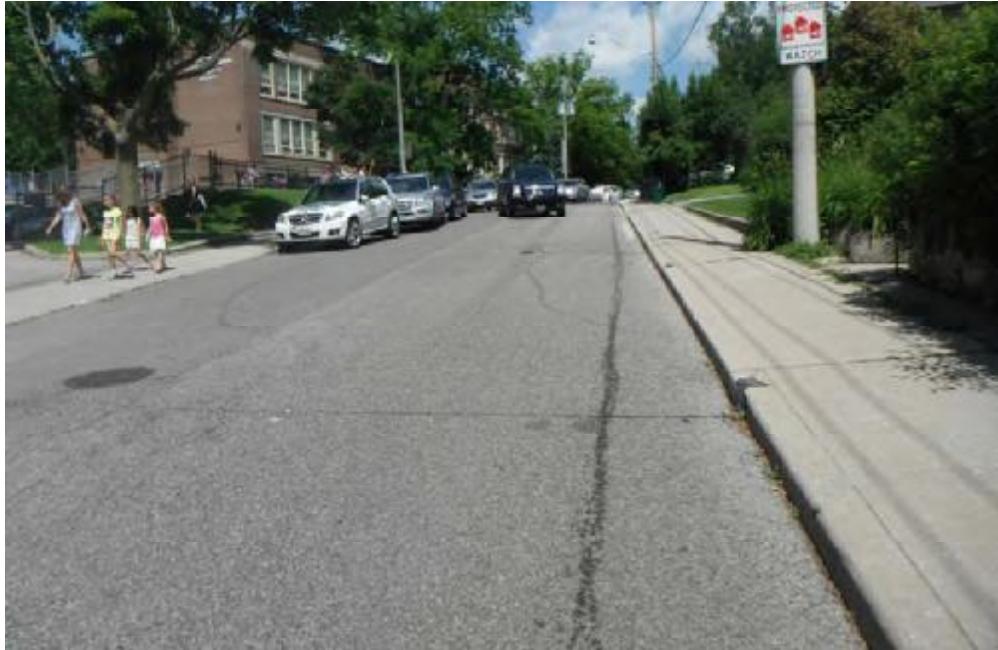
PHOTOGRAPH 37. Strathgowan Crescent, Section 1 from Blythwood Road to 128 Glengowan Road, urban cross section, looking north.

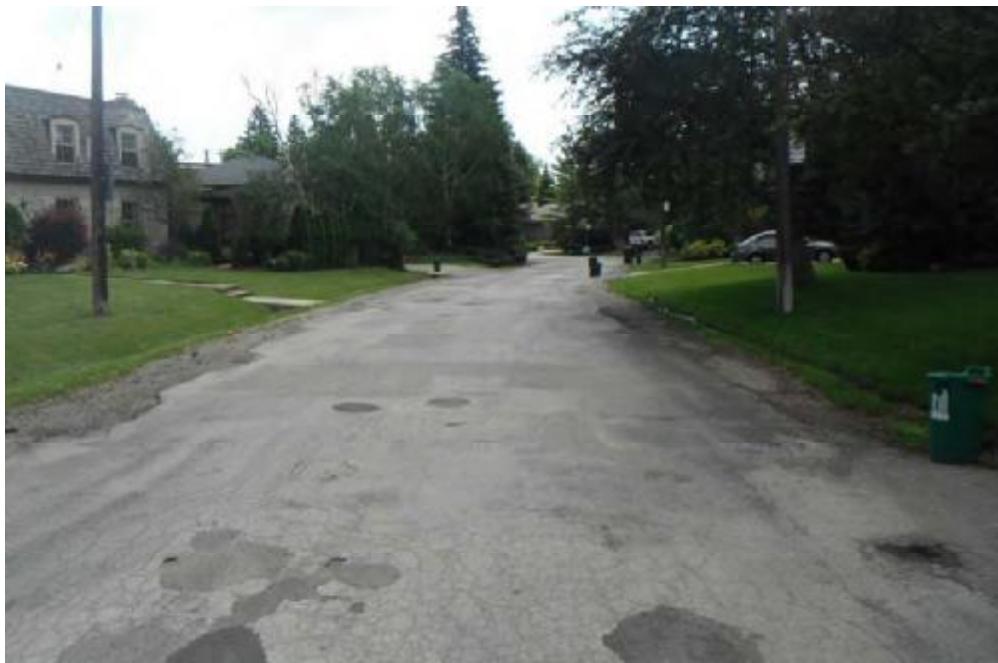
PHOTOGRAPH 38. Strathgowan Crescent, Section 2 from 128 Glengowan Road to Stratheden Road, rural cross section, looking north.

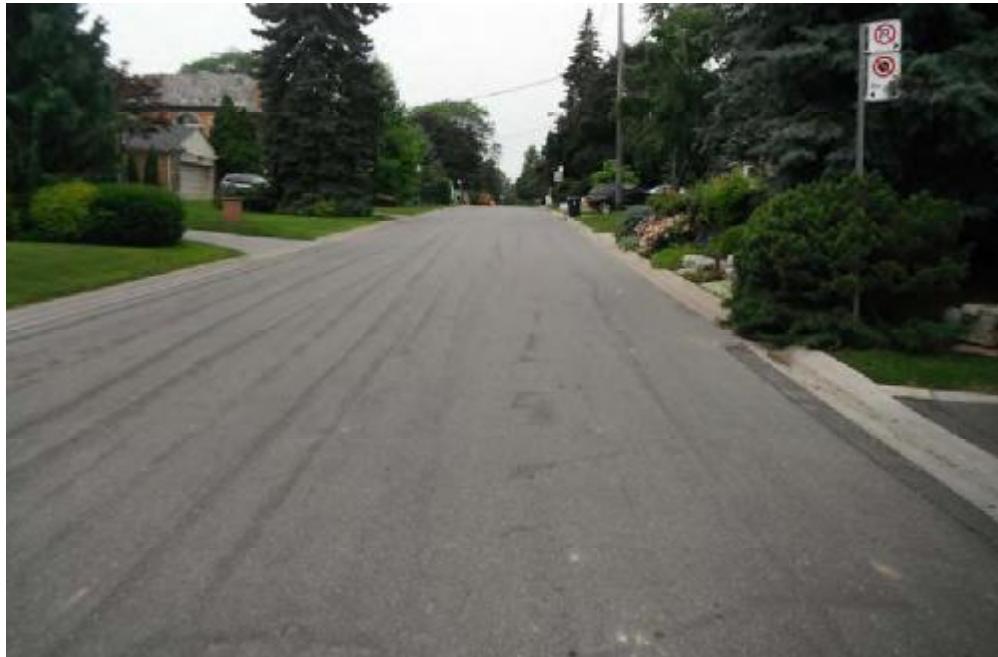
PHOTOGRAPH 39. Stratford Crescent, Section 1 from Mildenhall Road to 80 m east of Daneswood Road, urban cross section, looking west.

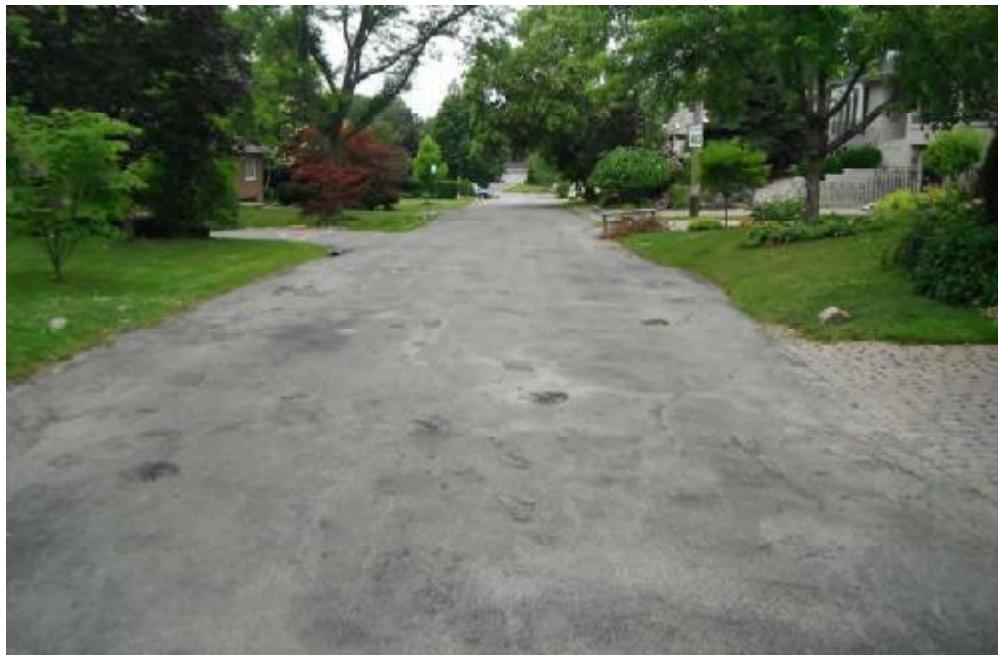
PHOTOGRAPH 40. Stratford Crescent, Section 2 from 101 Stratford Crescent to Mildenhall Road, rural cross section, looking west.

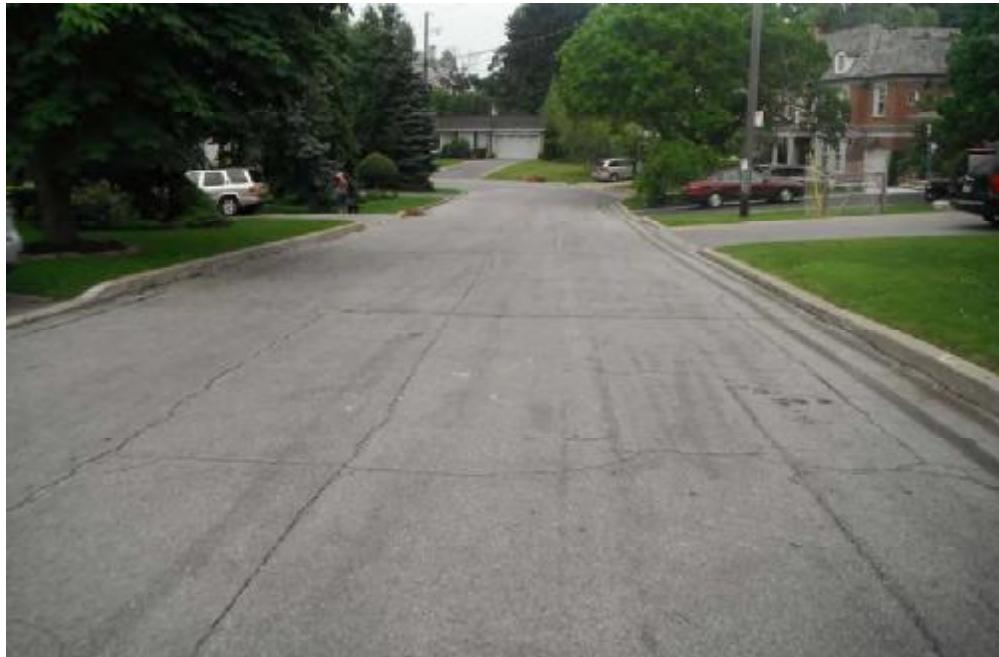
PHOTOGRAPH 41. Stratford Crescent, Section 3 from Blythwood Road to 101 Stratford Crescent, urban cross section, looking west.

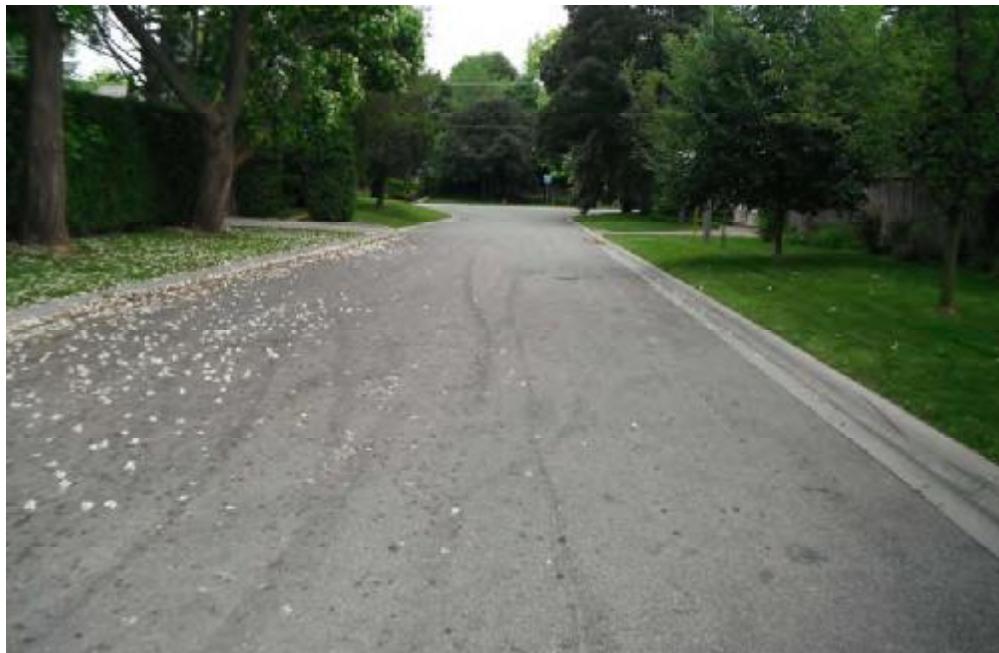
PHOTOGRAPH 42. Daneswood Road from Blythwood Road to Stratford Crescent, urban cross section, looking north.

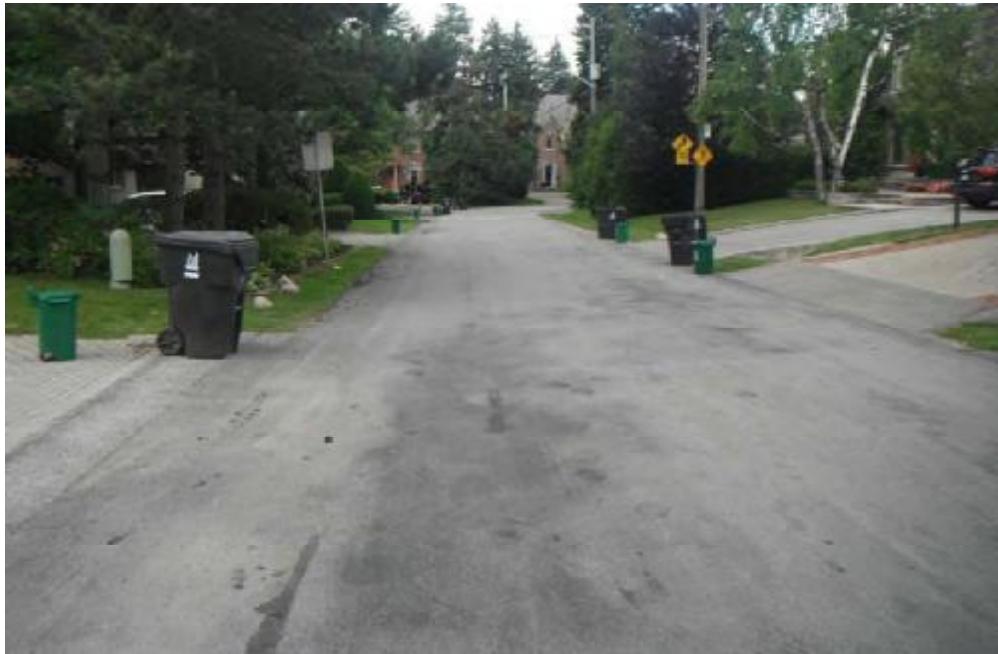
PHOTOGRAPH 43. Stratheden Road, Section 1 from Strathgowan Crescent to Mildenhall Road, rural cross section, looking west.

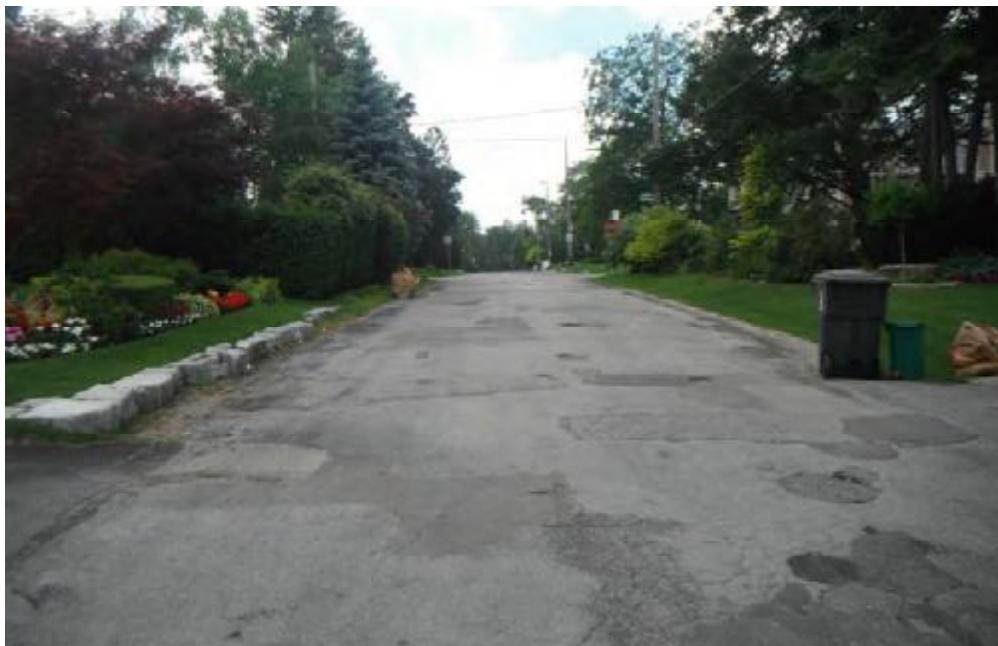
PHOTOGRAPH 44. Stratheden Road, Section 2 from Strathgowan Crescent to 35 Stratheden Road, rural cross section, looking west.

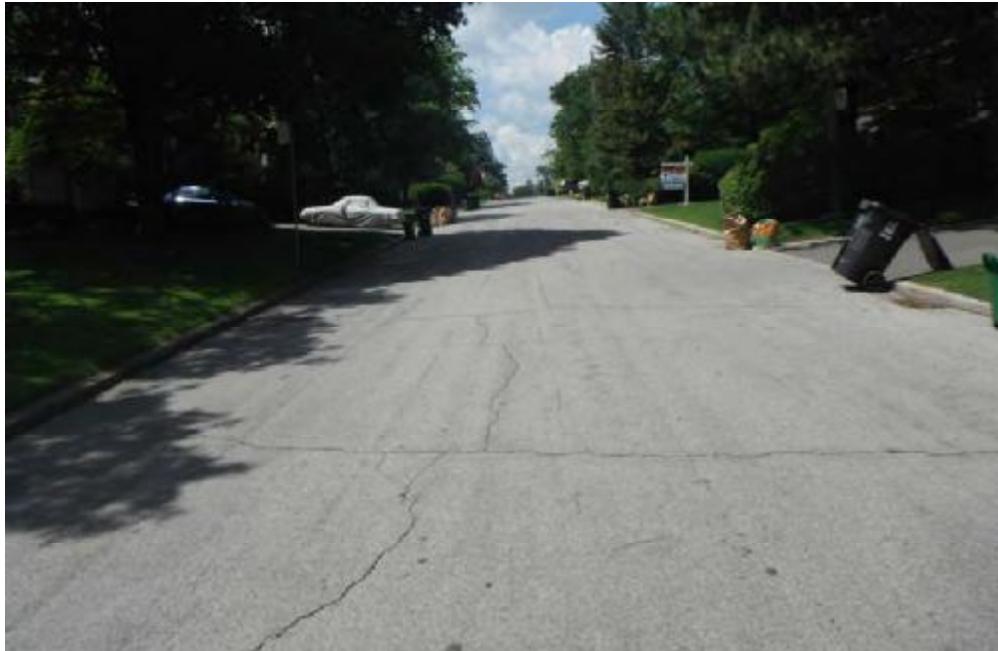
PHOTOGRAPH 45. Stratheden Road, Section 3 from 35 Stratheden Road to Daneswood Road, urban cross section, looking west.

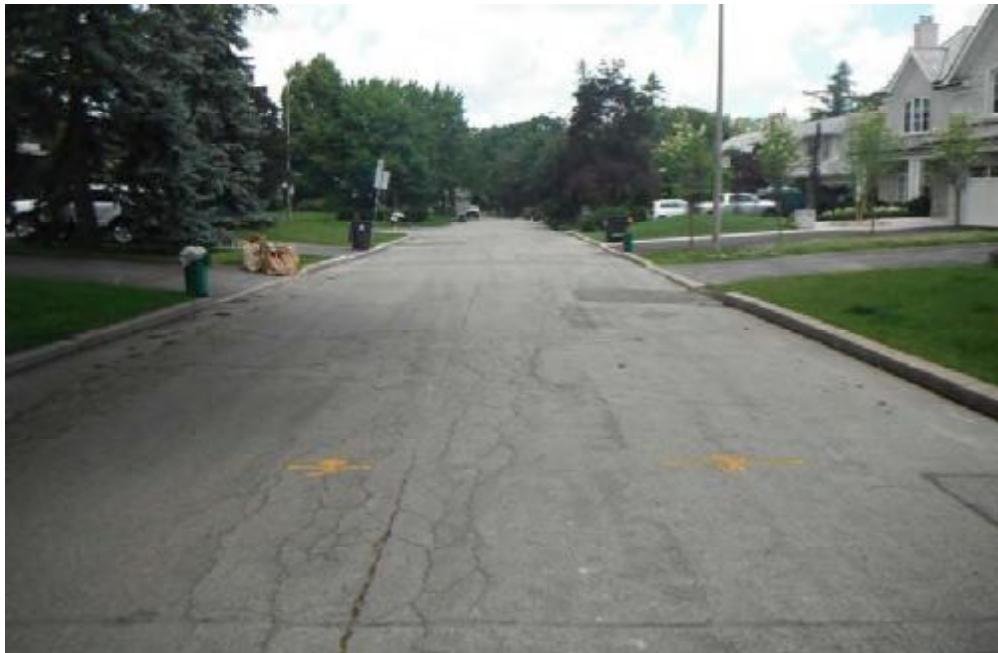
PHOTOGRAPH 46. Daneswood Road from Stratheden Road to Dawlish Avenue, urban cross section, looking north.

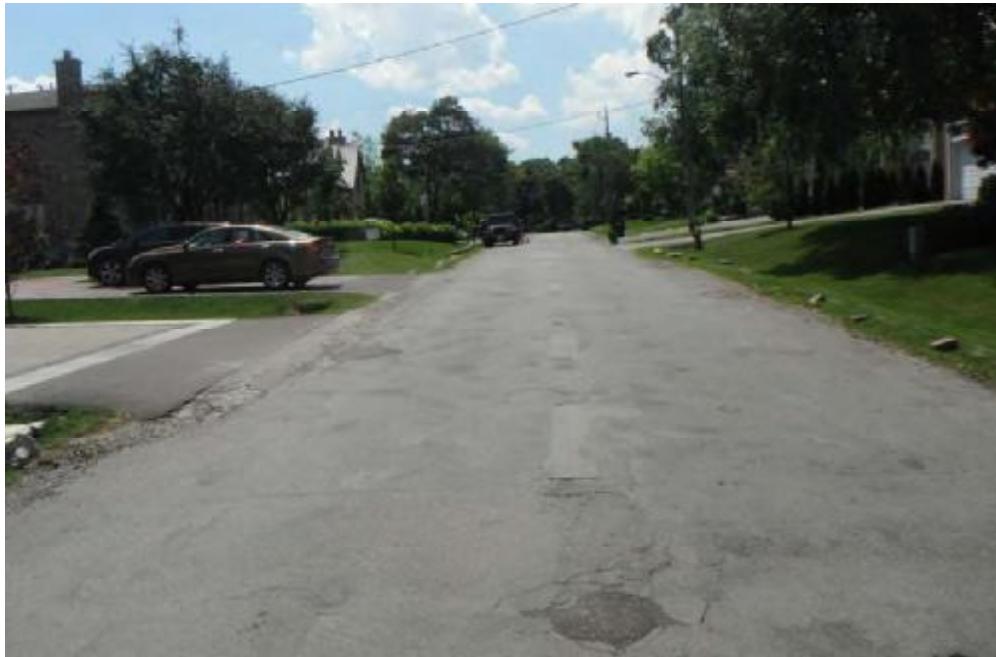
PHOTOGRAPH 47. Glenallan Road, Section 1 from Strathgowan Crescent to Mildenhall Road, rural cross section, looking north.

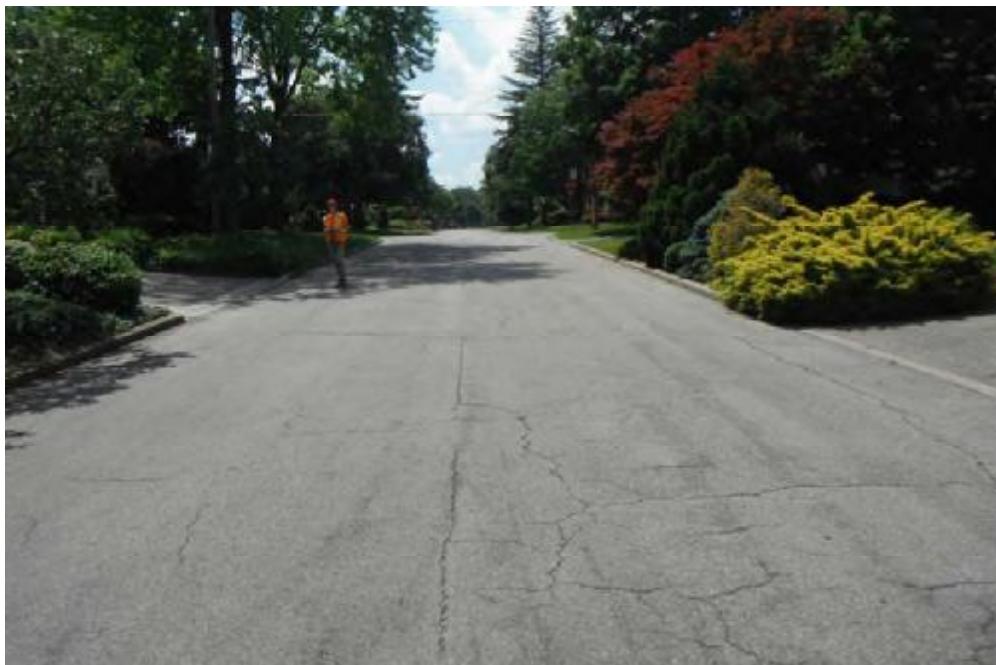
PHOTOGRAPH 48. Glenallan Road, Section 2 from Mildenhall Road to Daneswood Road, urban cross section, looking north.

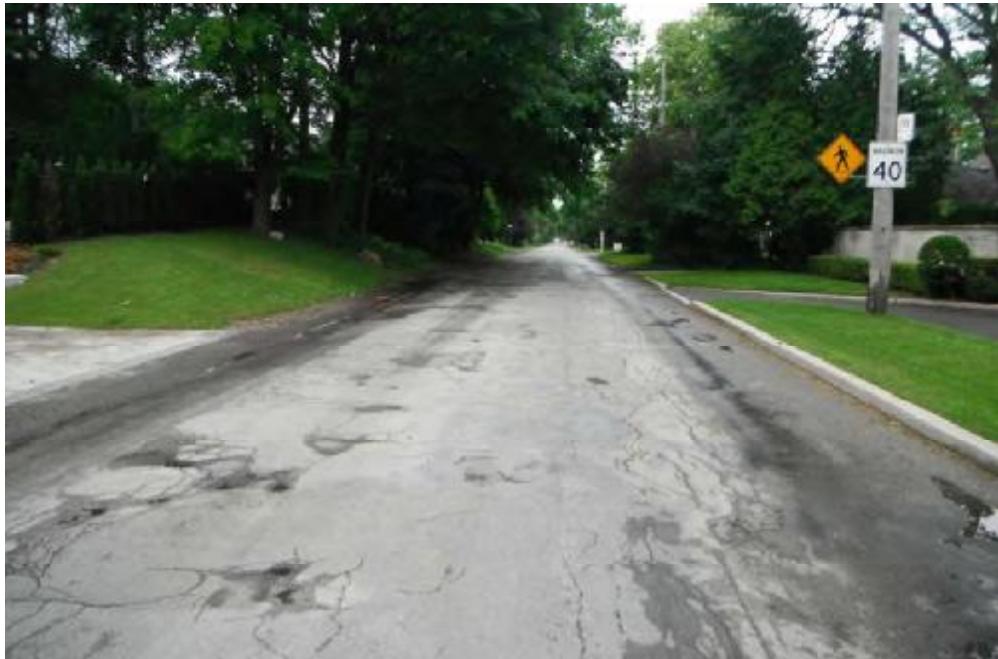
PHOTOGRAPH 49. Mildenhall Road from Blythwood Road to Lawrence Avenue East, rural cross section, looking north.

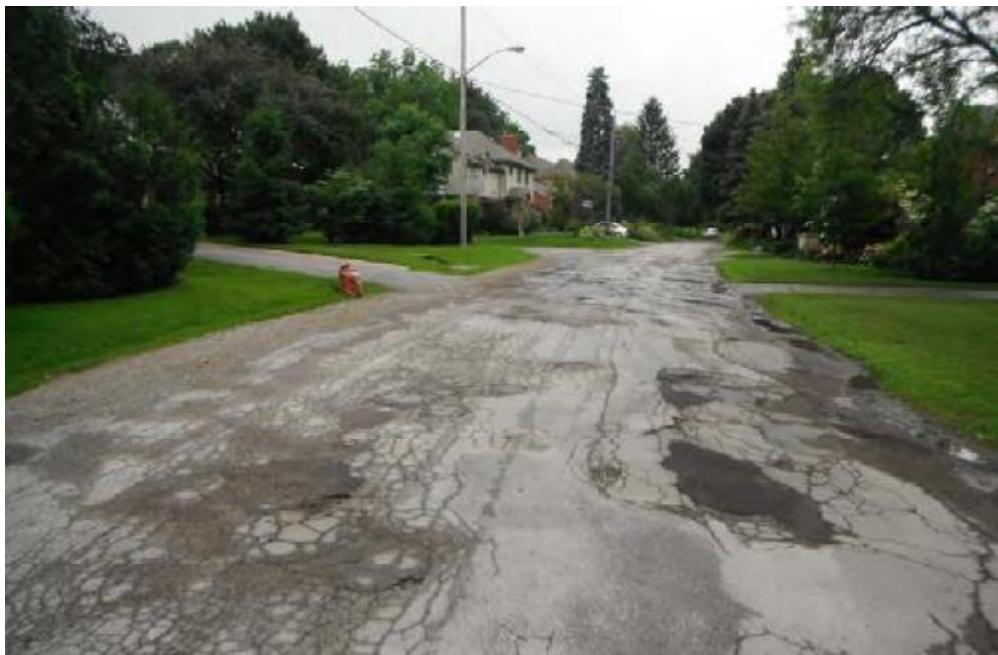
PHOTOGRAPH 50. Mildenhall Road from Lawrence Avenue East to Braeside Road, rural cross section, looking west.

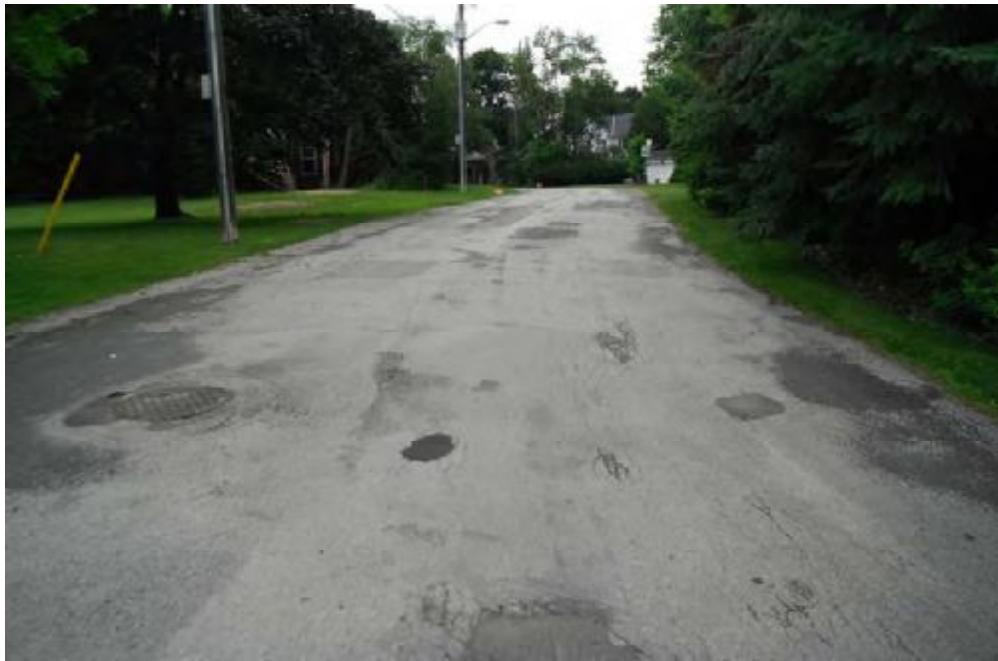
PHOTOGRAPH 51. Bayview Wood from Mildenhall Road to St. Aubyns Crescent, rural cross section, looking north.

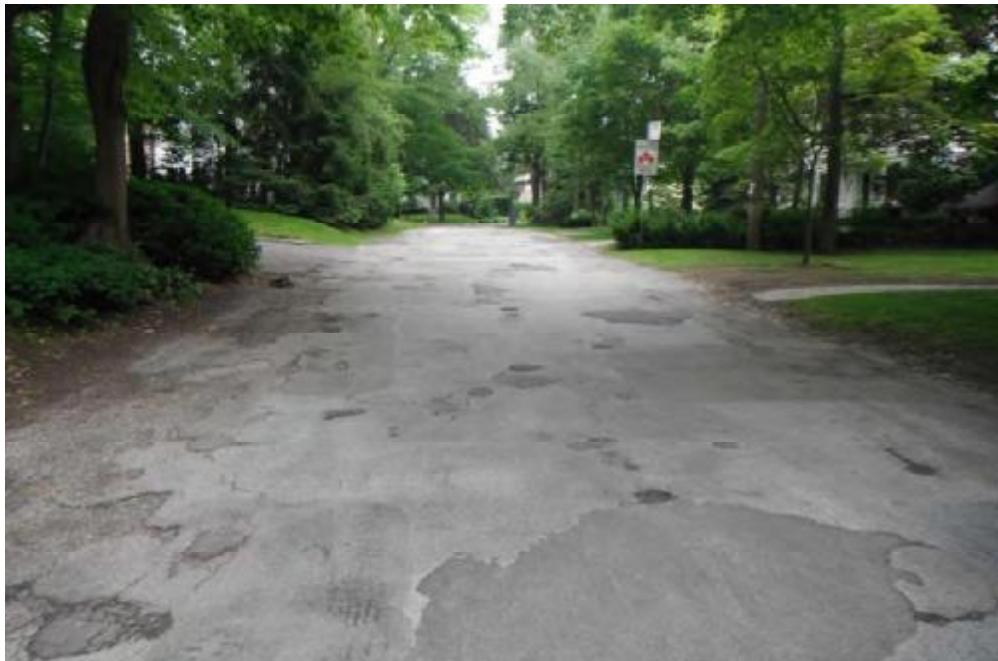
PHOTOGRAPH 52. Wood Avenue from St. Aubyns Crescent to Bayview Avenue, rural cross section, looking west.

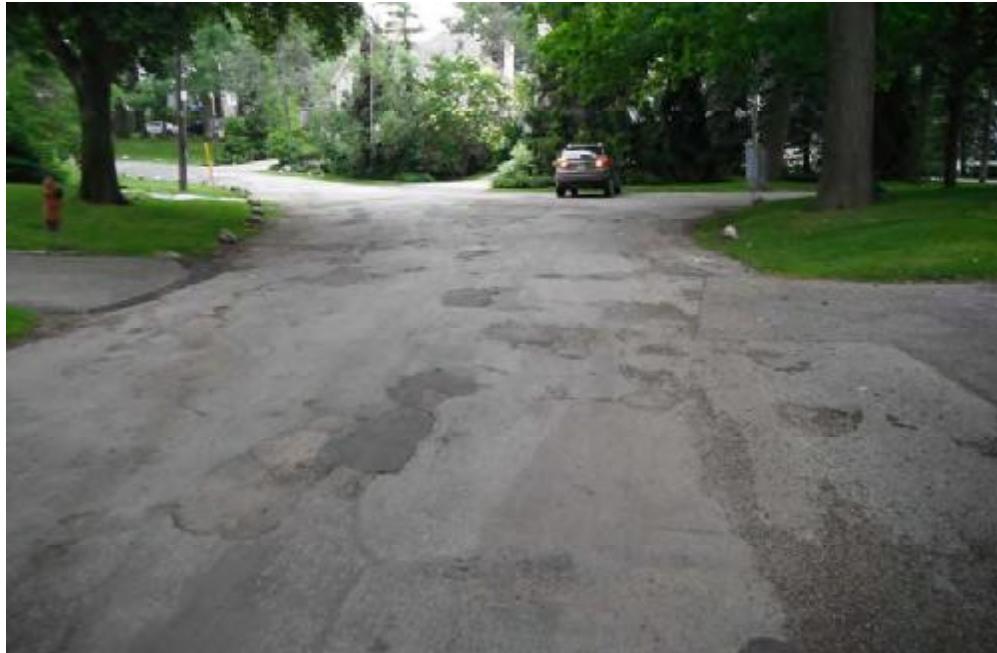
PHOTOGRAPH 53. St. Aubyns Crescent from Bayview Wood to Lewes Crescent, rural cross section, looking north.

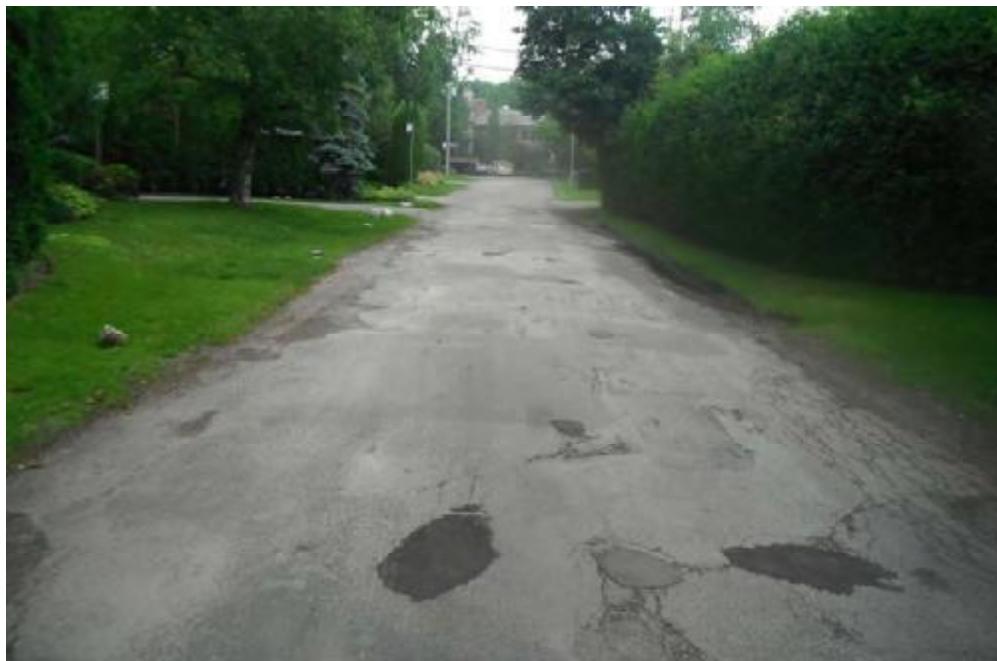
PHOTOGRAPH 54. Lewes Crescent from St. Leonards Avenue to St. Leonards Avenue, rural cross section, looking north.

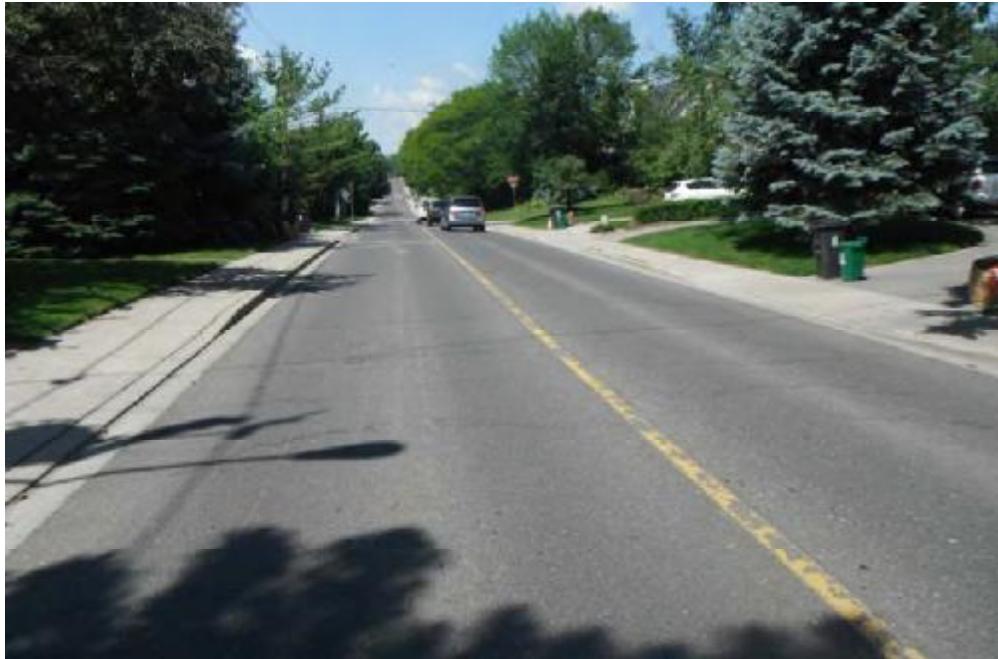
PHOTOGRAPH 55. Blythwood Road from Blyth Hill Road to Bayview Avenue, urban cross section, looking west.

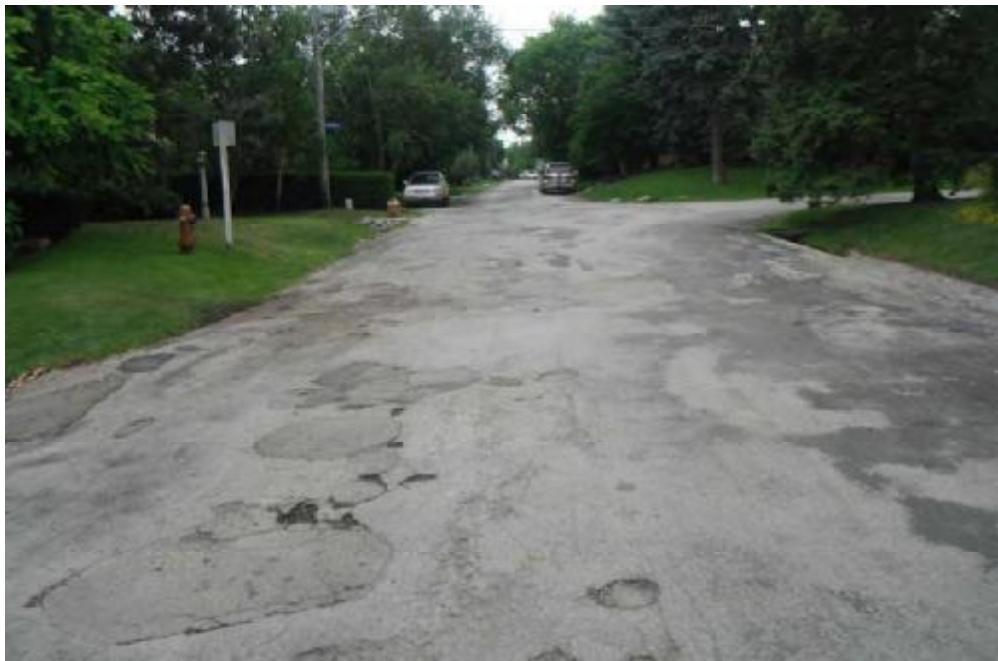
PHOTOGRAPH 56. Blyth Hill Road from Blythwood Road to end of Blyth Hill Road, rural cross section, looking west.

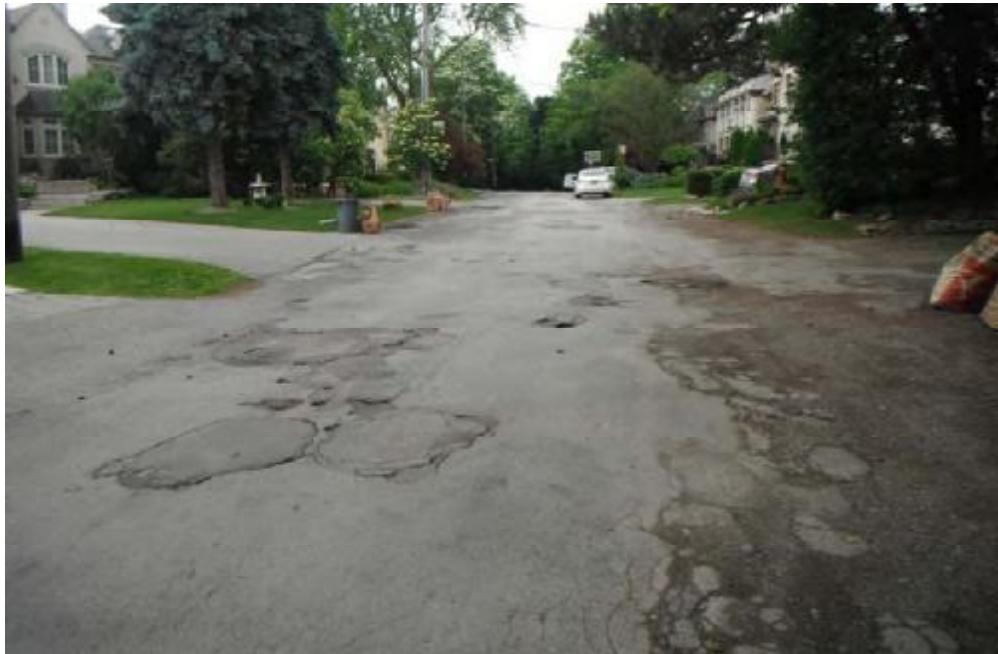
PHOTOGRAPH 57. Blyth Dale Road from Blythwood Road to Blyth Hill Road, rural cross section, looking north.

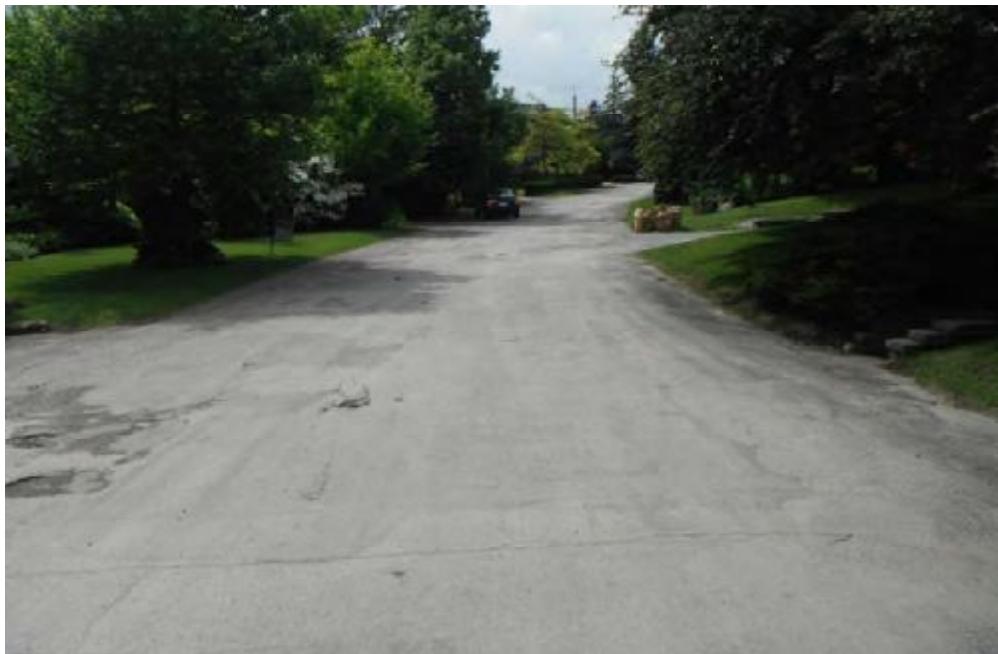
PHOTOGRAPH 58. Ridgefield Road from Blythwood Road to end of Ridgefield Road, rural cross section, looking north.

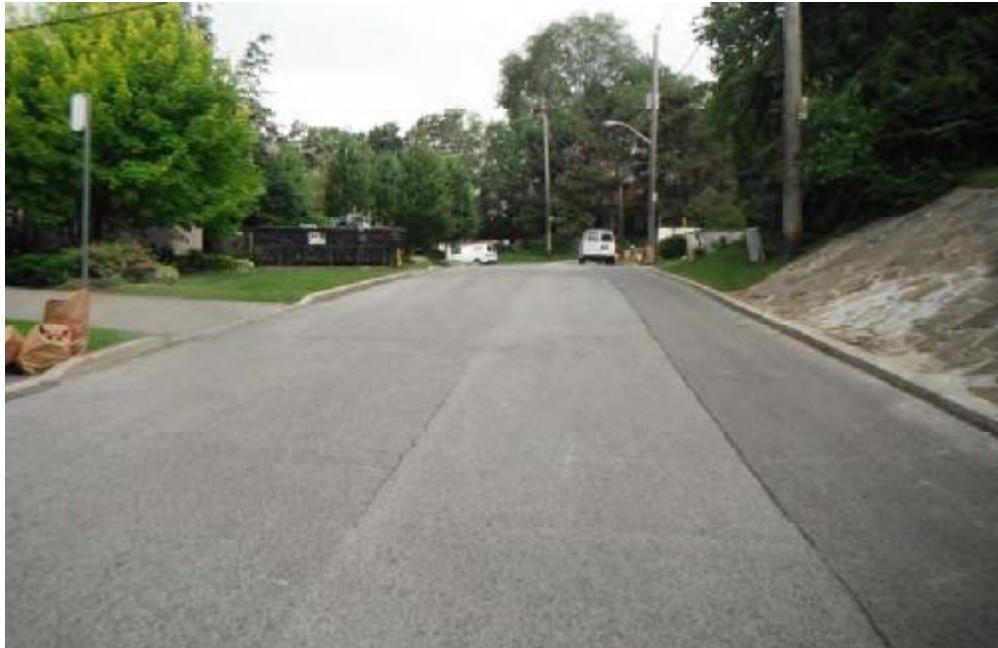
PHOTOGRAPH 59. Sunnydene Crescent from Bayview Avenue to Bayview Avenue, urban cross section, looking west.

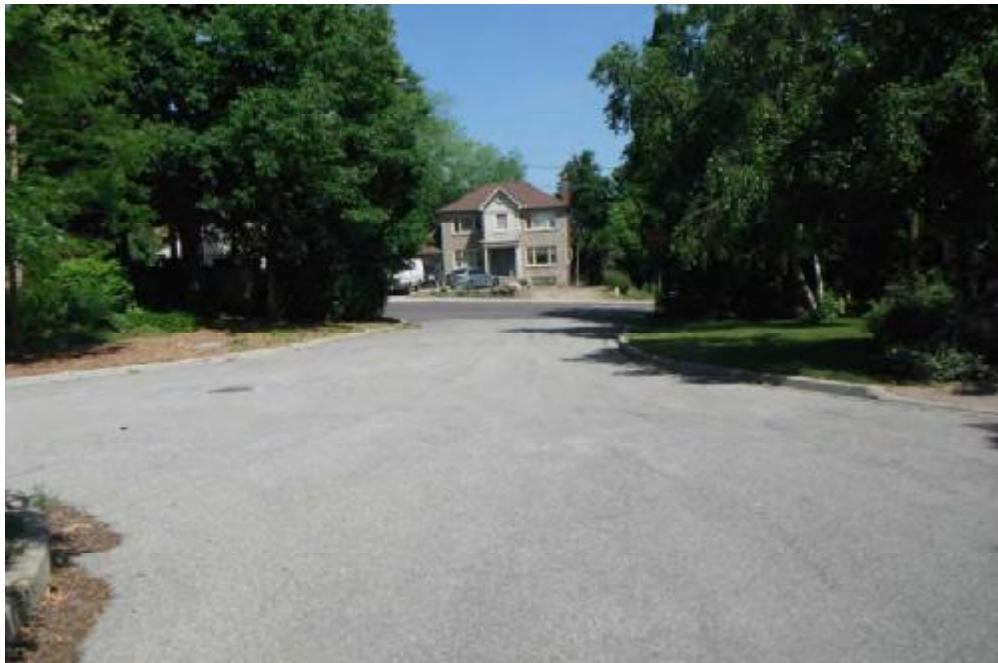
PHOTOGRAPH 60. Lauren Court from Blythwood Road to end of Lauren Court, urban cross section, looking north.

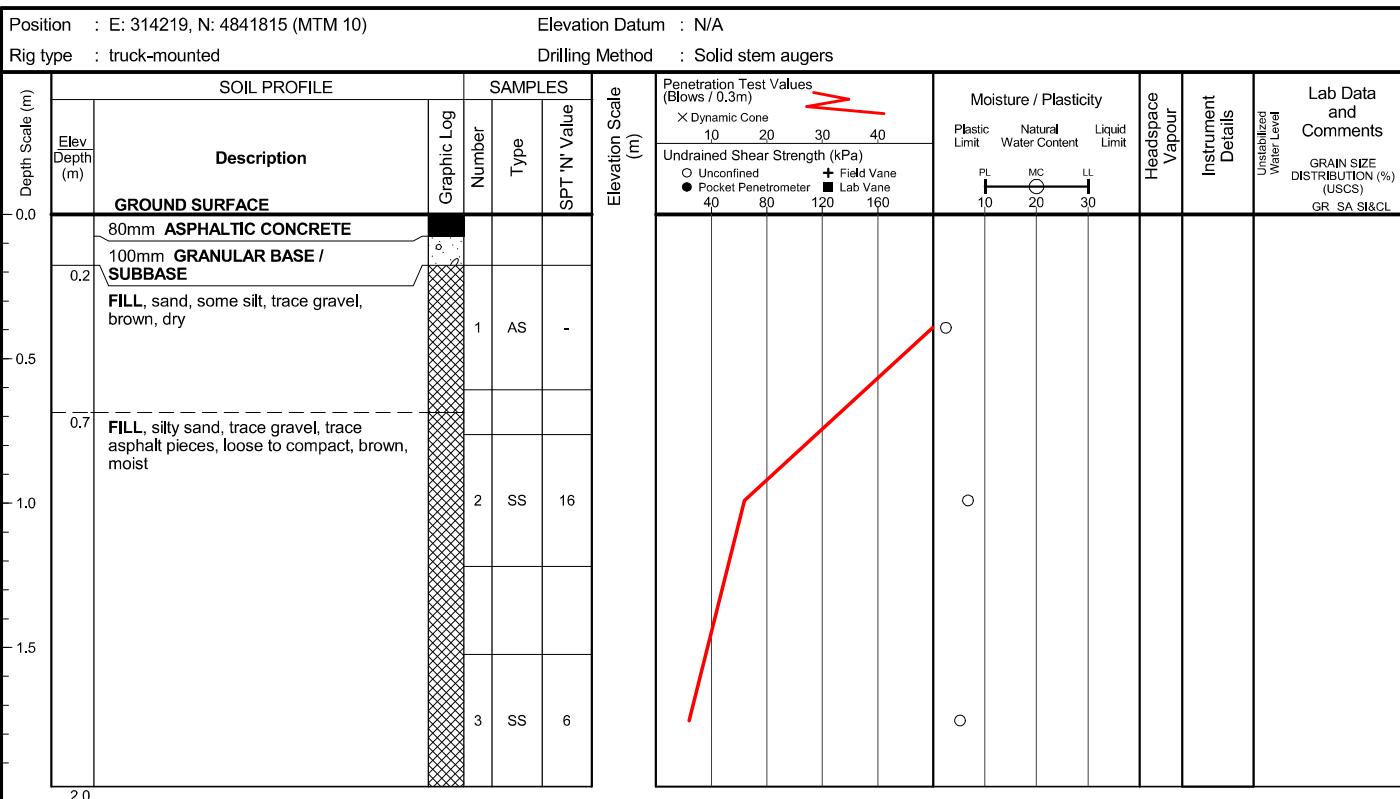
**END OF BOREHOLE**

Borehole was dry and open upon completion of drilling.

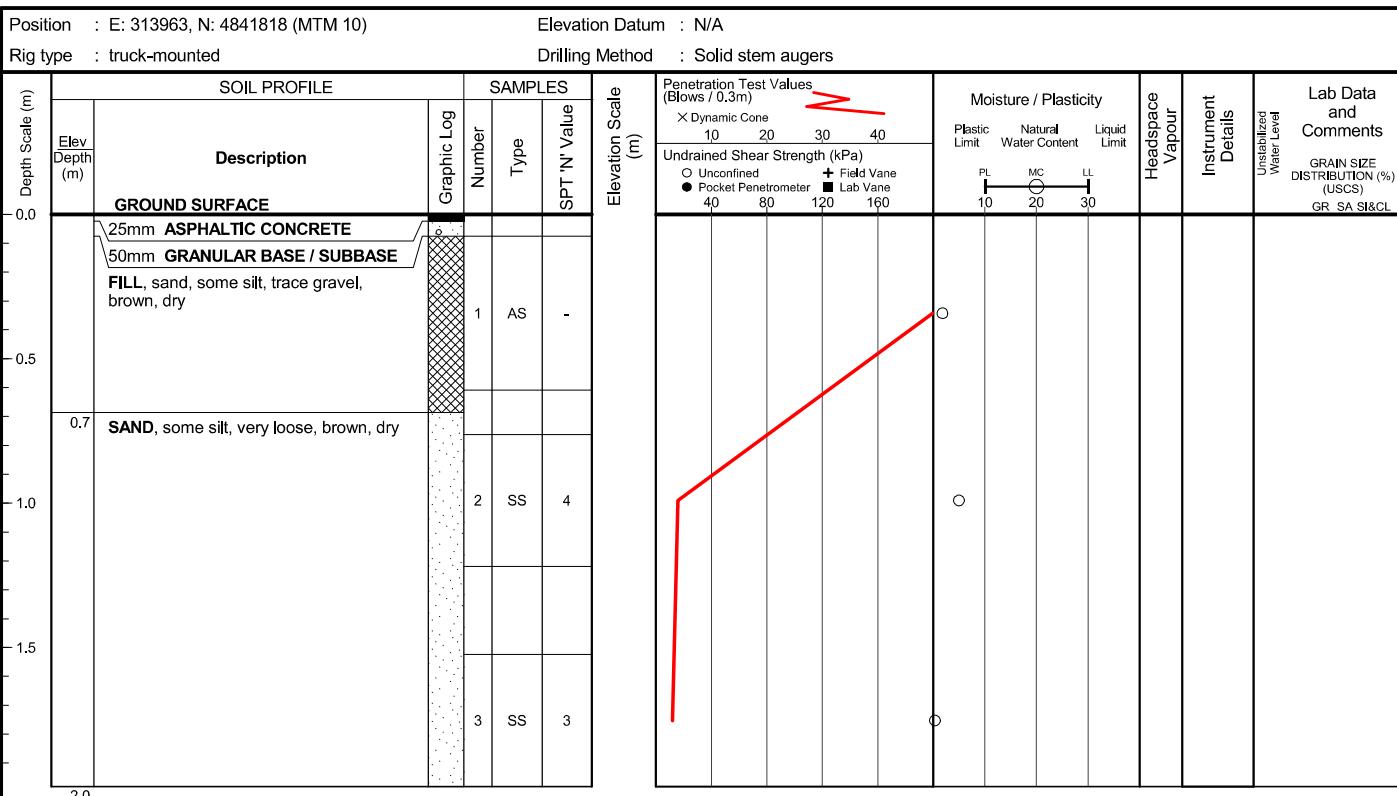
**END OF BOREHOLE**

Borehole was dry and open upon completion of drilling.
