Appendix F-1 – Preliminary Pavement Evaluation Report

**PRELIMINARY PAVEMENT EVALUATION REPORT
MUNICIPAL CLASS EA STUDY FOR
LAWRENCE PARK NEIGHBOURHOOD
CITY OF TORONTO, ONTARIO**

File No. 11-12-2126

December 06, 2013

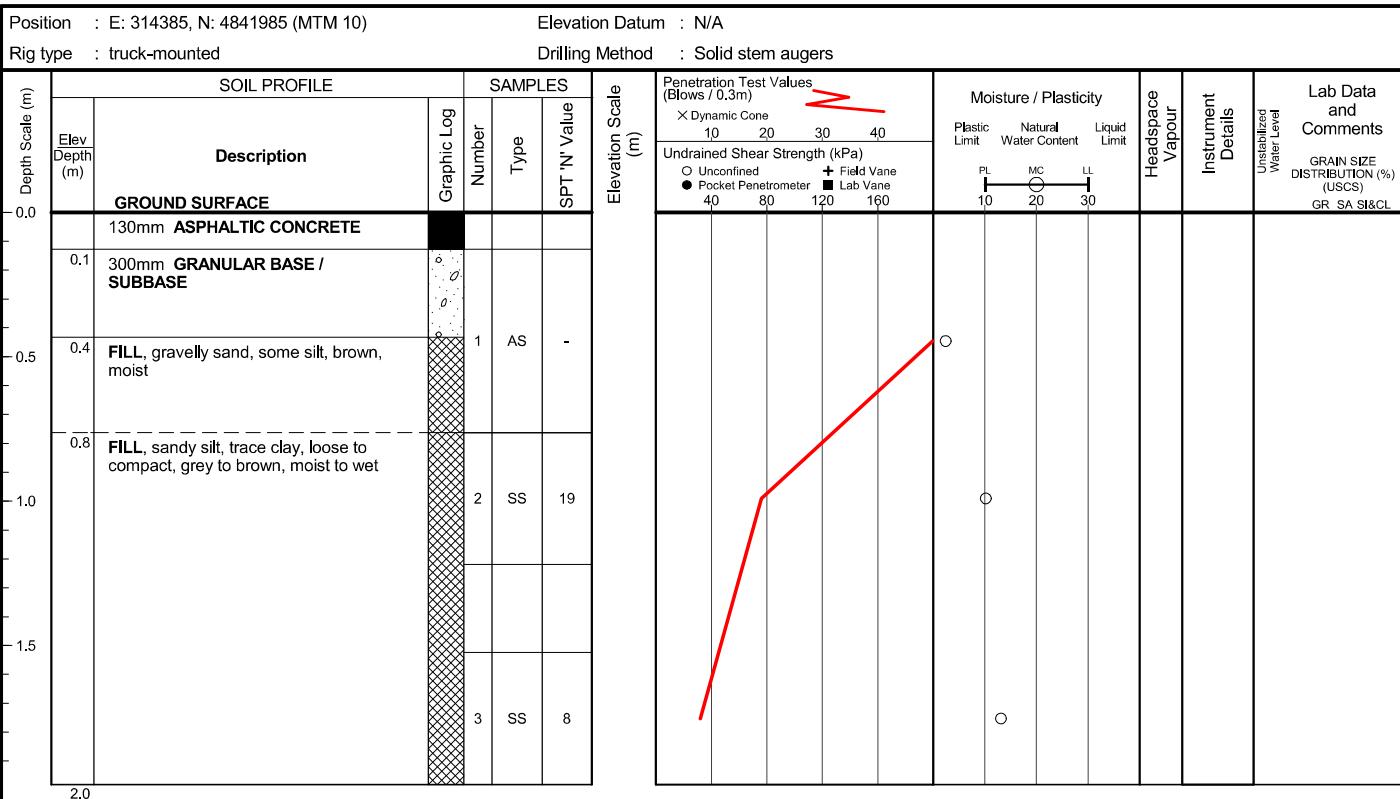
**END OF BOREHOLE**

Borehole was dry and open upon completion of drilling.

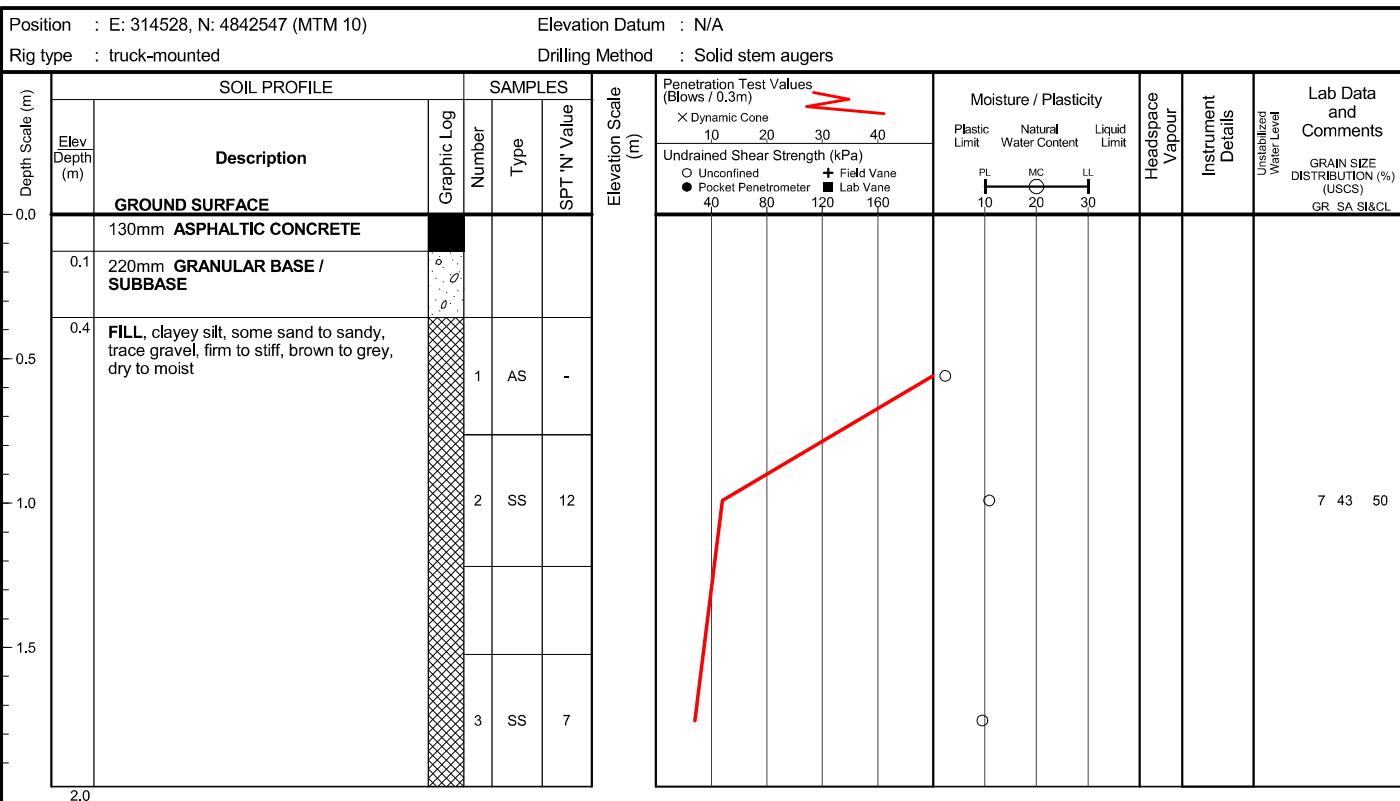
**END OF BOREHOLE**

Borehole was dry and open upon completion of drilling.

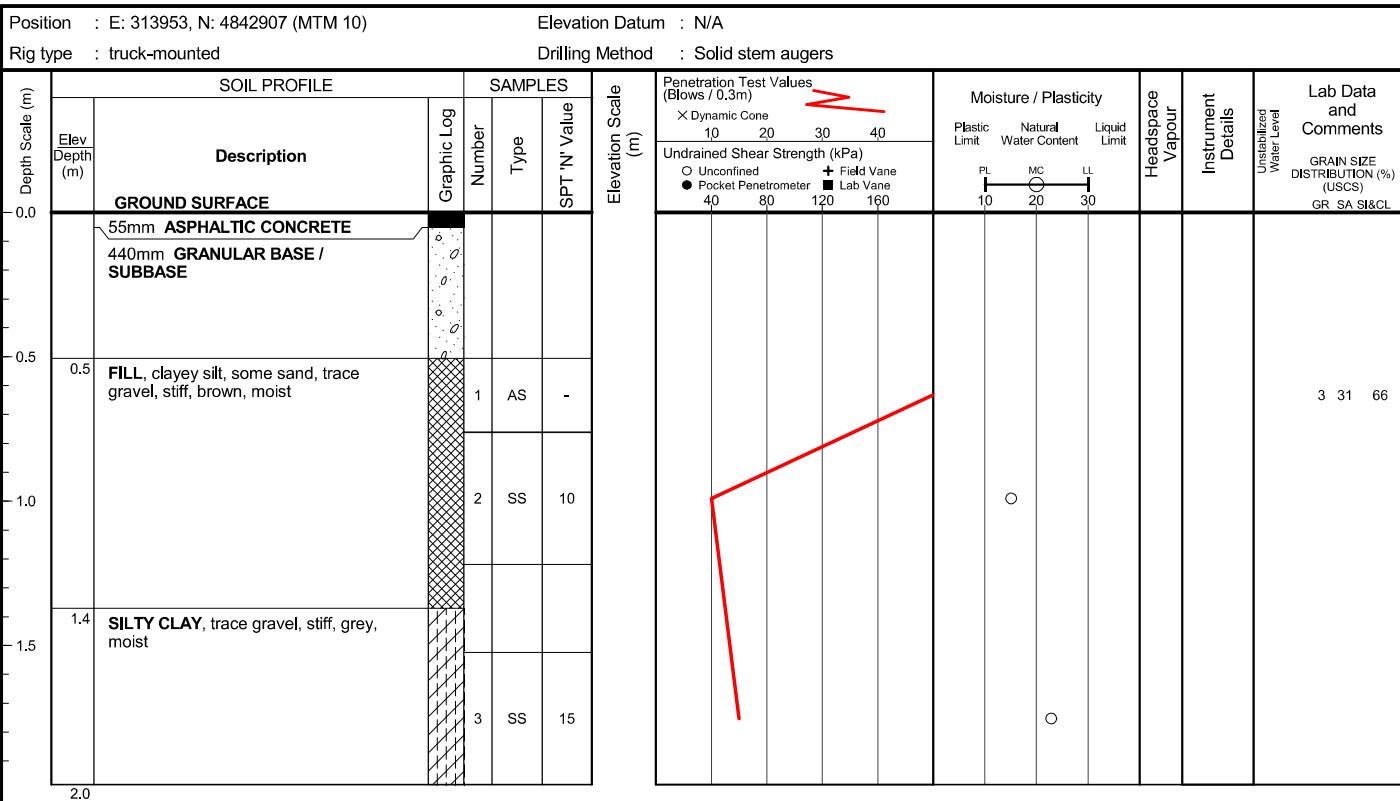
Borehole was dry and open upon completion of drilling.

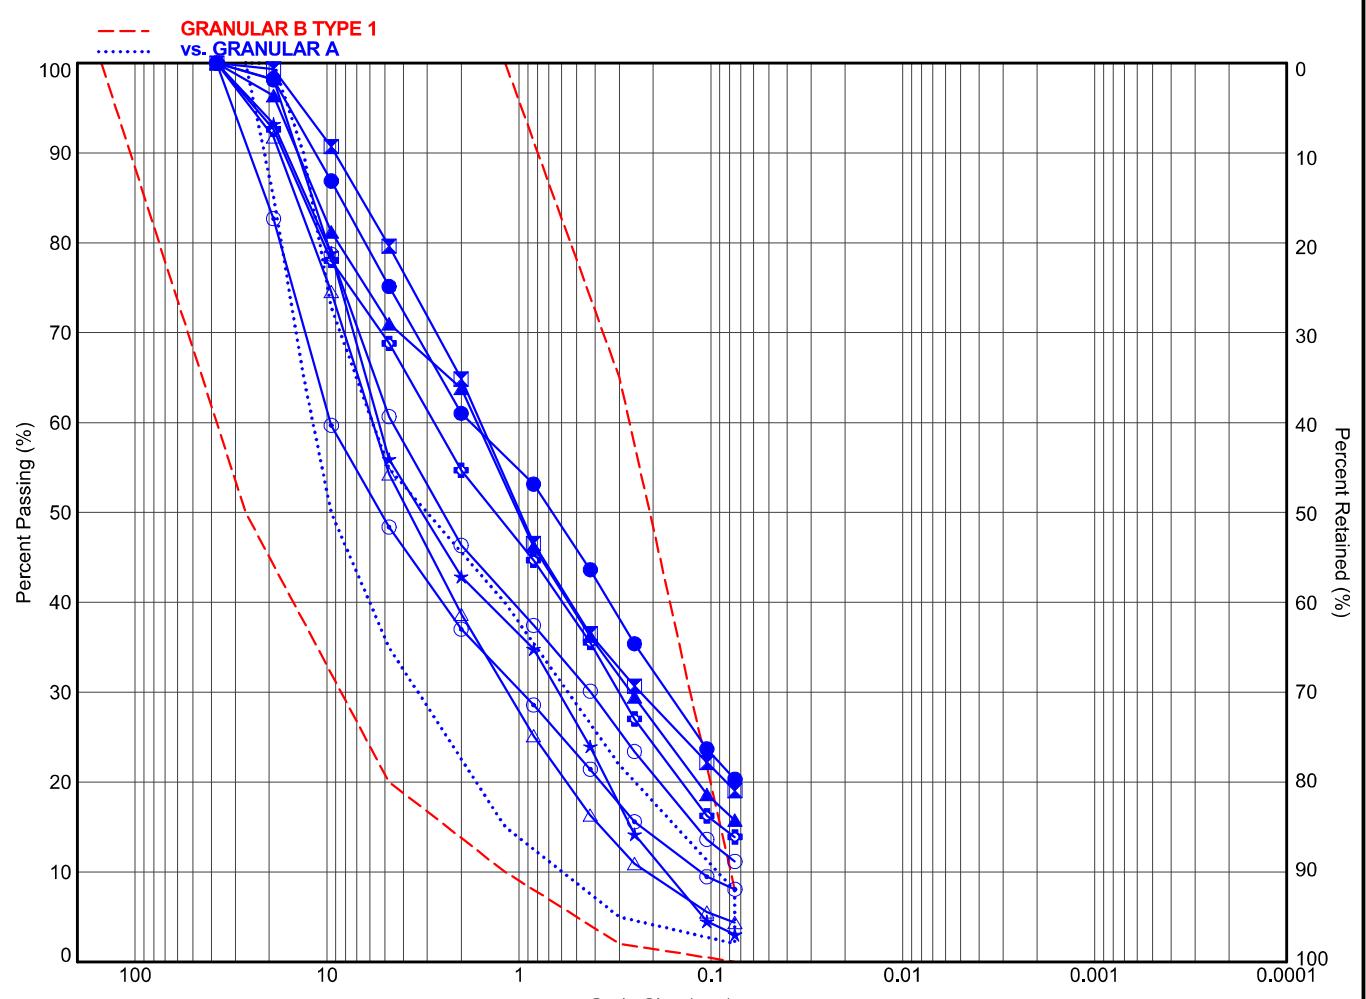
| UNIFIED SOIL CLASSIFICATION SYSTEM | | | | | | |
| Hole ID | Sample | Depth (m) | Elev. (m) | Gravel (%) | Sand (%) | Silt & Clay (%) |
| △ S27 & S28 | | | | 46 | 50 | 4 |

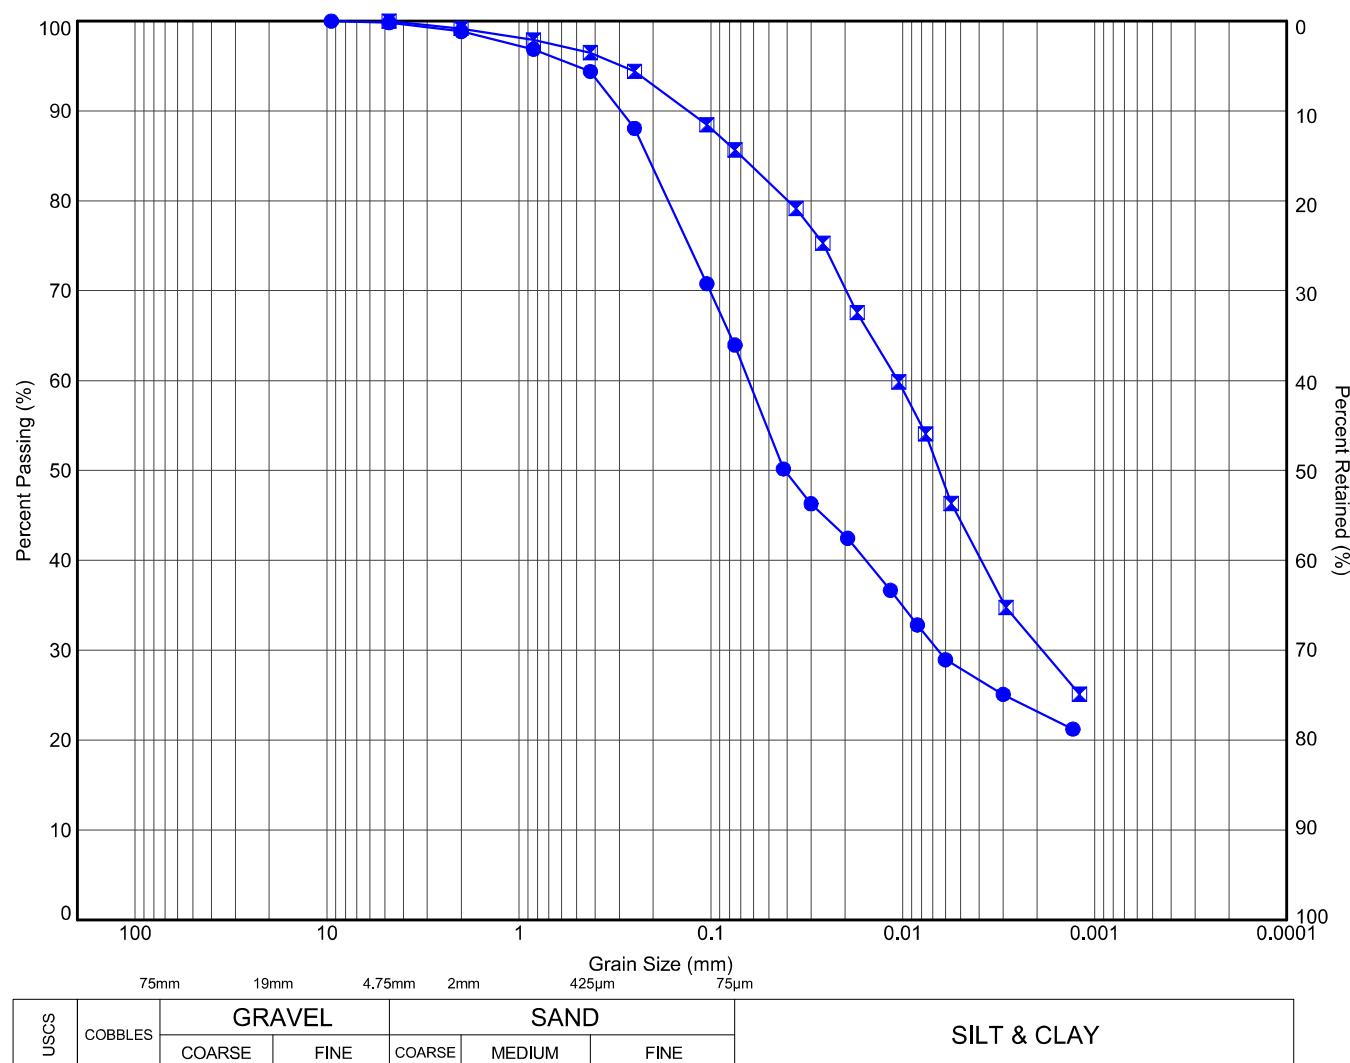
| UNIFIED SOIL CLASSIFICATION SYSTEM | | | | | | | |
| Hole ID | Sample | Depth (m) | Elev. (m) | Gravel (%) | Sand (%) | Silt & Clay (%) | Sample Description |
| ● 33 | AS1 | 0.5 | | 0 | 36 | 64 | |
| ■ 39 | AS1 | 0.5 | | 0 | 14 | 86 | |

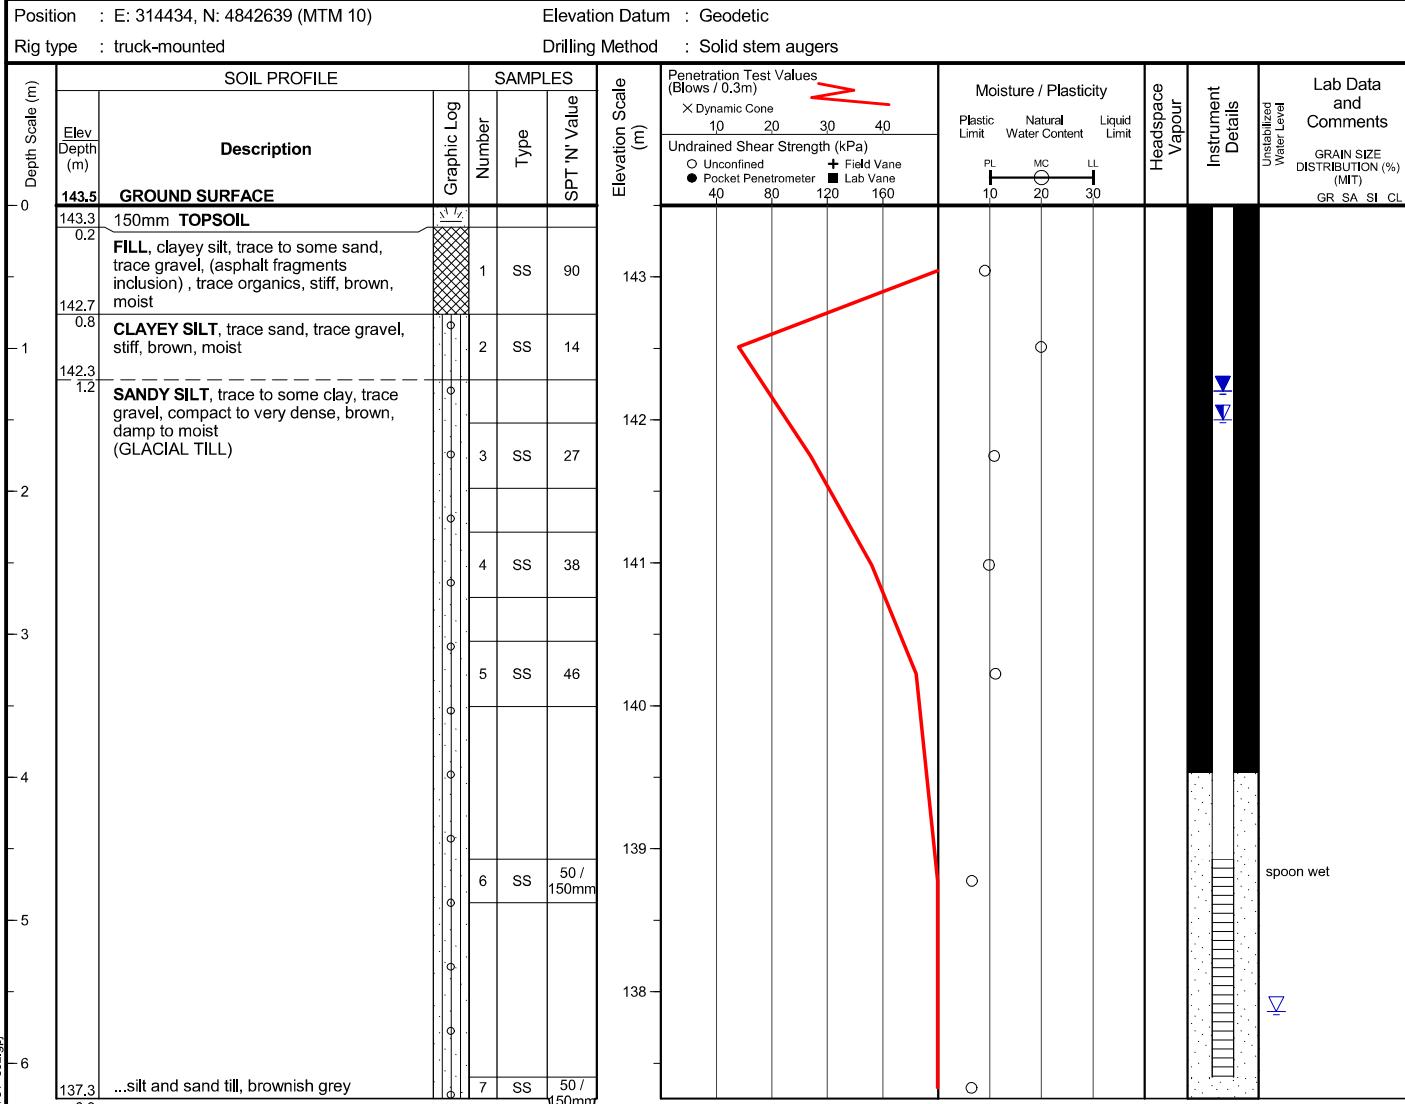
Rig type : truck-mounted

Drilling Method : Solid stem augers

END OF BOREHOLE

Unstabilized water level measured at 5.6 m below ground surface; borehole was open upon completion of drilling.

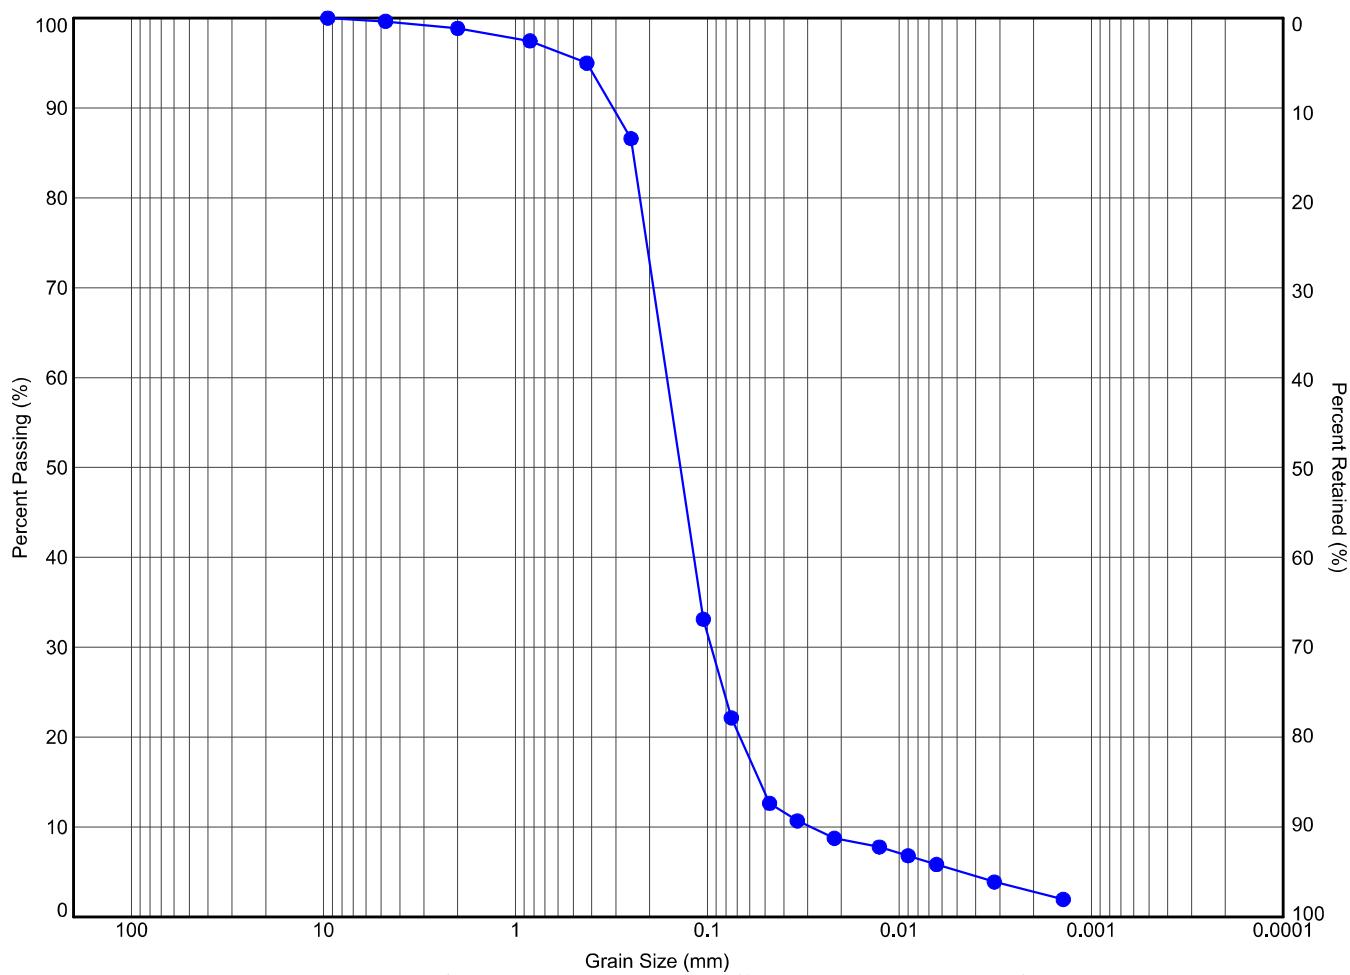
SIEVE AND HYDROMETER ANALYSIS

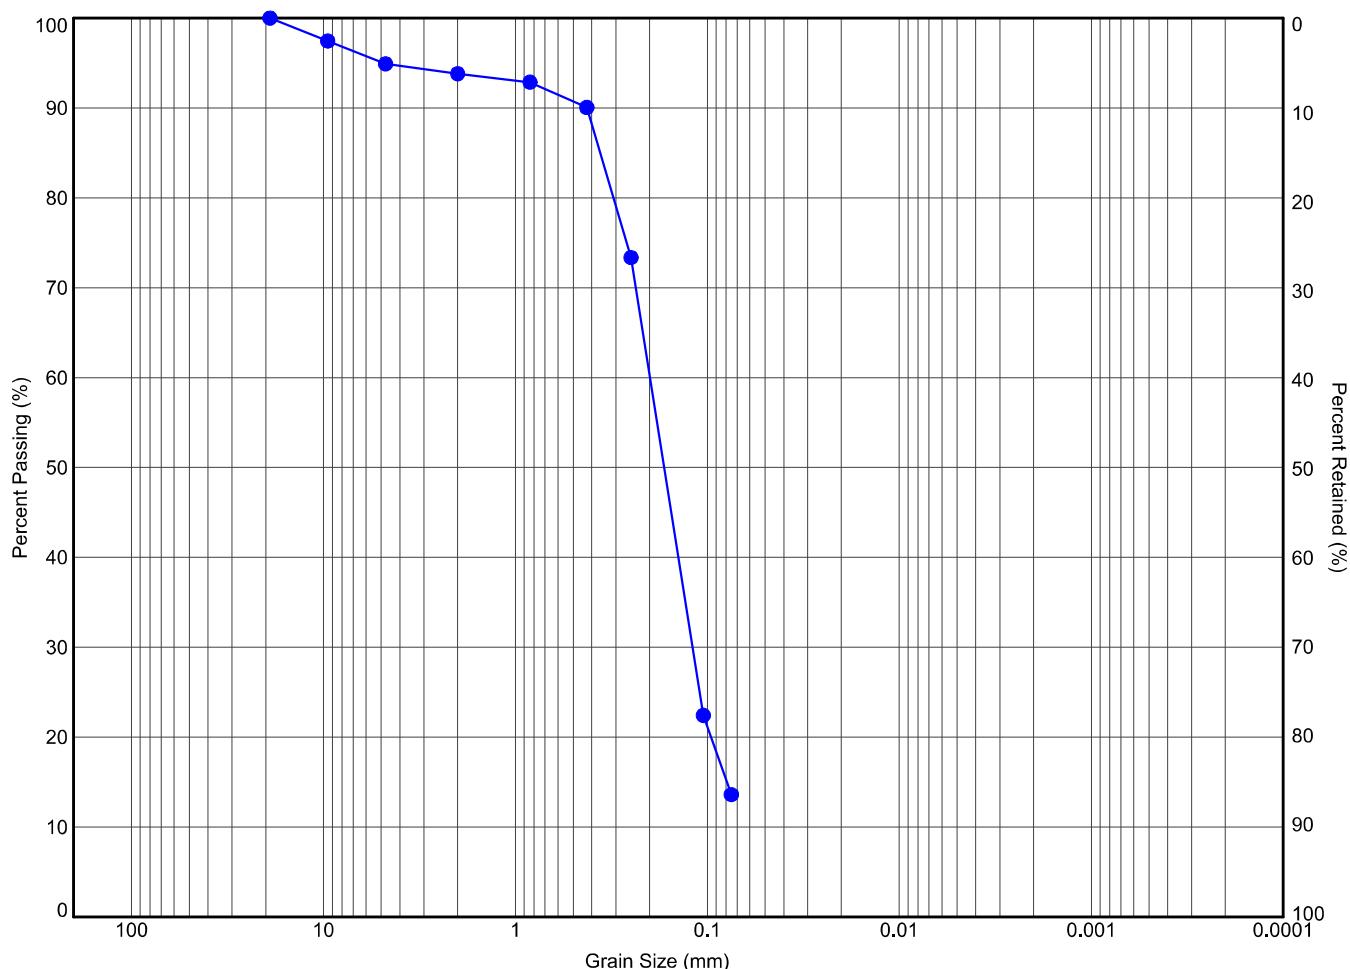
| MIT SYSTEM | | | | | | | |
|---|---|---|---|---|---|---|---|
| ● S3 | SS7 | 6.3 | 150.5 | 6 | 80 | | (14) |

| Terraprobe 11 Indell Lane, Brampton Ontario L6T 3Y3 (905) 796-2650 | Title: GRAIN SIZE DISTRIBUTION SAND, SOME SILT, TRACE GRAVEL | File No.: | 11-12-2126 |

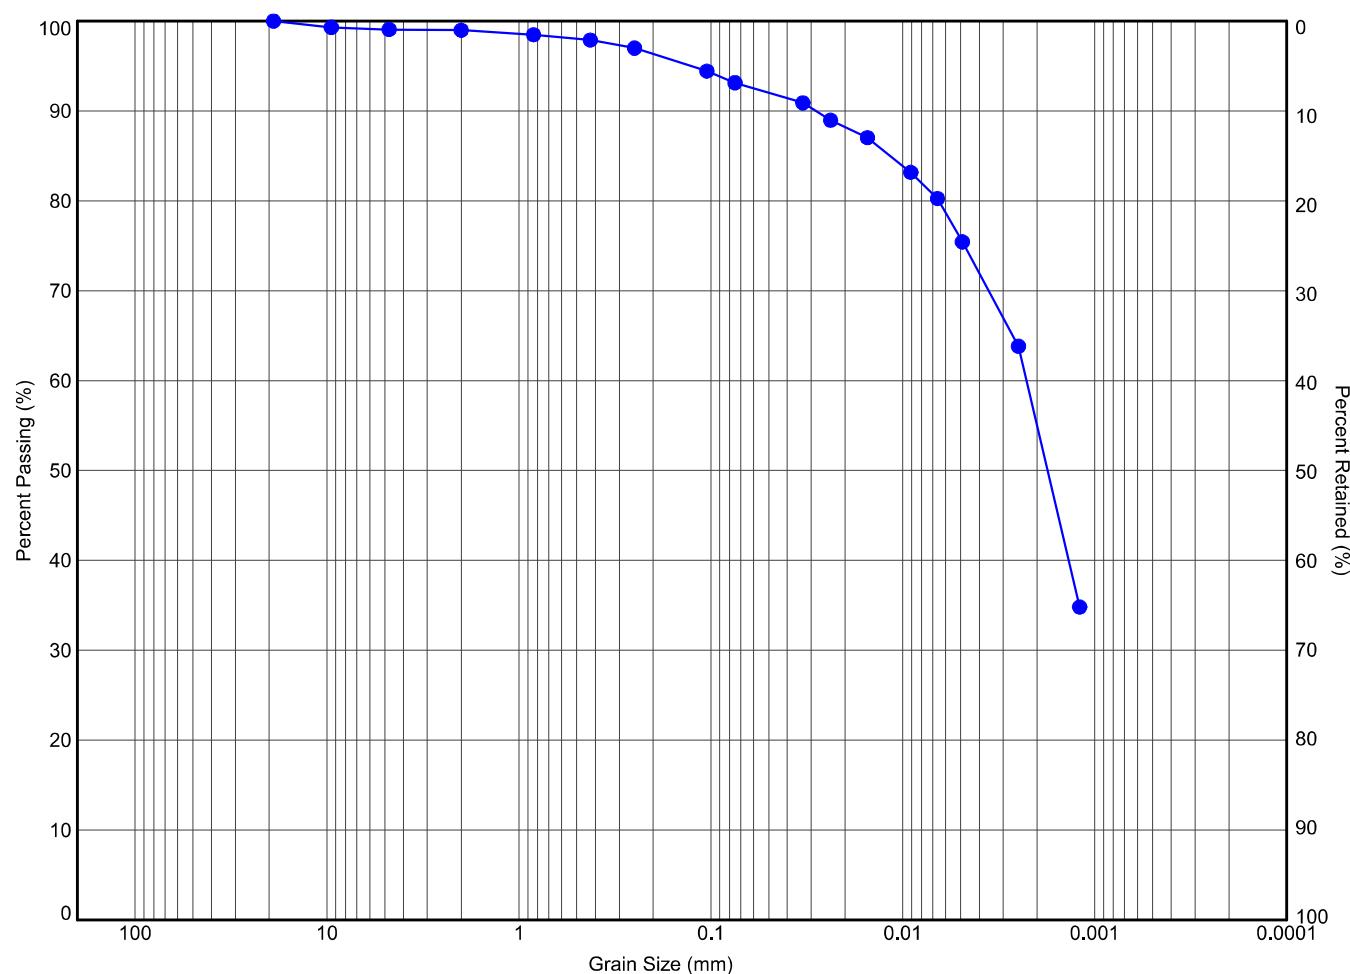
| Terraprobe 11 Indell Lane, Brampton Ontario L6T 3Y3 (905) 796-2650 | Title: GRAIN SIZE DISTRIBUTION CLAY AND SILT, TRACE SAND, TRACE GRAVEL | File No.: |

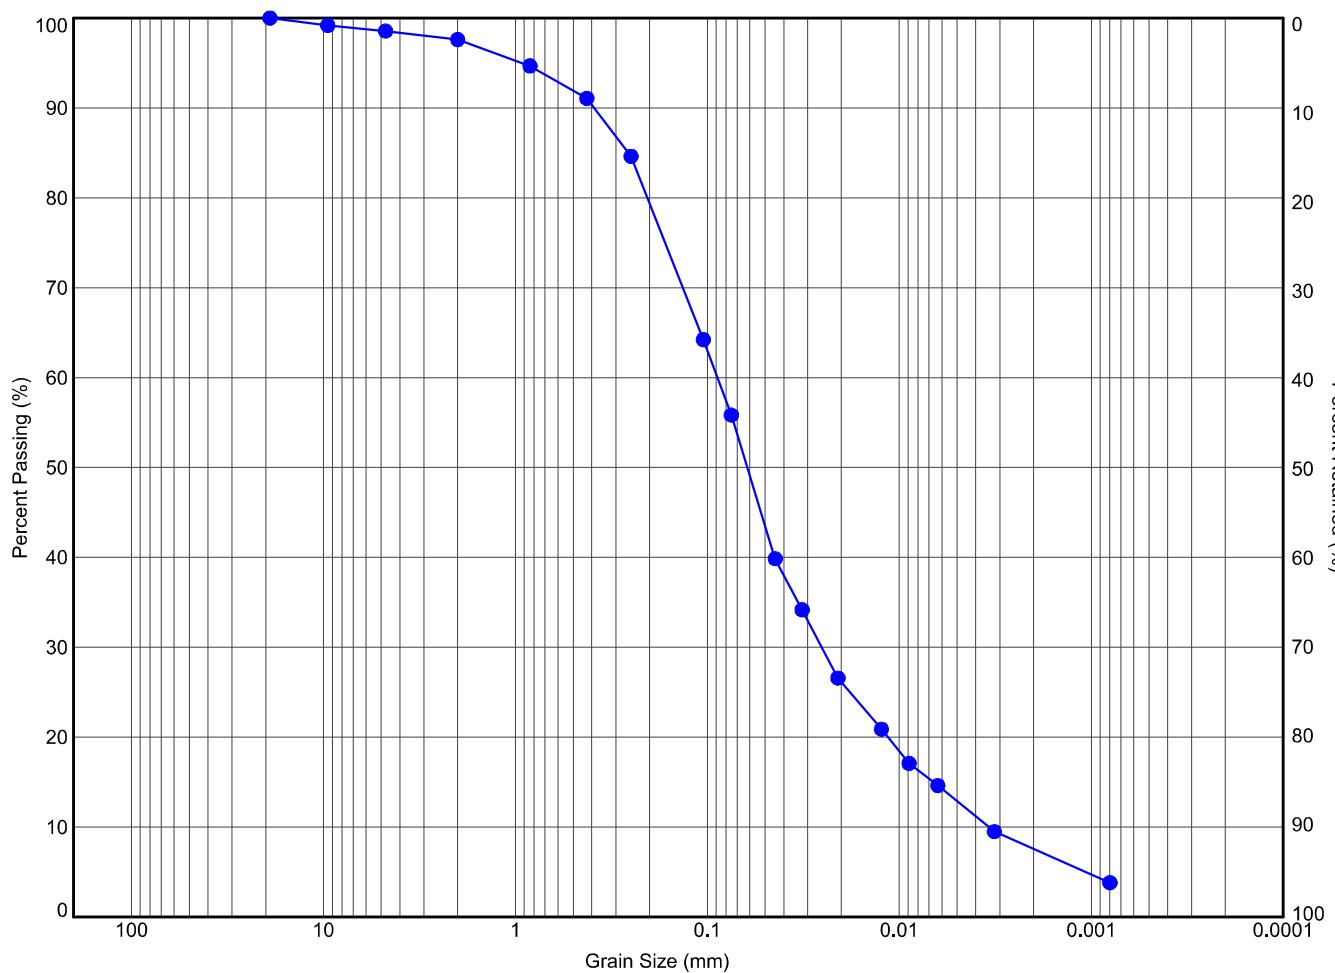
Title: **GRAIN SIZE DISTRIBUTION
SAND AND SILT, TRACE CLAY, TRACE GRAVEL (GLACIAL TILL)**

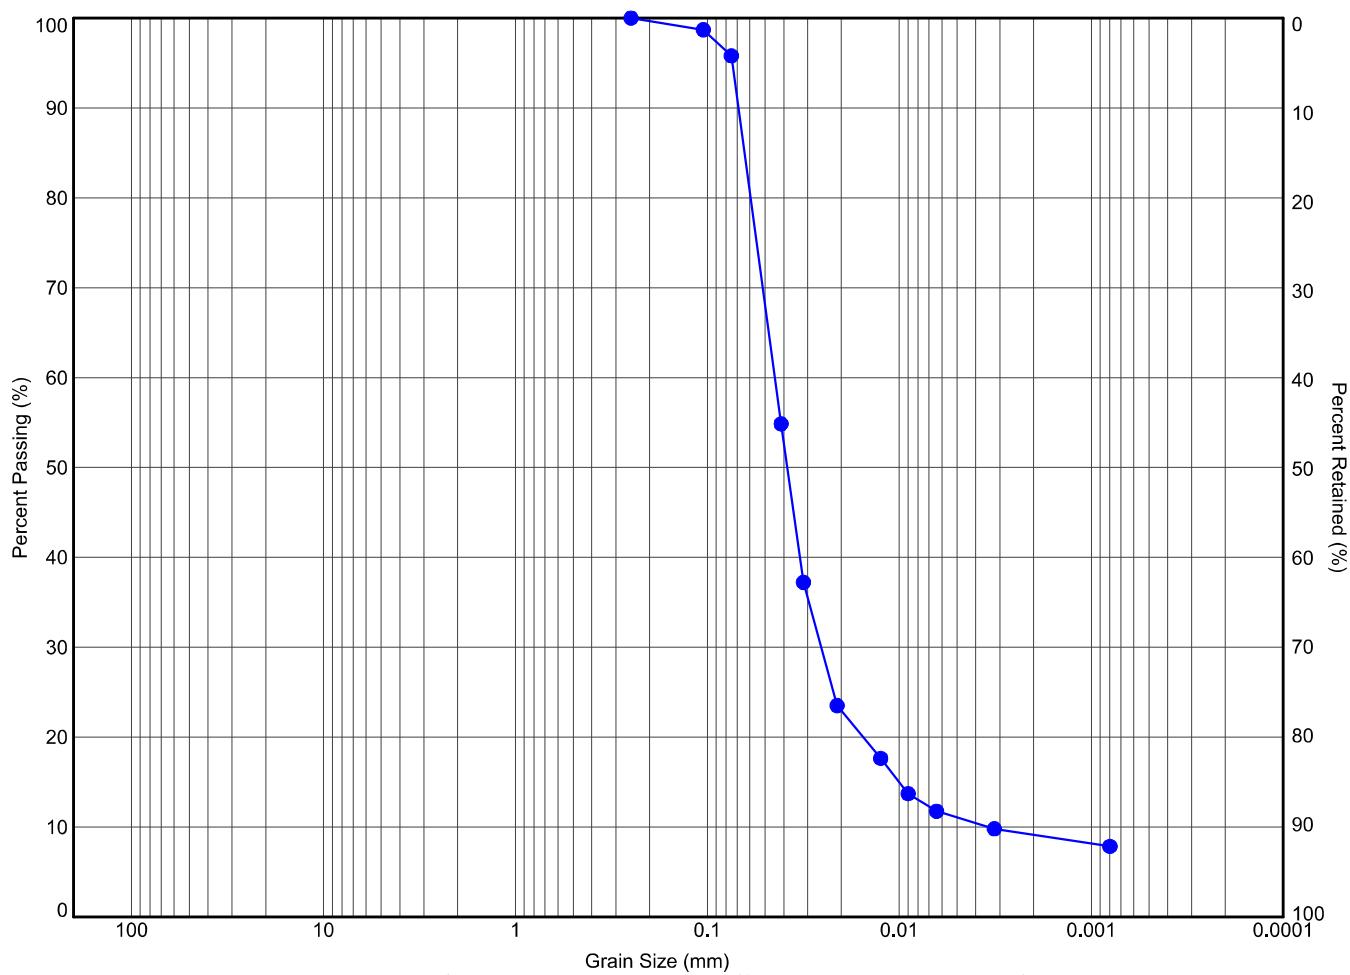
| Terraprobe 11 Indell Lane, Brampton Ontario L6T 3Y3 (905) 796-2650 | Title: File No.: | GRAIN SIZE DISTRIBUTION |
| | | SILT, SOME SAND, TRACE CLAY |

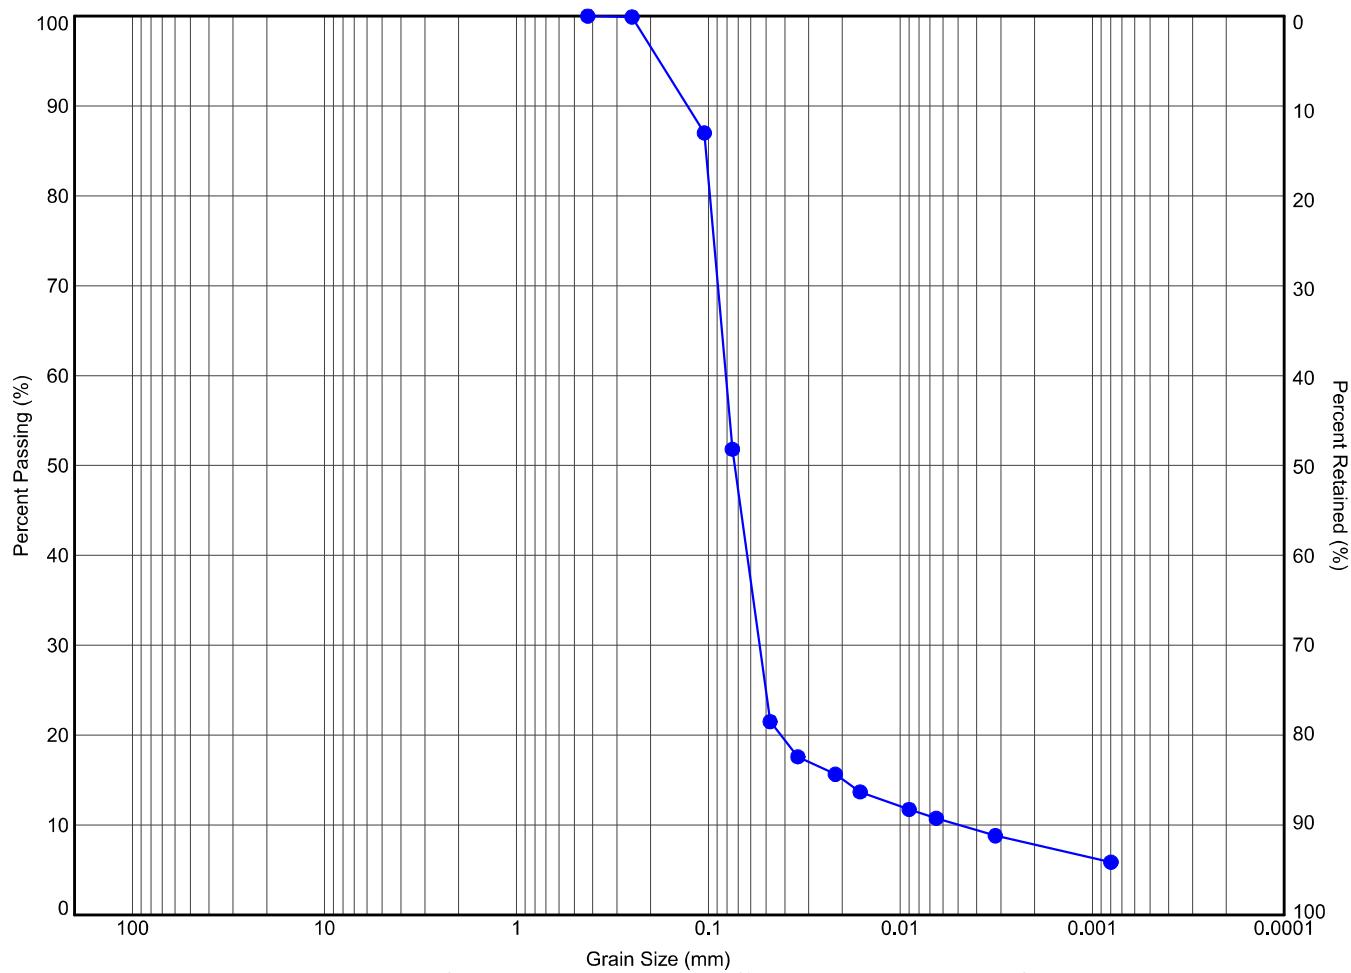
| Terraprobe <small>11 Indell Lane, Brampton Ontario L6T 3Y3 (905) 796-2650</small> | Title: File No.: | GRAIN SIZE DISTRIBUTION |
| | | SILTY SAND, TRACE CLAY |

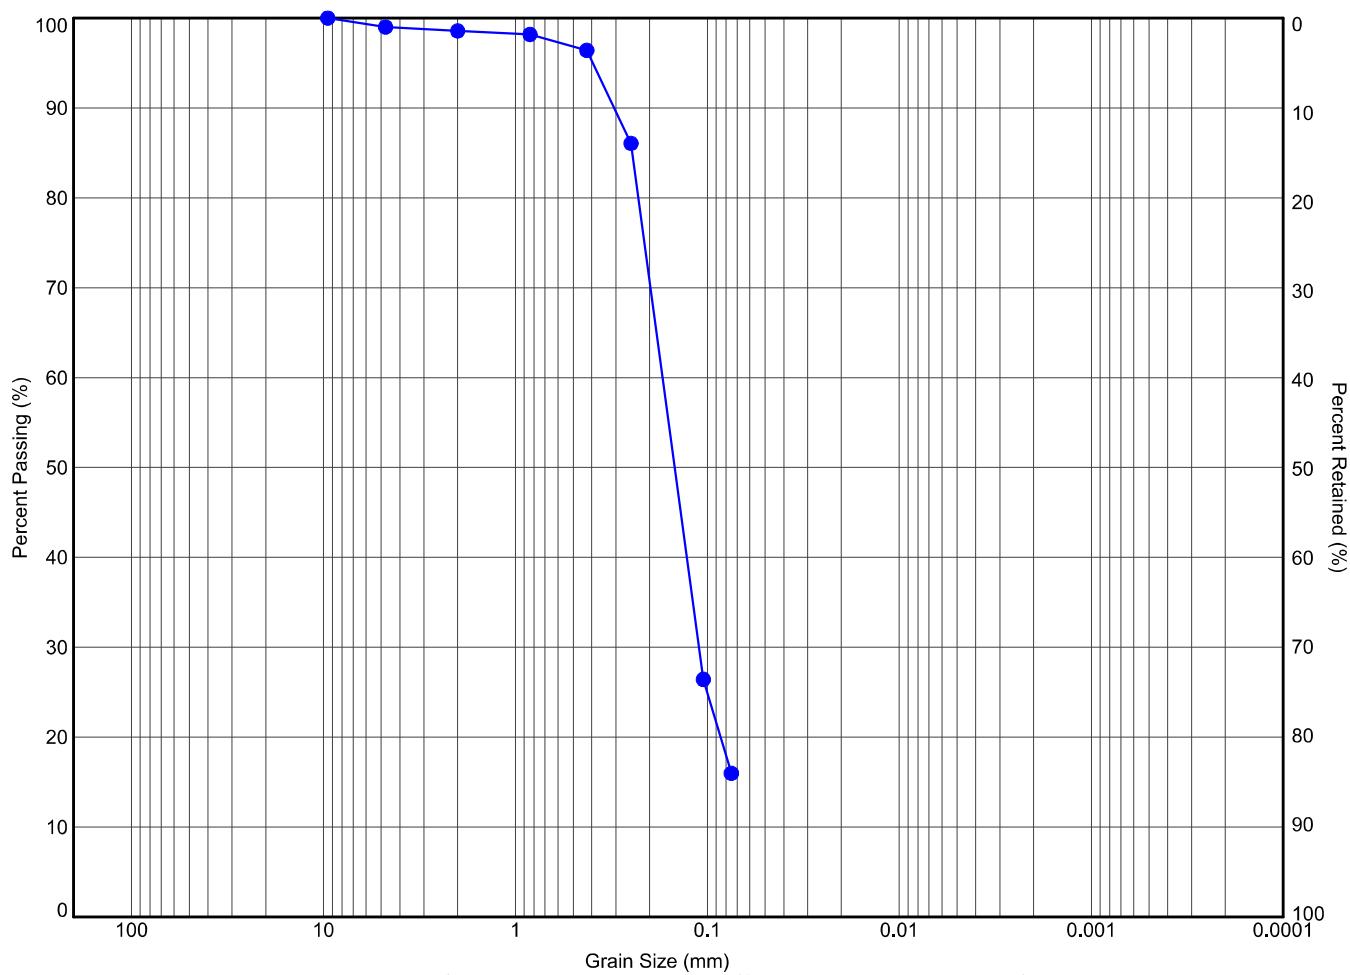
| Terraprobe 11 Indell Lane, Brampton Ontario L6T 3Y3 (905) 796-2650 | Title: GRAIN SIZE DISTRIBUTION SAND, SOME SILT, TRACE GRAVEL | File No.: |

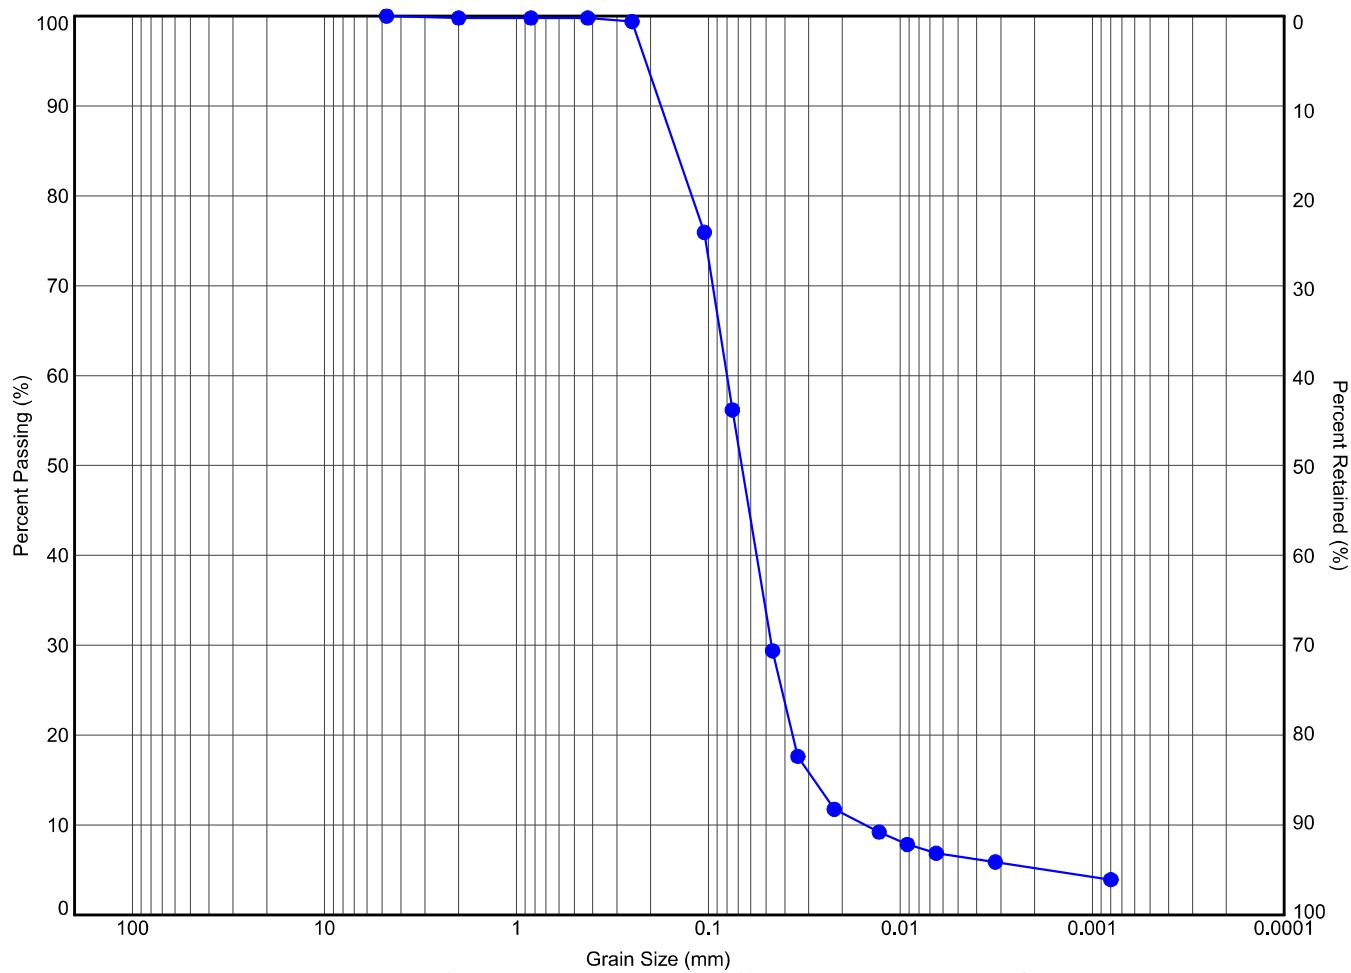
| Terraprobe <small>11 Indell Lane, Brampton Ontario L6T 3Y3 (905) 796-2650</small> | Title: GRAIN SIZE DISTRIBUTION SAND AND SILT, TRACE CLAY | File No.: |

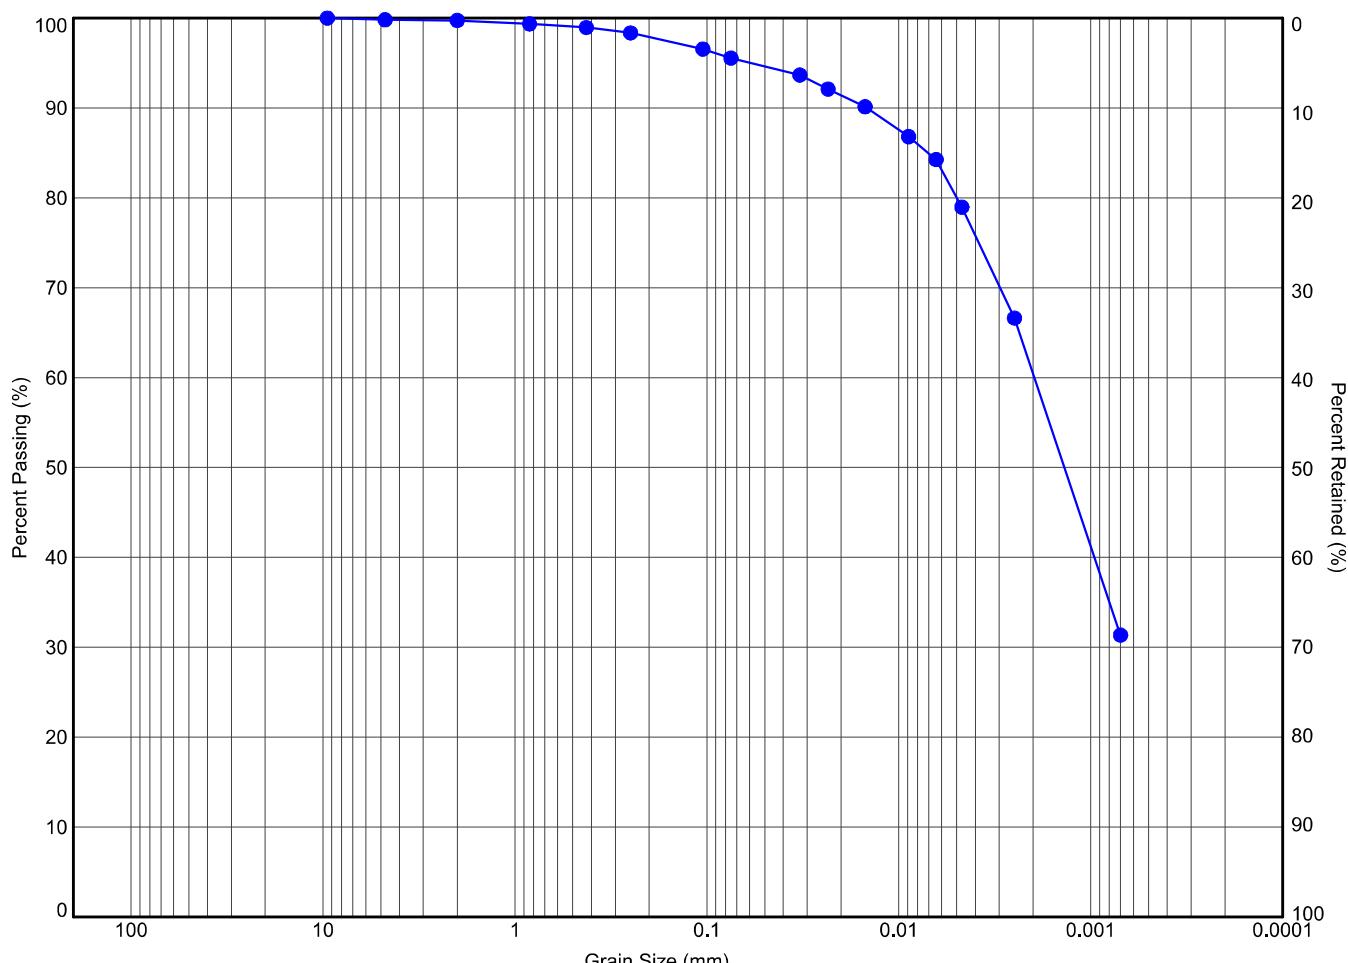
| Terraprobe 11 Indell Lane, Brampton Ontario L6T 3Y3 (905) 796-2650 | Title: File No.: | GRAIN SIZE DISTRIBUTION |
| | | CLAY AND SILT, TRACE SAND |

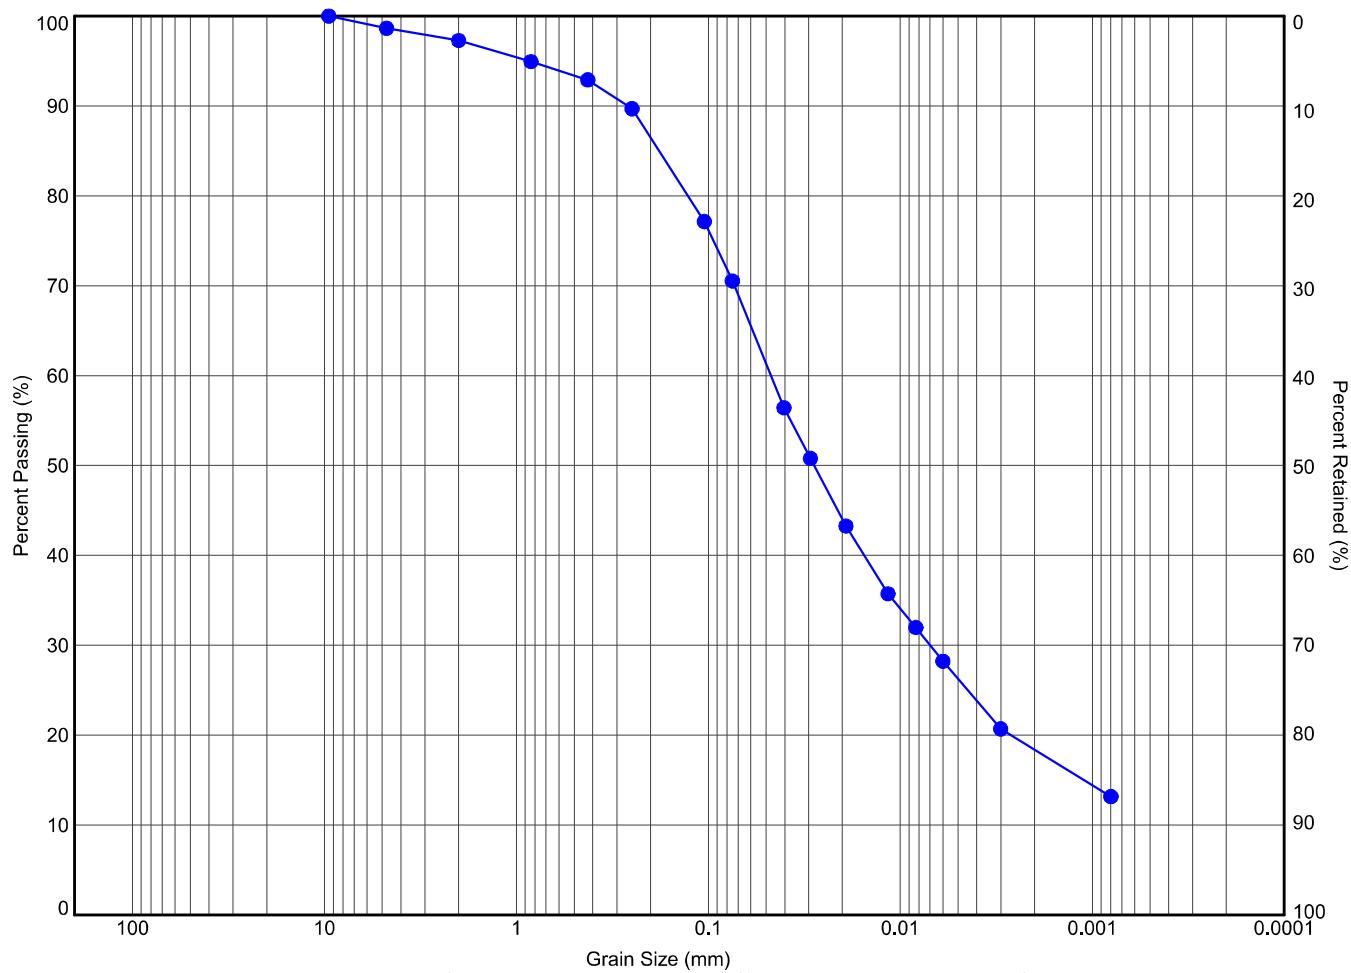
| MIT SYSTEM | | | | | | | |
|---|---|---|---|---|---|---|---|
| ● S30 | SS7 | 6.2 | 141.8 | 3 | 32 | 47 | 18 |

| Terraprobe <small>11 Indell Lane, Brampton Ontario L6T 3Y3 (905) 796-2650</small> | Title: GRAIN SIZE DISTRIBUTION SANDY SILT, SOME CLAY, TRACE GRAVEL (GLACIAL TILL) |
